The sinking of the Ro–Ro passenger ferry *SS Heraklion*

A. Papanikolaou^a, E. Boulougouris^{b,*} and A. Sklavenitis^a

Keywords: *SS Heraklion*, marine accident, damage stability, water on deck, extreme weather, sail-out permit, time simulation

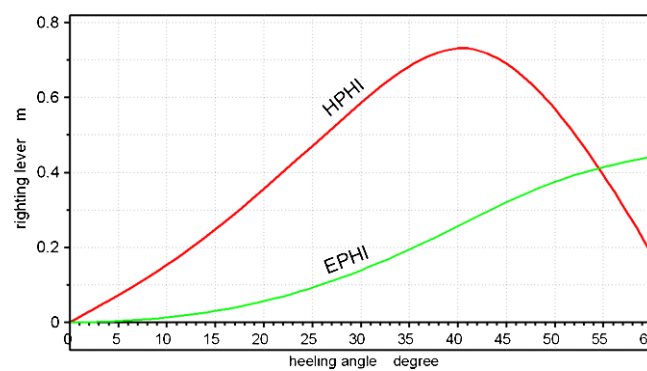
Fig. 7. Static (HPHI in m) and dynamic stability (EPHI in rad * m) at full load condition. (Colors are visible in the online version of the article; <http://dx.doi.org/10.3233/ISP-130109>.)

The results are in good agreement with those listed in the Georgiadis and Antoniou report [5]. The calculated displacement is 55.8 t less (−0.7%) and the metacentric height 0.09 m less than the reported values. Surprisingly, the vessel fulfilled modern intact stability criteria as shown in Table 5 (IMO Resolution A.749 (ES.IV)). The righting level at this loading condition is shown in Fig. 7 and is in good agreement with comparative figures of other researchers [2].

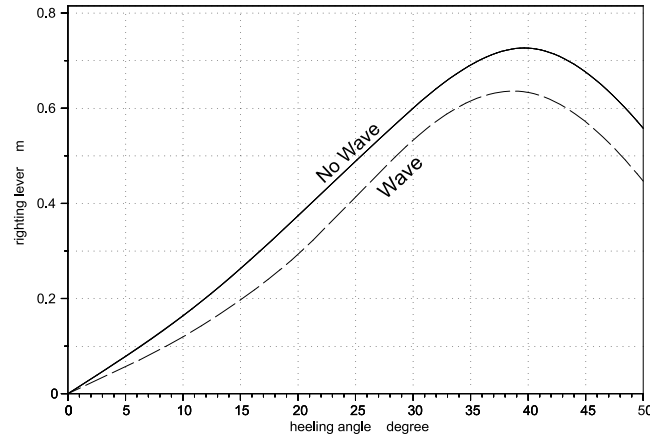
Fig. 8. Ship's stability in waves (wave crest).

The effect of stern or stern-quartering waves on ship's stability was also investigated, calculating at first the righting arm in waves. As can be seen in Fig. 8, there is a reduction of the righting arm with the ship on the wave crest ($H = 4$ m, wave length $\approx L_{wl}$), but this is not substantial, in view of ship's hull form. In addition, the guidance criteria provided by IMO for avoiding dangerous situations in adverse weather and sea conditions (MSC.1/Circ.1228 [6]) were examined. It includes dynamic stability phenomena that may occur in following and quartering seas, e.g. surf-riding and broaching-to phenomena; synchronous rolling motion; parametric rolling and combination of various dangerous phenomena. The respective phenomena, the conditions for their occurrence in general and in particular in the case of *SS Heraklion* in the night of accident were examined and the outcome is shown in Table 6. From these results it is obvious that *SS Heraklion* was in the night of the accident sailing in the dangerous zone of *very likely occurrence of successive high-wave attacks and likely of parametric rolling motions*.

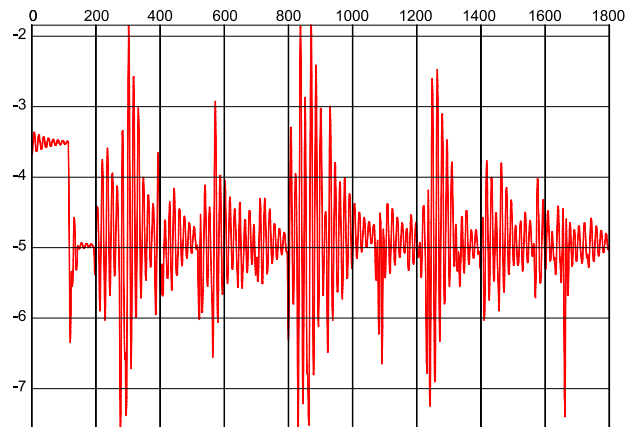
Fig. 11. Heeling angle vs time (s) for watertight cardeck. (Colors are visible in the online version of the article; <http://dx.doi.org/10.3233/ISP-130109>.)

Initially the forward car deck was considered watertight with no downflooding points. In this case the ship would not capsize as can be seen in the Fig. 11. As shown in Fig. 12, an average quantity of about 30 t of floodwater is entering the forward car-deck space though the side door opening. Ship's heeling increases from 3.7 degrees in still water due to the loading asymmetry to an average of about 5 degrees, rolling at times to more than 7 degrees; however, the ship is generally stable.

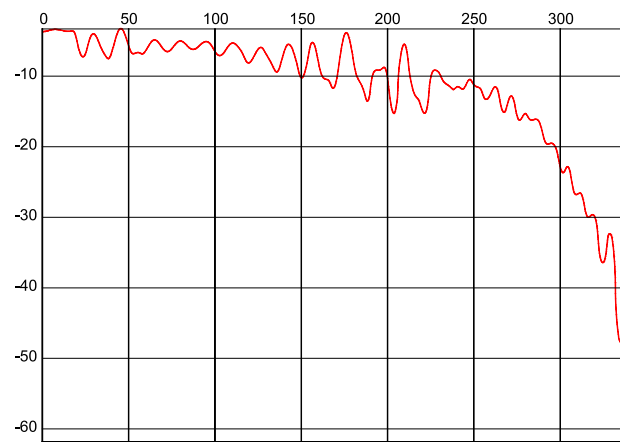
Fig. 13. Heeling angle vs time (s) for 0.1 m^2 cardeck downflooding opening area each. (Colors are visible in the online version of the article; <http://dx.doi.org/10.3233/ISP-130109>.)

Assuming that there are 6 down flooding openings on the car deck (for which there is evidence that it was not watertight), with an effective area of merely 0.1 m^2 , each connecting the cardeck space with the void spaces below, the situation changes dramatically. Now the list of the ship increases continuously and the ship capsizes after 340 s as can be seen in Fig. 13. The floodwater is following the same trend as it is shown in Fig. 14. The position of the ship just before capsizing is shown in Fig. 15.

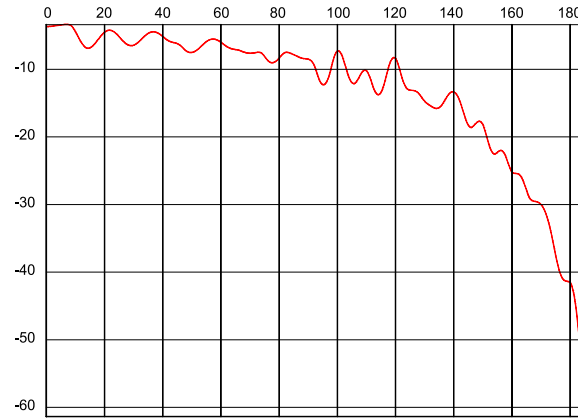
Fig. 16. Heeling angle versus time (s) for 0.2 m² cardeck downflooding opening area each. (Colors are visible in the online version of the article; <http://dx.doi.org/10.3233/ISP-130109>.)

Doubling the size of the downflooding openings results in the capsize of the ship in almost half the time, namely from 340 s to 185 s. It is interesting to note that

the floodwater quantity is about the same (around 2,500 t). The heeling angle time history for this case is illustrated in Fig. 16 while the floodwater time history is depicted in Fig. 17.
