**AN EXPERIMENTAL AND FINITE ELEMENT STUDY OF
THE LOW-CYCLE FATIGUE FAILURE OF A
GALVANIZED STEEL LIGHTING COLUMN**

James Wood^a, Louise A. Alexander^b and Ian Taylor^b

This paper presents the results of a low-cycle fatigue test on a lighting column. The wind induced vibration phenomena responsible for low cycle fatigue in such structures is discussed and the failure mechanism is examined. It was initially thought that poor quality weld detail was the major influence on the fatigue life of such columns. However, the significant role of the galvanised coating in the failure process is also highlighted.

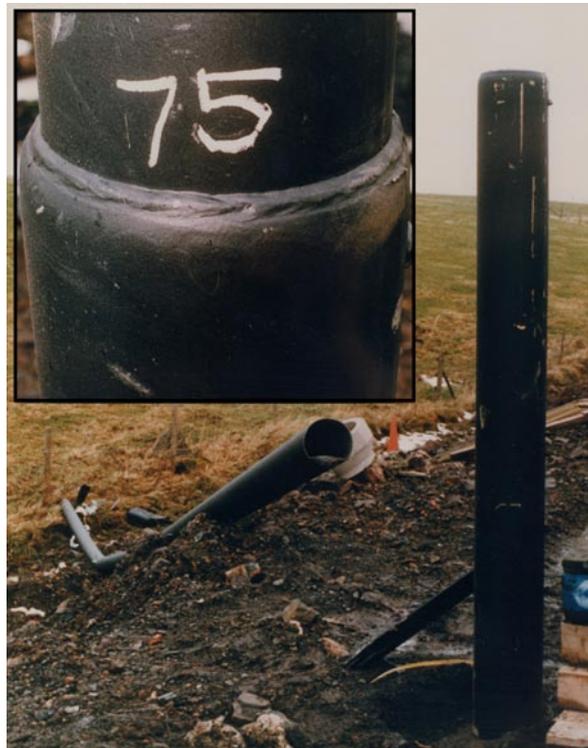
Figure 1: Low-cycle fatigue failure of 18m lighting column.

It may be observed that the columns failed at the fillet weld adjacent to the swage section above the door. The swage joint is the focus for the present investigation. The period of vibration, amplitude of vibration and time to failure for these newly installed columns, observable from the video footage associated with these failures, would indicate low-cycle fatigue as the failure mechanism. This type of failure proved to be a significant problem with particular designs of column throughout the UK.

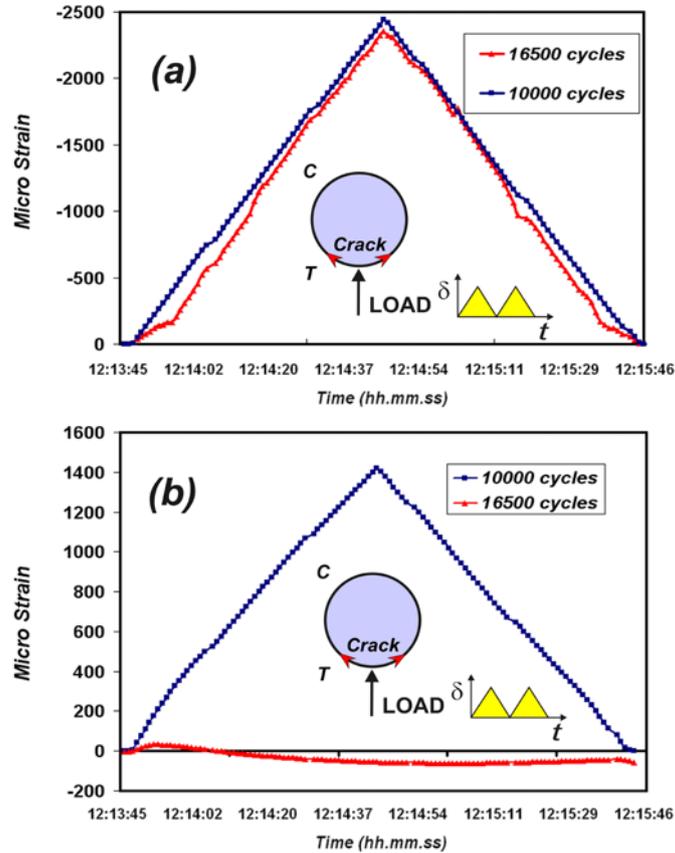
approximately 10 hours. The crack was found to be approximately 102mm long in the hoop direction along the weld toe, as illustrated in Figure 5.

Figure 5: Strain-time variation for 10000 and 16500 cycles.

Figure 5 shows the strain-time variation for the 10000 and 16500 cycles, for the longitudinal gauges closest to the swage joint on both the compression (a) and tensile (b) surfaces. Figure 5(b) shows the strain drop-off on the gauge on the tensile side as the crack develops around the circumference of the tube. There is clearly no such drop-off on the compression side.

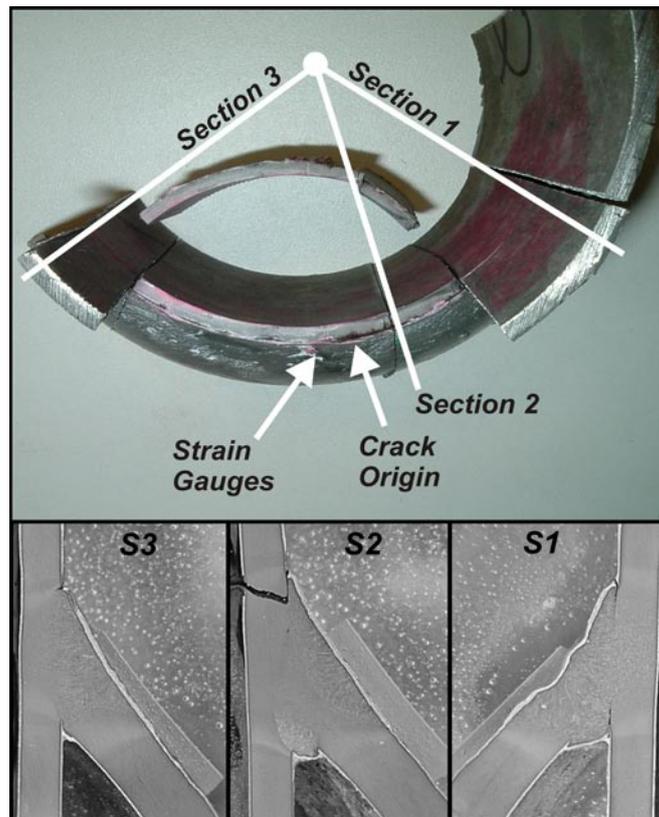
Figure 7: Micrograph specimen location.

First of all it may be observed in Figure 7, that the quality of the weld is very poor. At section S1 there is lack of penetration, poor root formation, wall thinning and irregular weld profile. This un-fused weld metal is referred to as a “cold lap” and can be a problem with high deposition rate welding. They can inhibit the successful application of weld toe improvement techniques such as toe grinding and also have the additional problem that the growing fatigue crack is not visible and hence is less easy to detect. Figure 7 also shows that the root formation is variable across all three sections, as is the thickness of galvanised coating. Cracks are evident at the weld toe in all three sections.

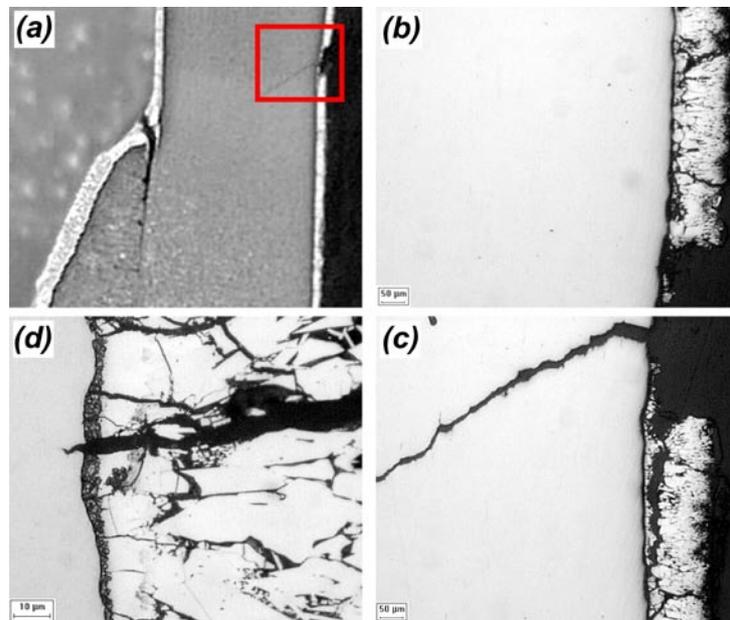
The micrographs for section S1 in Figure 8 show that the toe crack, instead of propagating through the thickness, as would be expected, has joined with the “crack” formed by the “cold lap”. The fact that these cracks are due to lack of fusion is apparent in Figure 7, as the root is still sealed with galvanizing.

Figure 8: Micrographs for specimen 1.

Interestingly however, Figures 8(a) and (c) show a fatigue crack developing from the inside surface of the tube. This is somewhat unexpected, in that the inner surface is not welded and lacks the stress concentrating toe. In addition, the nominal bending stress is not as high on the inner surface as it is on the outer. However, it may be observed that there is a section of the galvanised coating missing. It is postulated that the coating has de-bonded from the steel substrate due the axial compressive stresses in this vicinity. This in turn has acted as a severe stress concentration, leading to the development and propagation of the crack shown. The galvanised coating shows evidence of significant damage and cracking. Figure 8(d) shows a crack just starting to run from the galvanizing into the steel. It would therefore appear that the de-

bonding scenario is not necessary for crack initiation and propagation. These are significant observations and indicate that weld improvement may not in fact increase the fatigue life of galvanized steel lighting columns.

Given that the most severe corrosion will be on the outside of columns and the detrimental effect of galvanizing on fatigue performance, then columns may benefit if the inner surface was not galvanized in regions of stress / strain concentration.

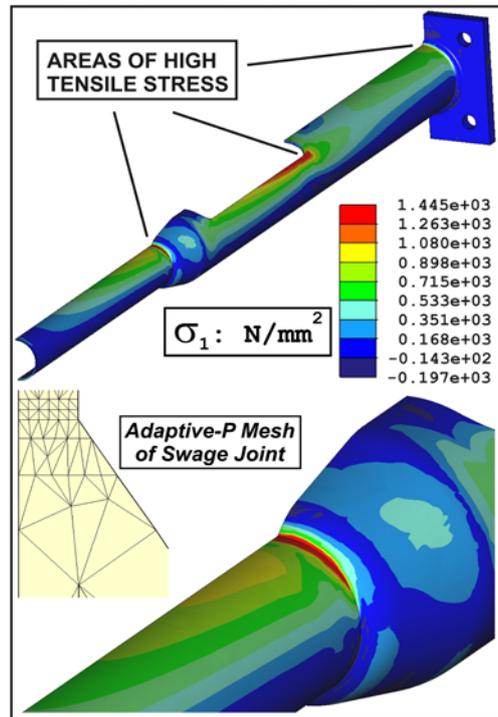
Figure 9 shows 3 areas of high stress – the base weld, the lower corner of the door opening and the swage joint. As has been previously indicated, it is the swage joint which is the focus of attention in this study.

Figure 9: Adaptive P-method Finite Element Model.

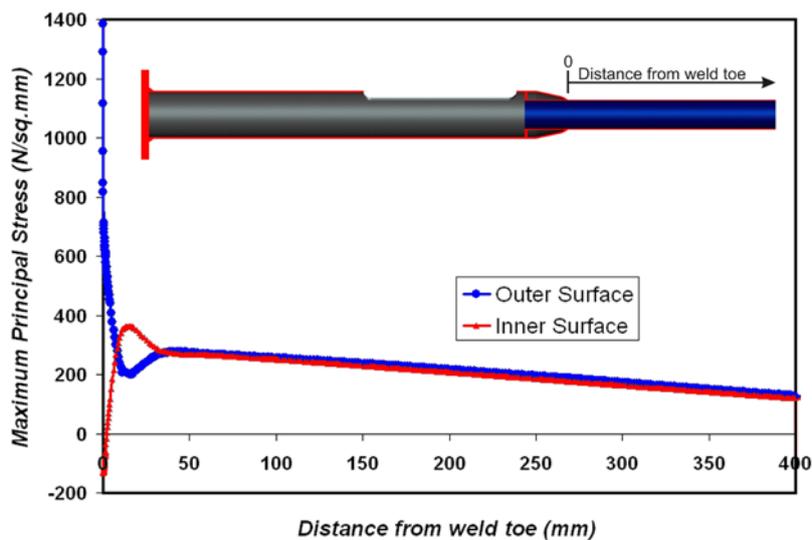
The localized nature of the stress concentration at the swage joint is illustrated in Figure 10. The stress distribution on the toe side tends to infinity with mesh refinement due to the singularity at the weld toe. The extremely localised effect due to the weld (within a quarter of the tube thickness of the weld toe) is superimposed on the gross geometric stress concentration due to the swage. It is the localized component due to the weld that has to be removed for fatigue assessment. This is necessary because the fatigue allowables in the Codes of Practice already include the effect of the weld.

The stress distribution on the inner surface is continuous however. This distribution is terminated opposite the toe for comparative purposes. The very steep gradient on the inner surface is also apparent and the axial bending stress becomes compressive within a distance of one wall thickness of the weld toe position. The compressive strains associated with this stress field could be the source of possible damage of the relatively low-ductility galvanised coating in this region. This in turn will result in fatigue cracks developing from the inner surface as observed in the experiment.

Figure 10: Maximum Principal Stress Decay at Swage Joint.
