An Investigation of Diesel-Generator Shaft and Bearing Failures.

Abstract: A shaft failure in a 634 kW diesel generator after 4000 hours of operation required investigation, especially when similar sets began to show signs of excessive bearing housing wear. The failure was found to be due to torsional fatigue caused by operation at an unforeseen resonant condition. The damage to the bearing housing of this type of set was also attributed to this behaviour.

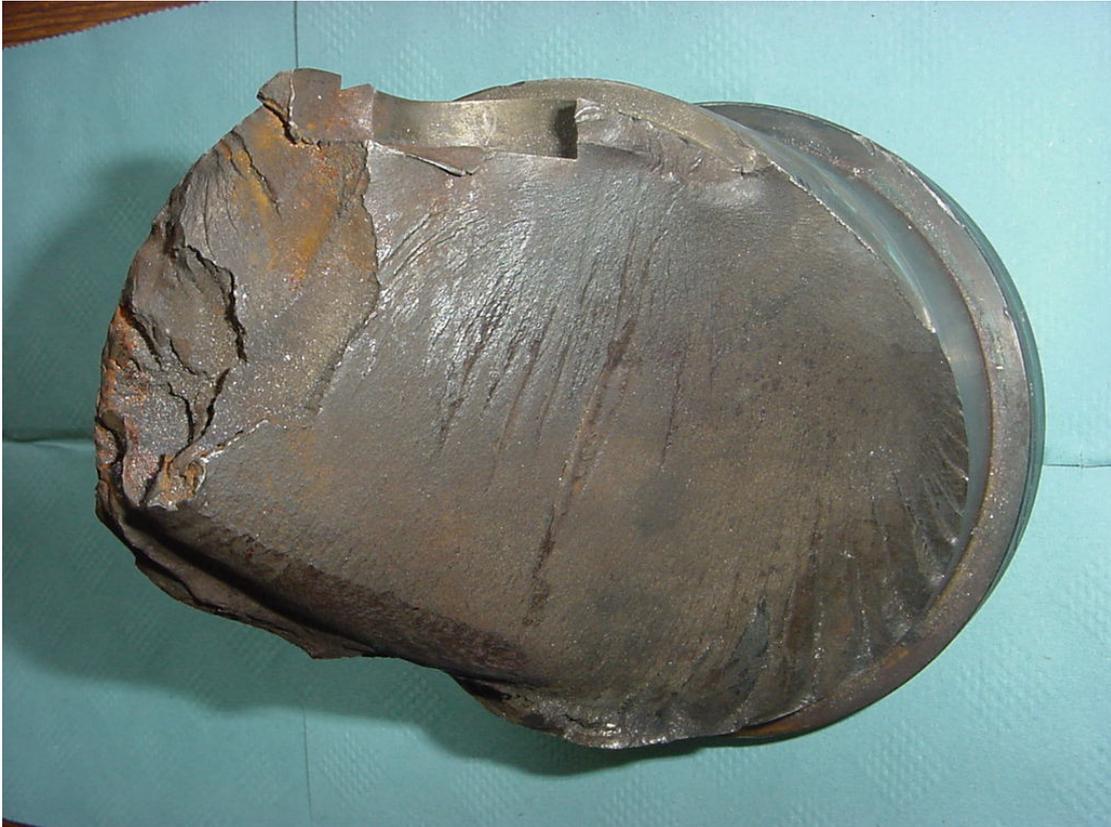
The generator shaft that failed was 110 mm diameter at the section where the break occurred. The fracture occurred near to the coupling end of the machine and the fracture surface included the keyway that was used to locate the coupling half on the generator shaft. Figure 1 shows the “generator side” of the failed shaft. The fractured surface was predominantly at 45° to the shaft axis and showed the classic signs of being a torsional fatigue failure.

The fracture surfaces had suffered significant consequential damage during the failure process so the site of initiation of the fatigue could not be determined with certainty using fractographic methods. Two potential sites were identified; 1) the keyway root 2) a possible indication of a 6 mm material defect, near to the surface of the plain shaft and approximately 20 mm from the keyway.

ESDU 86028 (2) provides information on stress concentration factors in standard keyways suggesting that the critical area is at the root where the parallel section meets the semicircular end and stress concentration levels of 3.4 – 4.0 are applicable based on the maximum shear stress in a plain shaft. The keyway root radii were checked to ensure that there was no possibility that they were sharper than the standard forms for which the data was applicable. The keyway dimensions were found to conform to the standard dimensions. This suggested that a fluctuating torsional shear stress of the order of 50 MN/m² would be necessary to initiate a fatigue failure from this site. It can be seen from Figure 1 that the fracture surface did include this most highly stressed region of the keyway.

Although the precise location of the fatigue crack initiation could not be determined, the analysis showed that either location was possible provided fluctuating shear stress levels in the region of 50 MN/m^2 were established in the shaft.

Figure 1 View of fractured shaft looking from coupling end towards generator.

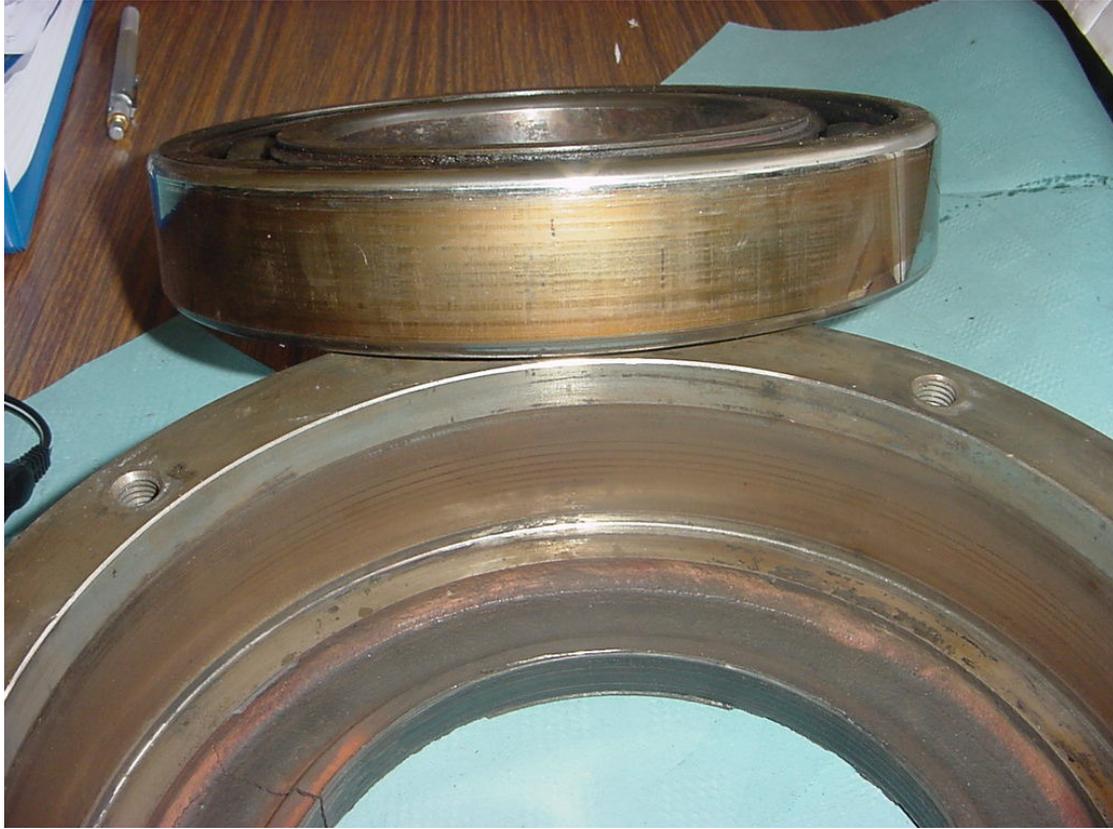
The bearing was a deep groove radial ball bearing of 120 mm inside diameter. The bearing itself had not failed but the cast iron housing showed excessive wear in the region where the outer race of the bearing sat. Micrometer measurements of the wear indicated reasonably uniform radial wear of 0.21 mm (0.008 inches) suggesting that

the outer race had been rotating within the bearing housing. This hypothesis was supported by circumferential marks and gouges on the outer race and discoloration of the bearing due to heat. Figure 2 shows the outer race of the bearing and the housing showing the wear and the marks. The discoloration showed a bluish tint over a 45° segment suggesting that a temperature of 290°C had been reached. The centre of this area was blackened so this temperature was considered to be an underestimate of the peak temperature actually attained within the bearing.

The bearing housing also showed signs of melting, plastic deformation and cracks on the inner bore (Figure 2) but this was attributed to the shaft failure rather than action within the bearing prior to the shaft failing.

Although the exact magnitude of the radial bearing force could not be accurately established it was considered that this proposed mechanism showed the possibility of generating a large, rotating, radial force from a torsional resonant operating condition and could explain the damage that was evident on a number of sets.

Figure 2 View of bearing and housing showing circumferential wear and marking.

The bearings and housings of similar sets were inspected and replaced where necessary. Existing and future designs of diesel driven generator sets are to be scrutinised for the possibility of torsional resonance under part load conditions.

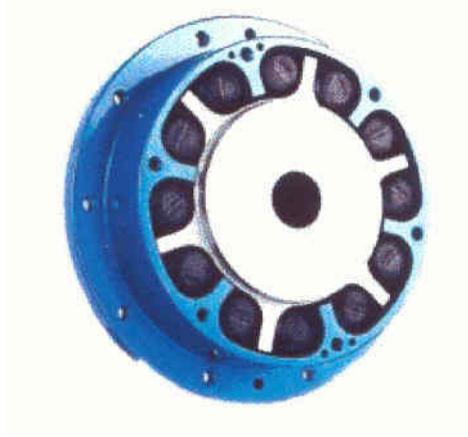
The coupling consisted of 12 rubber cylinders interspersed between driving and driven steel plates as shown in Figure 3. A visual inspection of the coupling found evidence of mechanical damage to the hub in the form of deformation and burring of some of the drive blades and blade cutting damage in the 6 rubber drive elements. The 6 drive elements had suffered excessive permanent set and all of the elements showed signs of hardening. The increase in hardness suggested that the elements had been subjected to high temperatures. This could have been due to high ambient operating conditions (operating temperatures of 70°C were common within sets operating in this region) or heat generated within the rubber if it was subjected to excessive, fluctuating compressive loading produced by torsional oscillation of the shafting system.

Figure 3 Flexible coupling of the type used on the diesel-generator set.

To cure the problem it was necessary to separate the 1st natural frequency of the system from the main torsional excitation frequency to avoid resonance under any load condition. To ensure this, it was necessary to reduce the natural frequency of the system at full load so that it lay below the excitation frequency of 37.5 Hz. This would result in the 1st natural frequency moving further away from 37.5 Hz as the load was reduced. By changing to softer, silicon rubber flexible elements within the coupling it was possible to start with a 1st torsional natural frequency of 34 Hz at full load. This was shown to be far enough away from the excitation frequency to significantly reduce torsional vibration problems. An added advantage of moving to silicon rubber was its ability to operate at higher ambient temperatures.
