1 **Structural integrity monitoring of onshore wind turbine concrete foundations**

2 Magnus Currie^{1*}, Mohamed Saafi^{2*}, Christos Tachtatzis³ and Francis Quail⁴

7 **Abstract**

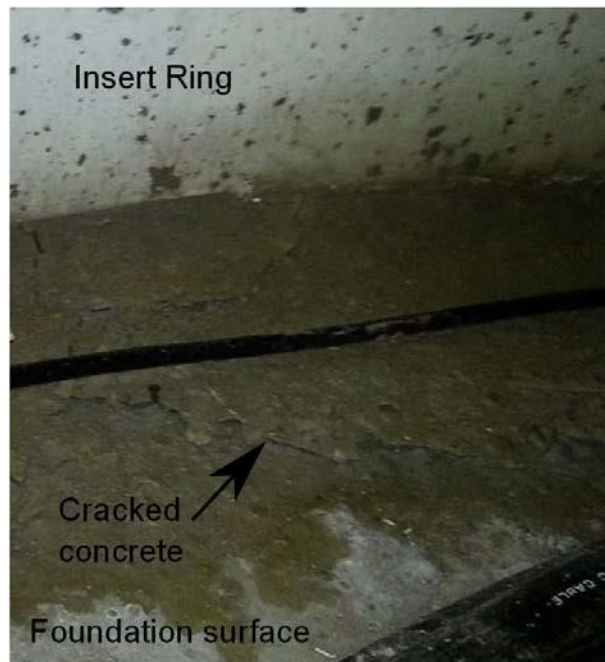
76 The onshore wind turbine concrete foundations with embedded ring shown in Fig. 1 are widely
77 used around the world. These types of foundations are the subject of this study with respect to
78 vertical movement. Several wind farms were visited to identify the main cause of this vertical
79 movement using Endoscopic filming through boreholes created in the foundations. The
80 Endoscopic filming showed significant voids filled with water under the flange of the embedded
81 ring. Significant erosion was also observed on the upper side of bottom flange due to the uplift
82 forces placed on the foundation by the rotor. These voids have caused excessive vertical
83 movement of the ring, leading to concrete cracking (Fig. 2) and failure of the water proofing
84 system.

314 Fig. 2 Cracked concrete foundation as a result of excessive displacement of the embedded ring.

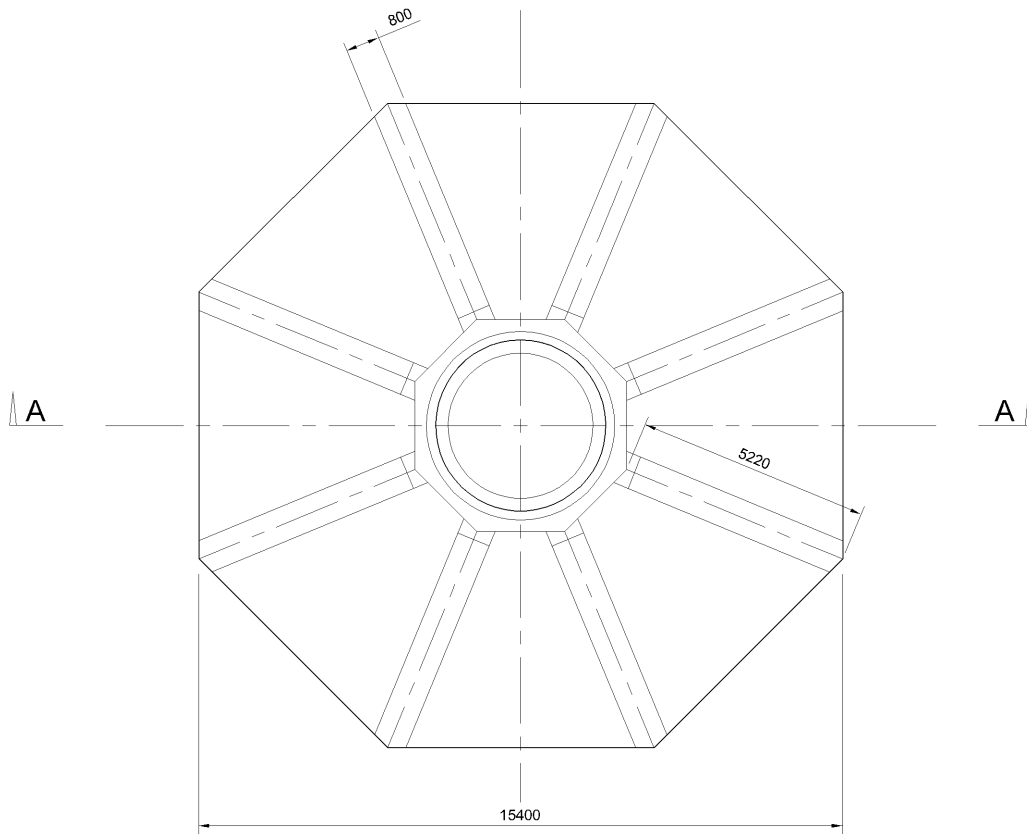
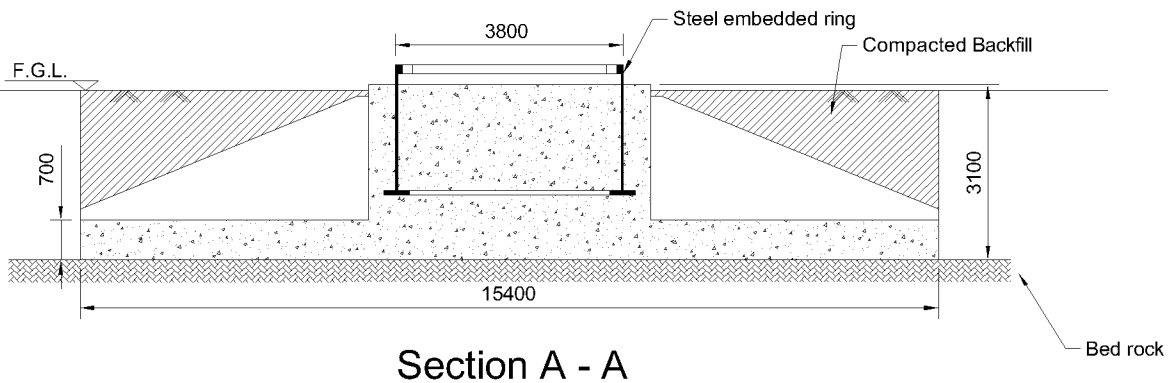
Fig. 3. Layout of the wind turbine concrete foundation (dimensions in mm)

91 The wind turbine test bed used in this investigation was a modern 2.0 MW pitch regulated
92 variable speed machine and in operation for at least five years. The exact location and turbine
93 model are confidential due to a non-disclosure agreement with the operator. The foundation
94 consisted of an octagonal reinforced concrete slab with an embedded steel ring connection
95 system. Fig. 3 shows the geometry of the foundation. The foundation was designed to support a
96 67 m-hub tower equipped with a rotor of 80 m in diameter.

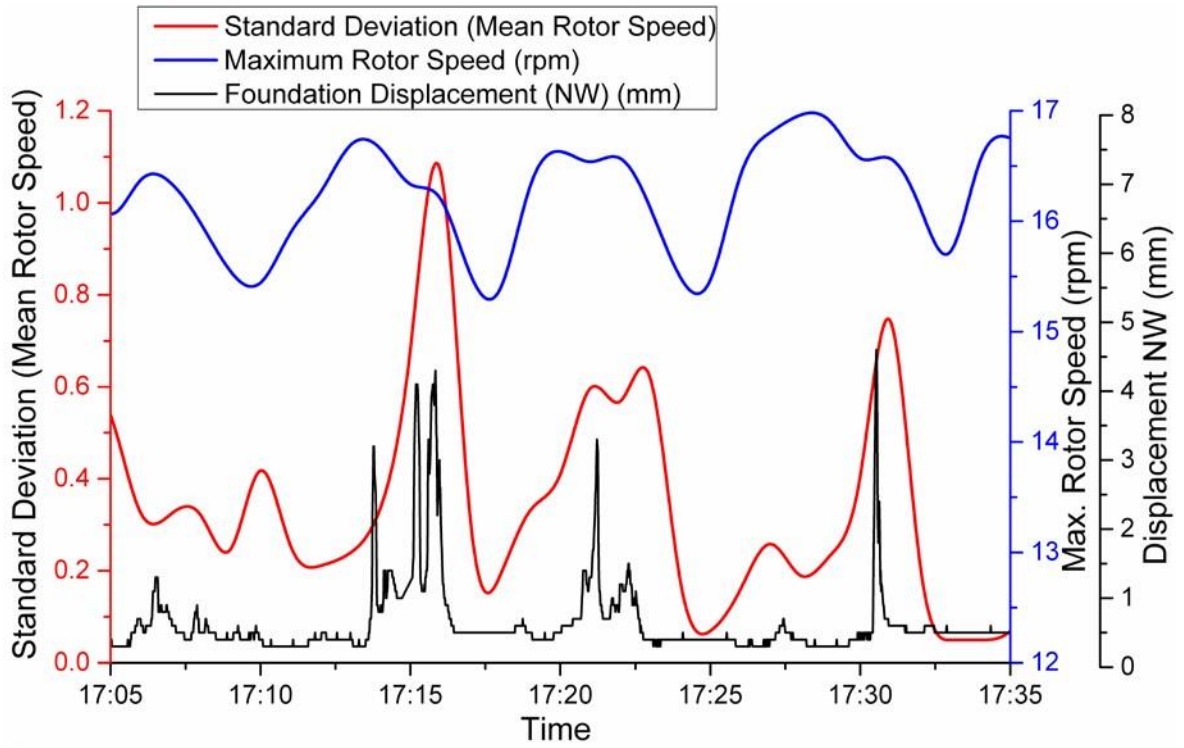
a)

144 Fig. 5a depicts the structural response of the embedded ring subjected to dynamic loading during
145 the turbine operating conditions over a period of 30 min. As can be seen, large drop offs in the
146 maximum rotor speed were observed. This was due to the drop in the wind speed. The standard
147 deviation of mean rotor speed exhibited peaks higher than 0.6, suggesting a period of turbulence.
148 The spikes in the ring displacement occurred in line with the standard deviation peak. This
149 means that during periods of turbulent wind, the rotor is subjected to sudden acceleration and
150 deceleration. This sudden change in the momentum resulted in the ring lifting and falling of the
151 embedded ring. This suggests that the embedded ring experiences vertical displacement during
152 sudden acceleration and deceleration of the rotor resulting from the change in the wind speed and
153 direction. Vertical displacement could also occur during shut down and start up events as this

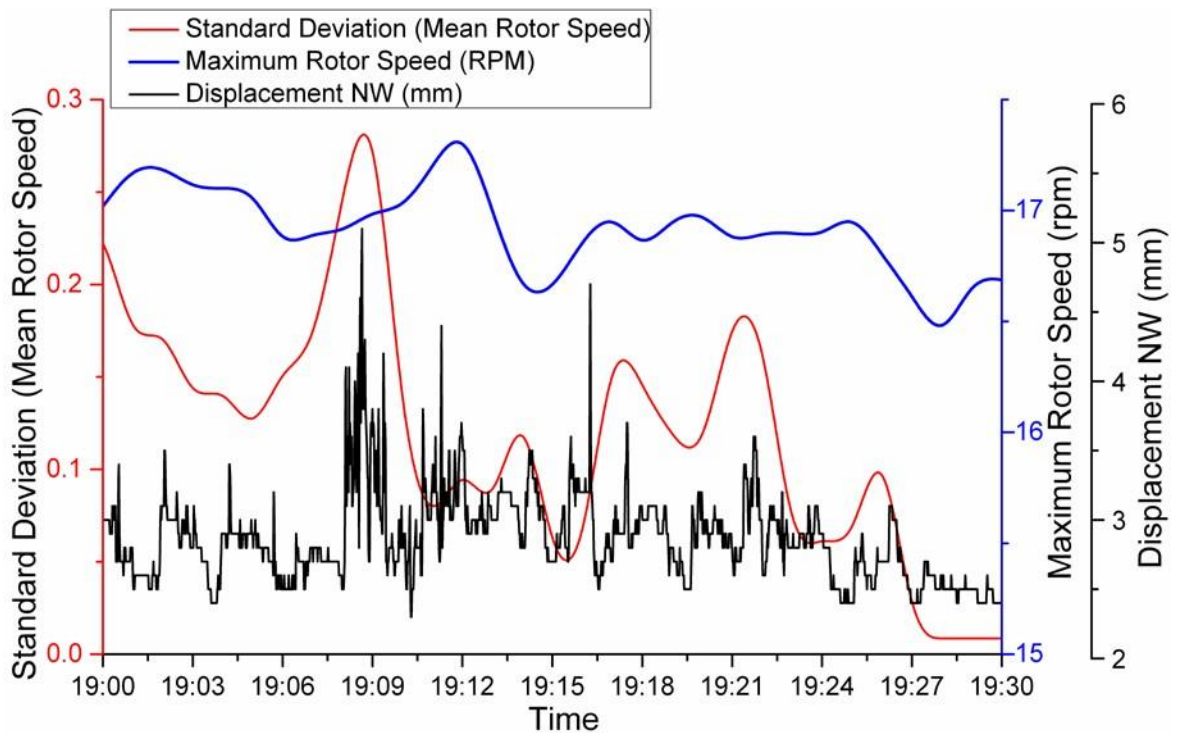
b)

154 produces sudden acceleration and deceleration of the rotor. Figure 5b shows a number of peak
155 displacements up to 5 mm. In this case, some of the peaks appeared to be related to the rotor
156 speed standard deviation e.g. turbulence, whilst others, such as at 19:12, appeared to be related to
157 the maximum rotor speed peaks.

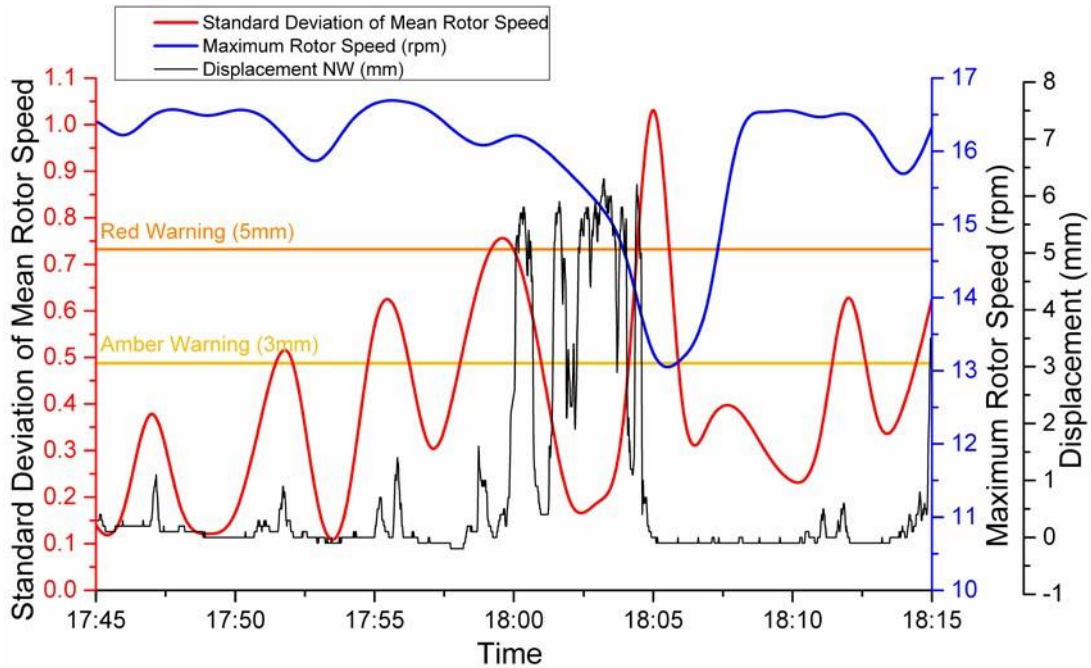
158 As shown in Fig. 6, the embedded ring experienced significant vertical displacement at
159 high wind speeds. Serious displacement was deemed by the operator to be any movement over 5
160 mm in magnitude. Most of the vertical displacement was witnessed in the rising direction with
161 the tower settling back downwards after rotor speeds stabilised. A significant period of
162 displacement over approximately 5 min was observed between 18:00 and 18:05. The amber and
163 red warning lines at 3 mm and 5 mm respectively indicate the warning bands required by the
164 operator for analysis. At 18:01 there was a large drop off in the rotor speed, which triggered
165 large upward then large downward displacements of over 5 mm, breaching the red warning line.
166 Five small displacement peaks between 0.5 mm and 1.5 mm were also observed. Each of these
167 peaks correlated with the rotor speed standard deviation peaks as shown in Fig. 6.

428 Fig. 6. Effect of high wind speed on the vertical displacement of the embedded ring.

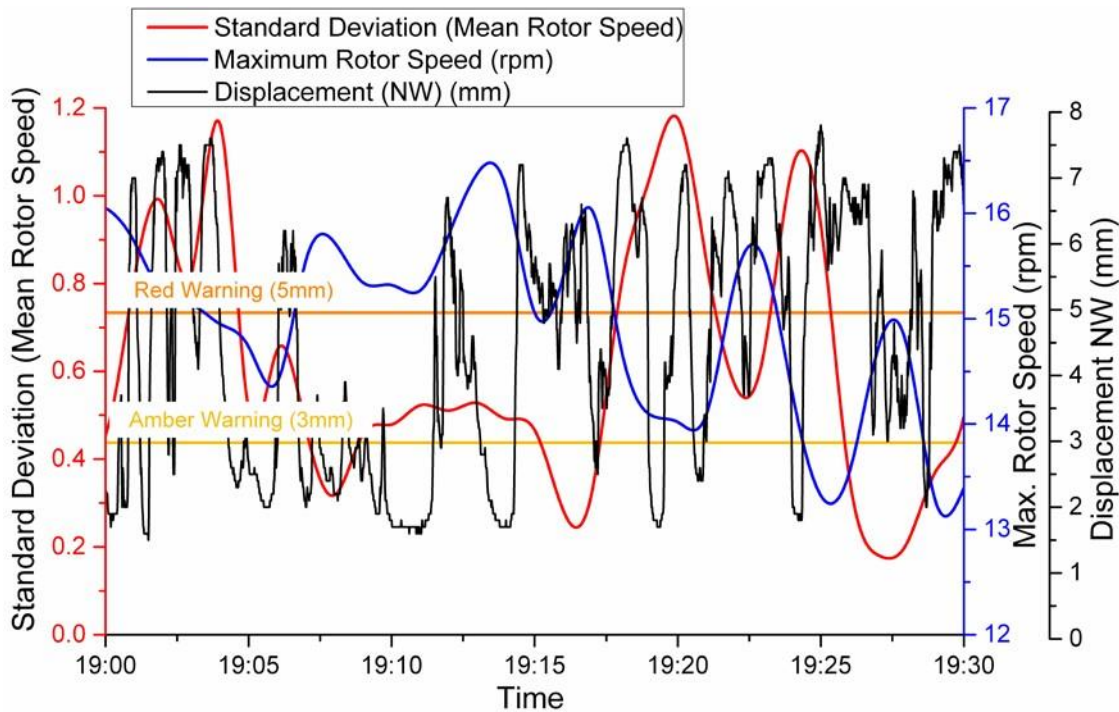
168 High wind speeds also resulted in significant vertical displacement of the ring as indicated in
169 Fig. 7. This illustrates one of the many variable periods of displacement observed during the
170 monitoring period. As can be seen, rising and falling of the ring around 7 mm through 6
171 prescribed cycles were observed over a period of 15 min. The overall displacement pattern
172 correlated roughly with the maximum rotor speed peaks and troughs as well as with the mean
173 rotor speed standard deviation peaks. It is clear that there was a significant ring movement
174 tracking the significant fluctuation in the rotor speed, particularly between 19:18 and 19:25, with
175 a full cycle occurred approximately every minute. This cyclic (rise and fall) movement would be
176 evident to an observer on site. The displacement during this period travelled through all three
177 warning bands, resulting in red warning alerts, which would result in a warning alarm.

444 Fig. 7. Cyclic vertical displacement of the embedded ring as a result of high wind speed.

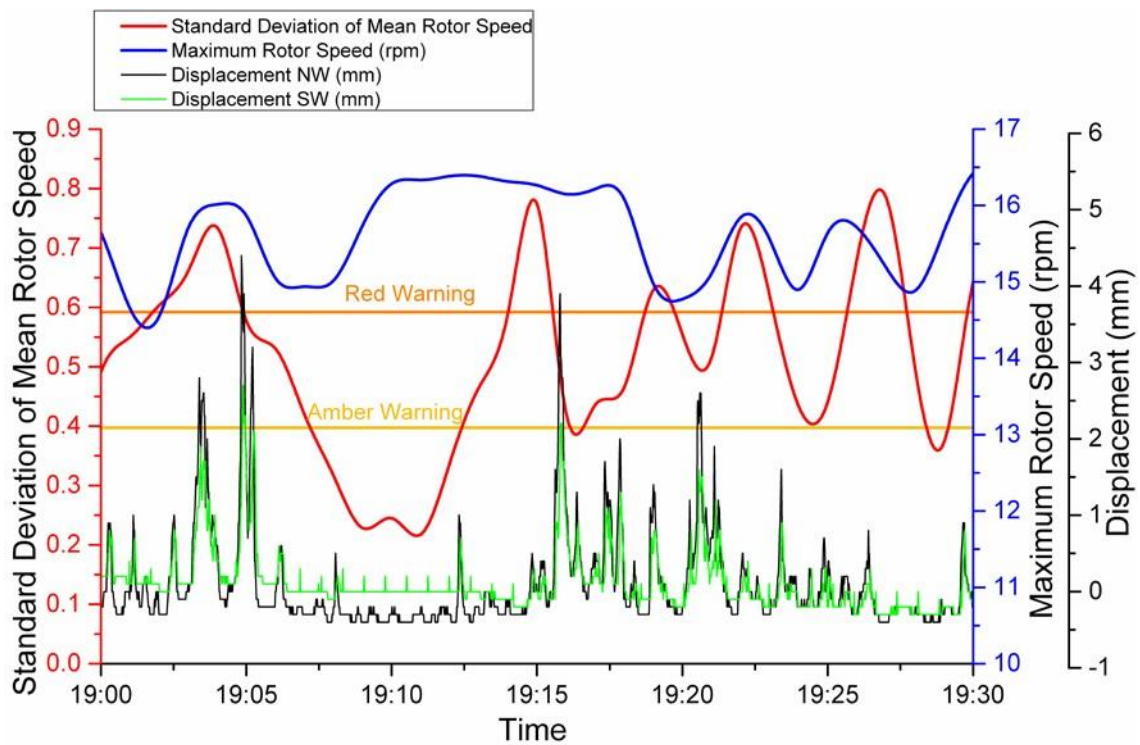
448 a)

179 Figure 8a shows the effect of the wind direction on the vertical displacement of the embedded
180 ring. As shown, the southwesterly wind was turbulent causing rotor speed changes between 14.5

181 rpm and 16.5 rpm. As previously discussed, the displacement peaks correlated approximately
182 with periods of the high mean rotor speed standard deviation. The NW and SW sensors picked
183 up exactly the same movements. However, the sensor NW, orthogonal to the wind direction,
184 recorded larger displacements at every peak. This was the result of the wind direction and
185 ultimately the position of the rotor. It is likely that the side where the wind hit will be pushed up
186 a little but the greatest vertical movement was observed in the side where the rotor is rotating
187 upwards as a result of the uplift force experienced on the NW side of the foundation.

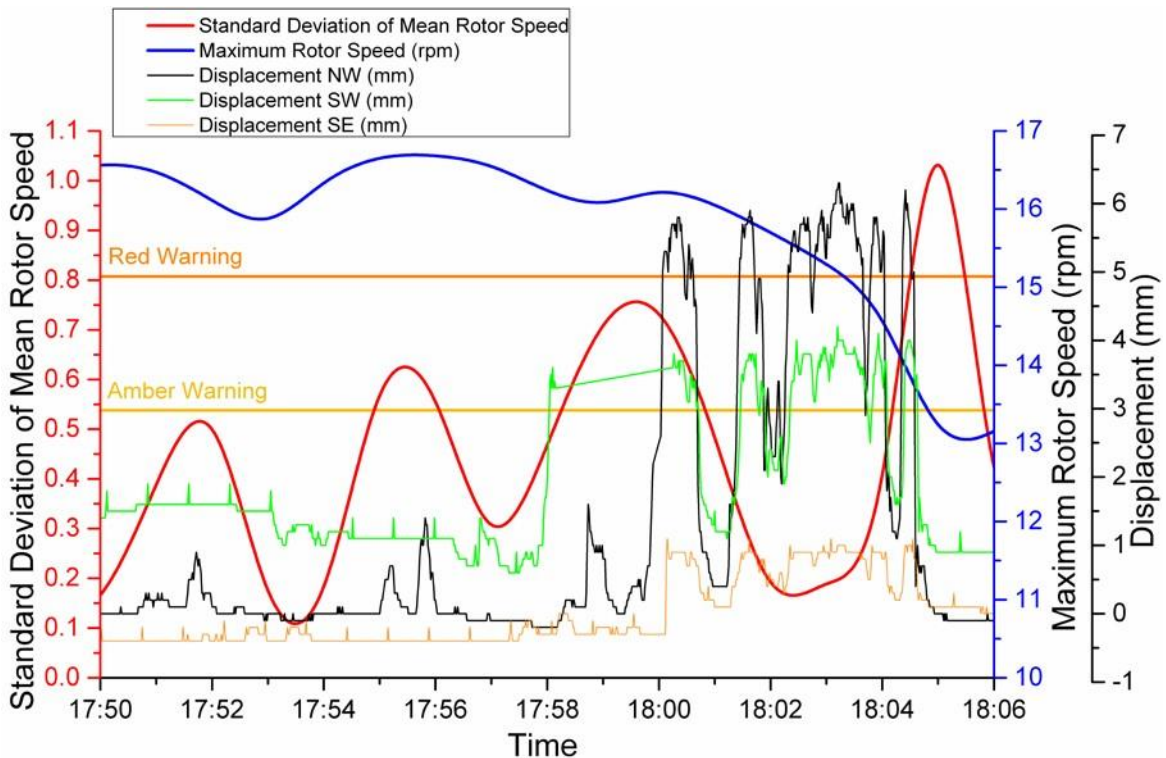
463 b)

188 Figure 8b shows the displacement recorded by the NW, SW and SE sensors during a major
189 dip in the rotor speed. The NE sensor provided a corrupted signal. It appeared that the
190 displacement was variable around the circumference of the ring as a result of the wind direction
191 and the rotor uplift forces. The NW side of the ring exhibited higher displacement as compared
192 to SW and SE sides. The response of the sensor in the SE corner was slightly below zero much
193 of the time suggesting that the foundation has eroded allowing a negative displacement below the
194 level the sensors were set at.
