Effect of impact Angle on the slurry erosion-corrosion of Stellite 6 and SS316

Effect of impact angle on the slurry erosion-corrosion of Stellite 6 and SS316

Abstract

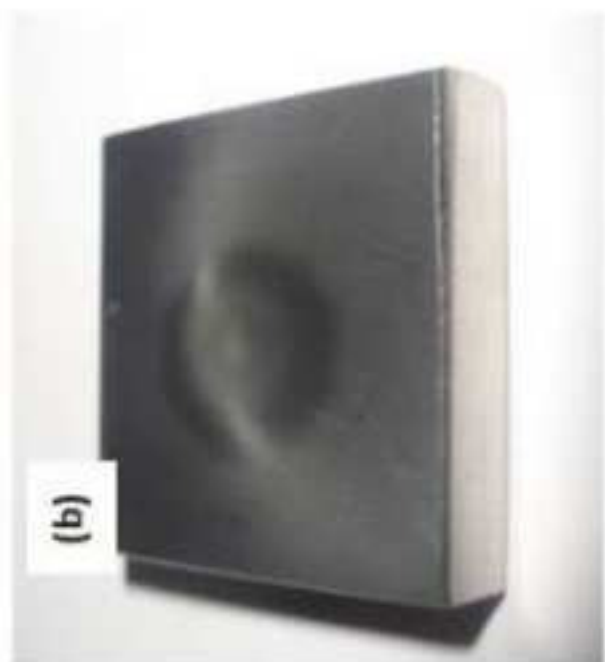
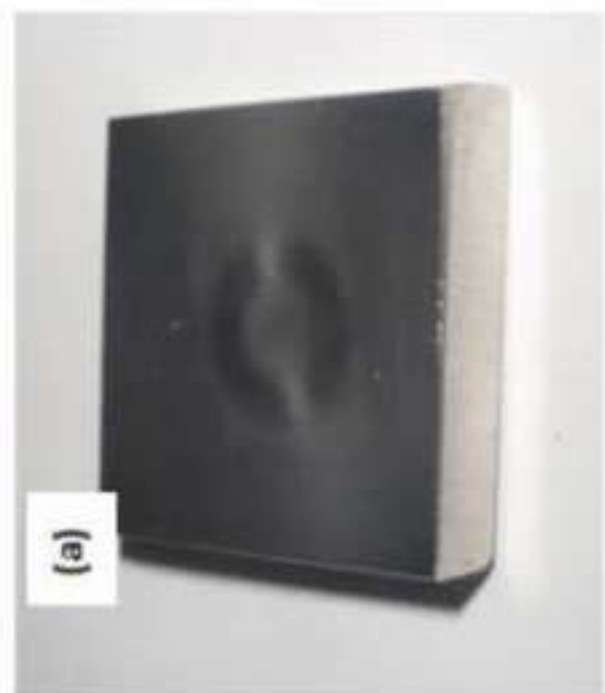
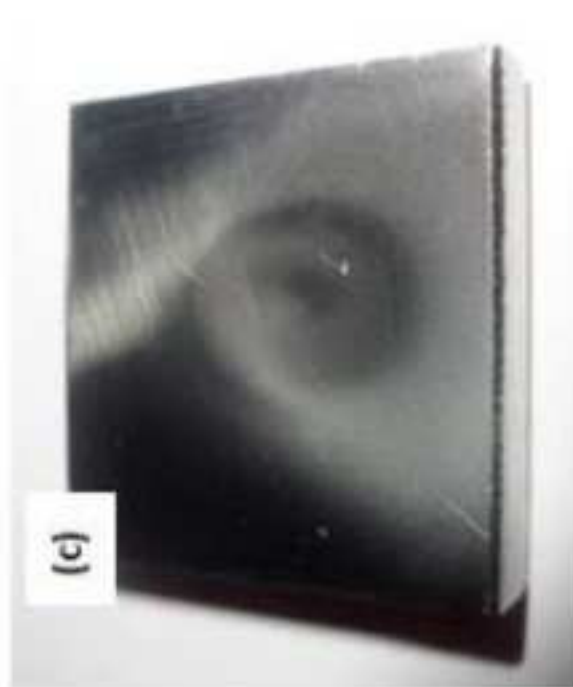
The exposed surfaces are significantly different between the varying angles of impingement. The perpendicular impingement wear scar for SS316 is shown in Figure 6(a). The wear scar is symmetrical with the most severe degradation of the surface occurring at the central impingement area. As the angle of impact tends to low angle of impingement at 20° the sand particles are abrading over the surface producing an elongated wear scar. The transition from high to low angle of impingement is clearly depicted in the macro images of the wear scars for SS316 in Figure 6.

Figure 6: Macro Image of SS316 wear scar at 90° (a), 60° (b), 45° (c), 20° (d)

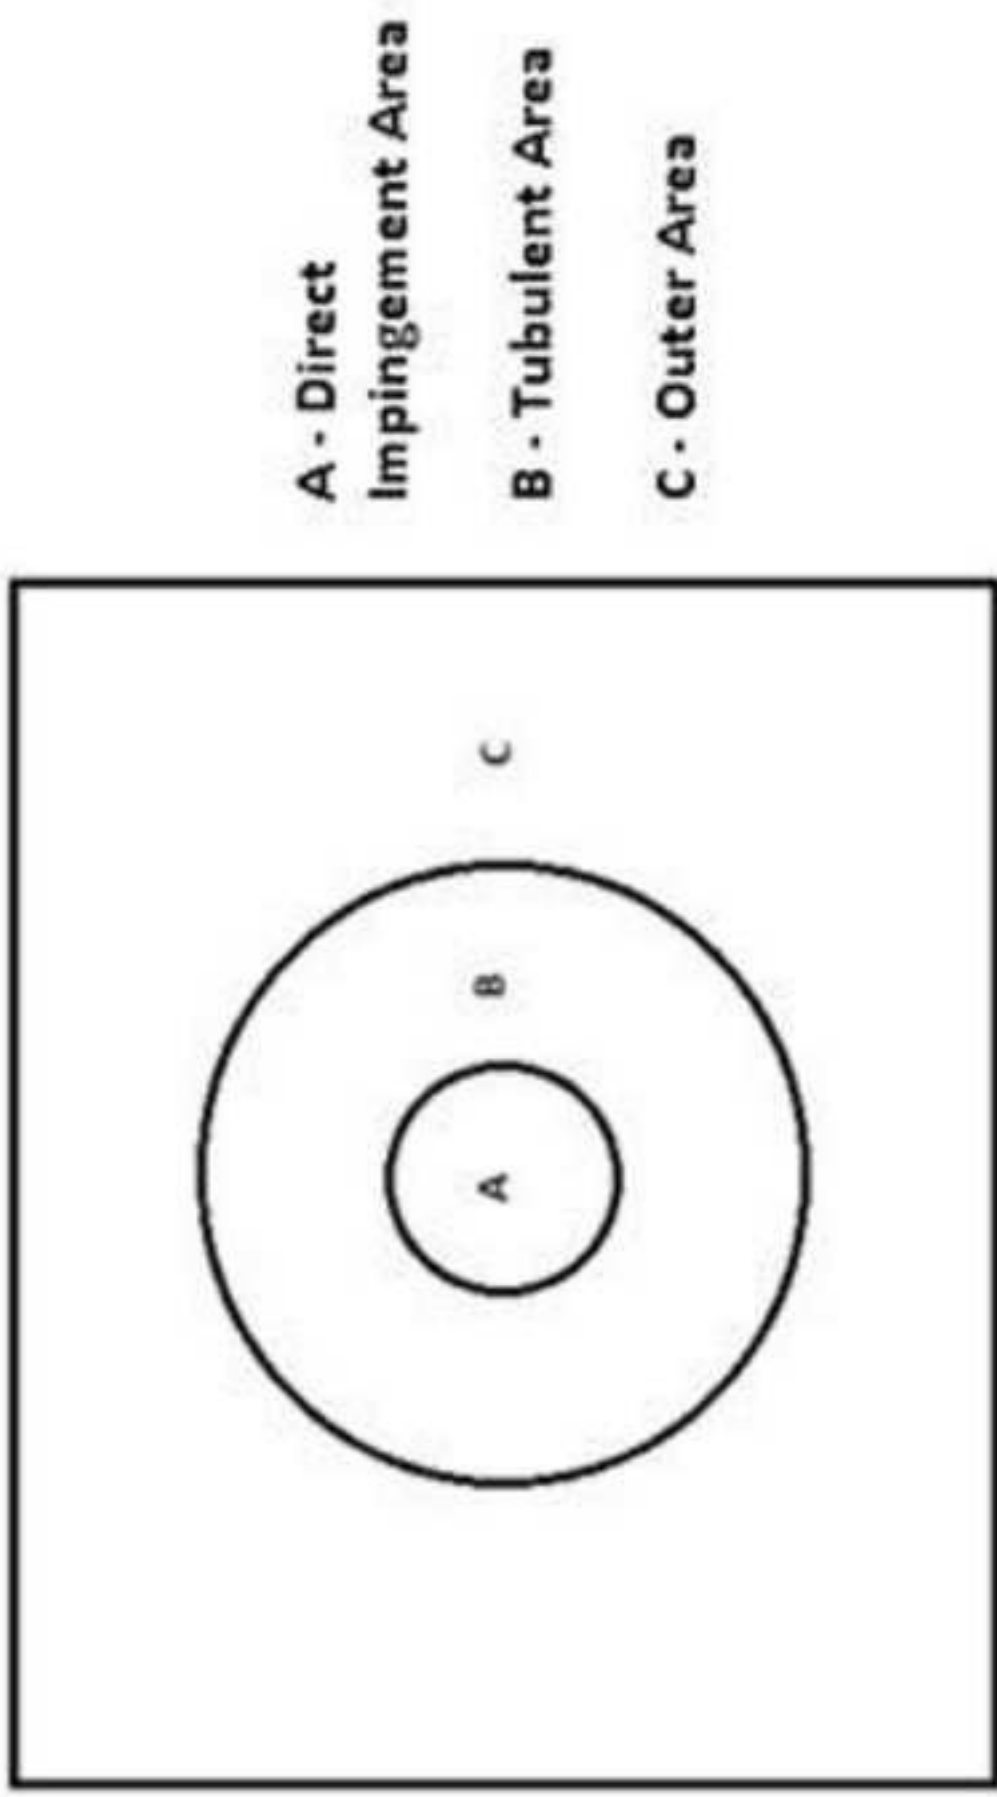
Figure 7: Characterisation of impingement at 90°

Impingement area A is the section of the surface where the flow of slurry has directly impinged upon the material; the microstructure in this area will suffer the highest degradation. Area B shows directionality in the degradation of the surface due to the turbulence caused by impinging sand particles. Area C presents random directionality of the microstructure which can be attributed to both corrosion and sliding abrasion.

**A - Direct
Impingement Area**

B - Tubulent Area

C - Outer Area

Figure 7 illustrates the characterisation of wear scars. Light microscopy was used as a method to understand the extent of degradation of the microstructure at varying areas of the exposed surface.

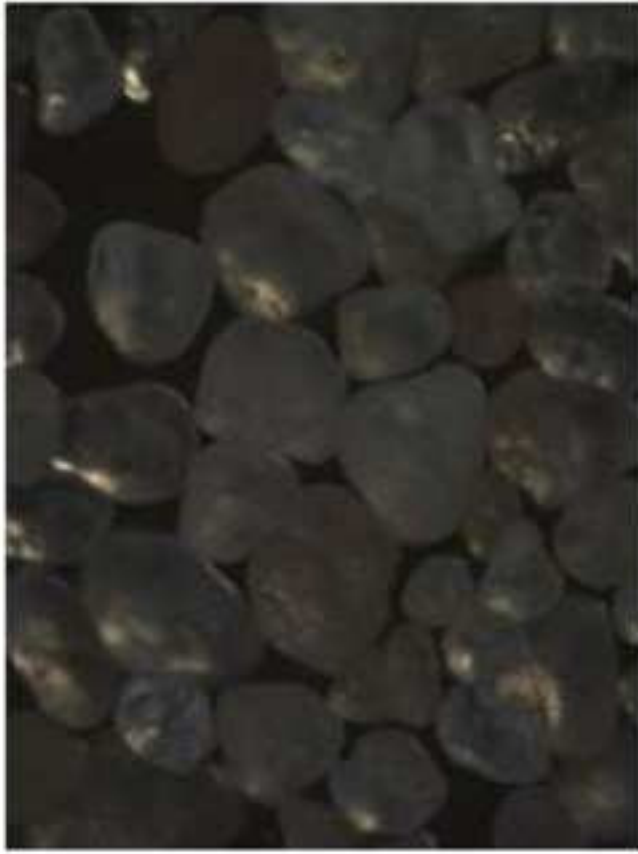
Figure 15 (a) and (b): Reduction in Angularity of Sand Particles during one hour experimental testing

(b): Angular Sand after Experiment

During the experiment the sand particles are continuously re-circulating and bombarding the specimen surface consequently reducing in angularity. The angular shape of the sand rounds within the one hour test. For this sand shape transformation, it is believed that the erosion rate will be at maximum at the start of the test. Similar events would happen within components that handle erosive-corrosive slurries since the most severe conditions will occur when, for example, a pump is starting and thus the relatively short one hour testing period simulates this effect within the limitations of the rig. A quantity of angular sand was analysed using light microscopy before and after the experiment to quantify how the one hour testing time changes the angularity of the sand. The rounding effect is shown in Figure 15 (a) and (b).

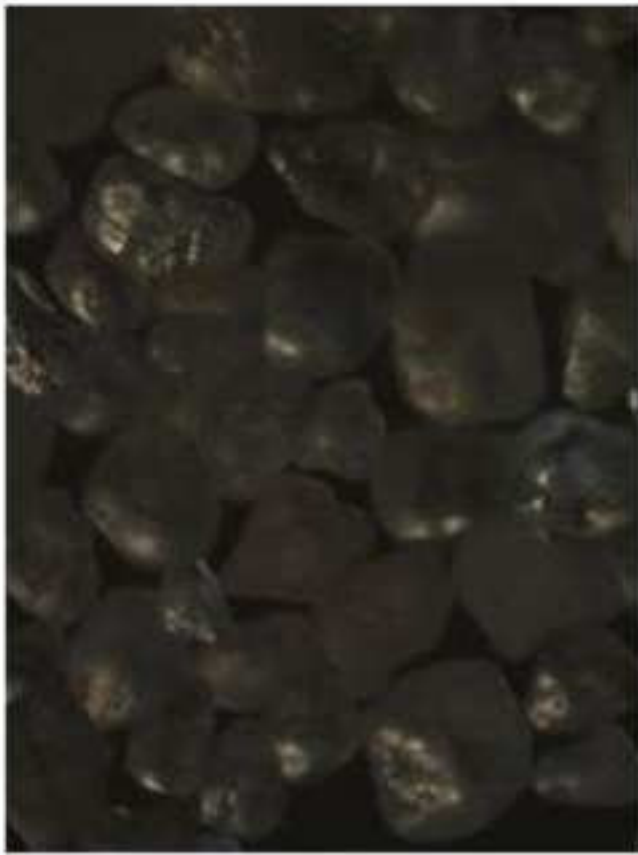
(a): Angular Sand before Experiment
