Mapping Synergy of Erosion Mechanisms of Tidal Turbine Composite Materials in Sea Water Conditions

Abstract Tidal energy, of all marine renewables energy, possesses higher persistency and predictability over long-time scales. Moreover, the higher density of water than air also results in greater power output from a tidal turbine than a wind turbine with similar dimensions. Due to the aggressive marine environment, there are barriers in the development of tidal power generation technology. In particular, with regard to increased rotor diameter, the selection of material presents significant challenges to be addressed including the tribological environment, such as solid particle erosion, cavitation erosion, the effect of high thrust loading on the turbine blade tips and the synergy between sea water conditions and such tribological phenomena. This research focuses on producing and testing a variety of composite materials with different fibres and reinforcement layouts to evaluate two main tribological issues in tidal environments: matrix cutting and reinforcement fracture. A slurry pot test rig was used to measure the effects of different impact angles and particles sizes at consta

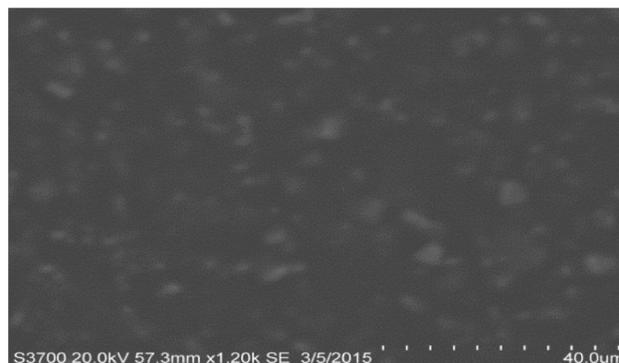
Figure 1 shows the SEM micrograph of the G10 epoxy glass laminate surface before the test. The faded brighter areas can be trapped micro-bubbles under the glossy surface or the residual dust during finishing the side surfaces of the rectangular shape samples. It should be noted that as the samples were purchased from a commercial supplier, some tiny dents and superficial scratches can exist on the test surfaces due to packing and transportation. Extra care was taken to use the samples for the tests with a surface finish close to perfect.

Fig. 1 SEM micrograph of an unexposed surface

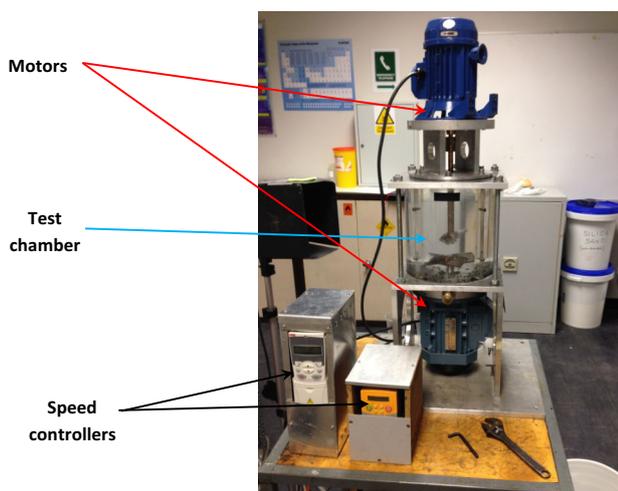
The modified slurry pot test rig was used for this experimental work. The rig consists of a test chamber and two motors one at the top and the other at the bottom of the test chamber. The upper motor functioned as a miniature tidal turbine rotor with blades and the bottom one worked as a stirrer of slurry. Figure 2 is an image of the test rig in a stationary mode and Fig. 3 illustrates the test chamber showing the inserted test samples and the direction of the slurry movement. This test configuration is useful to investigate the erosion resistance of different materials in rapidly and inexpensively.

Fig. 2 Slurry pot test rig

directions to avoid random motion of the particles, turbulence of the flow and error in the calculation of the impingement velocity [6]. The bottom four blades (stirrers) are pitched at 45° which is the optimal degree to provide good particle mixing in the axial flow in the test chamber as shown in Fig. 3 [8]. The speed of the motors was kept constant and the experimental configuration of the test rig is shown in Fig. 2.

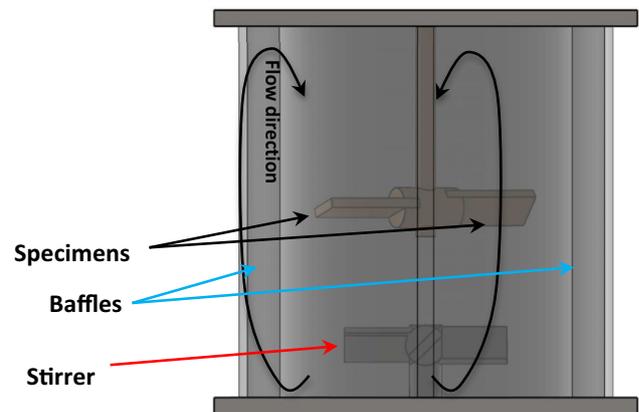
The test blade samples were inserted in different angled slots on a sample holder which acted as the hub of the turbine rotor. The angles of attack range was 0–90° with 15° increment. The four baffle bars are installed in the test chamber. The role of these baffles is to prevent unwanted swirling of the flow due to the rotation of the samples, to maintain axial flow and to minimise centrifuging effect of the fluid inside the test chamber. The bottom blades stir the solution and provide the longitudinal flow and a good mixing of the slurry [7]. Both motors rotate in opposite

Fig. 3 Test chamber

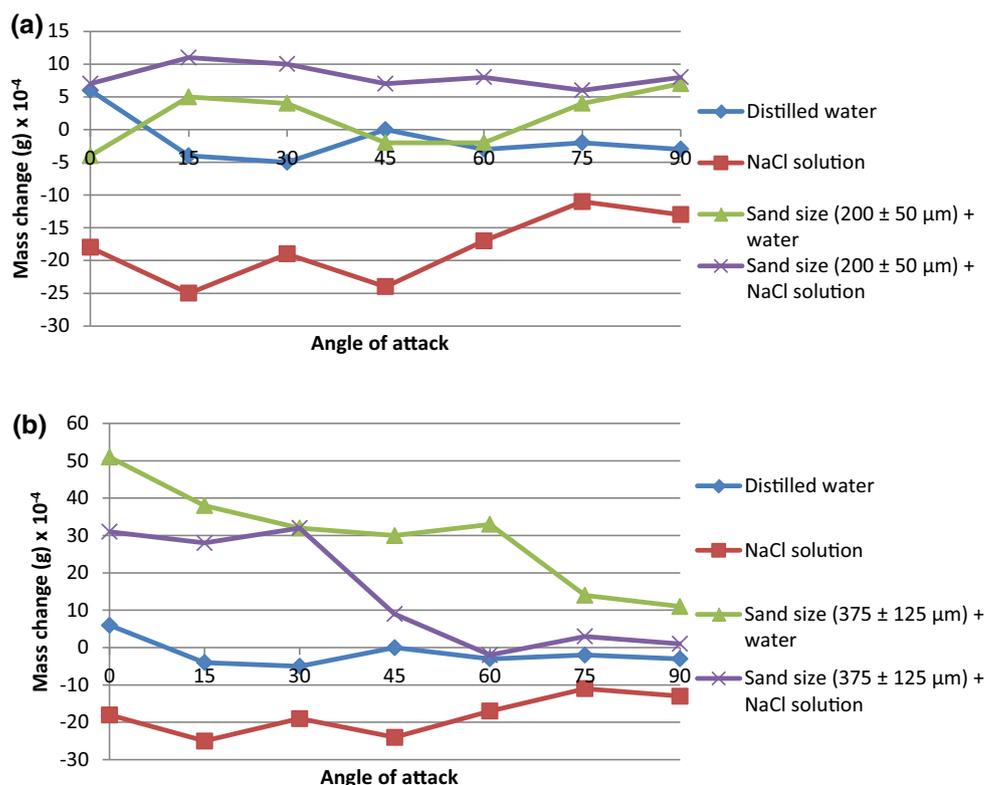
Fig. 4 Mass change as a function of impact angle: **a** NaCl water, sand size ($200 \pm 50 \mu\text{m}$) in water, and in NaCl water slurry and **b** NaCl water, sand size ($375 \pm 125 \mu\text{m}$) in water slurry and sand size ($375 \pm 125 \mu\text{m}$) in NaCl water slurry

Figure 4a shows that from the tests in NaCl solution, specimens have gained mass (negative mass loss) for the range of angles of attack. On the other hand, for sand size (200 ± 50 μm) in water, and NaCl water solution slurries, there is mass loss of the specimens for almost all of the combination of slurries and angles of attack. The mass loss is prominent for the tests carried out with sand size (200 ± 50 μm) + NaCl solution slurries. Figure 4b shows the results of tests carried out with sand size (375 ± 125 μm) in the same slurries that of Fig. 4a. A similar trend of mass loss is found for sand size (375 ± 125 μm) in water slurries and sand size (375 ± 125 μm) + NaCl water slurries.

As shown in Fig. 4, as compared with sand size ($200 \pm 50 \mu\text{m}$) in water slurry, a greater mass loss of the specimens is found for sand size ($375 \pm 125 \mu\text{m}$) in water slurry. Moreover, the mass loss due to erosion has increased with the increase in size of sand particles. The presence of the salt in slurries is affecting erosion behaviour of specimens. Higher mass gain occurs in the salt solution and comparatively higher mass loss occurs for all slurries in the lower impact angles up to 30° .

Figure 4 shows that specimens have gained mass for the tests carried out in NaCl solution, which is prominent at angle of attack up to 45° . Despite the fact that the G10 epoxy glass laminate is recognised for good adhesion between its components and low porosity, the NaCl solution enters into the material by a diffusion process and through pores in the matrix and can increase the mass gain following exposure. The retained salt solution can be seen on SEM micrograph of the tested surface exposed to NaCl only solution (Fig. 6a–c). Mass gain is an important factor that characterises the performance change of material in the whole degradation process. The degradation process includes physical as well as chemical process. It can be envisaged that initially the moisture penetrates rapidly into the void content in the matrix and fibre–matrix interface. This facilitates the interaction of the solution with the composite material, causing de-bonding of the composite matrix and reinforcement fibre, thus reducing the adhesion between resin and reinforcement, and ultimately exposing the reinforcement fibres (Fig. 6c).

Furthermore, the results in Fig. 4 show that the erosion rates are higher at the lower impact angles. This is a behaviour

that is normally observed for so-called “ductile erosion” patterns. From the literature, the erosion rate of ductile metals typically peaks at a particle impingement angle $30\text{--}50^\circ$ due to a localised plastic strain which leads to the failure of the deformed material (results which are observed for the impact with angular particles). For brittle materials, a peak in the erosion is normally observed at 90° angle of attack, and wear occurs in a form of cracking and chipping of the surface on the micro-scale [18]. Hutchings [19] has suggested that the material loss is observed when a critical fracture strain is reached. It is also stated that the formation and fracture of platelets control the erosion rate [11, 20]. The peaks of the erosion rate in the current work are observed at different angles of attack up to 60° which does not completely describe ductile material behaviour. Moreover, the fluctuation in erosive wear peaks can be attributed to the different slurries, angles of attack, particles characteristics and material as composites behave differently than metals (Fig. 4) [21].

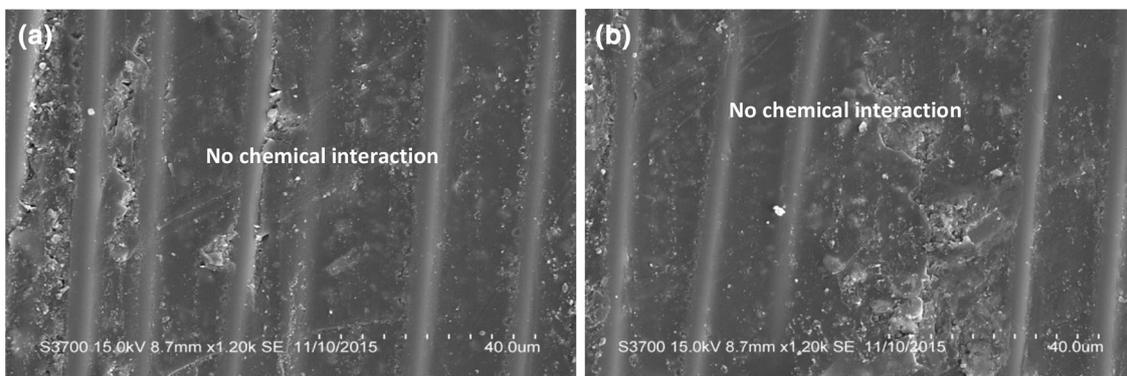
Fig. 5 Sample surface after a test in distilled water at 60° angle of attack

Figures 5 and 6a–d show the SEM micrograph of the specimen tested in distilled water and salty solution at angle of attack 60° , respectively. Figure 5 shows that there is no chemical interaction of distilled water with the specimen. In contrast, the NaCl solution interacted with the targeted surface in a different way. Figure 6 shows the pores have retained NaCl crystals which seems to be dried on the surface. At a higher magnification, it can be seen that any defects on the surface can increase the amount of

slurry as a result of de-bonding at the fibre–matrix interface, which would cause the mass loss of the specimens. Hence the mass change of the specimens would be the net effect of the both i.e. total mass gained minus mass is extracted. Moreover, a similar behaviour of mass gain and chemical interaction was found when the tests were carried out in sand + salt slurry (Figs. 10a, 12b, 14a). These observations are in agreement with the research work found in the literature [13–16]. No chemical interaction between slurry and composite can be seen when the tests were carried out in distilled water with and without particles (Figs. 5, 9, 11, 13).

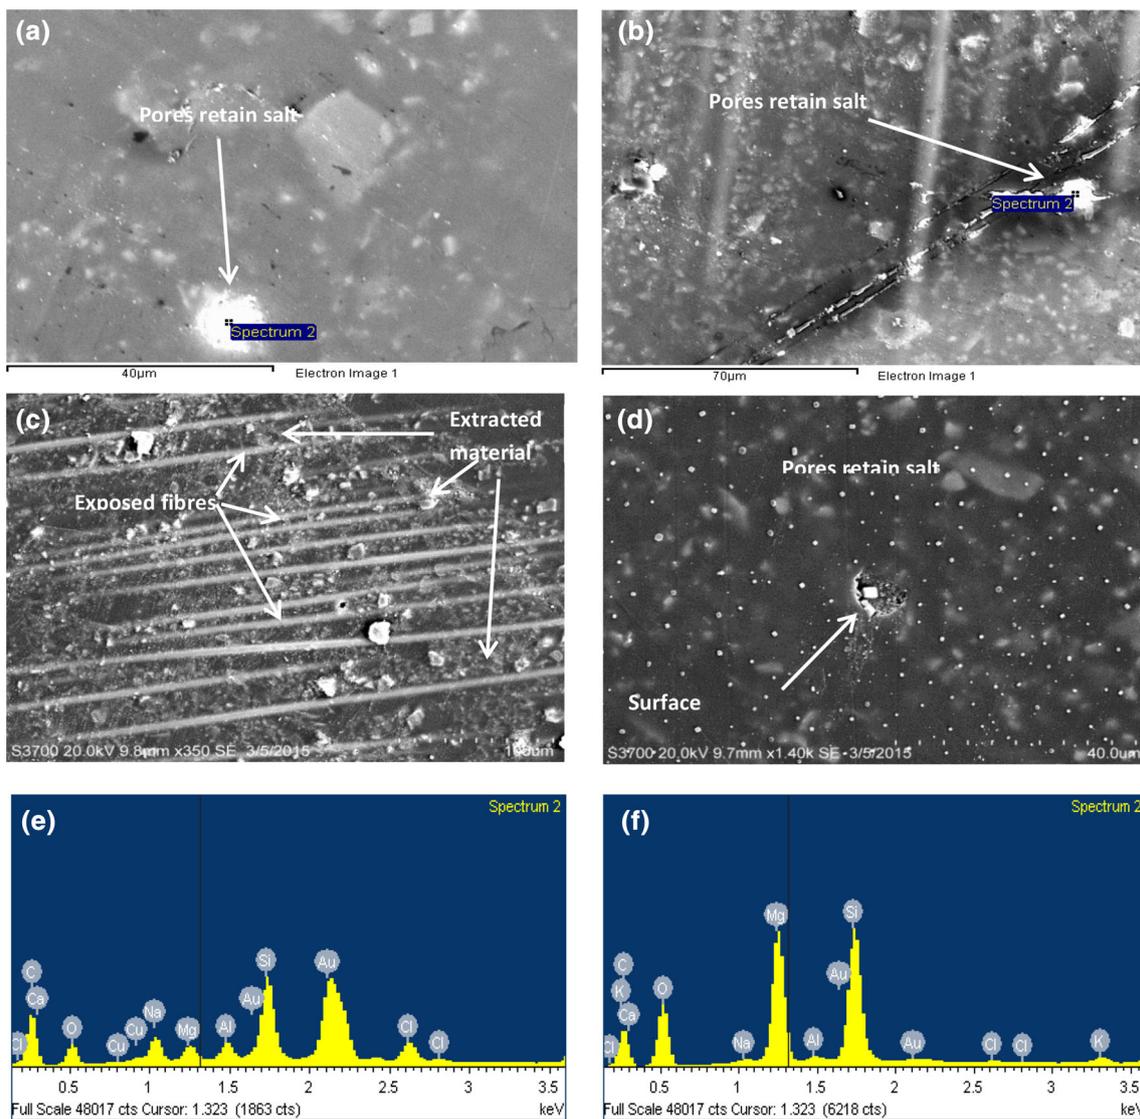
Fig. 6 Sample surface after a test in NaCl solution at 60° angle of attack **a** site 1, **b** site 2, **c** site 3, **d** site 4, **e** EDX analysis of site of (a) and EDX analysis of site of (b)

the accumulated salt on the surface (Fig. 6a, b, e, f). As the glass cloth fibres were woven in 0° and 90° directions, the top layer of the glass fibres in one direction was closer to the surface and caused some imperfection on the surface. The presence of NaCl in water interacting with the composite surface appeared to have de-bonded the matrix and reinforcement, which results in an exposure of the reinforcement fibres along with particles of extruded material on the surface (Fig. 6c, d).

Similar to the other angles of attack in sand and water slurry, no interaction of the slurry with targeted surface can be seen at 60° and impact wear is more prominent (Fig. 13), but for sand size ($375 \pm 125 \mu\text{m}$) in the NaCl water slurry at 60° angle of attack, the targeted surface shows de-bonding of matrix and reinforcement fibre, exposure and fracture reinforcement fibre, pit formation, and formation of platelet and flakes (Fig. 14). A similar interaction of the NaCl solution with the specimen surface is evident in Fig. 6.

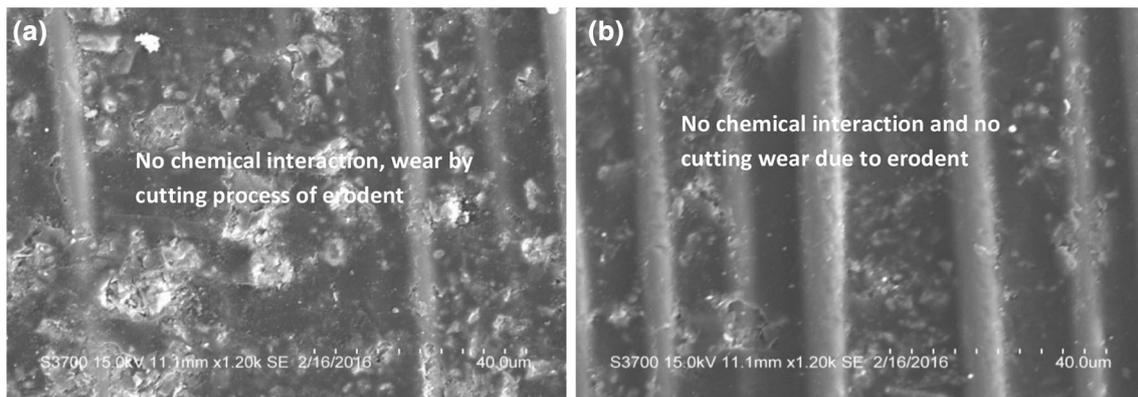
Fig. 7 Sample surface after a test in sand size ($200 \pm 50 \mu\text{m}$) in water slurry, **a** at 15° angle of attack and **b** at 45° angle of attack

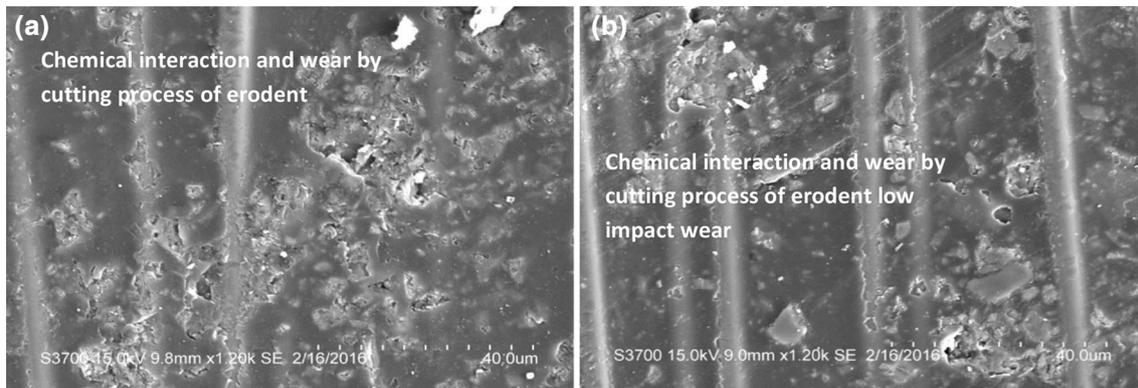
Fig. 8 Sample surface following exposure of sand size ($200 \pm 50 \mu\text{m}$) in the NaCl water slurry, **a** at 15° angle of attack and **b** at 45° angle of attack

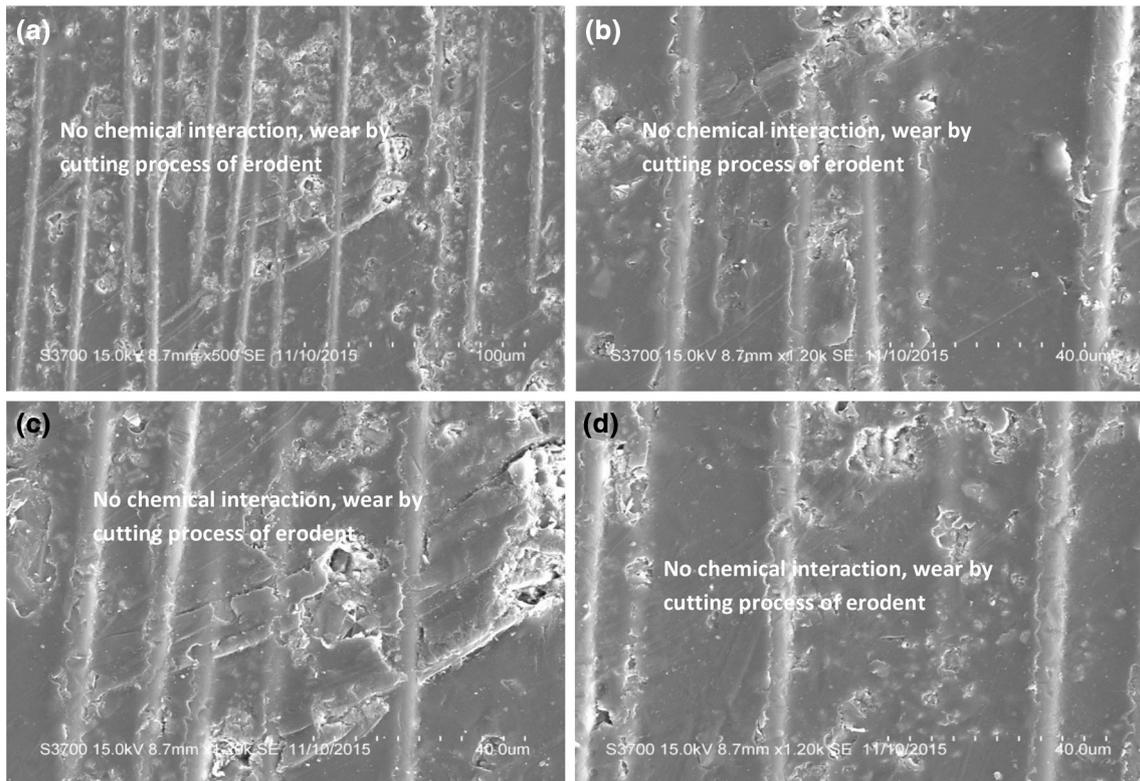
Figure 9 shows the eroded surface of the specimen for test carried out in sand size ($375 \pm 125 \mu\text{m}$) in water slurry at angle of attack 15° , where erosive wear is evident by the cutting action of solid particles. In the sand size ($375 \pm 125 \mu\text{m}$) and NaCl water solution, the erosion mechanisms are different from those observed for the sand in water only slurry (Fig. 10). At lower magnification, Fig. 10a shows the cutting action of the targeted surface, where impingement of the solid particles and blistering occurs due to diffusion of NaCl water into the specimen surface. In the higher magnification images, the typical effects of the slurry erosion on the exposed surface, i.e. cutting of matrix lead to pits formation and exposure of

Fig. 9 Sample surface after a test in sand size ($375 \pm 125 \mu\text{m}$) in water only at 15° angle of attack **a** site 1, **b** site 2, **c** site 3 and **d** site 4

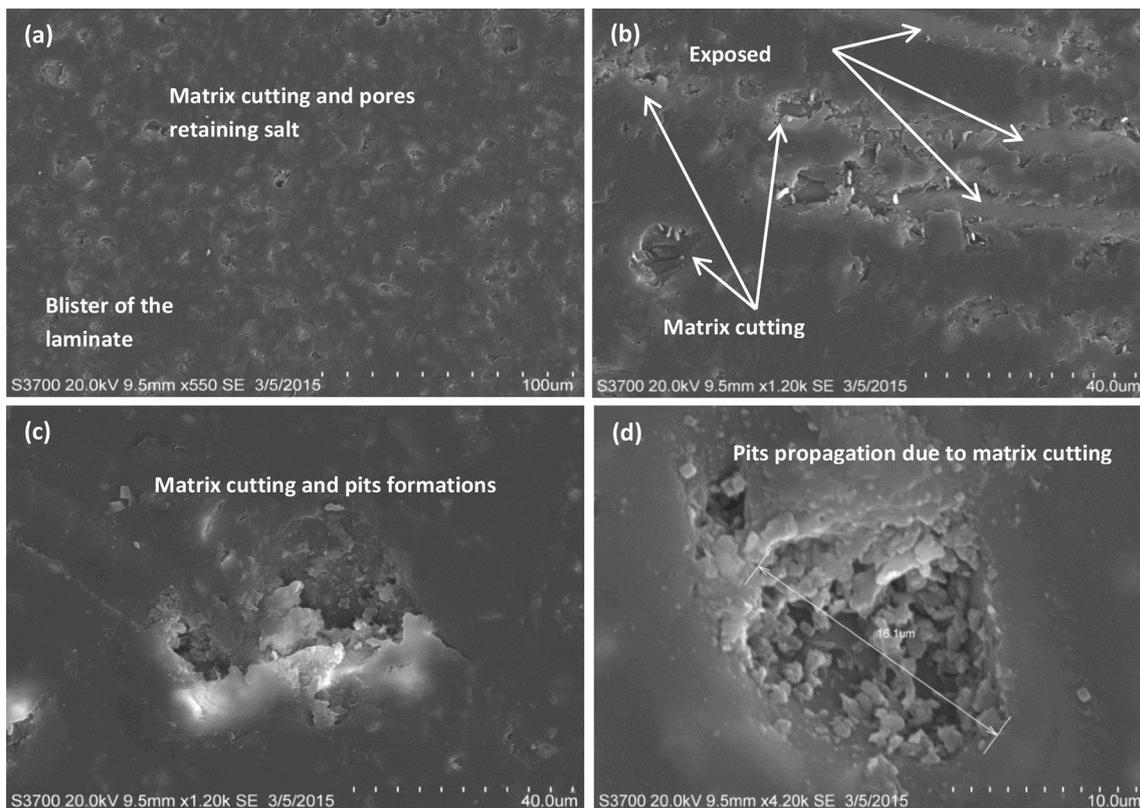
Fig. 10 Sample surface after a test in sand size ($375 \pm 125 \mu\text{m}$) + NaCl solution at 15° angle of attack **a** site 1, **b** site 2, **c** site 3 and **d** site 4

reinforcement fibres (Fig. 10b), pits and platelet formation (Fig. 10c) [10] and propagation of pits due to matrix cutting (Fig. 10d) can be seen.

Similarly the degradation of mechanical properties, when the tests were carried out in NaCl only solution and sand + NaCl solution, the erosive wear resistance of the G10 epoxy glass laminate was also affected in shape of enhanced mass loss, blistering of the laminate, swelling of attacked surface, de-bonding at fibre–matrix interface, and damage of reinforcement and matrix due to fractures, cracks

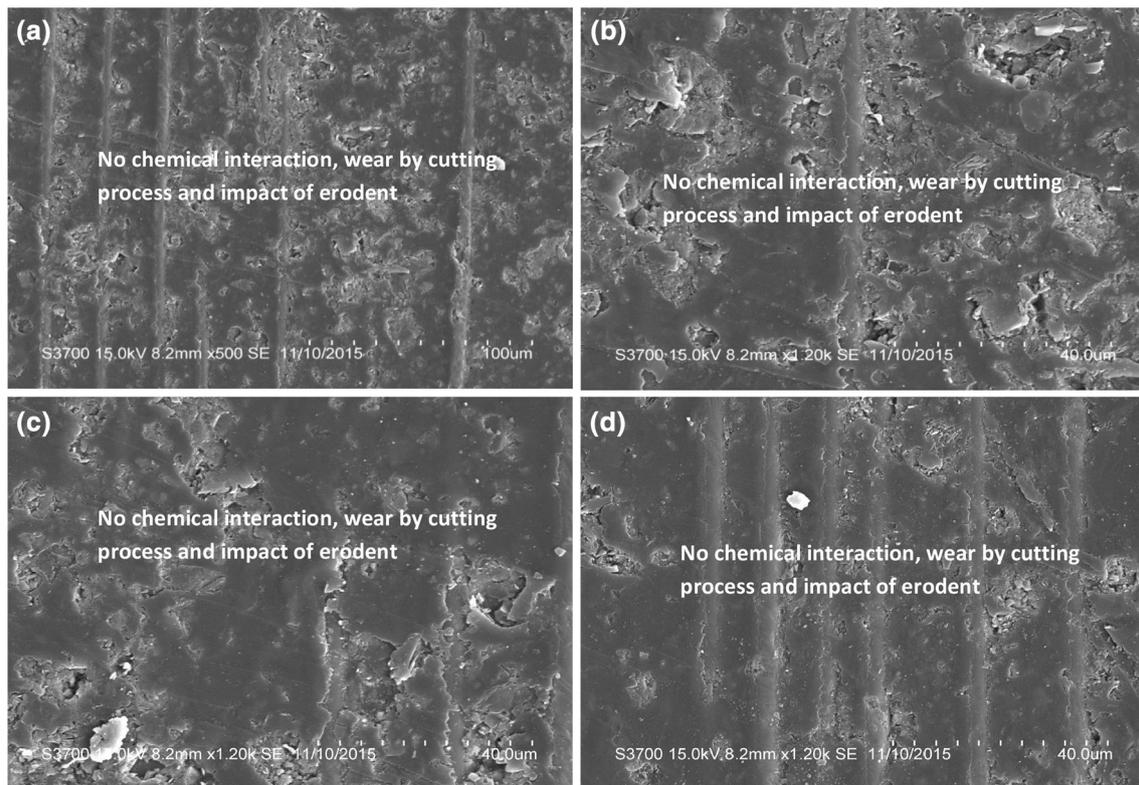
Fig. 11 Sample surface after a test in sand size ($375 \pm 125 \mu\text{m}$) in water at 45° angle of attack **a** site 1, **b** site 2, **c** site 3 and **d** site 4

For sand in water only slurry, at impact angle of 45° , matrix cutting and impact wear by solid particles occurred (Fig. 11). For the sand + NaCl solution at this impingement angle, more interaction of salt and sand with targeted surface can be seen (Fig. 12). At this angle, the enhanced damage of the exposed surface in the sand + NaCl slurry occurred by a range of erosion mechanisms. Figure 12a–c show the erosive wear and due to impact and matrix cutting by abrasive particles, which led to pits formations, surface damages, cracks initiations, exposure of reinforcement fibres, formation of fibres fragments, etc. Figure 12d shows that the targeted surface has been swollen due to salt, and reinforcement fracture is occurring due to impingement of erodent in the slurry.

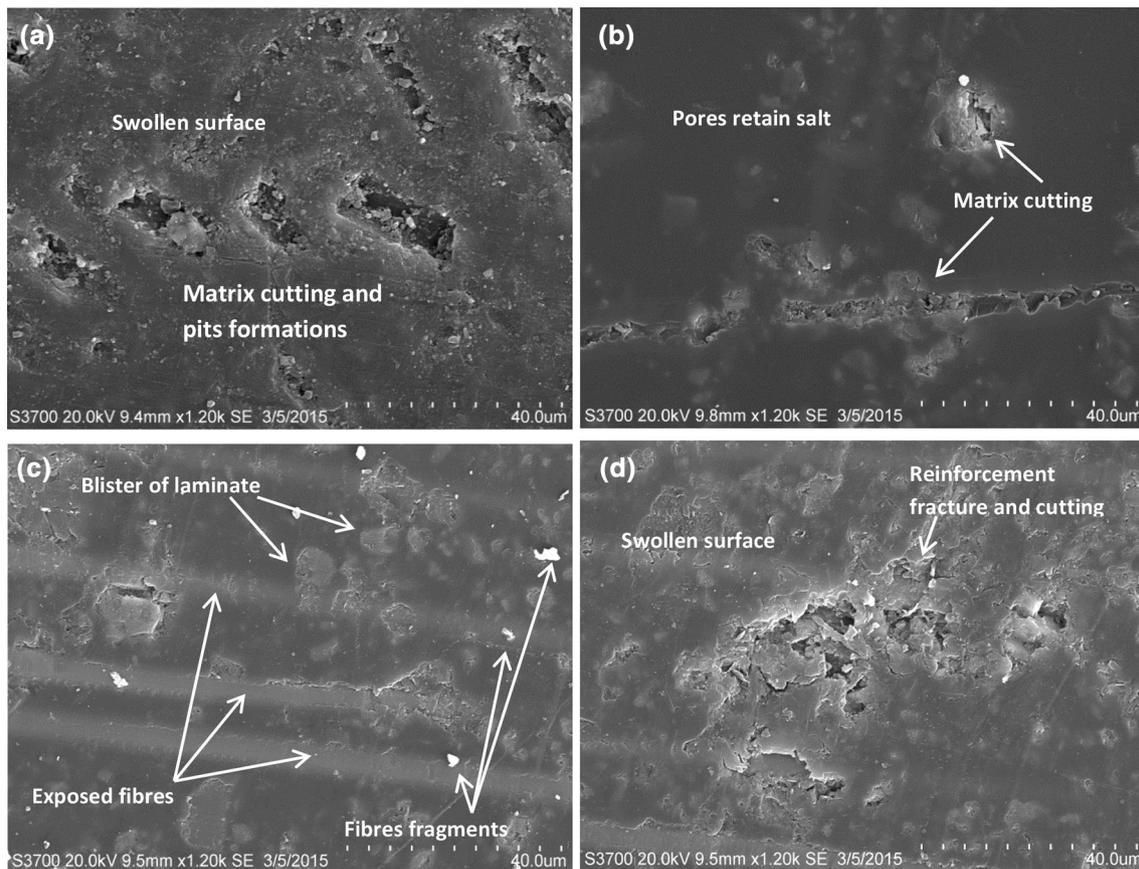
Fig. 12 Sample surface after a test in sand size ($375 \pm 125 \mu\text{m}$) + NaCl solution at 45° angle of attack **a** site 1, **b** site 2, **c** site 3 and **d** site 4

(Figs. 6, 10, 12, 14). Interesting observations can be seen in Fig. 4b for the tests carried out at 60° , where the highest mass loss and erosive wear occurred by cutting process and impact of erodent (Fig. 13), for sand size ($375 \pm 125 \mu\text{m}$) only solution. Contrary to this, the lowest mass loss can be seen for sand size ($375 \pm 125 \mu\text{m}$) + NaCl solution. The intensity of damage of the attacked surface is evidence of synergistic effects of NaCl + sand size ($375 \pm 125 \mu\text{m}$) slurry for this impingement angle, SEM micrograph (Fig. 14). Moreover, at 60° angle of attack, this composite behaves like a semi-brittle material in sand size ($375 \pm 125 \mu\text{m}$) in water slurry (Figs. 13, 15b), while it behaves as semi-ductile material in sand size ($375 \pm 125 \mu\text{m}$) + NaCl solution (Figs. 14, 15b). There is more interaction of the salt solution with this composite at 60° angle of attack (Figs. 6c, 14a). The chemical interaction and transition in composite physical properties are evident of synergistic effects of the salt in slurry (Figs. 5, 14).

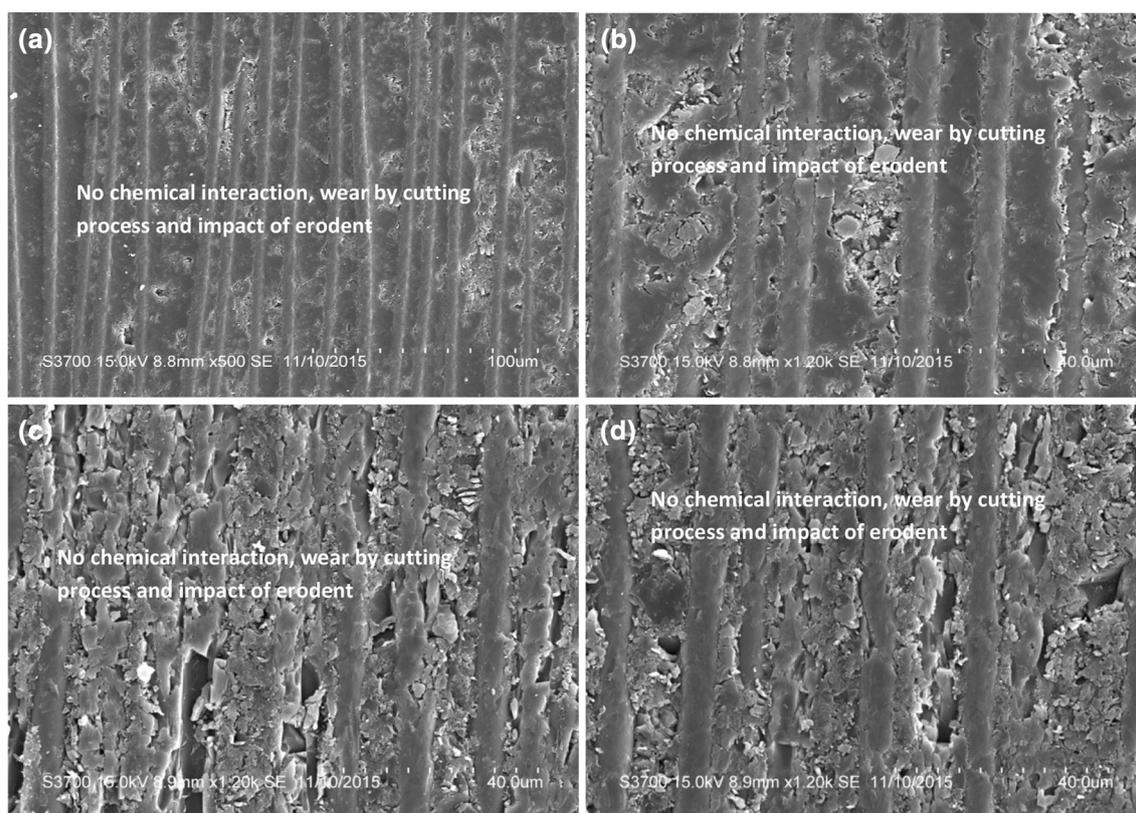
Fig. 13 Sample surface after a test in sand size ($375 \pm 125 \mu\text{m}$) in water at 60° angle of attack **a** site 1, **b** site 2, **c** site 3 and **d** site 4

Regime II This area shows the erosive wear due to the smaller particles. The wear rate is lower for these combinations of slurry and angle of attack. The composite behaves like a ductile material and the wear occurred due to micro-cutting action of the erodent (Figs. 13, 14).

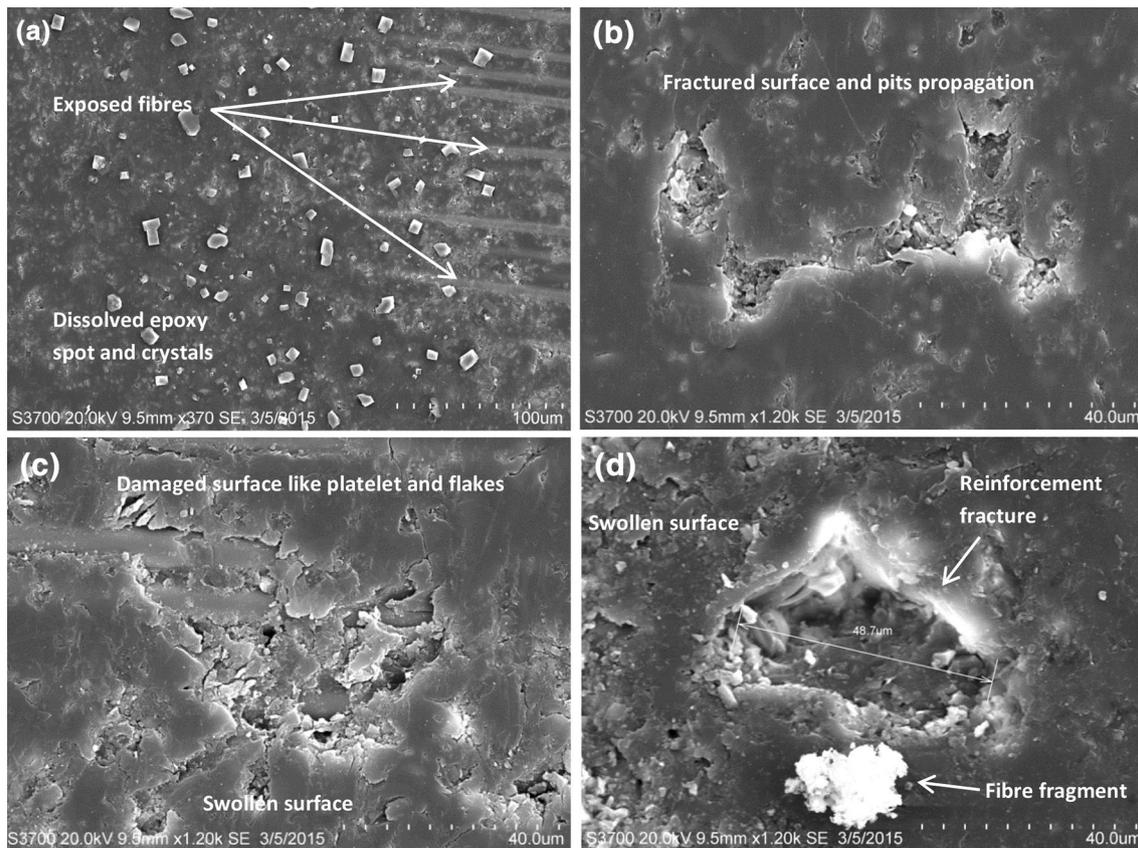
Fig. 14 Sample surface following exposure to sand size ($375 \pm 125 \mu\text{m}$) + NaCl solution at 60° angle of attack **a** site 1, **b** site 2, **c** site 3 and **d** site 4

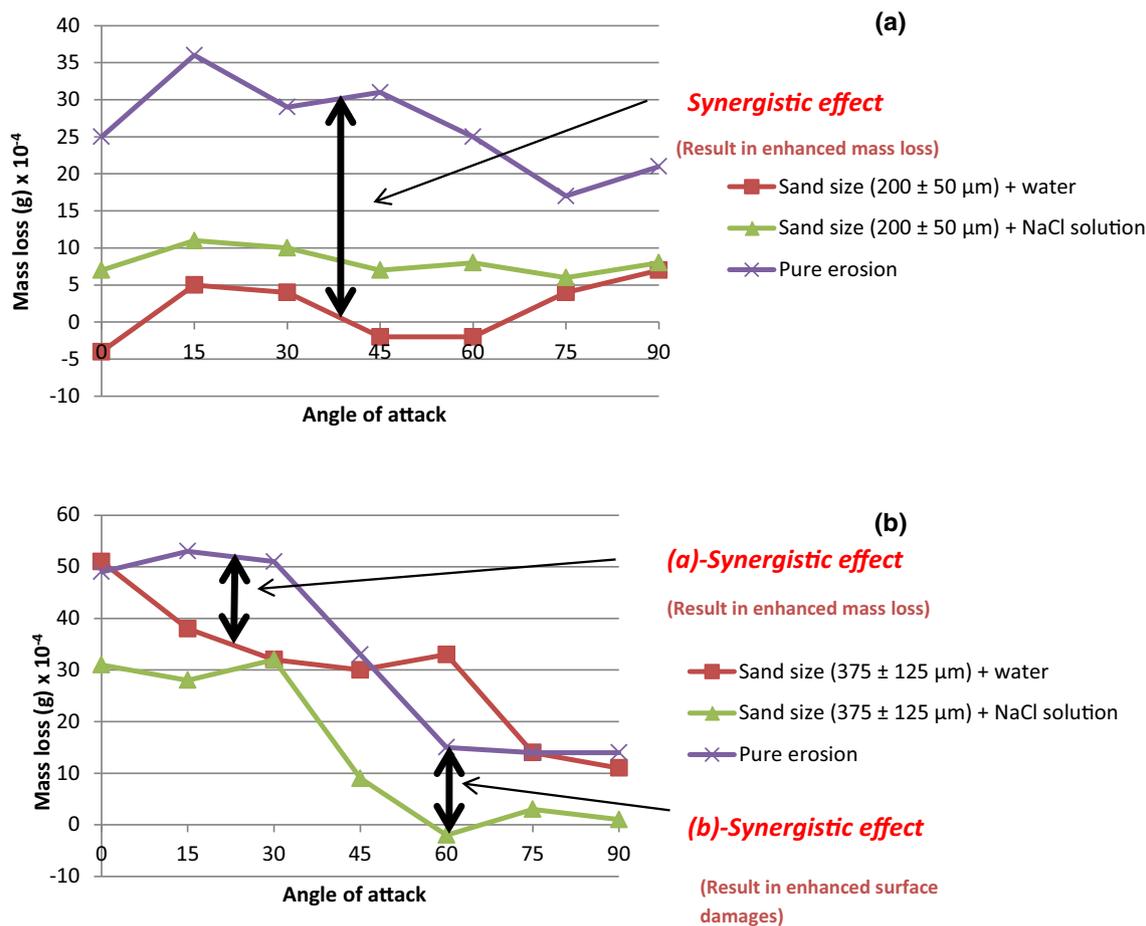
tests to the mass loss of the specimens for respective tests in NaCl + sand solution. Figure 15a, b show that the presence of salt in sand + NaCl slurries has significantly increased the amount of erosive wear. The upwards shifting of pure erosion curves (increase in mass loss) in Fig. 15, and the enhanced degradation of the target surface (Fig. 14) emphasises the deleterious effects of salt solution on the tribological performance of this materials, and the importance of synergistic effects of the NaCl solution and sand.

Fig. 15 Synergistic effects, **a** due to sand size (200 ± 50 µm) + NaCl slurry and **b** due to sand size (375 ± 125 µm) + NaCl slurry

Regime III This region of the mechanistic map is related to the highest surface damage due to the impact of erodent and synergistic effects of salt in the solution. There is a lower mass loss (Figs. 4, 15), due to softening of the reinforcement resulting from sand + NaCl slurry synergy as mentioned above under Sect. 4.1. Erosive wear by impact of erodent dominates. Impact damage can cause a reduction in strength of the composite as much as 40 % [33]. Voids and pores between layers can also pose serious problems to the integrity of the polymer matrix composite (PMC) [34]. Due to the synergy of sand + NaCl slurry, different types of erosion mechanisms are identified i.e. de-bonding at fibre–matrix interface and exposed reinforcement fibres, pit formation, fibre fracture, platelet and flake formation, delamination and swelling of surface (Fig. 14). These erosive wear mechanisms are in agreement with those found in literature [10, 18, 26, 35] (Fig. 16).

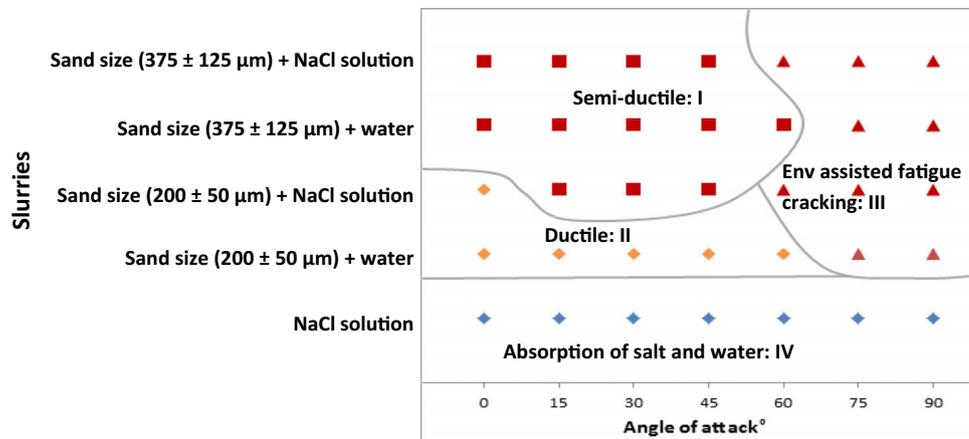
Fig. 16 Erosion mechanism map

mechanisms to the actual operational conditions. Figure 16 shows the slurry erosion wear mechanisms map of G10 epoxy glass laminate. The erosion mechanism transition boundaries are approximate and identify wear mechanisms in five regimes which can be described as:

Regime I For these combinations of slurries and angles of attack, severe erosive wear occurs due to enhanced mass loss of the specimens (Fig. 4). There is some suggestion that according to the literature [10, 20, 31, 32], composite materials with high reinforcement volume fractions are expected to behave like brittle materials. However, Fig. 15 shows that this composite seems to be exhibiting semi-ductile erosive behaviour in this regime. It is evident from SEM micrographs (Figs. 7, 8, 9, 10, 11, 12) that the wear mechanisms in this region are cutting of the matrix, pit formation, cracking and swelling of matrix material. These figures show that once the outer layer of the surface is cracked, the pits propagate towards the adjacent damage; the material loss rate is accelerated by the cutting action.

Regime IV This area shows the effects of NaCl solution only on this composite material. The NaCl solution is absorbed and there is mass gain of the specimens. The NaCl interacts with the resin resulting in de-bonding at fibre–matrix interface and exposure of reinforcement fibres (Figs. 4, 6).
