Evaluation of the synergistic erosion-corrosion behaviour of HVOF thermal spray coatings

Abstract

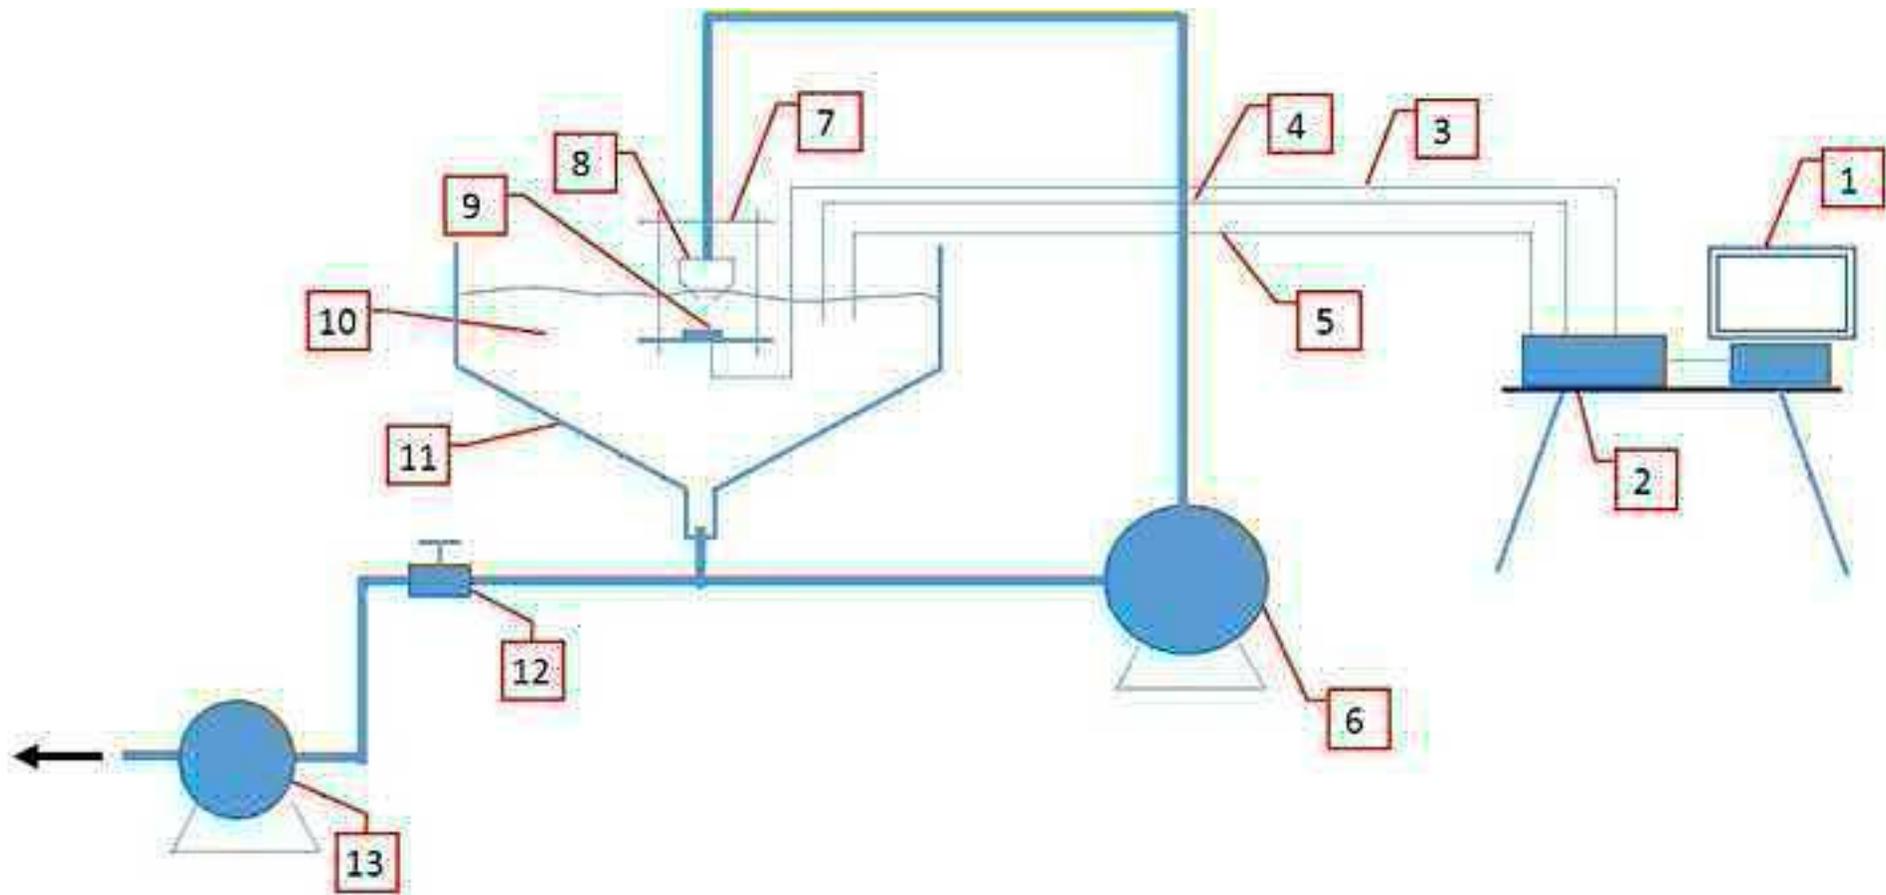
Figure 2
[Click here to download high resolution image](#)

A closed loop jet impingement system, as seen as a schematic in Figure 2, was used to carry out this comparative study, as similar systems have been used extensively by researchers to study the effects of erosion – corrosion on materials under high velocity, sand-containing flow regimes [14,38–40]. The benefits of this liquid impingement system include the ability to accurately control the flow velocity, manipulate the impingement angle and vary the quantity of erosive particles within the slurry. The stated variables have been shown to have significant impact on the rate of mass loss experienced by the damaged material [15,41]. The main tank contained the slurry solution with pump 1 circulating the solution from the main

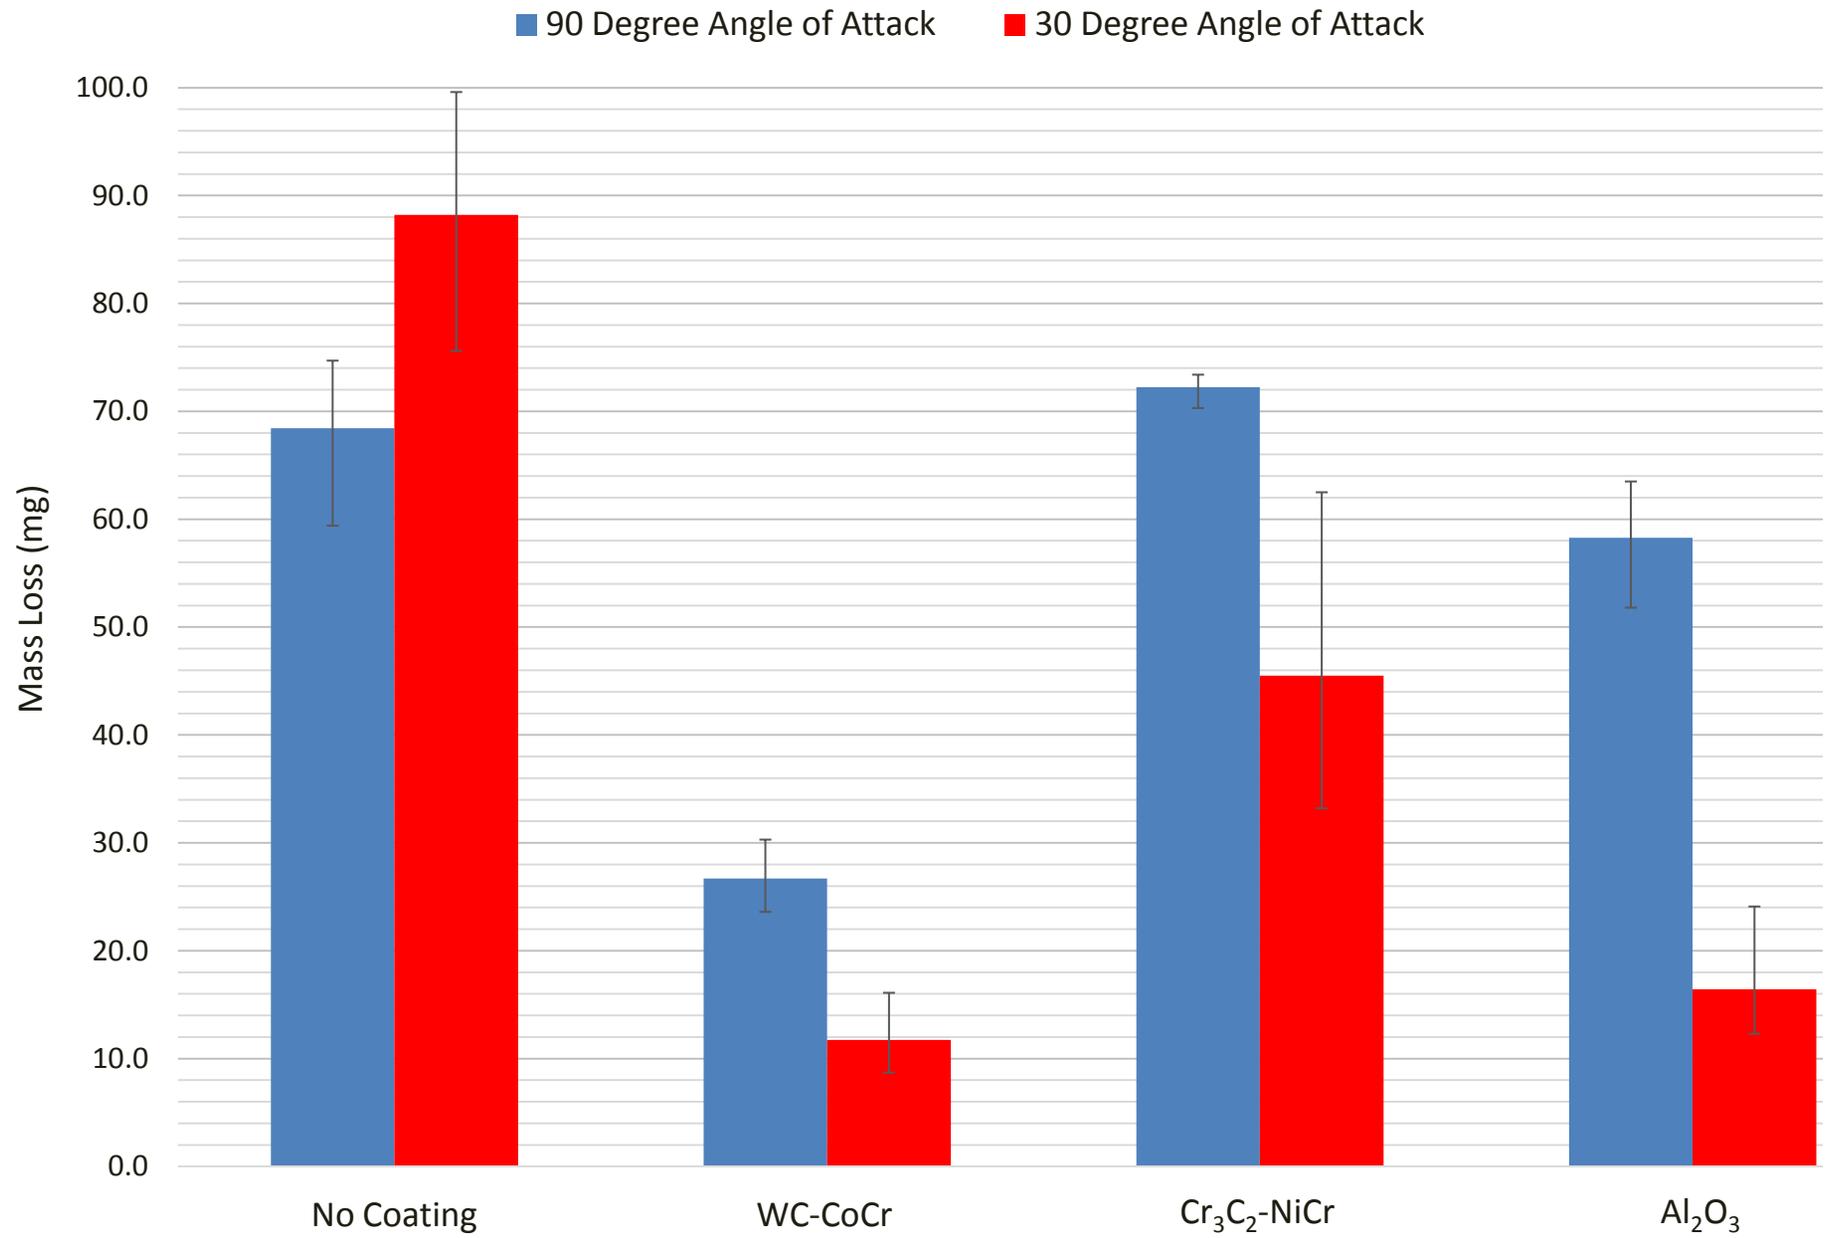
Figure 6
[Click here to download Figure: FIG6.xlsx](#)

Figure 6 displays the influence of the angle of attack on the free erosion-corrosion mass loss. The average mass loss for each coating type is shown over three test replicates for both 90° and 30° angle of attack. Error bars indicate the range of individual test results. It should be noted that the indicated mass loss for Cr₃C₂-NiCr and Al₂O₃ specimens also includes mass loss from the substrate material, due to the coatings being breached within the highly aggressive test conditions.

Fig 6. Mass loss under free erosion-corrosion conditions at 90° and 30° angle of attack.

Despite its high hardness, the Al₂O₃ coating has experienced significant mass loss under 90° angle of attack, with the calculated average mass loss being close to that of uncoated S355. In contrast to impingement at 90°, the Al₂O₃ specimen exhibits substantially less mass loss under impingement at 30°. This is in agreement with the reported findings [15] in which the increased quantity of carbides results in maximum damage occurring at higher angles of attack. A similar mechanism exists within the Cr₃C₂-NiCr specimens, with attack at 90° causing greater mass loss than the uncoated material. The coating suffered less degradation at 30°, however still proved the poorest performing coating of the three. Reduced mass loss over the Cr₃C₂-NiCr and Al₂O₃ coated specimens demonstrates the ability

of Cobalt to effectively retain carbide particles within the coating matrix. This, combined with the increased hardness of the coating, has resulted in WC-CoCr functioning as an effective protective layer for S355 steel under erosion – corrosion conditions at both 90° and 30° angles of attack. The findings support previous work on the erosion-corrosion of HVOF coatings under multiple angles of attack [15,29,44–46].

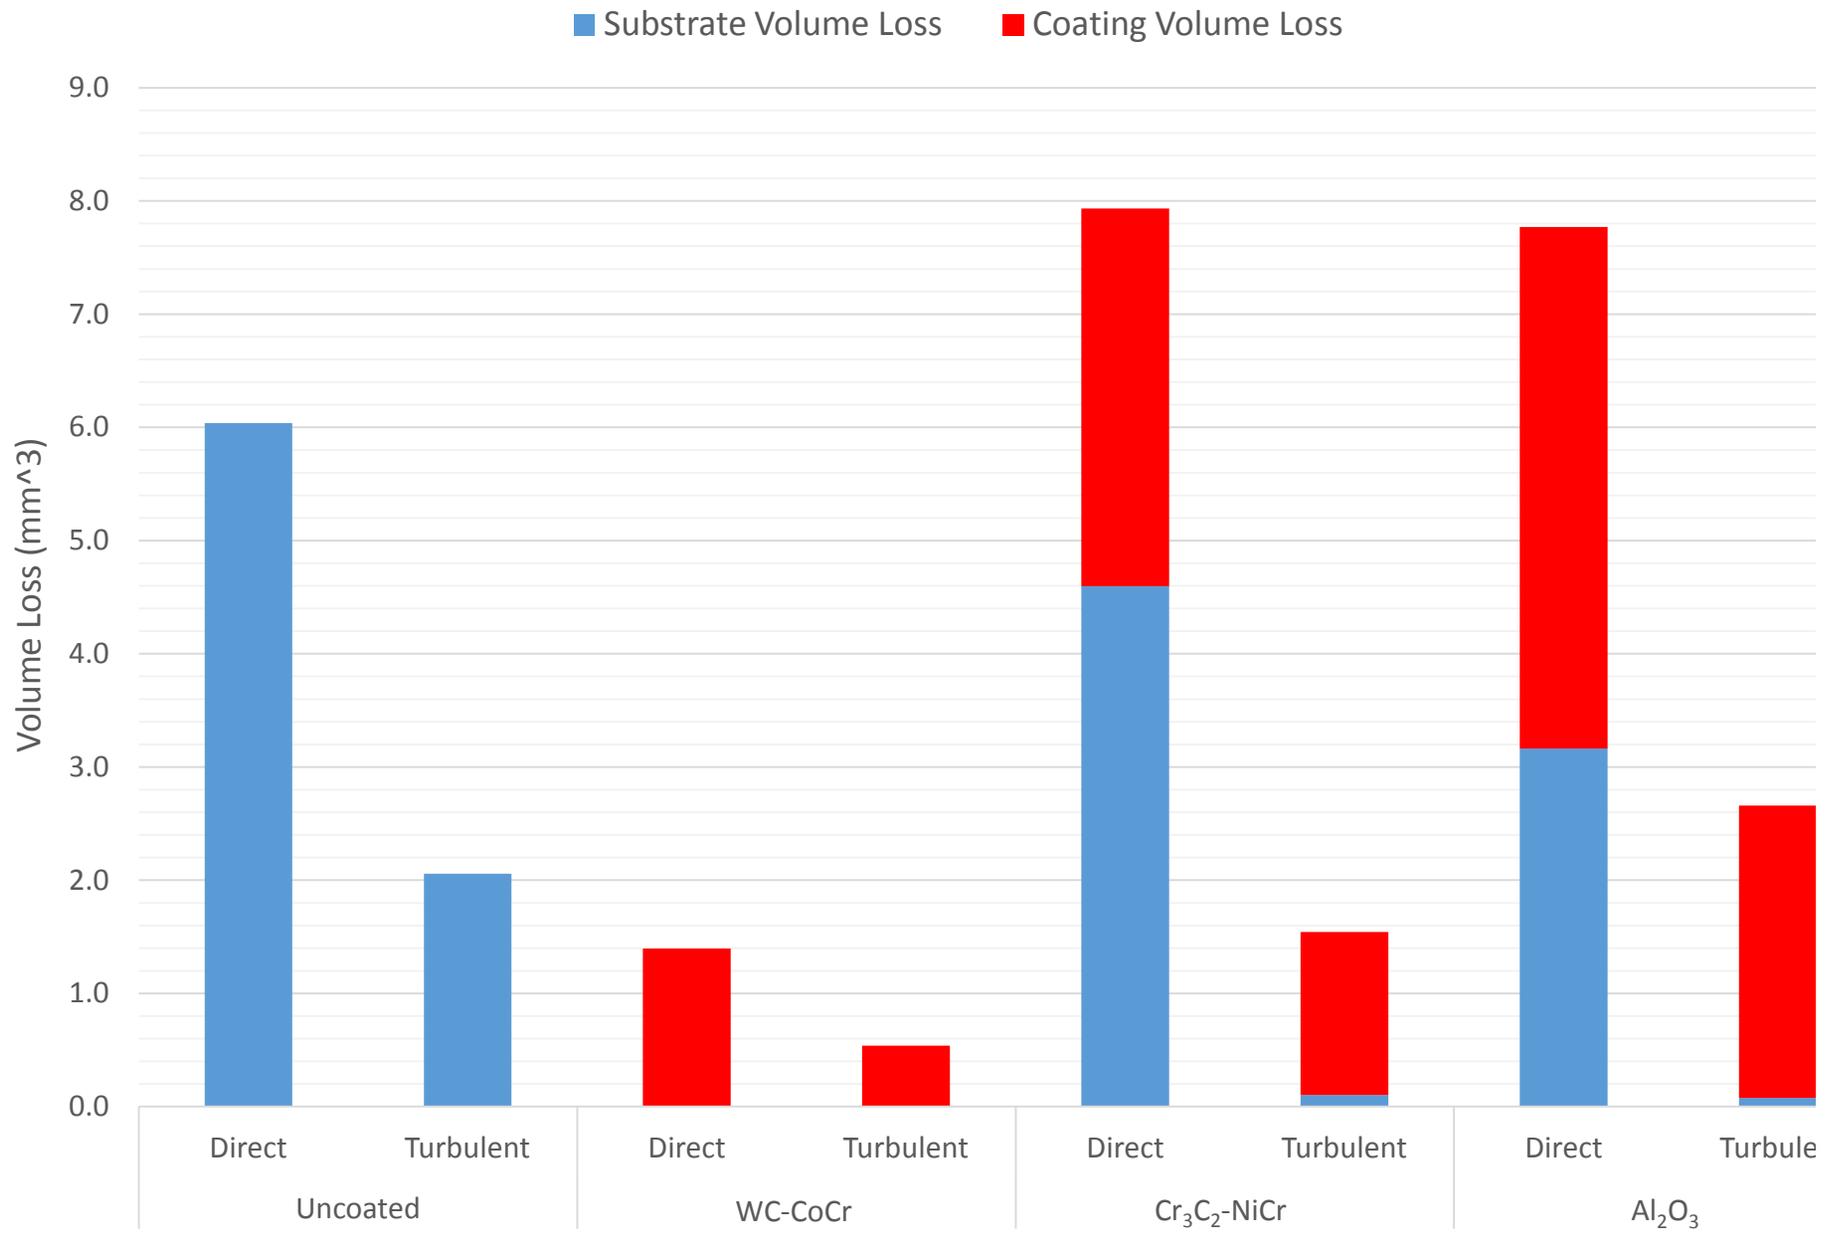
Figure 8
[Click here to download Figure: FIG8.xlsx](#)

Figure 8 depicts the resulting volume loss within the wear scar, highlighting the volume loss from the coating layer and substrate, for both the directly impinged and turbulent regions. Volume loss in the turbulent region is determined by measuring the

difference in volume losses between the entire wear scar and the directly impinged region using the Alicona surface analysis system.

The data presents a number of noteworthy trends; Cr_3C_2 -NiCr specimens suffered the greatest loss of material from the specimen substrate, with total volume loss in the direct zone comprising approximately 40% coating loss and 60% substrate loss. WC-CoCr is the only coating that has not been penetrated following 1-hour of exposure to the impinging slurry. Without the deep impact crater observed in other specimens, the impinging particles are free to scour across the surface of the WC-CoCr coating, eroding a wider area of material as demonstrated in Figure 5. The total volume loss recorded in WC-CoCr is approximately 20% of the value recorded for the uncoated material. Both Cr_3C_2 -NiCr and Al_2O_3 specimens have sustained substantial damage to the substrate material immediately beneath the directly impinged zone. This has formed a deep crater; increased depth of this crater correlates to the reduced respective volume loss from the turbulent region, with the shallower WC-CoCr wear scar promoting increased sliding erosion in the turbulent zone.

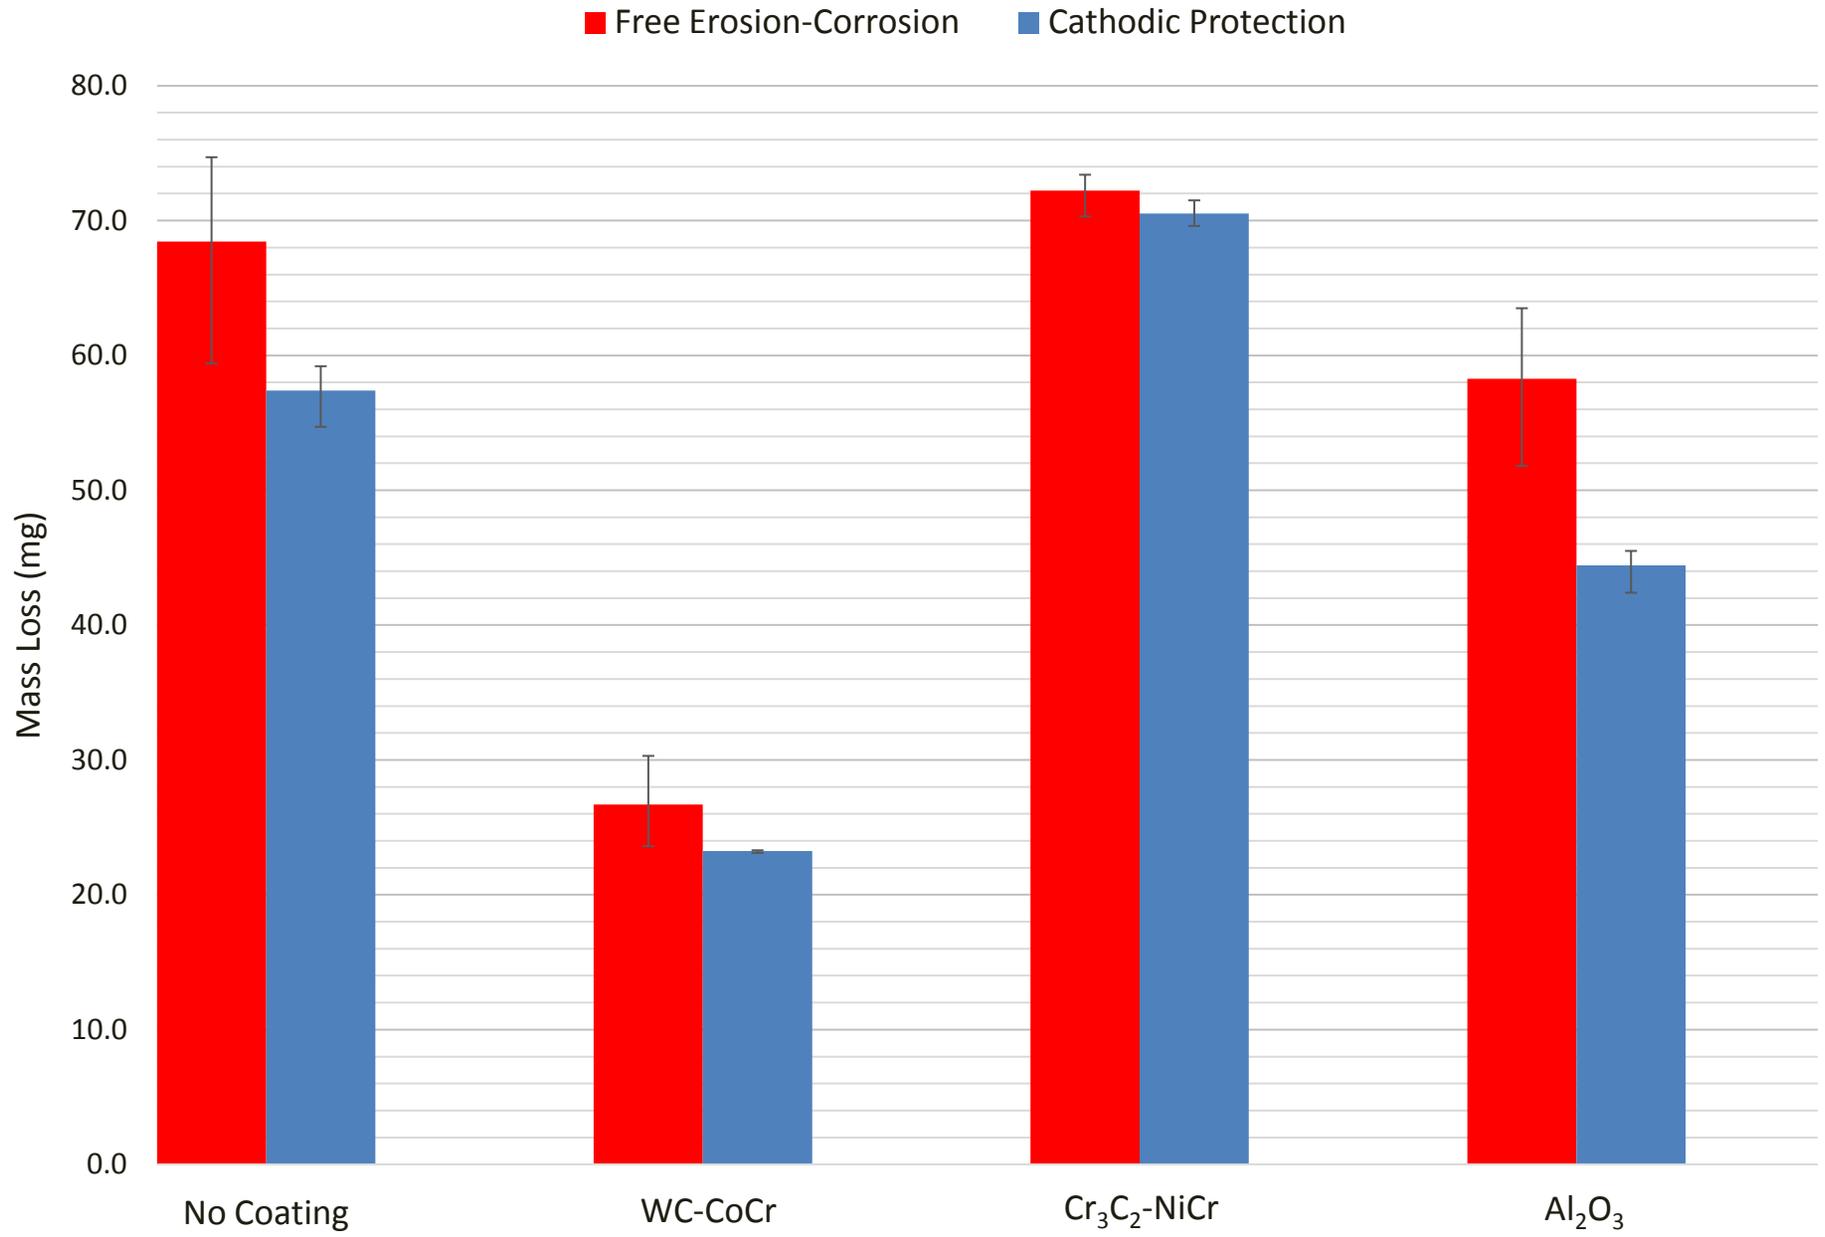
Figure 9
[Click here to download Figure: FIG9.xlsx](#)

Electrochemical measurements are necessary to determine the contributing factors of erosion, corrosion and the synergistic effects of both to the total mass loss. Figure 9 illustrates the average mass loss variation between the three coatings under free erosion – corrosion conditions and with applied CP.

Erosion-corrosion mass loss experiments show WC-CoCr coatings to yield around 60% reduction in mass loss with and without applied CP, over the uncoated substrate. Conversely, both Cr_3C_2 -NiCr and Al_2O_3 specimens resulted in enhanced mass loss when compared with uncoated S355 substrate. Applied CP has had the most significant impact on

the uncoated and Al_2O_3 specimens, with mass loss of CP protected specimens measurably less than observed under free erosion – corrosion conditions.

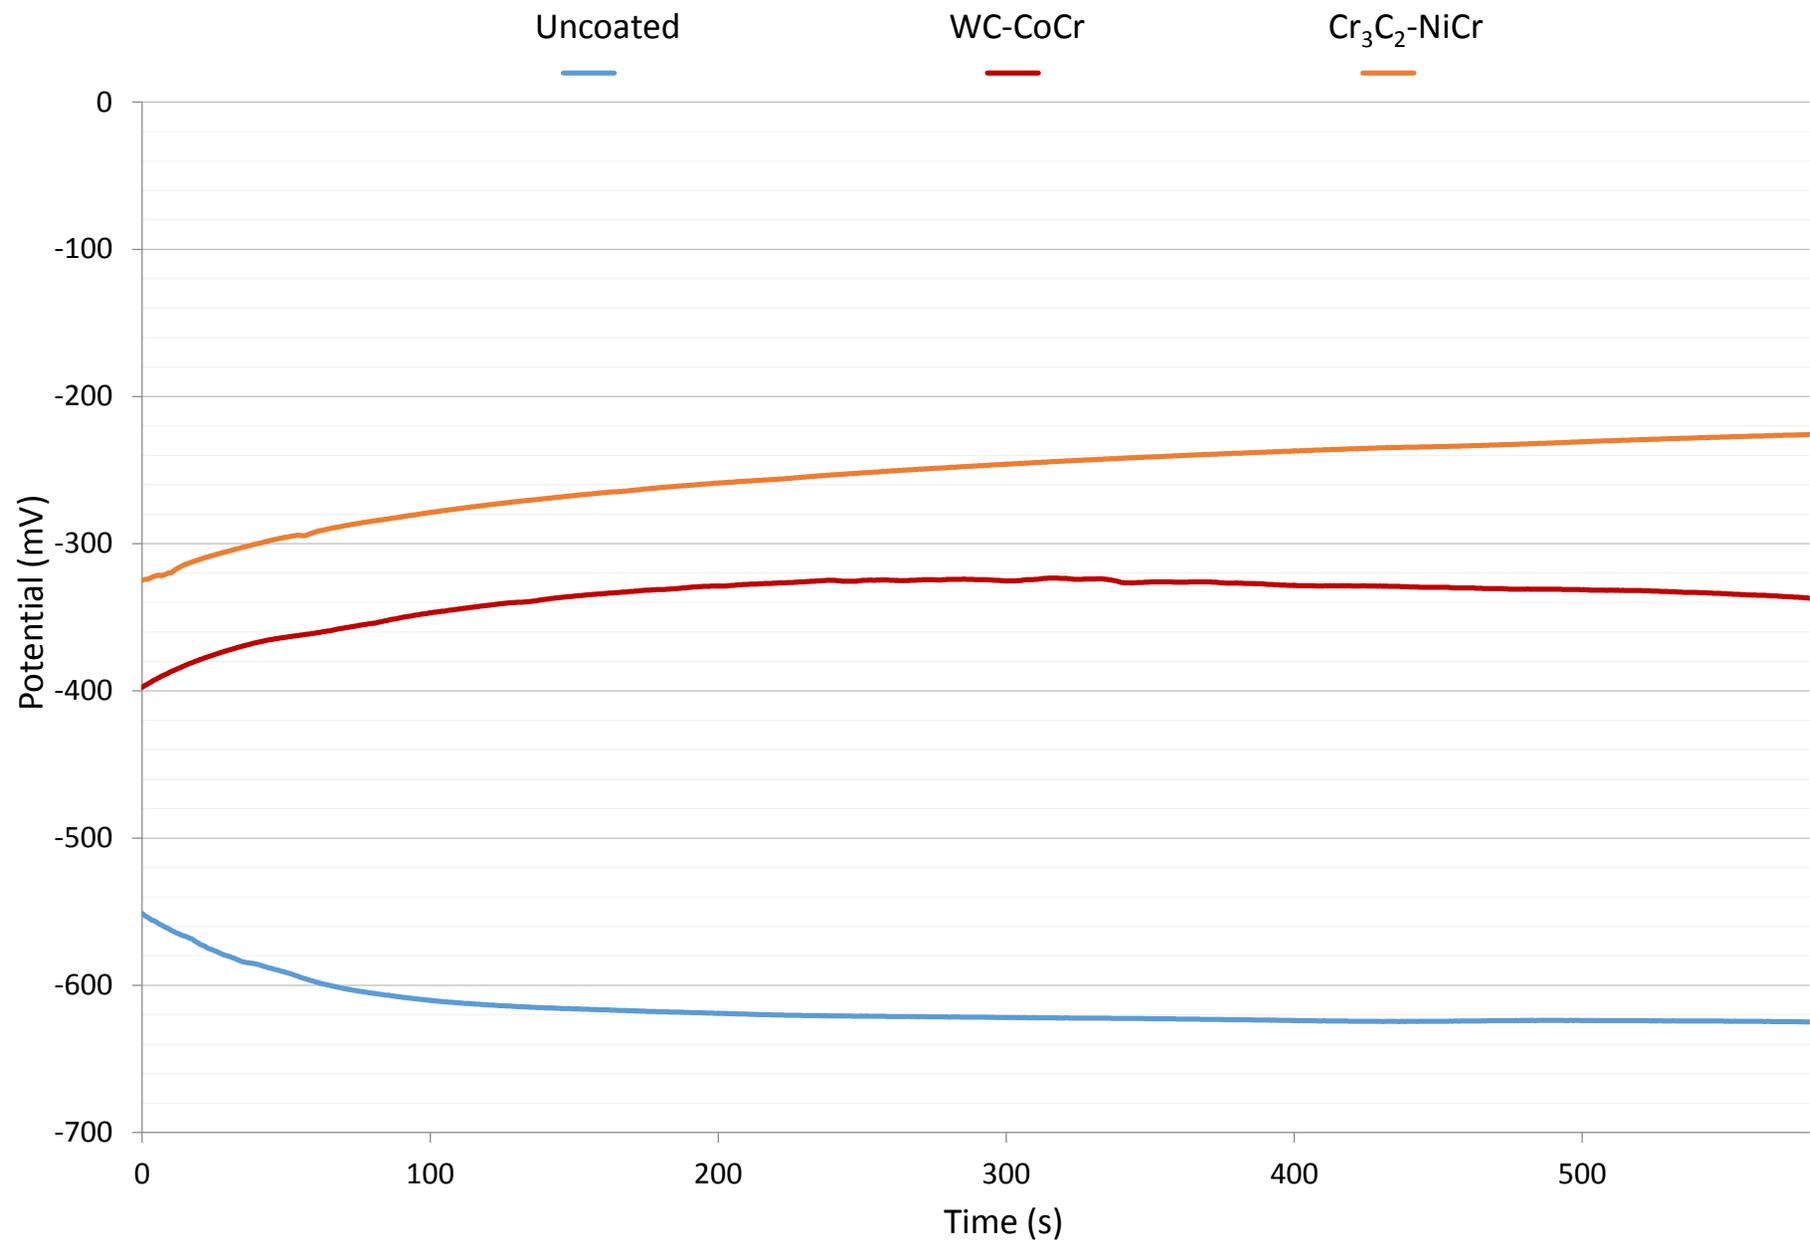
Figure 10a
[Click here to download Figure: FIG10a.xlsx](#)

The application of CP necessitated the measurement of OCP for each coating material under both flowing and static conditions. Figure 10a outlines the variation in E_{corr} between the three coating types and the uncoated S355 substrate for static conditions, with Figure 10b showing results for flowing conditions.

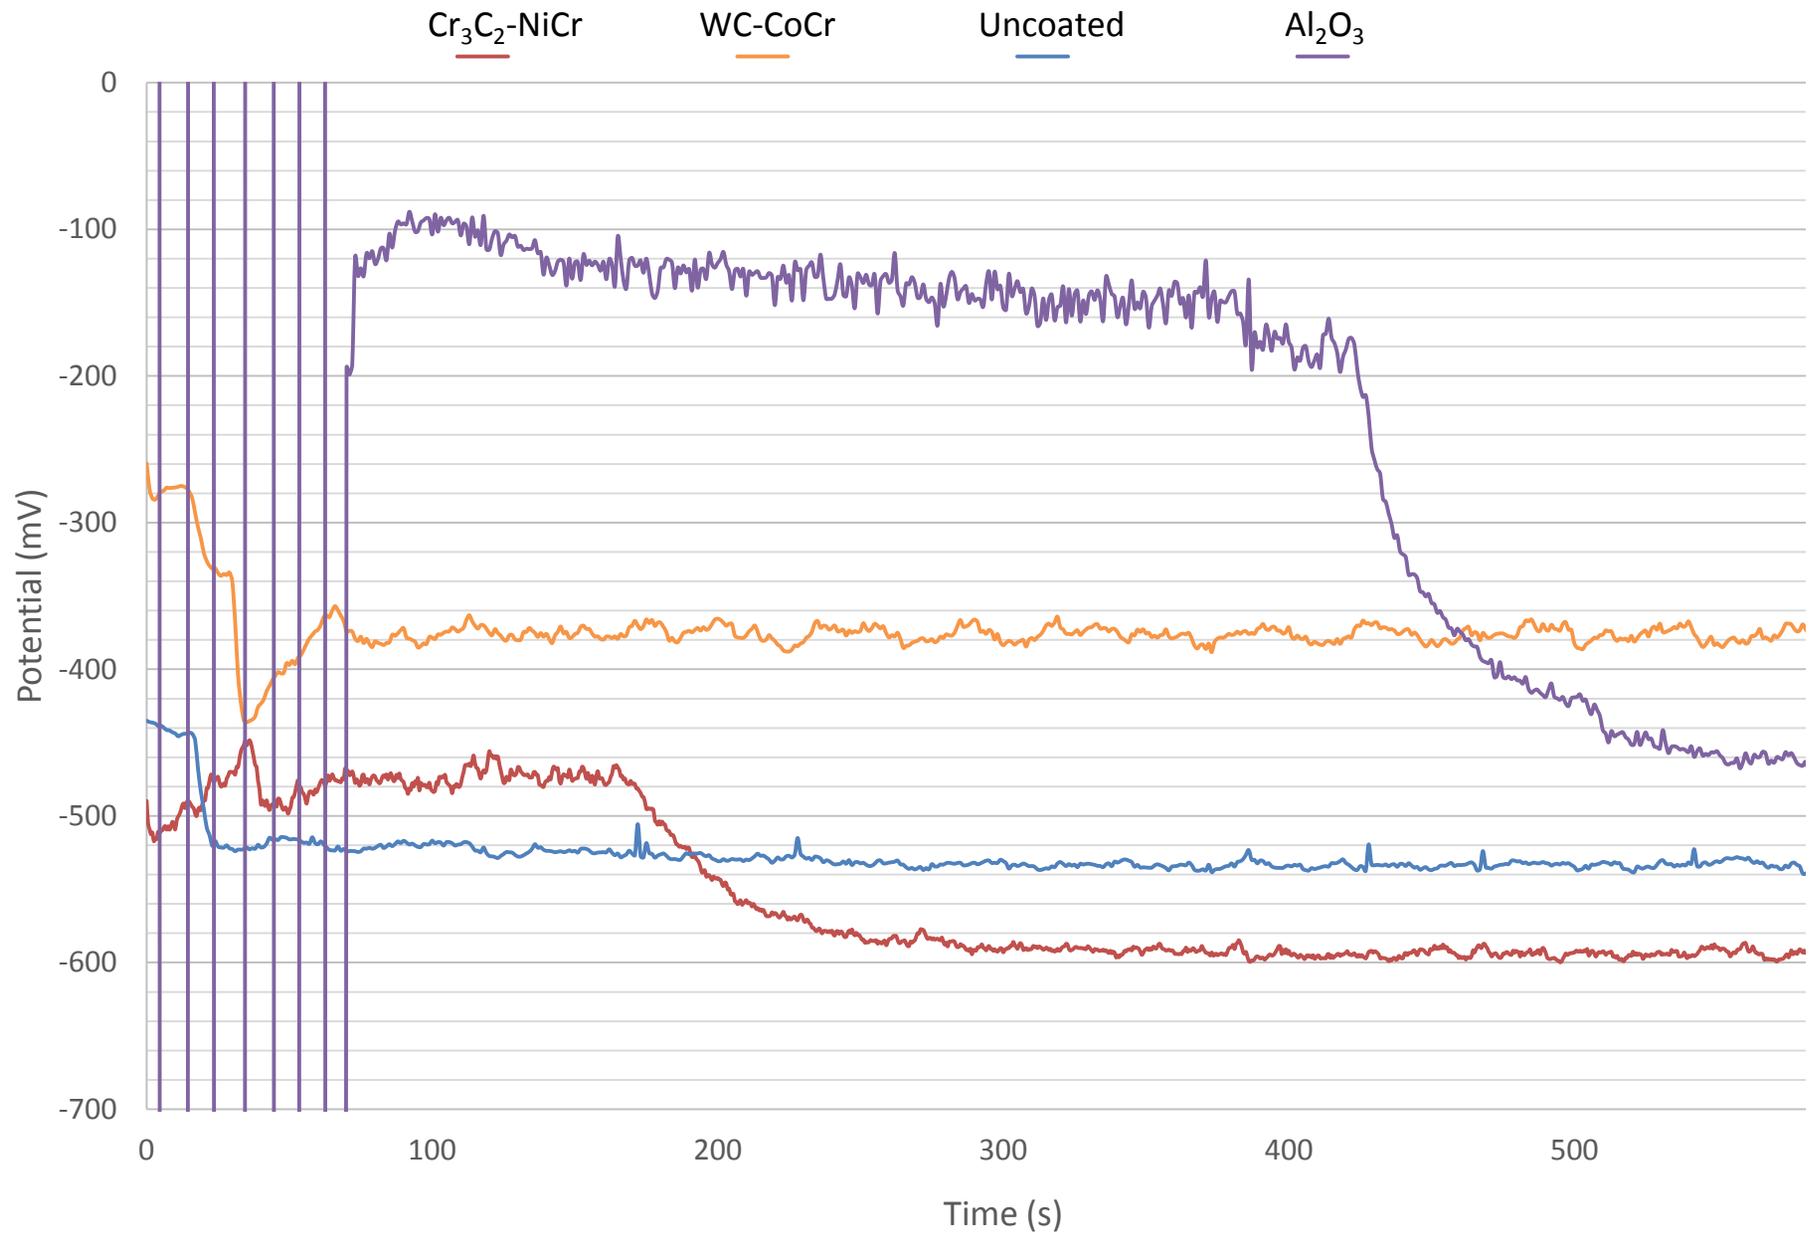
Figure 10b
[Click here to download Figure: FIG10b.xlsx](#)

After 200 s of exposure to the flowing slurry, the E_{corr} values for $\text{Cr}_3\text{C}_2\text{-NiCr}$ dropped to approximately -600 mV. The proximity of this value to the E_{corr} of uncoated S355 demonstrates that the coating has been damaged to such an extent that current is able to flow between the slurry and the substrate. Under static conditions, the Al_2O_3 coating restricted the flow of current between the slurry and the electrode. As a result, no corrosion density data is presented for this coating in static conditions. When exposed to the impinging slurry, no current flow was detected for 100 s, after which a -80 mV voltage was measured across the working electrode. Given that the Al_2O_3 coating halts the flow of current, the identified voltage is ascribed to the current flowing between the substrate and the slurry. Continued impingement led to an increase in the detected voltage, thus indicating that more of the substrate material has been exposed to the slurry. After 420 s, the E_{corr} of the specimen fell rapidly to -480 mV and stayed constant at this value for the remainder of the test. The results demonstrate that following 80 s of exposure, the impinging jet has damaged the coating sufficiently to allow current flow between the substrate and the slurry. Continued impingement has led to the complete removal of the Al_2O_3 layer after 420 s, at which point the E_{corr} of the specimen dropped to a value similar to that of the uncoated S355 substrate. This further highlights the poor performance of Al_2O_3 and $\text{Cr}_3\text{C}_2\text{-NiCr}$ as protective surface coatings exposed to aggressive slurry erosion. The rapid removal of coating material

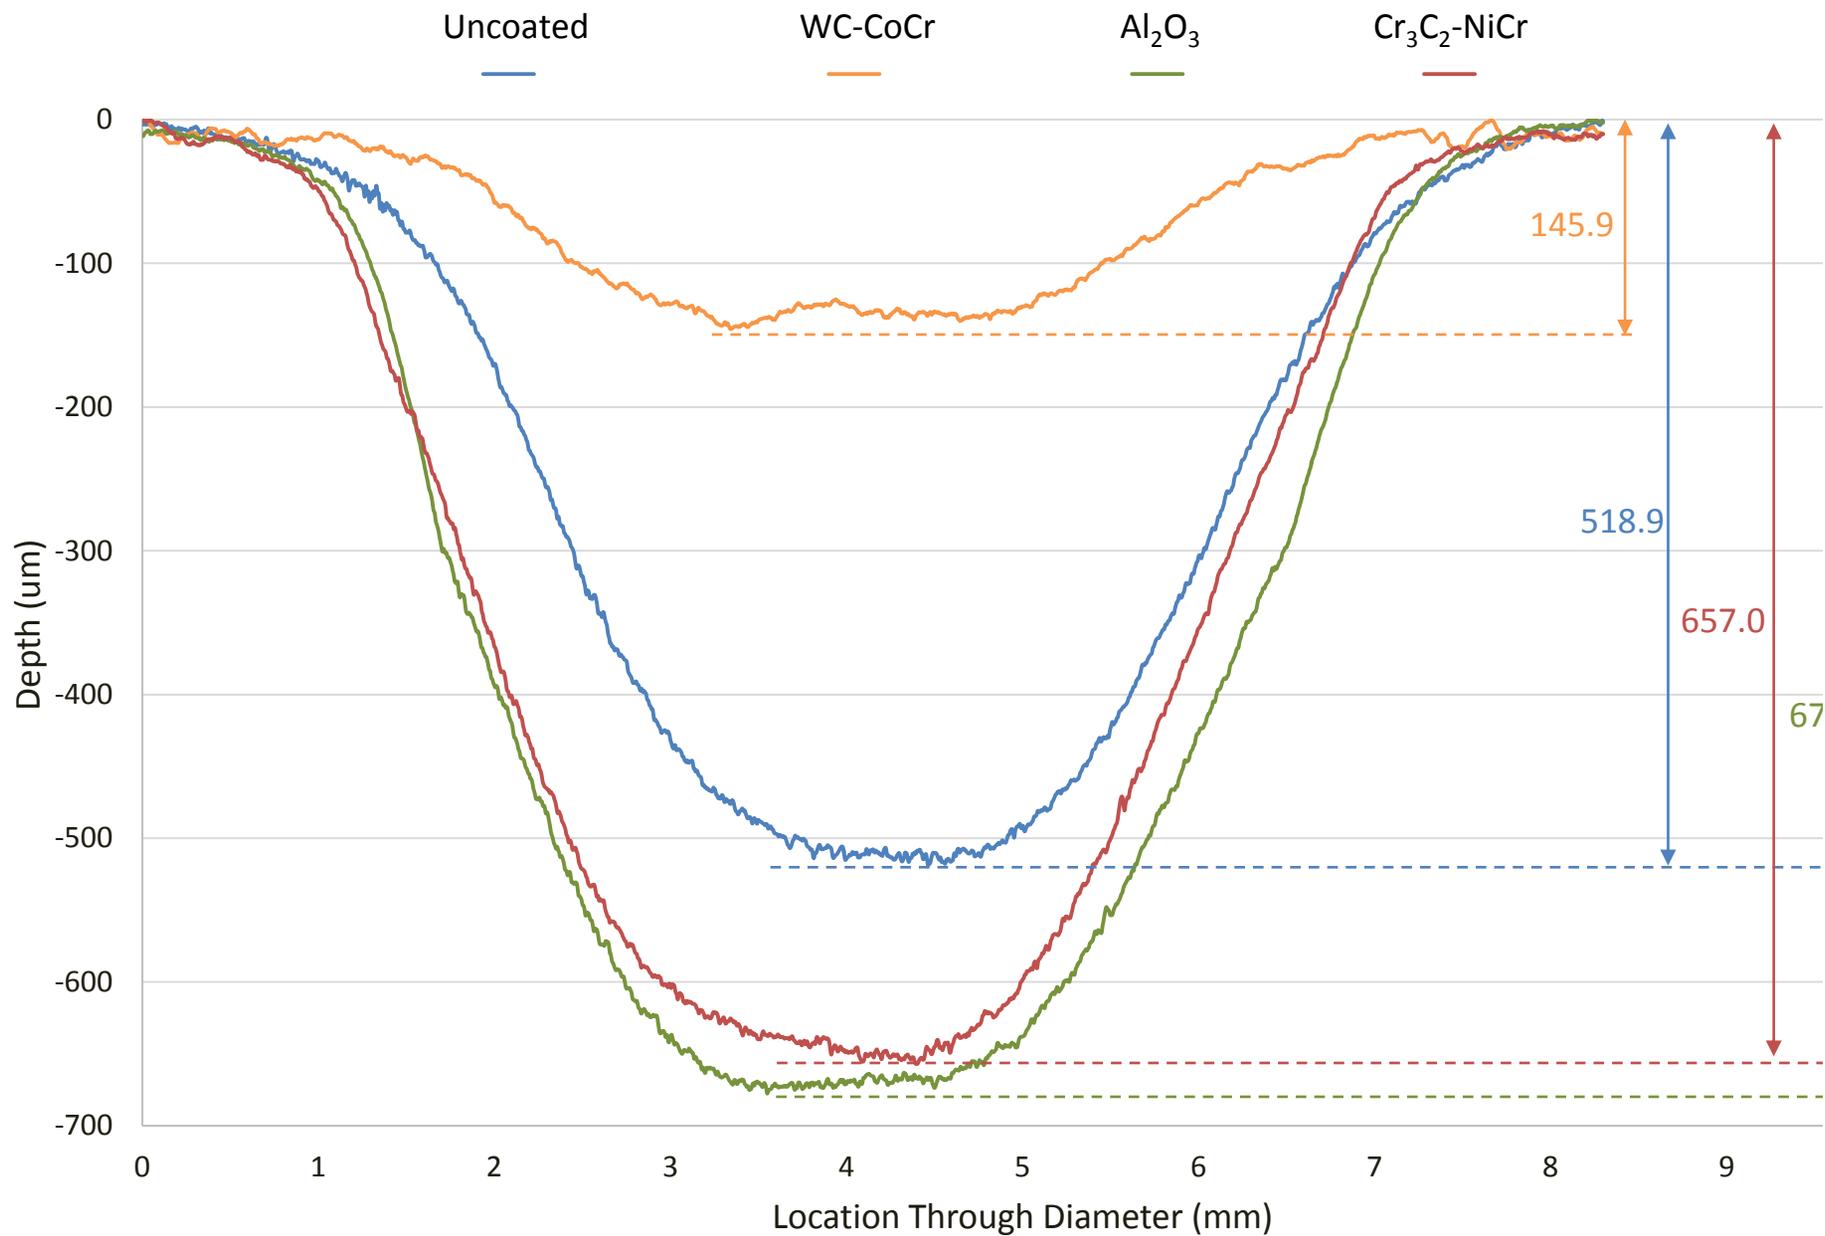
Figure 12
[Click here to download Figure: FIG12.xlsx](#)

The typical wear scar for each of the three coatings and the uncoated S355 was captured using an Alicona optical imaging system and is highlighted in Figure 4. Figure 12 depicts a comparative analysis of the wear scar depths from each coating material following 1-hour free erosion – corrosion impingement, measured using a surface profilometer. Wear scar depth was corroborated using an Alicona with results being shown in Table 7. It is evident that the Al₂O₃ coating has developed the largest wear scar, with a maximum

recorded depth of 678 μm . The scar depth for $\text{Cr}_3\text{C}_2 - \text{NiCr}$ was shown to be marginally shallower, however, given the comparably thin coating layer, the substrate penetration depth is 100 μm greater than in the Al_2O_3 . The recorded maximum wear scar depth for WC-CoCr was 141.7 μm . With an indicated coating thickness of 180 μm , the results verify that the coating layer has not been breached following the 1-hour liquid impingement test. The significant reduction in wear scar depth clearly demonstrates that WC-CoCr has provided superior protection of the S355 substrate over other assessed coatings.

Both the $\text{Cr}_3\text{C}_2\text{-NiCr}$ and uncoated specimens exhibited similar wear scars, with $\text{Cr}_3\text{C}_2\text{-NiCr}$ developing a scar of marginally greater depth. Wear scar analysis indicates the deleterious effects of $\text{Cr}_3\text{C}_2\text{-NiCr}$ and Al_2O_3 coating on S355 substrate. In both instances, the presence of a coating increased the total mass loss and enlarged the produced wear scar. This phenomenon has been attributed to the erosive effects of coating particulates previously removed by the impinging slurry acting as a secondary erodent.

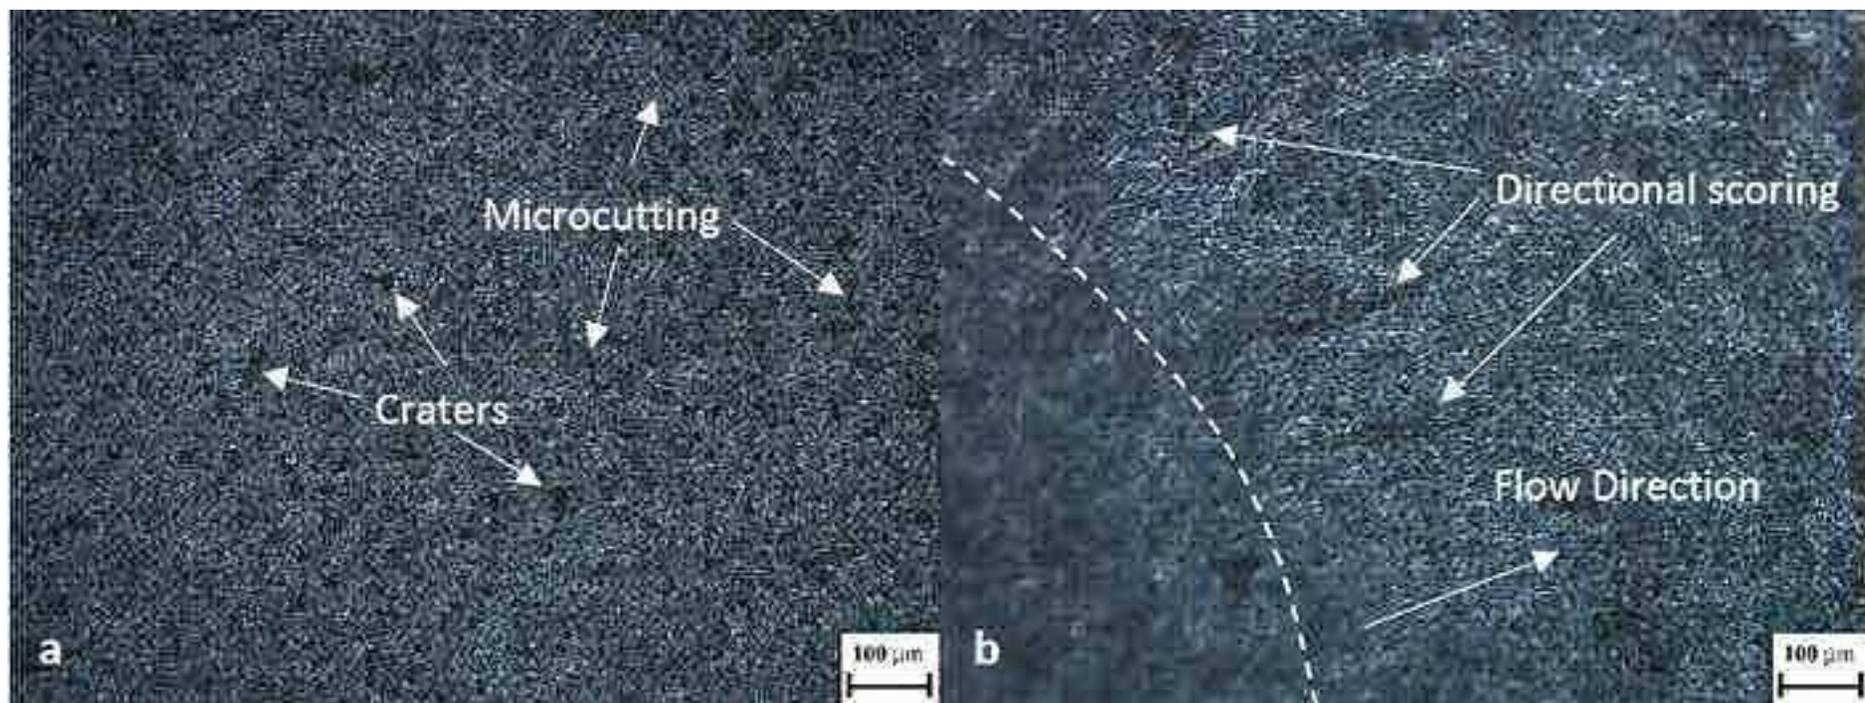
Figure 15
[Click here to download high resolution image](#)

Micrographs of the central impinged and turbulent zones within the WC-CoCr coating are depicted in Figure 15 and reveal a wear mechanism similar to that observed in uncoated S355. There is evidence of impact craters within the directly impinged zone. The presence of craters indicates the surrounding material has retained its structure following impact. With continued liquid impingement, carbide particles fracture and cannot be retained by the cobalt matrix, with continuous flow eventually removing the particles from the coating matrix altogether. Corroborating results have been obtained by Thakur et al. [34]. The remaining cobalt binder has insufficient hardness to withstand the erosive conditions and is eventually removed. Microcutting is also evident and is linked to the ploughing of silica particles and removal of soft cobalt binder. The observations are in accordance with those reported in associated studies [50,51]. The superior wear performance of the WC-CoCr coating can be attributed to the cobalt binder effectively retaining the hard carbide particles within the matrix. The turbulent zone shown in Figure 15b depicts some signs of directionality but in contrast with other specimens, shows signs of more erratic wear. This is to be expected given the lack of a defined impact crater.

Fig 15. Optical image of WC-CoCr coated specimen following free erosion-corrosion test. a) directly impinged region, b) turbulent region [x100, Unetched].
