Performance evaluation of HVOF deposited cermet coatings under dry and slurry erosion

Abstract

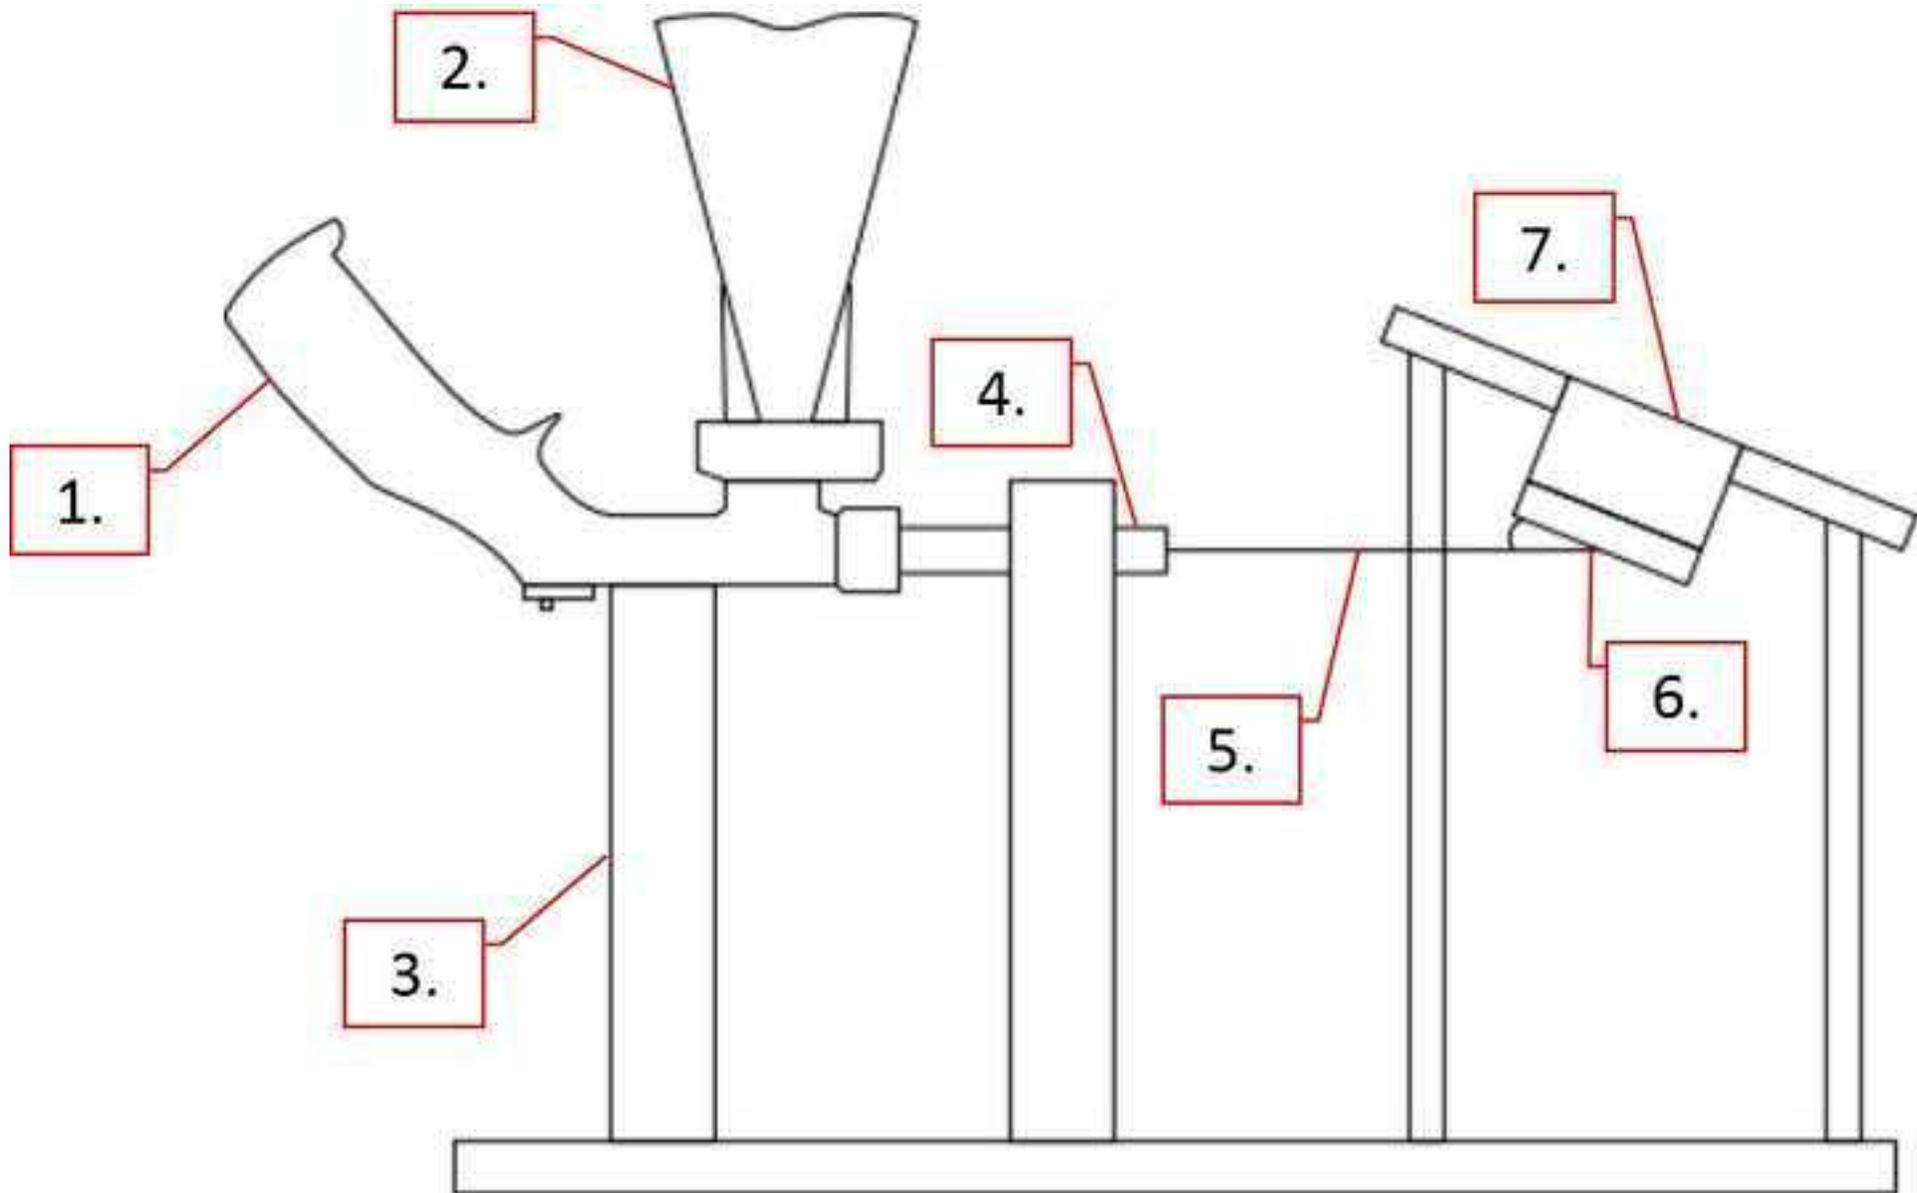
Figure 1
[Click here to download high resolution image](#)

A sand blasting gun with inverted particle feeder, shown as a schematic in Figure 1, was selected to carry out dry erosion testing. Comparable systems have been utilized in previous studies [14,19,27,28].

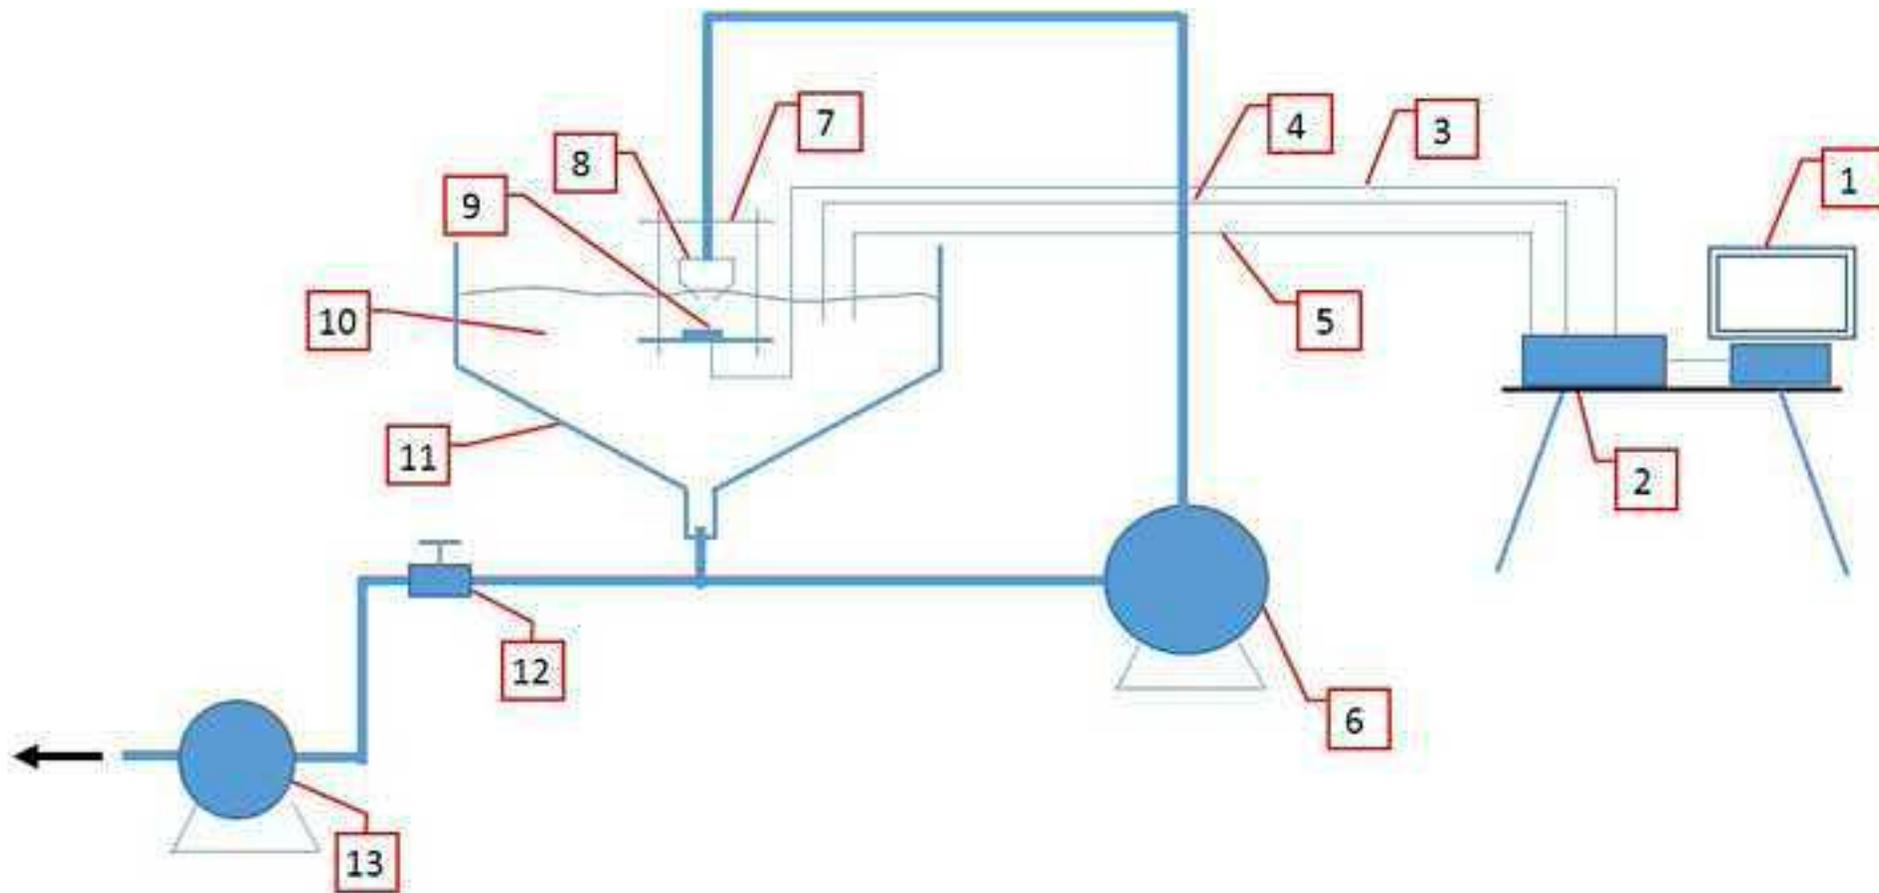
Figure 2
[Click here to download high resolution image](#)

A closed loop jet impingement rig, shown as a schematic in Figure 2, was selected to facilitate the slurry erosion experiments as similar systems have been used in existing studies to determine the effects of erosion and corrosion within a flowing environment [22,30–32]. A closed loop system offers the ability to accurately control and alter the flow velocity, modify the impingement angle and manipulate the quantity of erosive particles within the slurry. These variables are known to influence the rate of mass loss [21,33]. The slurry used throughout the study comprised of a 3.5 wt.% NaCl solution containing FS9 grade angular silica sand with an average particle size of 0.355 mm. Test specimens were positioned directly beneath the nozzle, whilst fully immersed in the slurry solution. Pump 2 allowed removal of slurry, with the system subsequently flushed with fresh water to remove all trace particulates, thereby ensuring consistent sand concentration throughout all experimental trials. Table 3 details the experimental parameters for the liquid impingement tests.

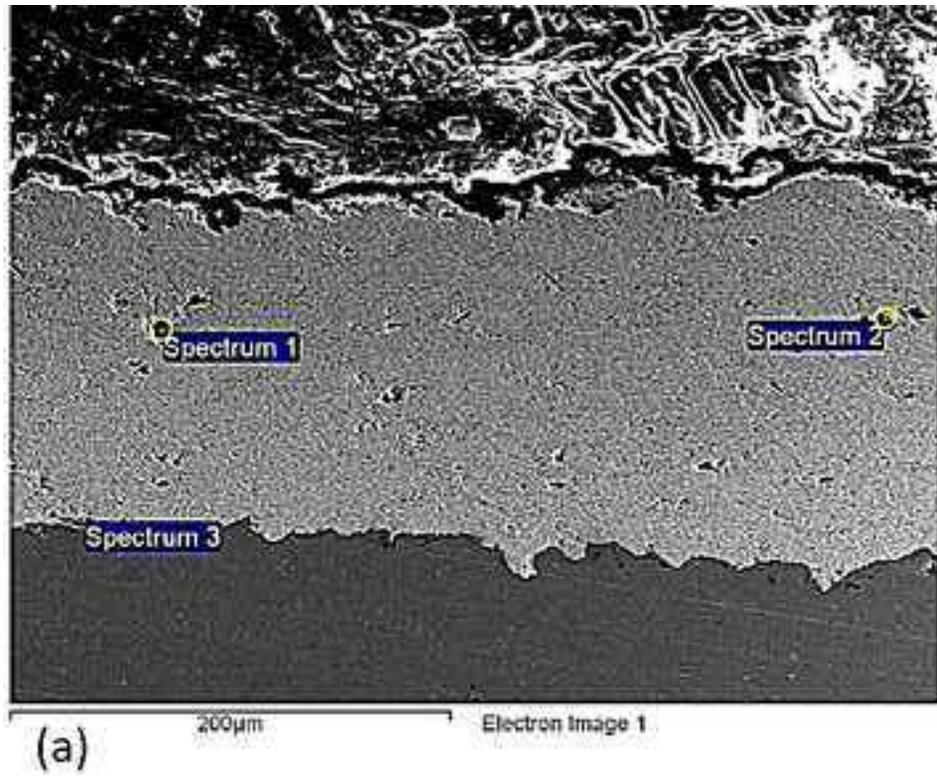
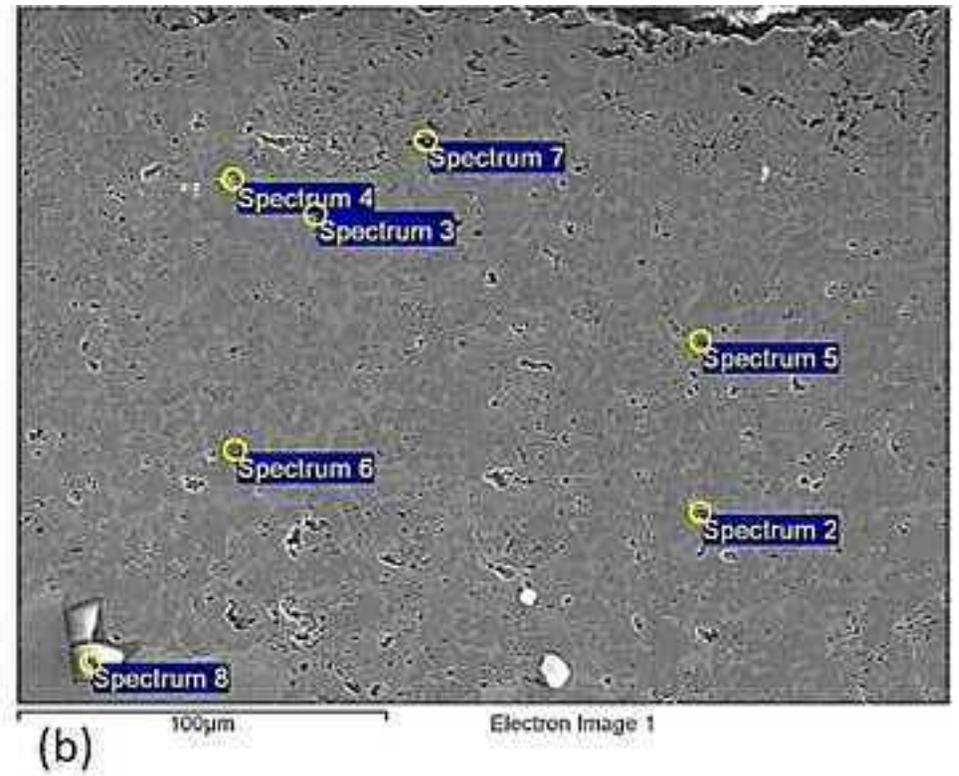
Figure 5
[Click here to download high resolution image](#)

SEM with EDS provided verification of features highlighted through light optical microscopy. Figure 5 depicts the various features and locations where EDS spot analysis was performed. Scanning of regions denoted as spectra 1 and 2 produced comparatively low deadtime, indicating that the areas scanned are void locations. Defect free regions present chemical compositions reflecting the composition of the sprayed particles (Table 1) .

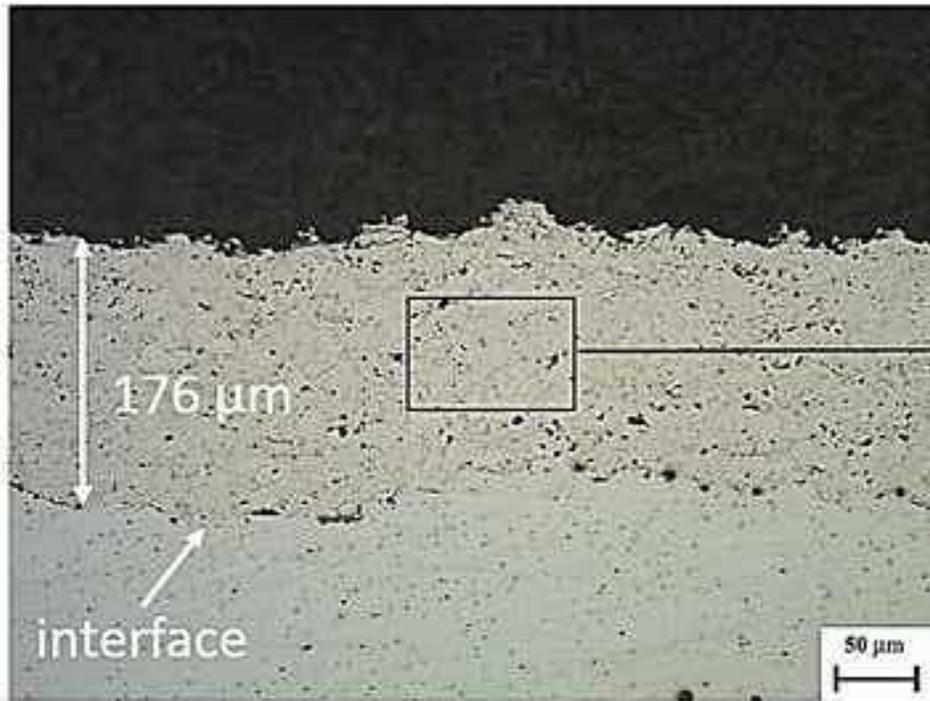
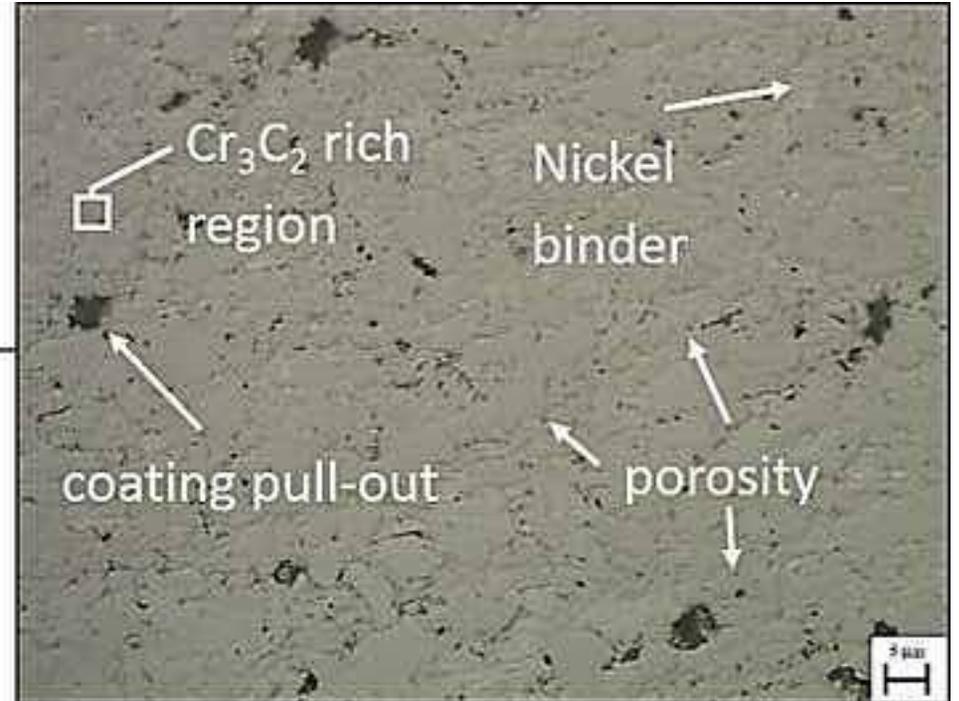
Figure 6
[Click here to download high resolution image](#)

Figure 6a presents a micrograph of the Cr₃C₂-NiCr coating. As with WC-CoCr, the coating layer is generally dense with minimal porosity. There is evidence of carbide pull-out which can be attributed to the metallographic preparation process [42].

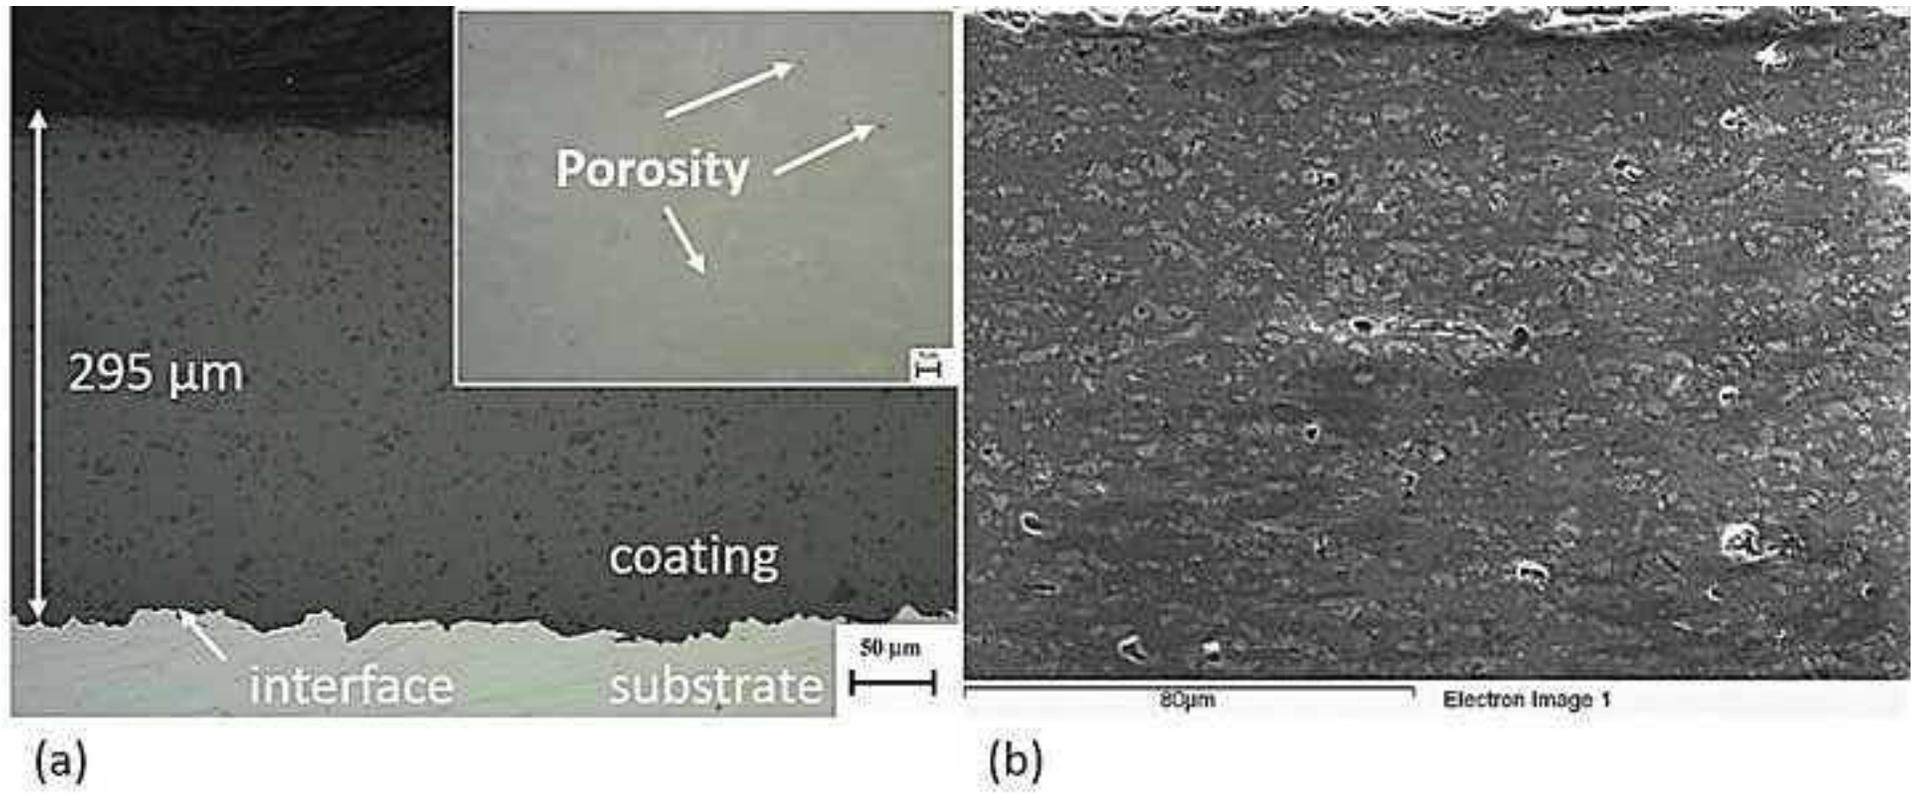
Figure 7
[Click here to download high resolution image](#)

An optical micrograph of the Al₂O₃ coating is presented in Figure 7a, with Figure 7b depicting a scanning electron micrograph of the same region. As with Cr₃C₂-NiCr and WC-CoCr, the Al₂O₃ coating presented a dense structure showing limited signs of porosity or inclusions within the coating layer (Figure 7a). The micrograph, (Figure 7b) exhibits signs of limited porosity and corroborates the findings of the porosimetry (Table 4). The high particle temperature is sufficient to cause flattening [43] of the alumina particles. However, due to the oxide particles being larger than the carbides retained in the cermet powders [36–38], the porosity of the Al₂O₃ coating is greater than that of WC-CoCr and Cr₃C₂-NiCr. Results of SEM analysis present consistent chemical composition throughout the coating. As expected quantities of Oxygen (53 wt.%) and Aluminium (47 wt.%) were detected, with any other trace elements being below 0.5 wt.%.

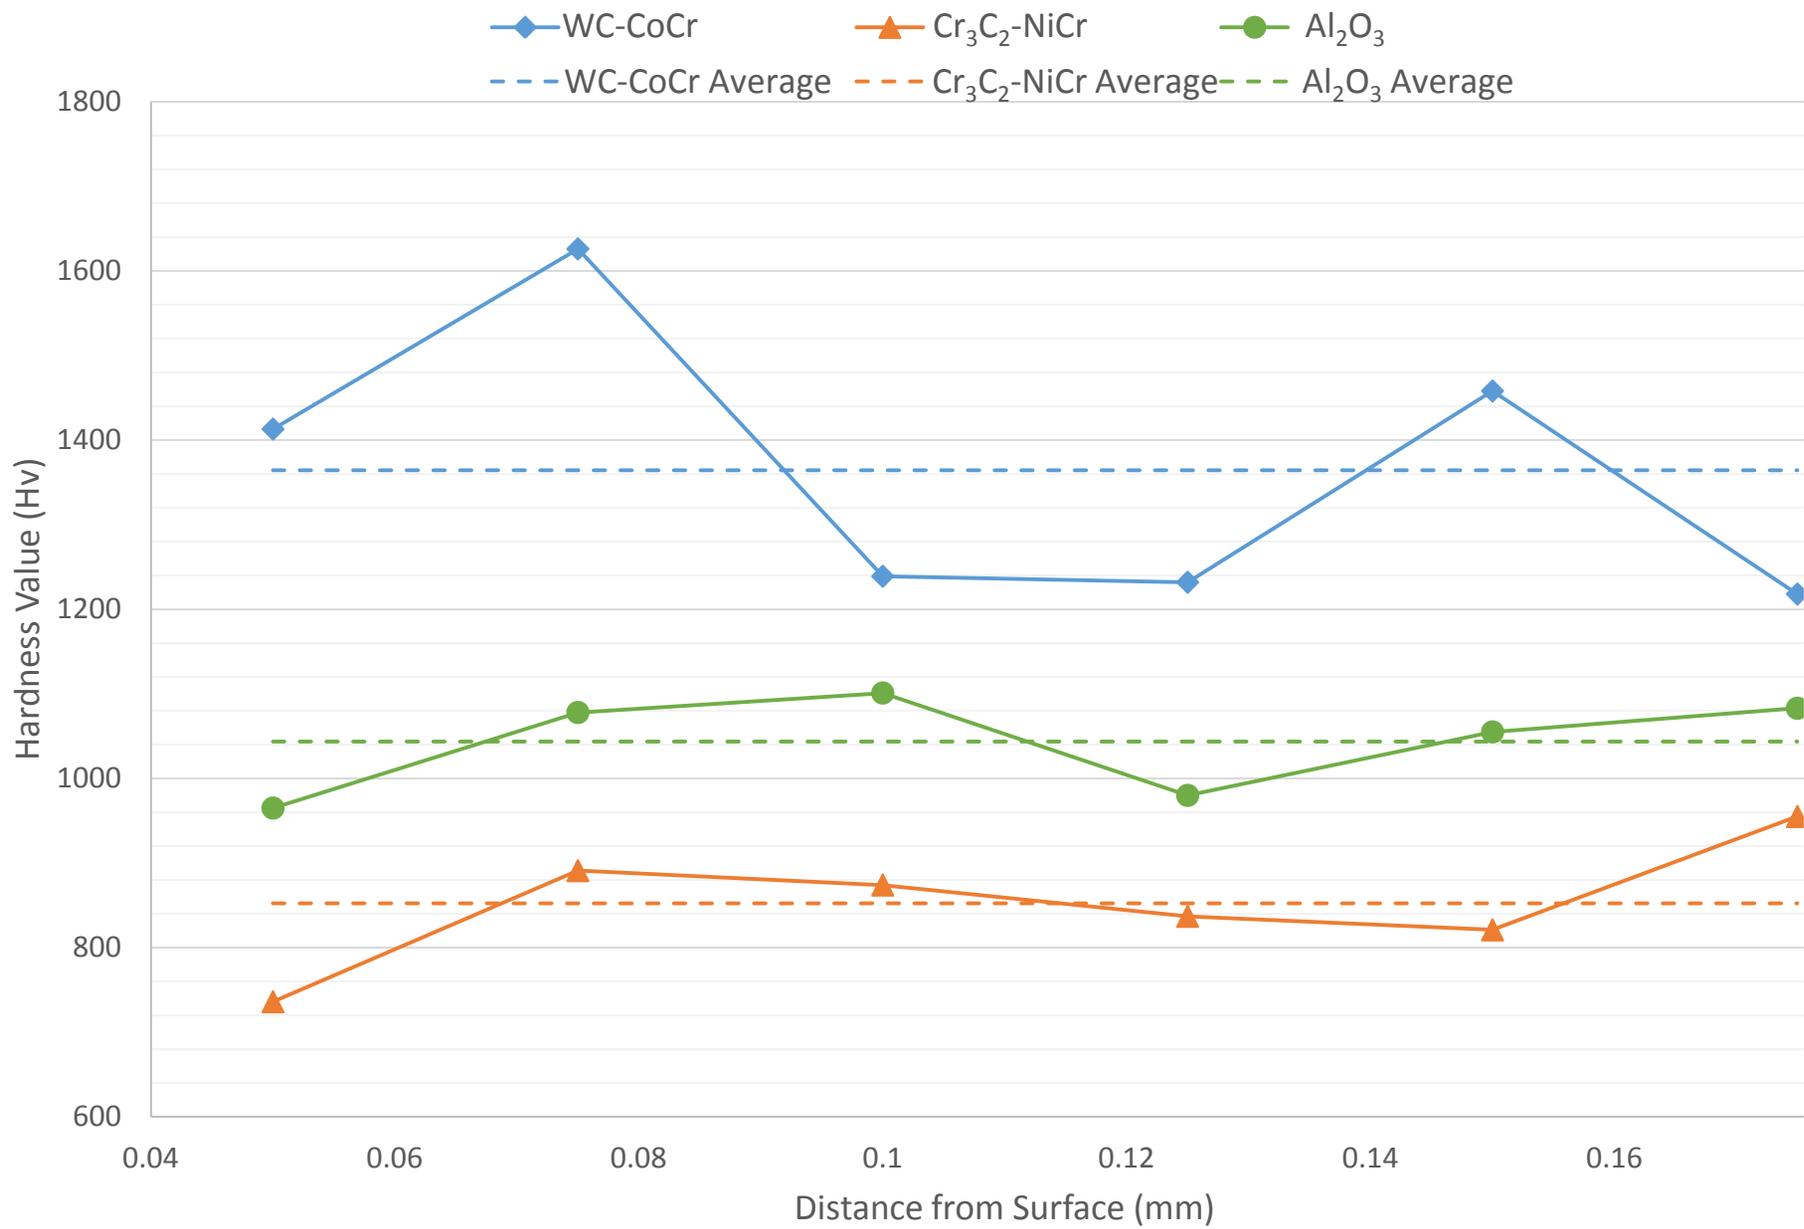
Figure 8 illustrates the variation in micro-hardness between the three coatings with values recorded at intervals of 20 µm through the coating thickness. WC-CoCr exhibited the highest overall average hardness at 1364 HV. This constitutes a substantial increase over the S355, found to have a

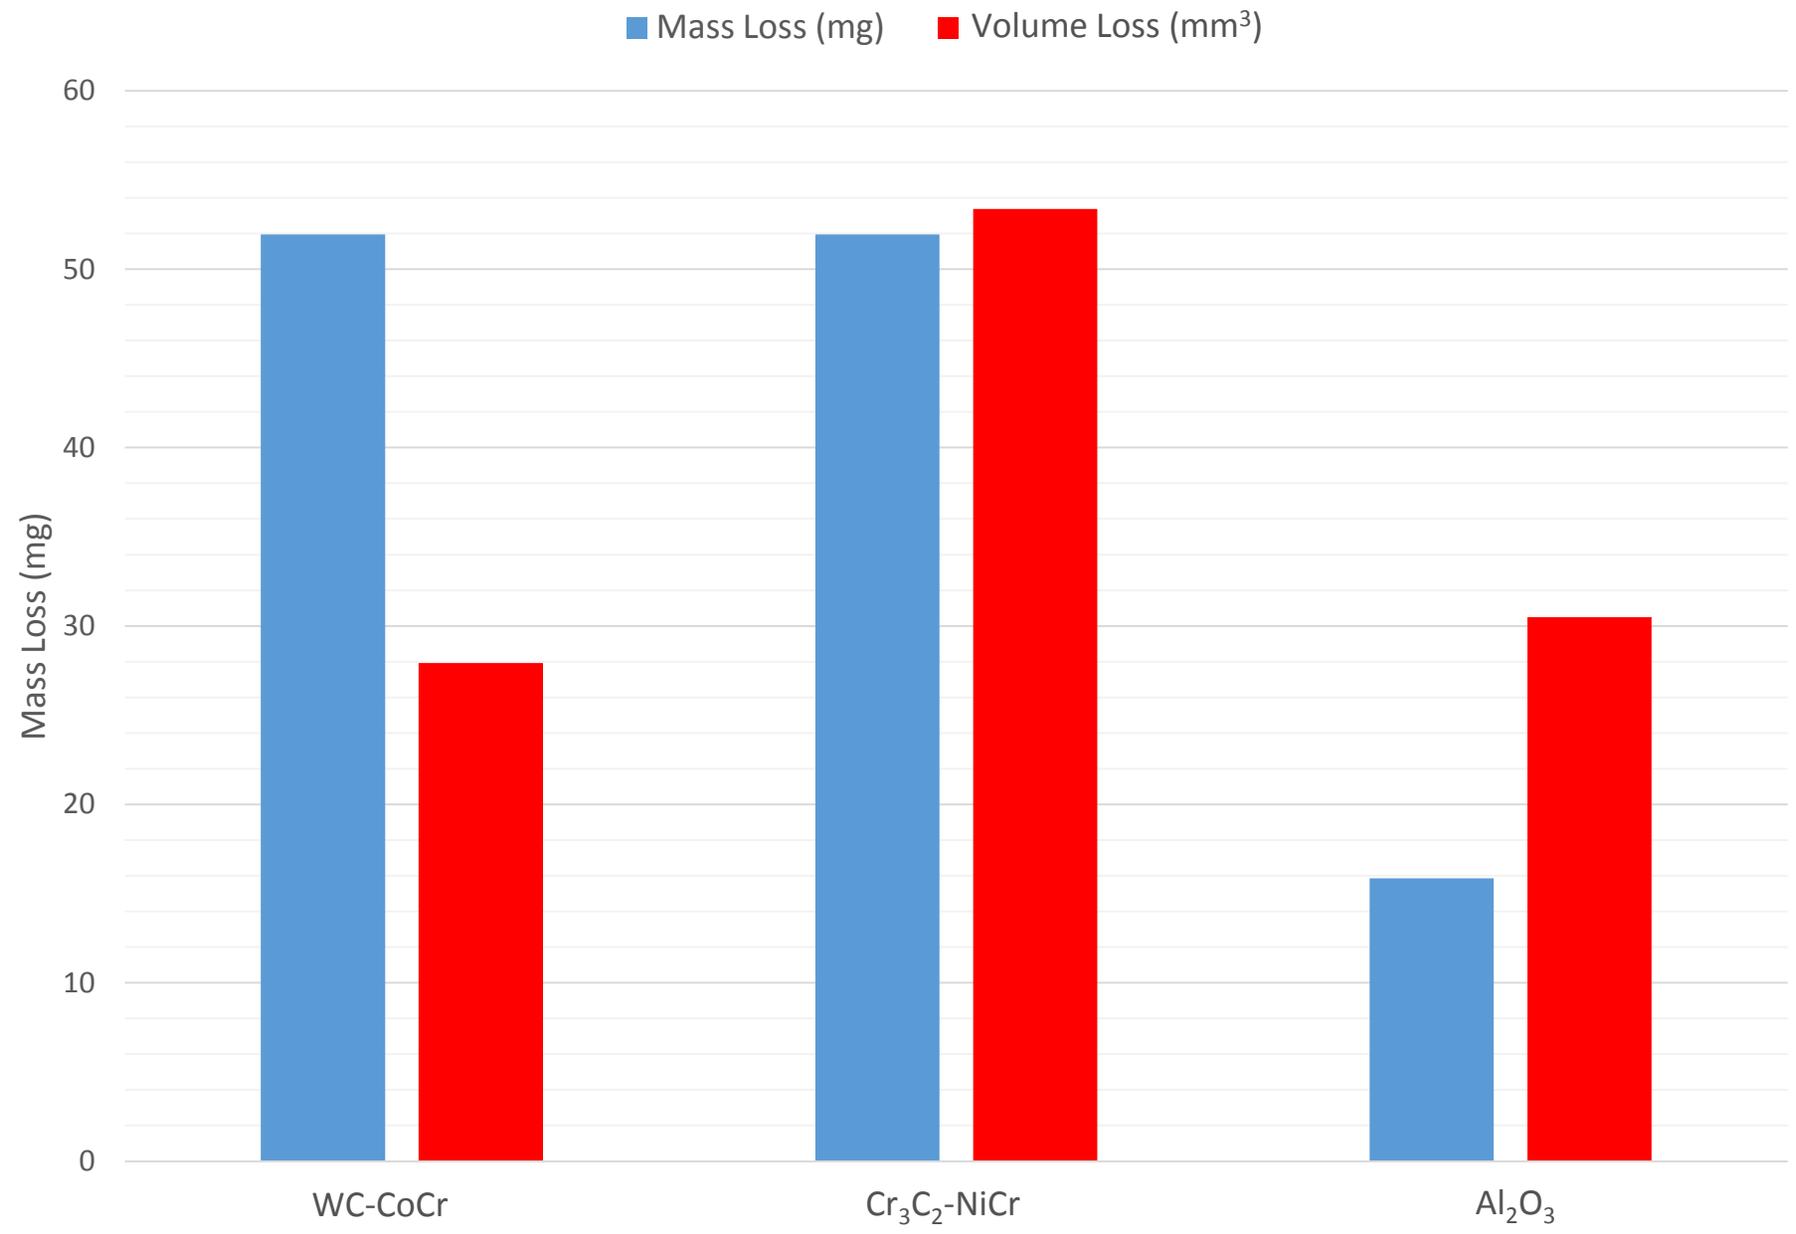
Figure 9
[Click here to download Figure: Fig 9.xlsx](#)

Fig 9. Average mass and volume loss under dry erosion conditions.

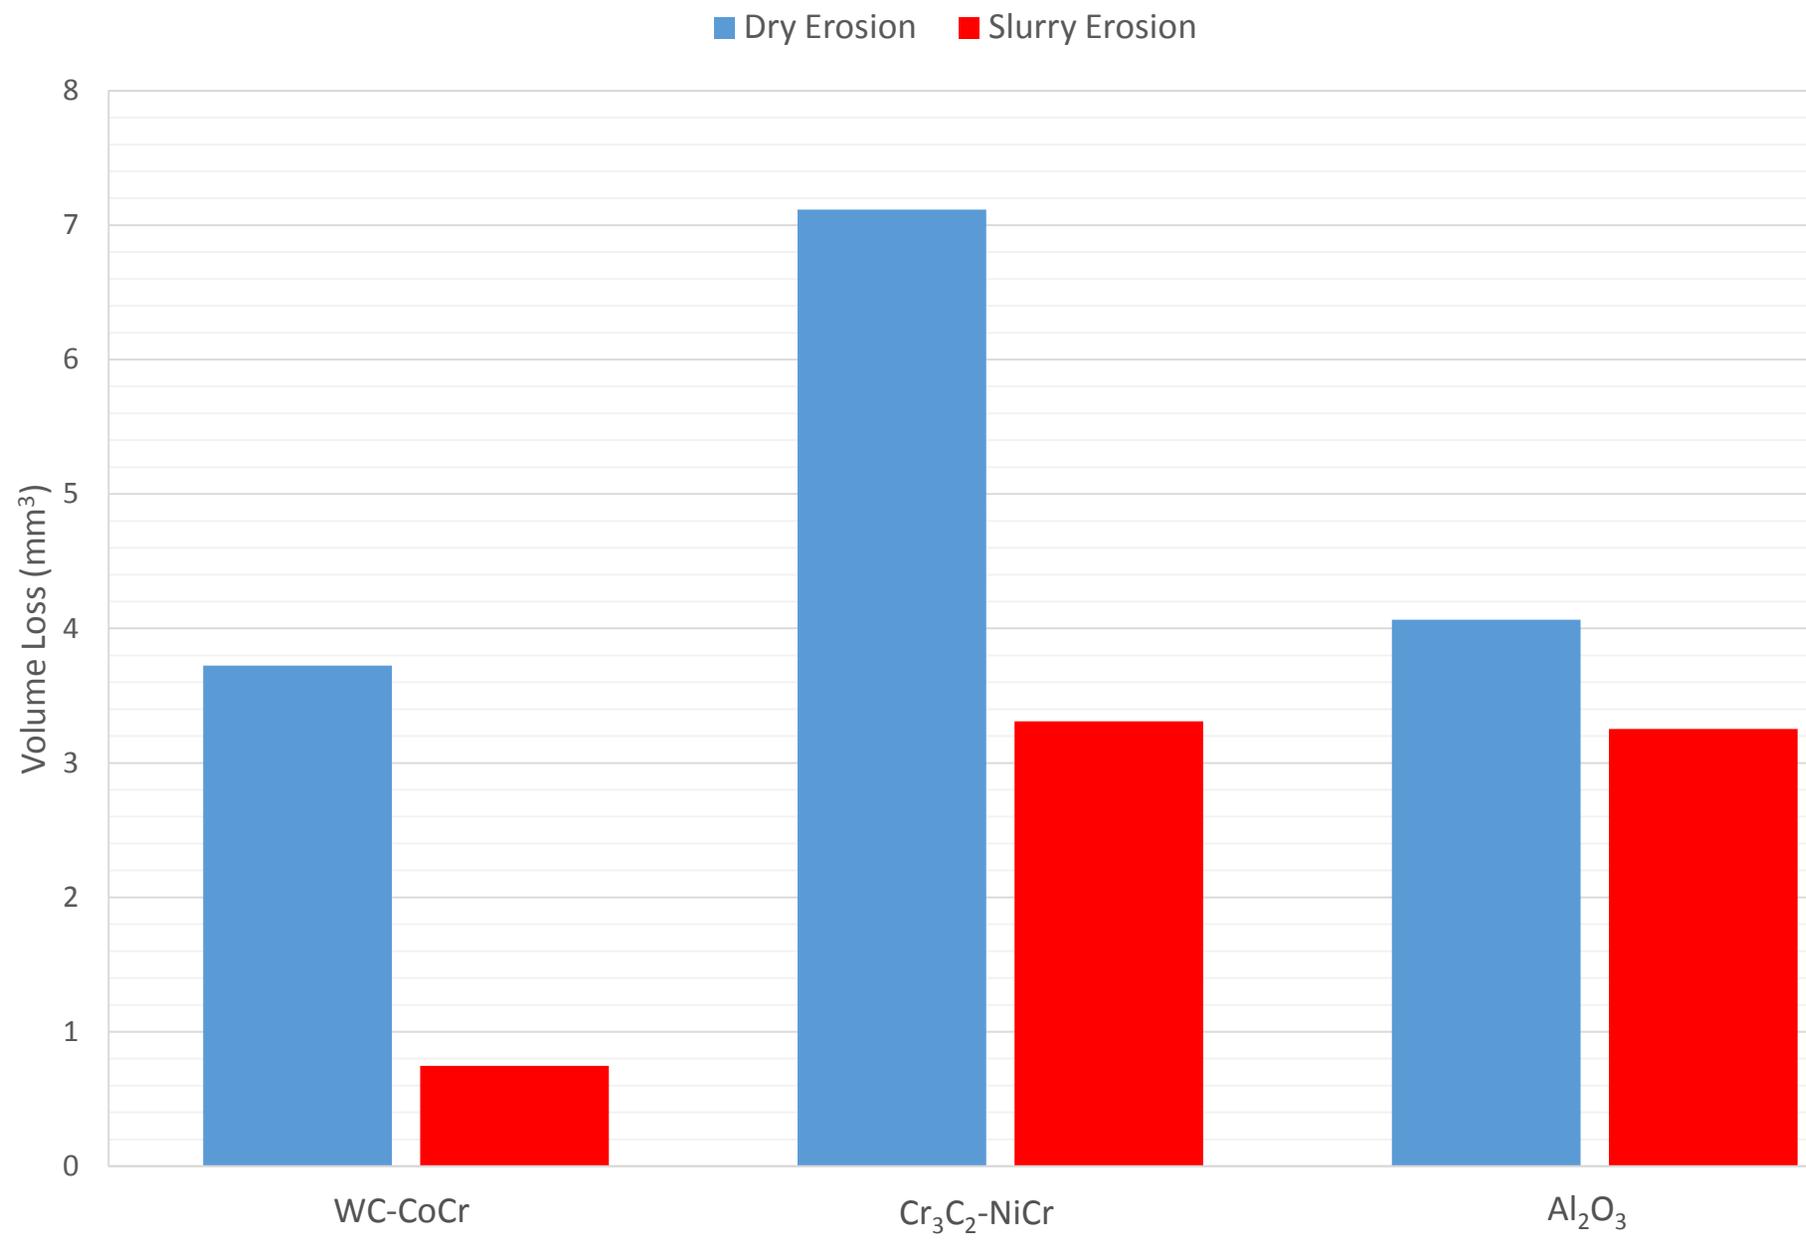
Figure 11

Direct comparison of volume loss under slurry and dry erosion (Figure 11) shows significantly increased levels of material loss under dry erosion conditions. This can be attributed to both the variation in impact velocity and the morphology of impinging particles, between the two testing regimes. Existing research has shown particle velocity under slurry conditions to be significantly reduced as a consequence of the squeeze film effects [46,47]. Squeeze film is the phenomenon whereby the slurry acts as a barrier between the impinging particles and the surface [46,47]. Energy is required to break this barrier, which in turn, decreases the particle impact velocity. As a result, the cumulative erosive damage is reduced. Conversely, the particle velocity under dry erosion will reflect the gas velocity emanating from the nozzle [48]. The variation in particle morphology also accounts for the increased volume loss under dry jet erosion with Levy et al. [49] demonstrating a rise in the erosion rate with increased erodent hardness. Numerous studies also report the influence of erosive particle material, size and shape on the recorded erosion rate [27,49–51].

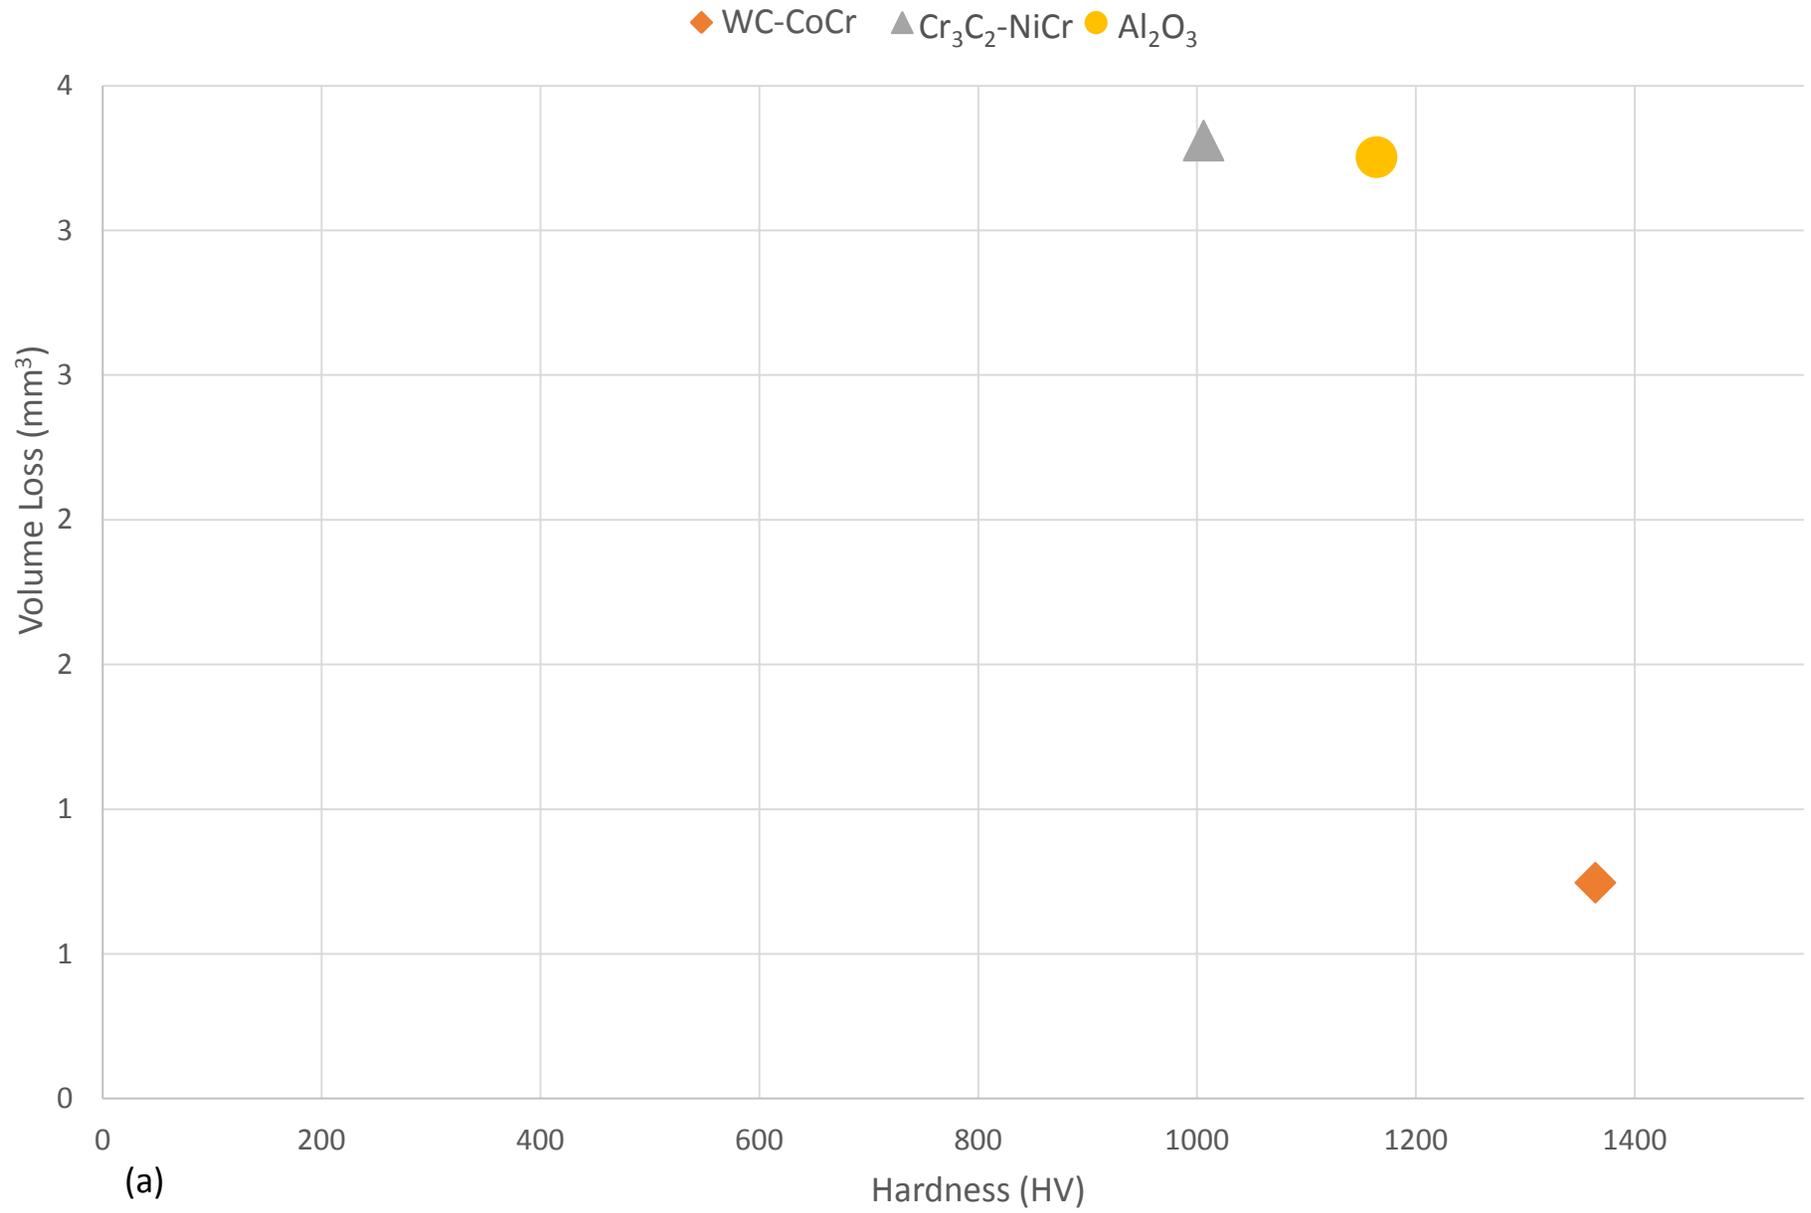
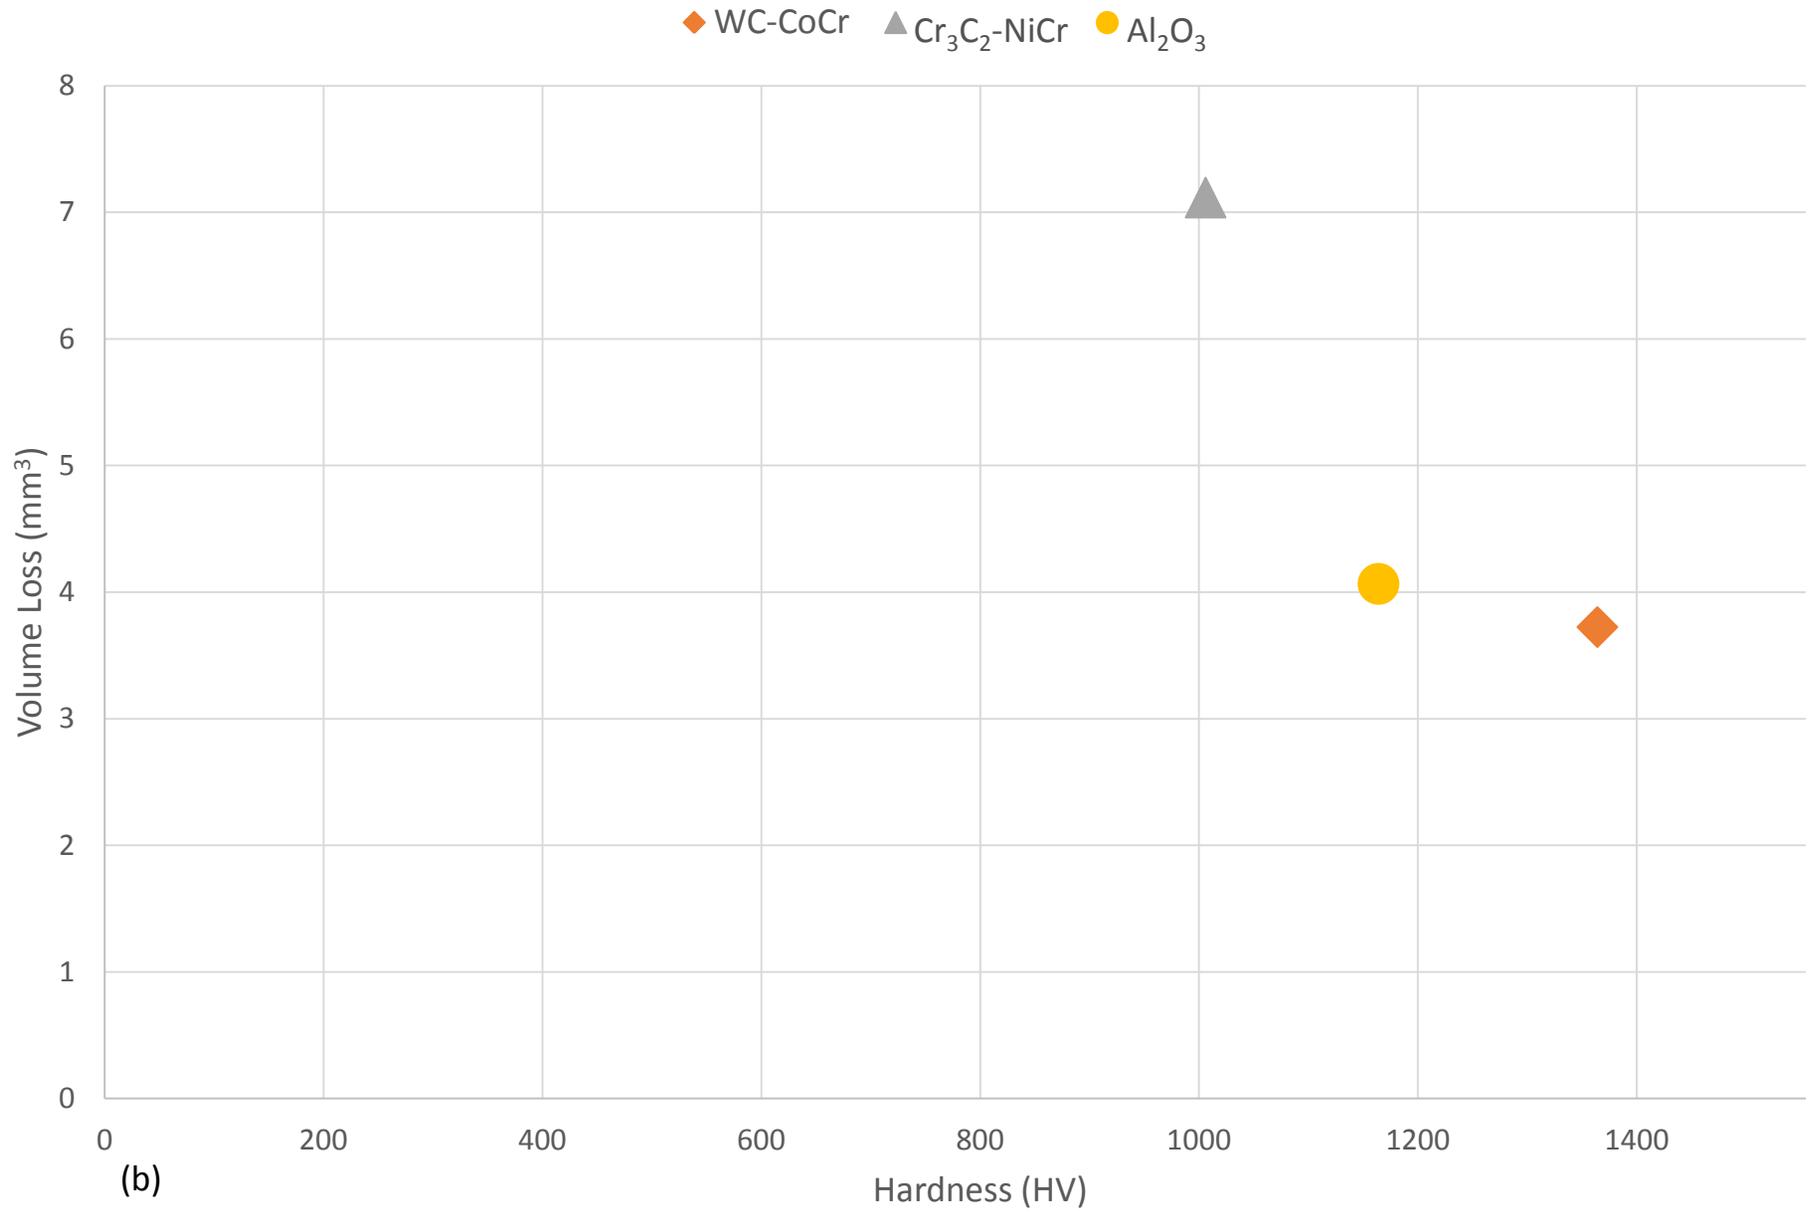
Figure 12a
[Click here to download Figure: Fig 12a.xlsx](#)

Volume loss with respect to coating hardness, for both test regimes, is displayed in Figure 12. Under dry erosion conditions, the Al_2O_3 coating suffers comparable volume loss with WC-CoCr. Conversely, slurry erosion conditions result in the Al_2O_3 specimen experiencing similar volume loss to the Cr_3C_2 -NiCr. Two significant observations can be identified from this data. The first is that the Cr_3C_2 -NiCr coating has produced the greatest volume loss under both test regimes. Given that Cr_3C_2 -NiCr possesses the lowest overall hardness of the three coatings, it can be argued that coating hardness is inversely proportional to volume loss at shallow angles of attack. This is in agreement with the work of several research groups [14,21,44,45,52]. The second observation concerns the variation in the volume loss between each coating type under the two test regimes. The data shows that WC-CoCr and Al_2O_3 coatings behave differently under dry erosion and slurry erosion. Specifically, WC-CoCr demonstrates a comparably high volume loss under dry erosion, with Al_2O_3 demonstrating increased volume loss under slurry erosion. Thus, for ceramic-based coatings, dry erosion testing does not necessarily reflect the erosion mechanisms and associated material losses that are
