Performance evaluation of HVOF deposited cermet coatings under dry and slurry erosion

Abstract

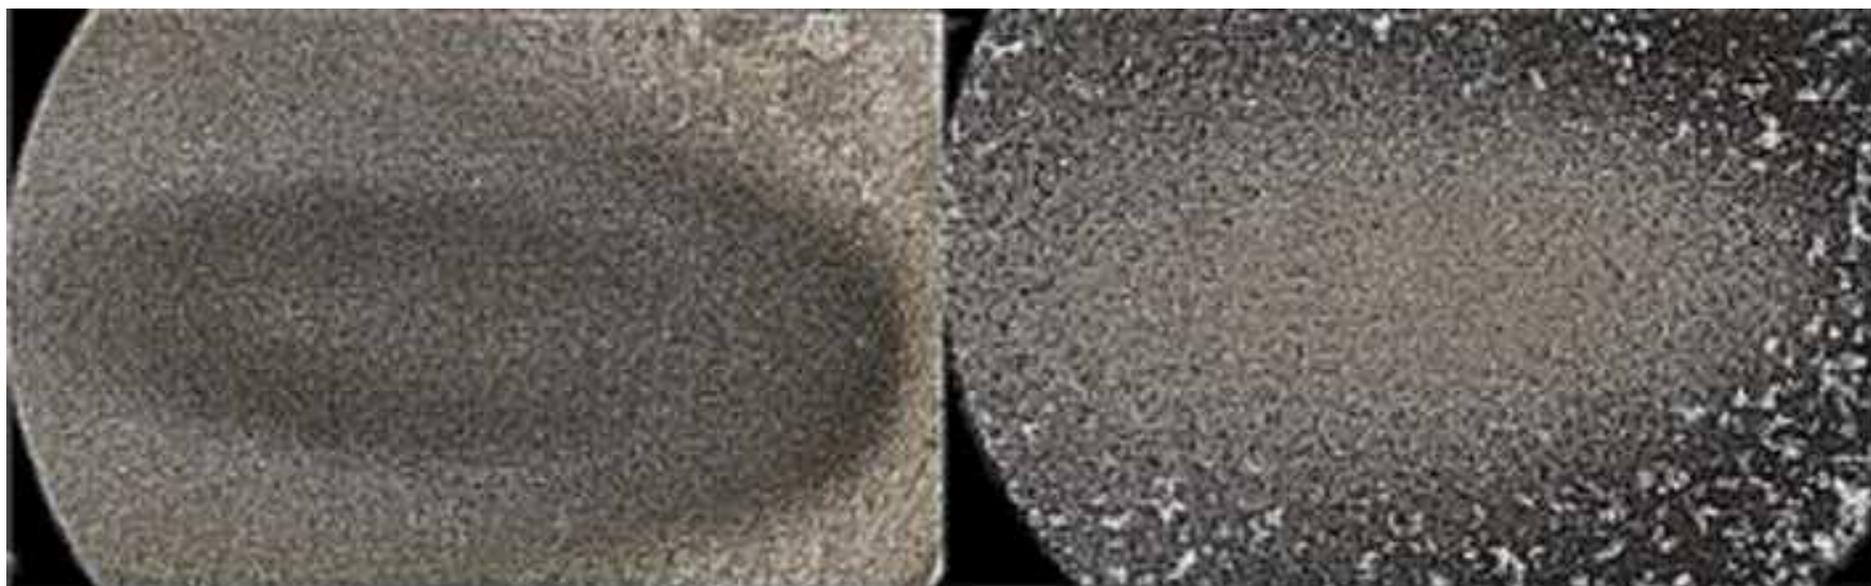
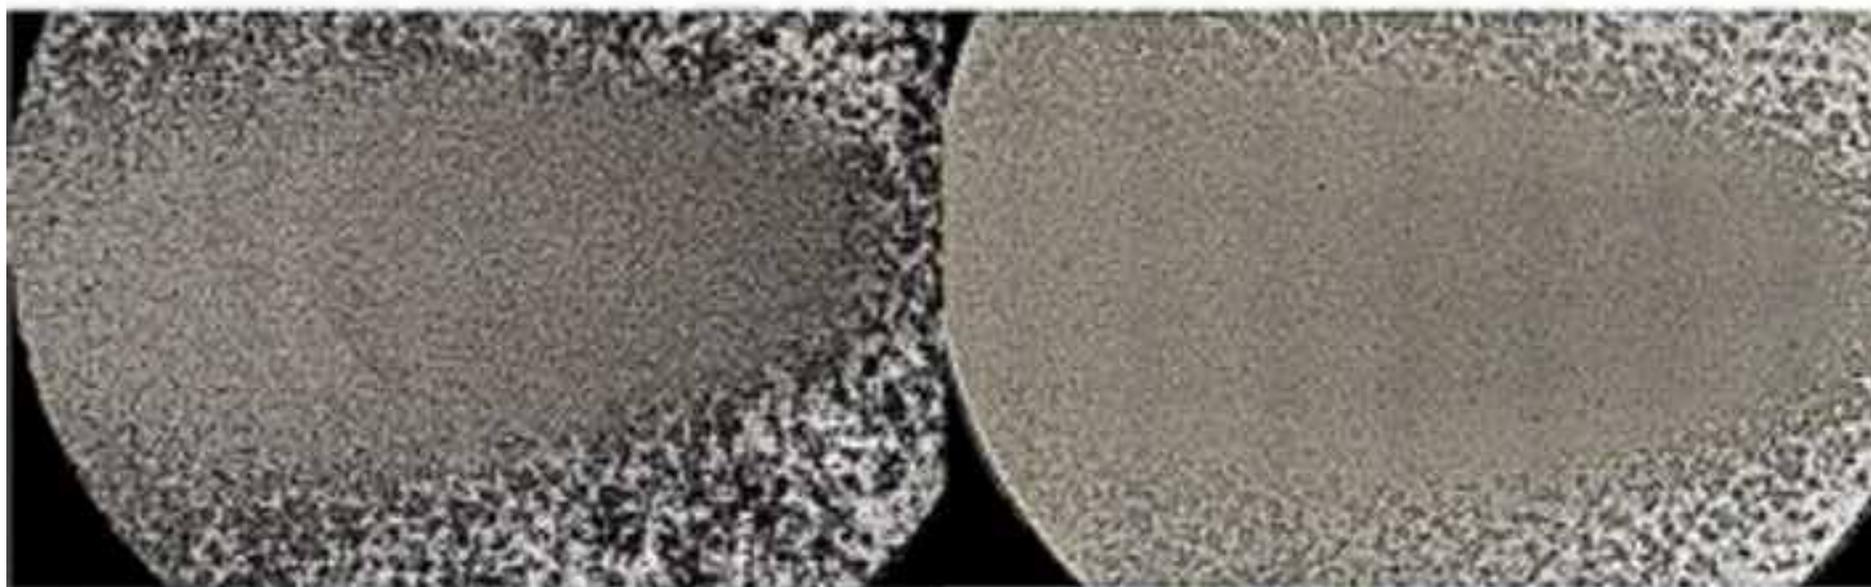
Figure 13
[Click here to download high resolution image](#)

The wear scar of each coating material and uncoated S355 was captured using an Alicona optical imaging system (Figure 13). Table 6 outlines the corresponding wear scar depth for each specimen following slurry erosion trials, measured using the Alicona system. Results reveal a significant variation in the typical wear scar produced. The uncoated specimen has developed the largest wear scar, with a maximum-recorded depth of 628.82 μm . The recorded scar depth for $\text{Cr}_3\text{C}_2\text{-NiCr}$ and for Al_2O_3 are similar. When compared with the as-deposited coating thickness (Table 4), this demonstrates that neither the $\text{Cr}_3\text{C}_2\text{-NiCr}$ nor the Al_2O_3 coatings have been breached during the slurry erosion test. The measured scar depth for WC-CoCr had a maximum value of 50.84 μm . With an indicated coating thickness of 180 μm , (Table 4) the results verify that the coating layer has not been breached following the 1-hour slurry erosion test. The significant reduction in wear scar demonstrates WC-CoCr has provided superior erosion resistance over the other assessed coatings under impingement at 20° .

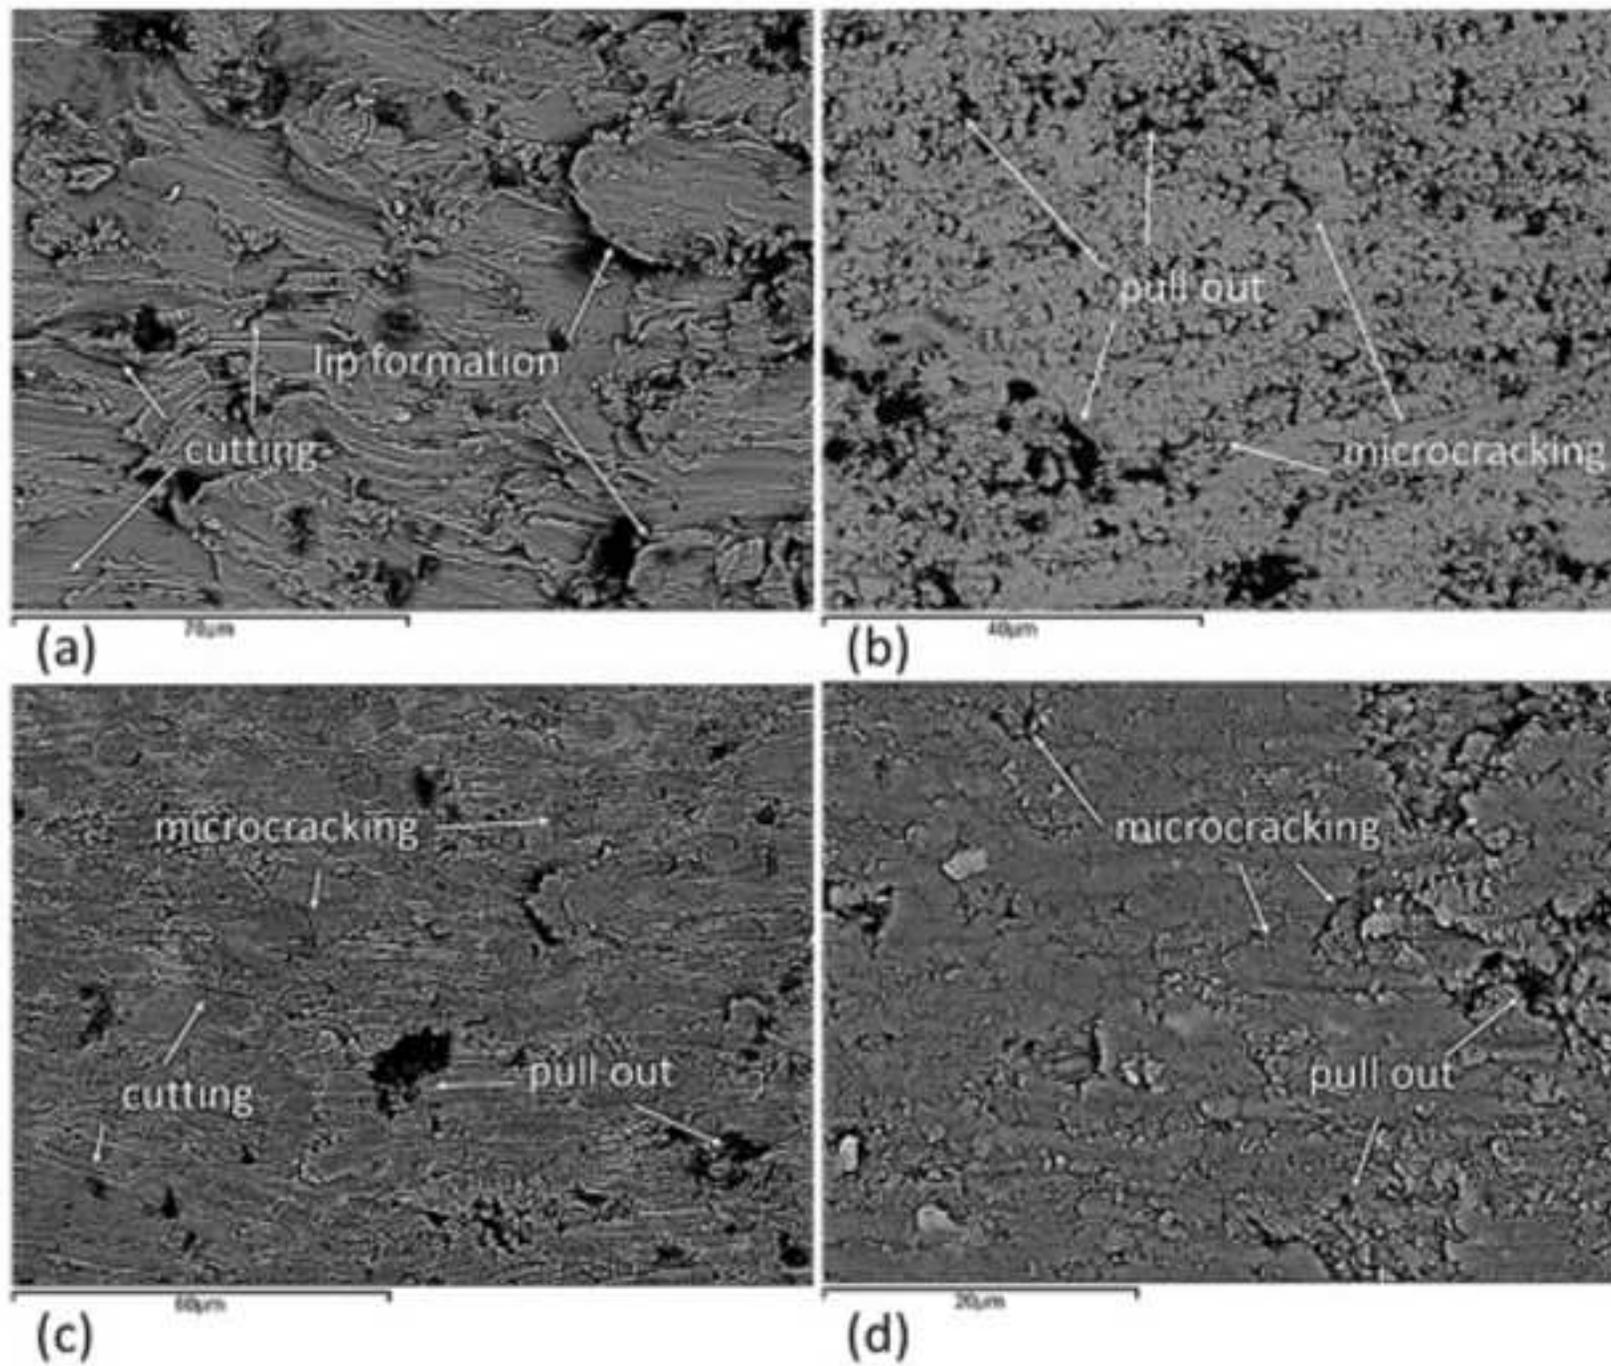
Figure 14
[Click here to download high resolution image](#)

Figure 14a exhibits substantial cutting and lip formation within the impinged zone on the uncoated S355. This wear pattern is consistent with the erosion of ductile materials as noted by

A scanning electron micrograph showing the wear scar of WC-CoCr is depicted in Figure 14b. When compared with Figure 14a, the image highlights that the mechanisms resulting in material removal are different for ductile and ceramic substrates. Specifically, the WC-CoCr micrograph (Figure 14b), reveals extensive carbide removal with noticeably less scoring and cutting. Evidence of scoring is visible, however is contained within the ductile Cobalt binder. This feature is to be expected given the comparably low hardness of Cobalt over WC. Repeated impact causes the breakdown of the binder, typically initiating at the carbide-binder interface [54]. The removal of Cobalt leads to a lack of binding material capable of retaining the carbides within the coating, eventually resulting in them being plucked from the surface by the impinging slurry. These observations align with the widely accepted breakdown mechanism of WC-CoCr based coatings under slurry erosion [55–58].

Figure 14c depicts the impinged region of the Cr_3C_2 -NiCr coated specimen and highlights the existence of both ductile and brittle mechanisms of material removal. Specifically, the image exhibits the presence of cutting and ploughing marks, in addition to pull-out and micro-cracking. The existence of the observed features leads to the conclusion that the Cr_3C_2 -NiCr demonstrates both brittle and ductile modes of material removal. A study by Hong et al. [59] reported a similar result following the cavitation silt-erosion of Cr_3C_2 -NiCr. Moreover, corresponding features were identified by Zavareh et al. [18] following tribological and electrochemical assesment of a Cr_3C_2 -NiCr coating

Fig 14. Scanning electron micrographs of a) uncoated specimen [x900], b) WC-CoCr [x1500], c) $\text{Cr}_3\text{C}_2\text{-NiCr}$ [x1000], d) Al_2O_3 [x2500], following slurry erosion test.

The impinged region of the Al_2O_3 coated specimen contains unique features not observed within the previously examined wear scars. The pure ceramic coating is highly brittle and possesses no ductile binder. As a consequence, erosion is dominated by micro-cracking and delamination of splats, (plastically deformed particles) [41], from the surface. Figure 14d depicts some of these features within the impinged region. The lack of ductile binder results in the removal of the Al_2O_3 layer due to the low cohesive strength between deposited particles [60]. This leads to the removal of coating “flakes” from the surface. An extensive study by Yang et al. [60] recorded a corresponding outcome on Al_2O_3 coatings with varying levels of Cr_2O_3 . The addition of Cr_2O_3 was shown to increase the cohesive strength of the coating layer thereby improving the erosion resistance [60].
