Eddy current testing of AGR fuel cladding

Abstract

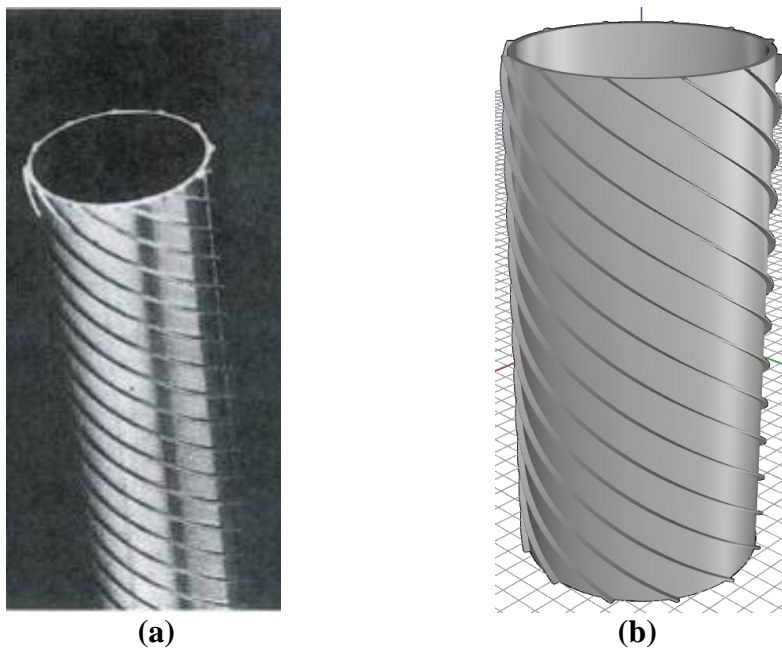
Figure 1. AGR fuel cladding (pin): (a) photograph, (b) CAD model

Figure 1a&b shows a photograph and a CAD model of an AGR fuel cladding (pin), respectively. Material of AGR fuel cladding is austenitic stainless steel (SS) of the following chemical composition: 20Cr-25Ni-Nb ⁽¹⁾. Its electrical conductivity σ is reported to be 0.993 MS/m ^(1, 2). Magnetic properties of the material are not known. Normally, austenitic SS is non-ferromagnetic, that is its relative magnetic permeability (μ_r) is very close to 1. It has been reported that similar AGR fuel pins were slightly magnetic ⁽¹⁾. On the other hand, it has also been reported that AGR fuel cladding material only becomes magnetic after thermal treatment at 900°C for 48 hours ⁽³⁾. These electromagnetic properties make AGR fuel cladding suitable for inspection by means of electromagnetic NDT methods such as ECT.

AGR fuel pins are stainless steel cylindrical ribbed pipes of 1000mm length, inner diameter of the rod is circa 14.6 mm, external diameter of the rod without ribbing is circa 15.4mm and external diameter of the rod with ribbing is circa 16.2mm (a rib height is circa 400 μ m), wall thickness of circa 0.4mm.

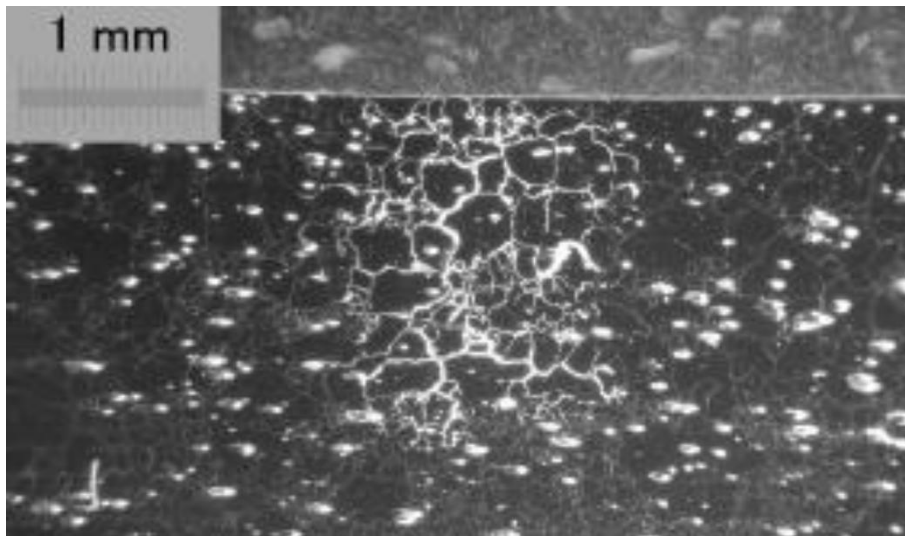
Figure 2. Metallographic cross section perpendicular to a stress corrosion crack

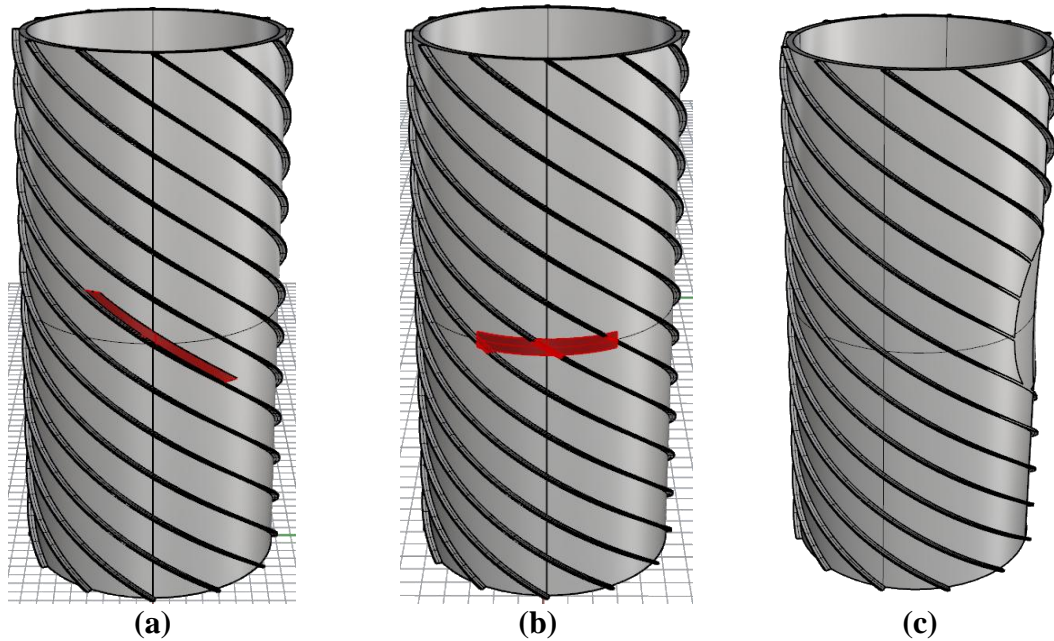
Figure 3. AGR fuel pins used in the ECT study: (a) pin with a helical EDM notch parallel to the ribbing; (b) pin with a circumferential EDM notch; (c) localised clad wall thinning

- 1) Helical EDM notches parallel to the ribbing as shown in Figure 3a. The notches had lengths of 2.5mm, 5mm and 10mm and depths of 25%, 50%, 75% and 100% of the cladding wall thickness located on the outer diameter of the fuel pin and thus denoted as OD25%, OD50%, OD75% and Through.
- 2) Circumferential EDM notches (shown in Figure 3b) of depth of 50% of the total wall thickness and lengths of 4mm, 9mm and 12mm.
- 3) Localised clad thinning (shown in Figure 3c) imitating general corrosion which had depths of 100 μ m, 200 μ m and 300 μ m with extent of the wear in the scan direction being circa 4mm, 6mm and 7mm, respectively. The clad thinning was produced by abrasion.

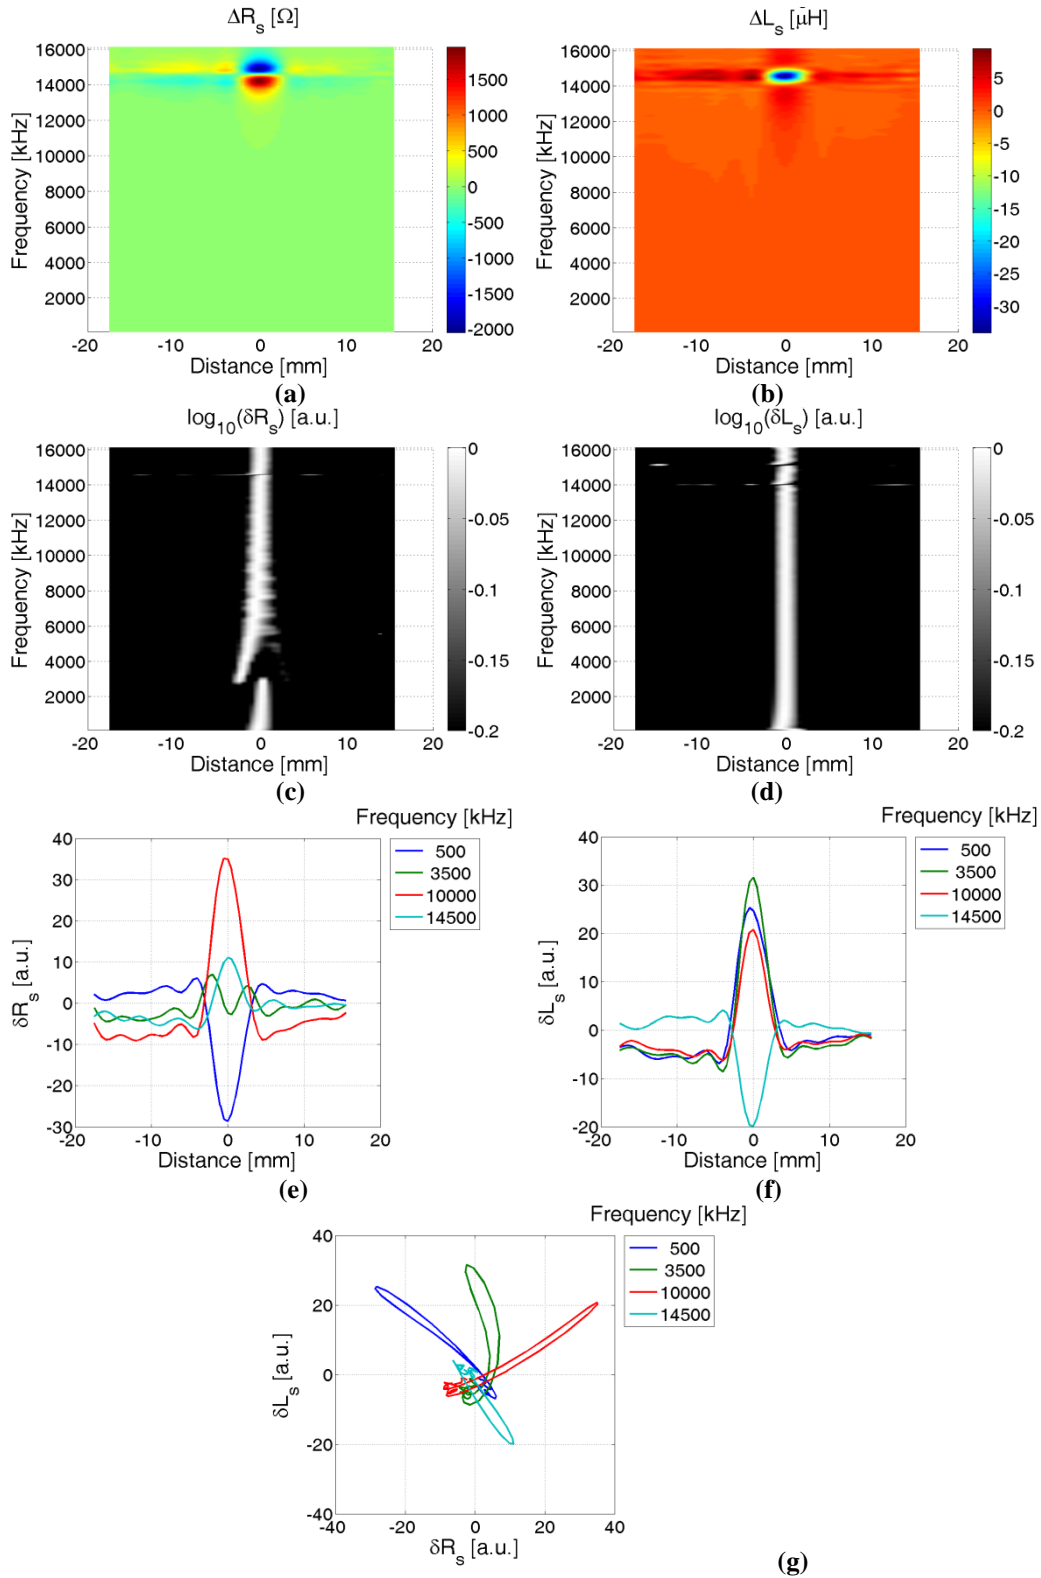
Figure 4. EC response of a probe coil to a helical EDM notch of 5mm length through the entire fuel cladding wall thickness: (a) absolute difference response spectrogram of R_s , (b) absolute difference response spectrogram of L_s , (c) relative difference response spectrogram of R_s , (d) relative difference response spectrogram of L_s , (e) line scan of relative difference response of R_s at selected frequencies, (f) line scan of relative difference response of L_s at selected frequencies, (g) complex impedance plane representation of relative difference response at selected frequencies.

Figures 4 to 6 represent EC responses of the probe coil to the tested helical EDM notches. Defects as shallow as OD50% and as short as 2.5mm were unambiguously detected. EC responses to OD25% were distinguished, however they had low SNRs.

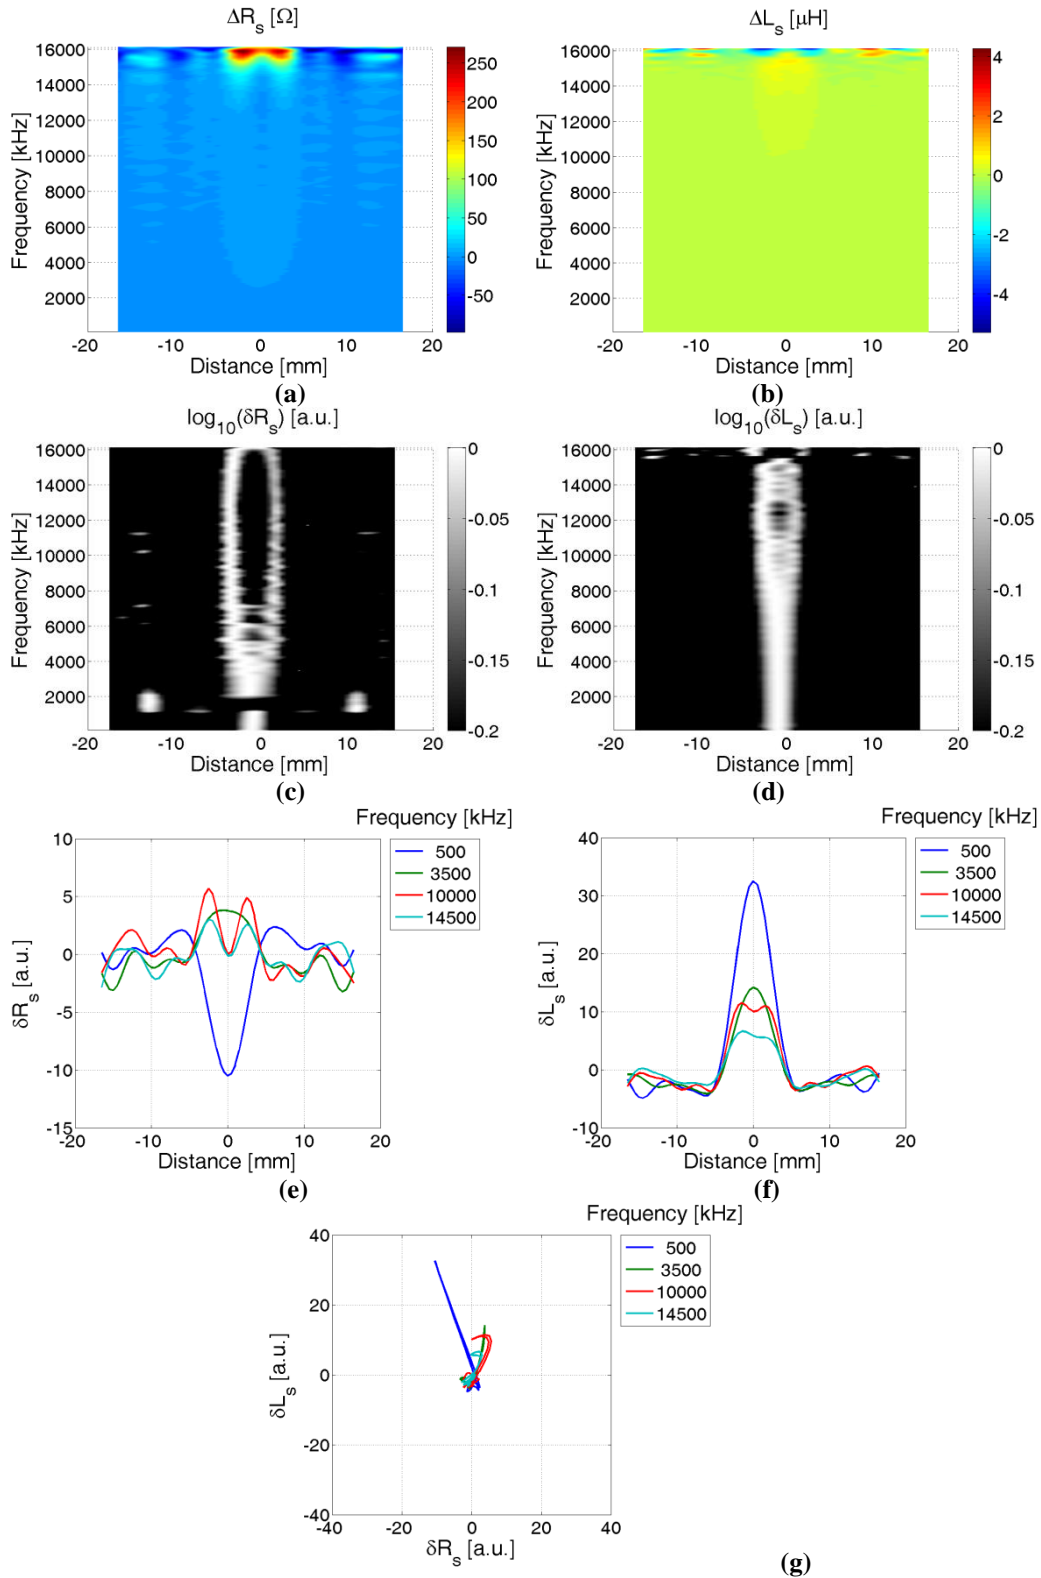
Figure 5. EC response of a probe coil to a helical EDM OD75% notch of 5mm length: (a) absolute difference response spectrogram of R_s , (b) absolute difference response spectrogram of L_s , (c) relative difference response spectrogram of R_s , (d) relative difference response spectrogram of L_s , (e) line scan of relative difference response of R_s at selected frequencies, (f) line scan of relative difference response of L_s at selected frequencies, (g) complex impedance plane representation of relative difference response at selected frequencies.

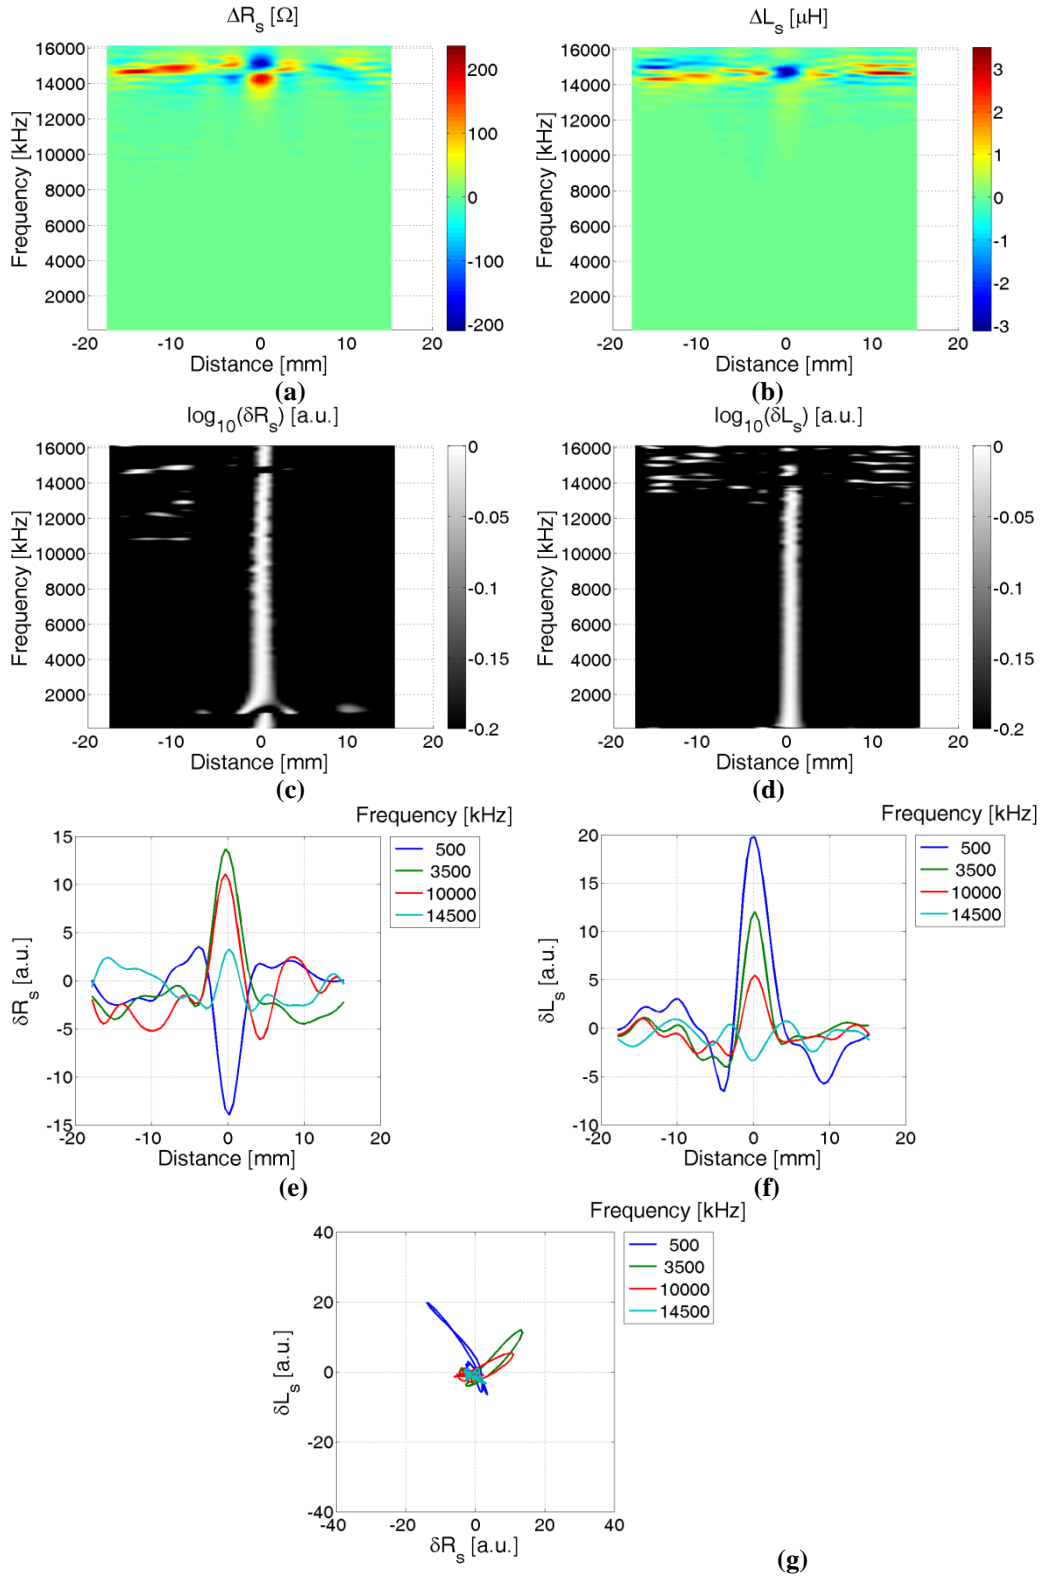
Figure 6. EC response of a probe coil to a helical EDM OD50% notch of 5mm length: (a) absolute difference response spectrogram of R_s , (b) absolute difference response spectrogram of L_s , (c) relative difference response spectrogram of R_s , (d) relative difference response spectrogram of L_s , (e) line scan of relative difference response of R_s at selected frequencies, (f) line scan of relative difference response of L_s at selected frequencies, (g) complex impedance plane representation of relative difference response at selected frequencies.

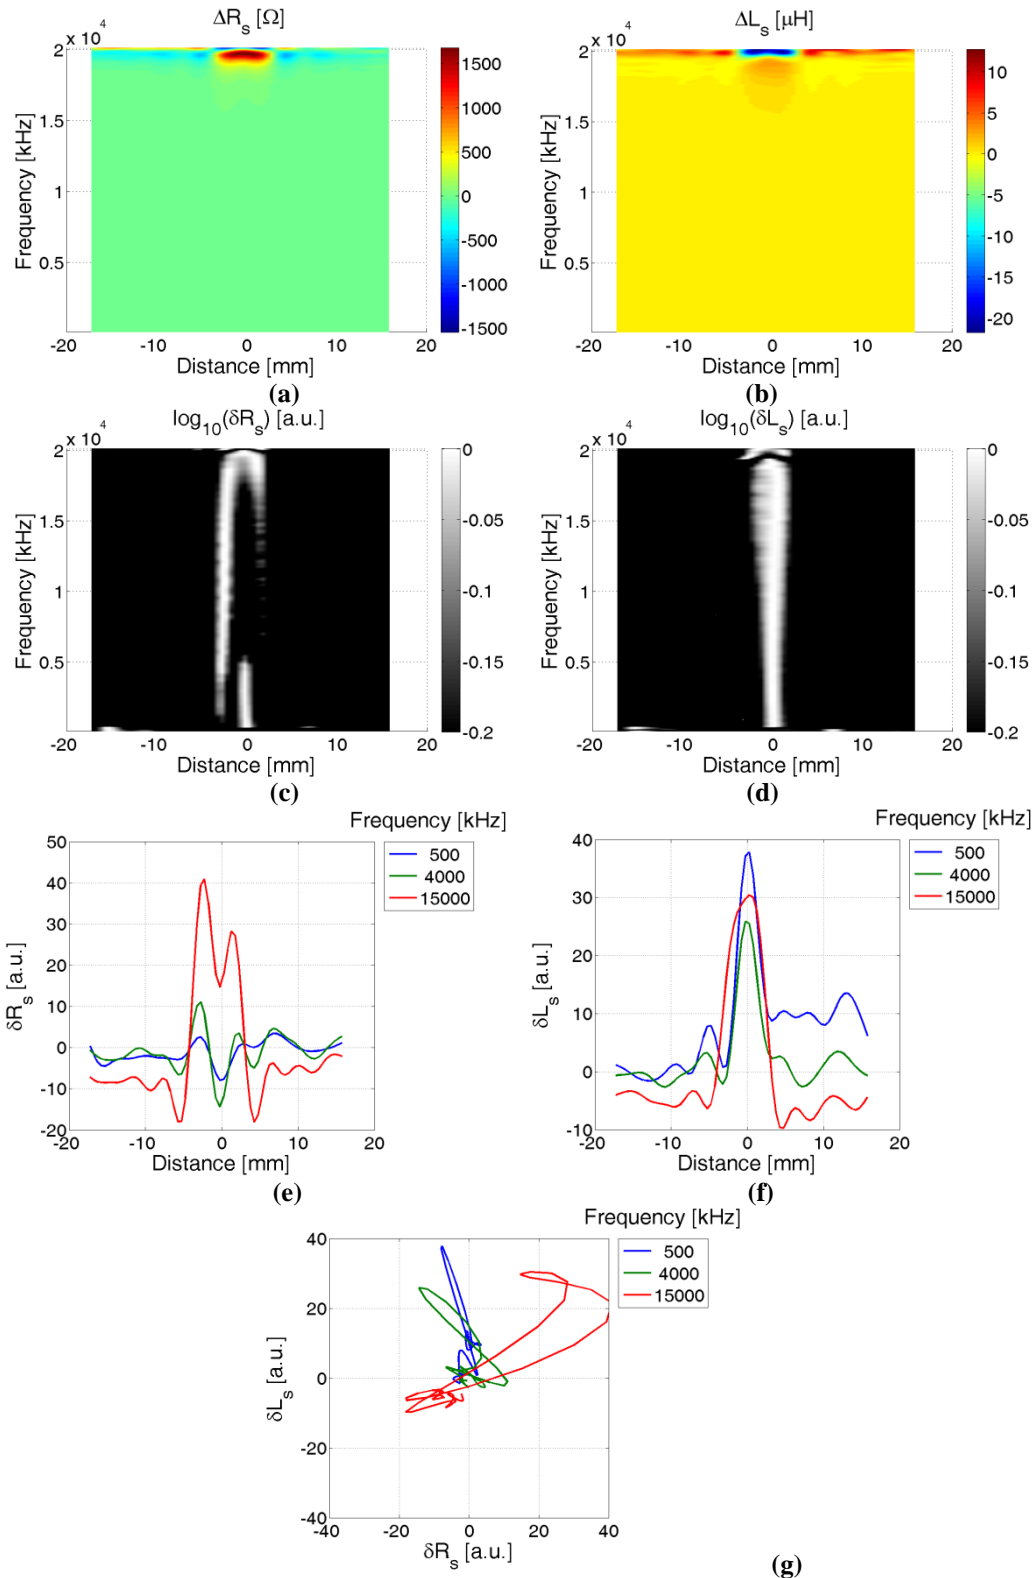
Figure 7. EC response of a probe coil to a circumferential EDM OD50% notch of 12mm length: (a) absolute difference response spectrogram of R_s , (b) absolute difference response spectrogram of L_s , (c) relative difference response spectrogram of R_s , (d) relative difference response spectrogram of L_s , (e) line scan of relative difference response of R_s at selected frequencies, (f) line scan of relative difference response of L_s at selected frequencies, (g) complex impedance plane representation of relative difference response at selected frequencies.

Figure 7 represents EC response of the probe coil to a circumferential EDM OD50% notch. Even though these defects represent very small disturbance for eddy currents, they produce characteristic EC signatures in the respective spectrograms.

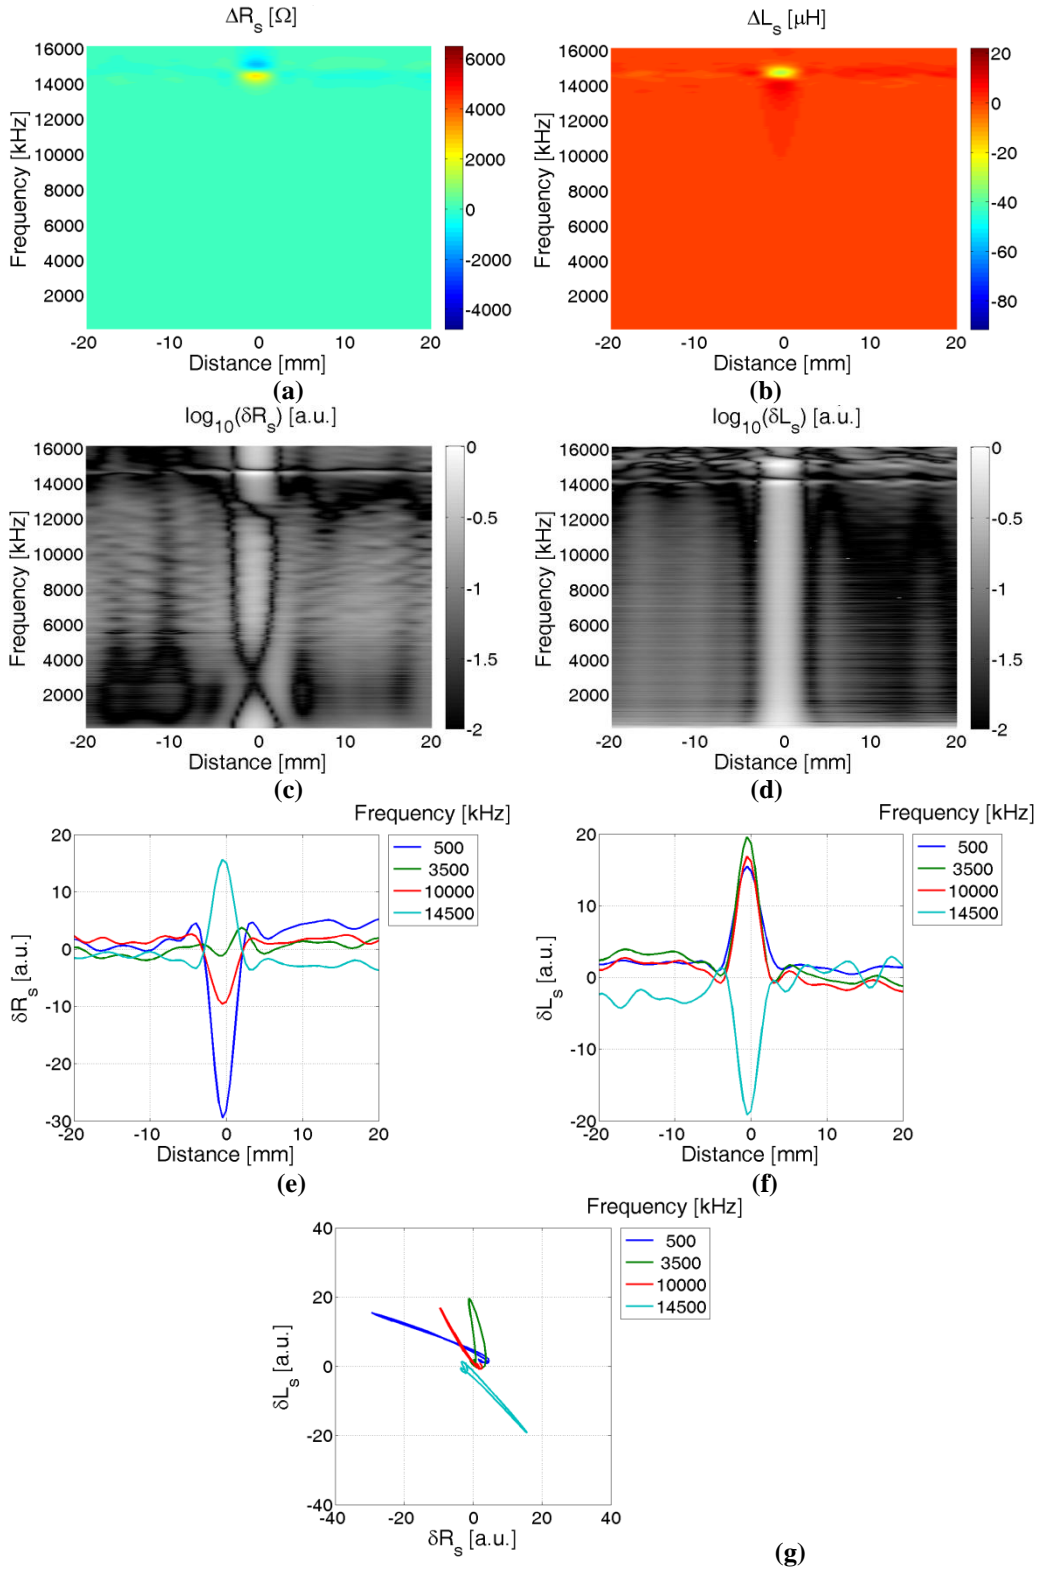
Figure 8. EC response of a probe coil to a localised wall thinning by 200µm: (a) absolute difference response spectrogram of R_s , (b) absolute difference response spectrogram of L_s , (c) relative difference response spectrogram of R_s , (d) relative difference response spectrogram of L_s , (e) line scan of relative difference response of R_s at selected frequencies, (f) line scan of relative difference response of L_s at selected frequencies, (g) complex impedance plane representation of relative difference response at selected frequencies.

Figure 8 represents EC response of the probe coil to localised wall thinning. External wall thinning effectively results in probe lift-off variation and even 100µm lift-off causes a clear EC response.
