Some Thoughts on Mapping Tribological Issues of Wind Turbine Blades Due to Effects of Onshore and Offshore Raindrop Erosion

Abstract

This paper represents the investigation of liquid impacts on wind turbine blade materials in the simulation of onshore and offshore environmental conditions. G 10 epoxy glass laminate was used as a specimen material. The experimental work was carried out on a raindrop erosion test rig at the varying angles of attack for a range tip speed. Two solutions, i.e. pure and salt water, were used to highlight the effects of offshore environment on this material when it is being used as wind turbine blades. Test results show that the erosive wear increased with an increase in droplet impact velocity. Erosion mapping techniques were used to compare the erosive wear behaviour of this material for application to onshore and offshore applications as candidate wind turbine materials.

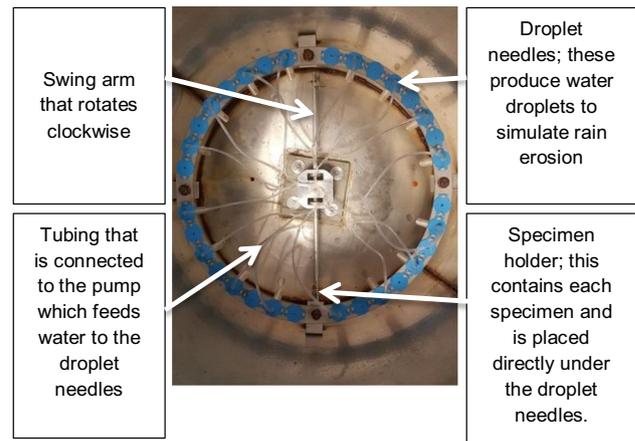
Fig. 1 Rain drop erosion test rig

A raindrop erosion test rig was used for this experimental work (Fig. 1). This rig was constructed at the University of Strathclyde to simulate in the working conditions of a wind turbine in a rainy weather. It consists of swing arms having a sample holder at the end. Arms rotate clockwise in this configuration. An impact angle alteration mechanism has been developed to adjust the arm at the required position. A metallic ring with needle holders is fitted exactly above sample's rotation path. Sixteen droplet needles (23 G) and plastic tubing are fixed to the rig to simulate raindrops. The droplet needles can be changed to get different drops of different diameters. Specimen holders locate the samples directly under the droplet needles. A peristaltic pump is fitted to provide a constant flow of solution to all needles to maintain droplet size. An electric motor rotates the swing arms. The output of the motor is controlled through a frequency metre to get the variable tip speeds.

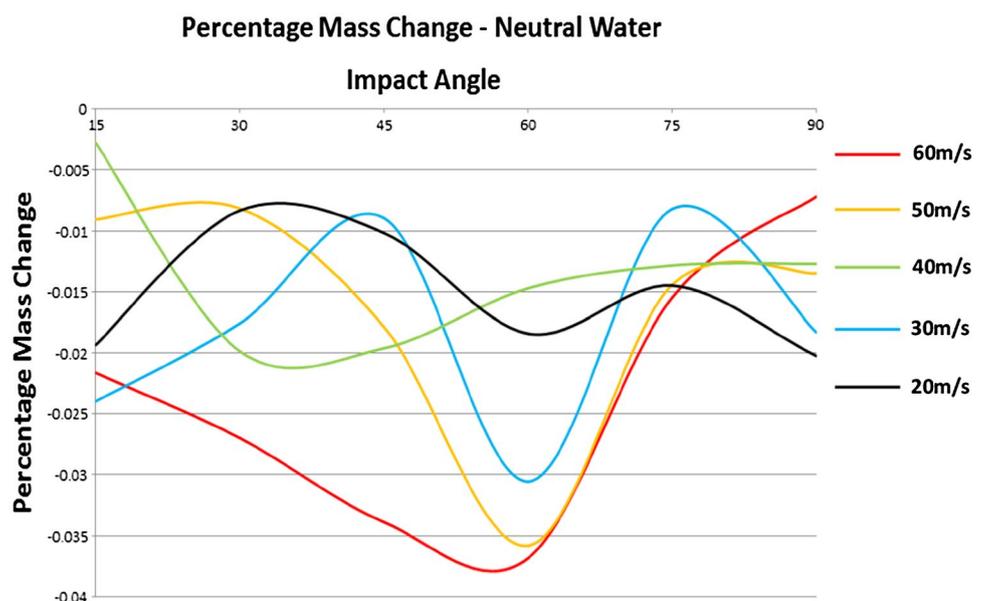
Fig. 2 Percentage mass change results from the neutral water testing

Figures 2 and 3 show the mass change of the specimens in pure water and salt water, respectively. The tests carried out in pure water show that the specimen has gained mass for each combination of tip speed and impact angle (Fig. 2). On the other hand, there is different behaviour of mass change in salt water (Fig. 3). For slower tip speeds,

In pure water, the specimens have gained mass for each combination of raindrop impact velocity and angle of attack. However, the composite is showing different erosion behaviours at various impact velocities for the range of impact angles (Fig. 2). The maximum mass loss was at 60 m s^{-1}

this, these composites have poor tribological resistance due to the material class, i.e. anisotropic material, i.e. modulus of elasticity changes in different directions. Raindrop erosion tests on G10 epoxy glass laminate in onshore and offshore laboratory-simulated conditions of wind turbine blades have highlighted erosion issues with this composite material. Test results show that raindrop impact has affected this material under both environments, i.e. in onshore as well as in offshore conditions (Figs. 2 and 3).

It is clear from Figs. 2 and 3 that the effects of change in droplet impact velocity are more prominent. With an increase in impact velocity of the droplet, the erosion interaction with specimen increases. The effect of change in tip velocity can be seen in different shapes such as mass gain, increase in mass loss and increased surface damage (Fig. 5e, f). The literature shows that researchers have attempted to establish the dependency of impacting velocity, raindrop size and erosion rate, but in vain. However, it

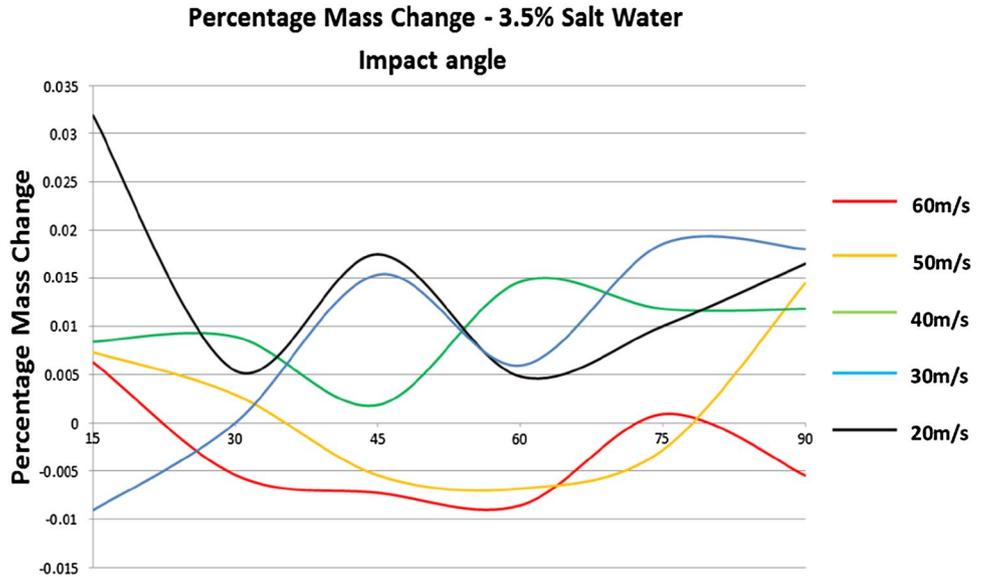
Fig. 3 Percentage mass change results from the salt water testing

there is a mass loss, while at higher tip speeds there is more mass gain as compared to that observed in pure water.

On the other hand, in salt water, specimens have shown different mechanisms of erosion than those exposed to pure water (Fig. 3). For the lower impact velocities, there is a mass loss from all angles of attack, while at higher velocities, specimens gained mass for the range of impact angles. The maximum mass loss was at 30 m s^{-1} at 15° angle of attack with a mass loss of 0.008 g that is equivalent to a 0.007% decrease in mass. Maximum mass

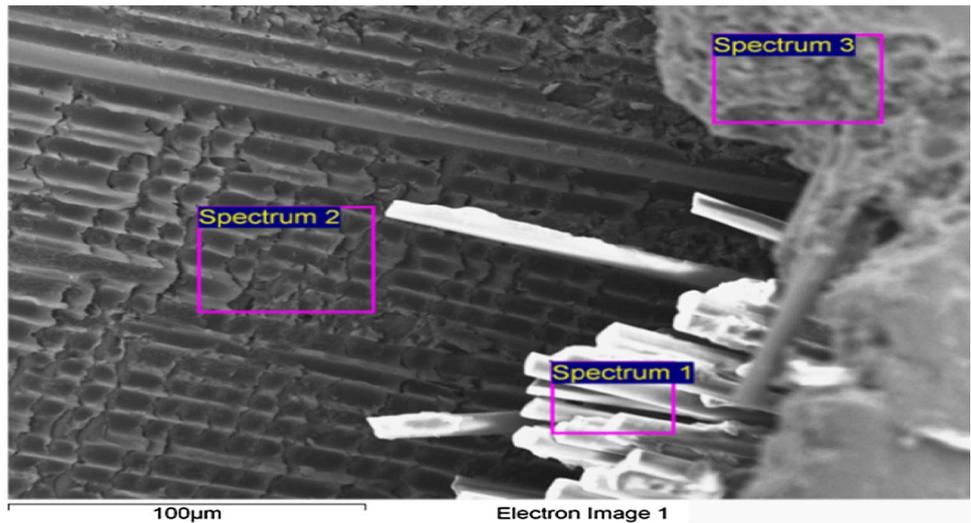
Fig. 4 SEM of eroded specimen subject to 3.5% salt water at 60 m s⁻¹ and 75°

Figure 4 shows the SEM of the exposed surface of a specimen in salt water at 60 m s⁻¹ tip speed and 75° impact angle showing significant degradation. Table 2 shows the results of an EDX analysis on the exposed surface of a specimen in salt

water at 60 m s⁻¹ tip speed and 75° impact angle, indicating the deposits of salt on the surface.

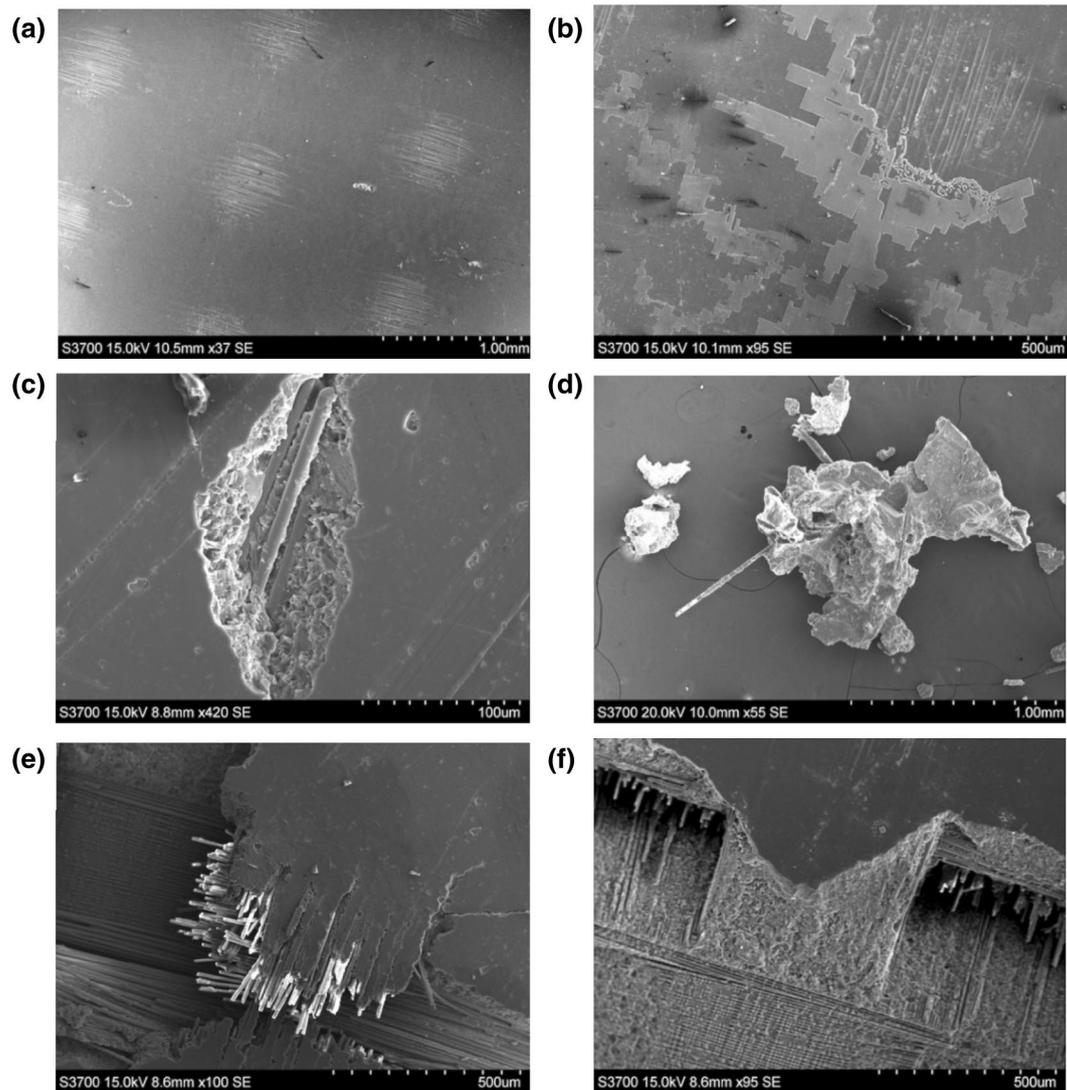
Fig. 5 shows SEM images of the exposed surfaces in simple water and salt water at different tip speeds and impact angles of a: (a) control specimen that did not undergo any testing, (b) specimen that was subjected to exposure to 3.5% salt water at a tip speed 40 m s⁻¹ and impact 75°, (c)

Fig. 5 SEM images of the surfaces of **a**: a control specimen that did not undergo any testing, **b** specimen that was subject to 3.5% salt water at 40 m s^{-1} and 75° , **c** specimen that was subject to neutral water at 40 m s^{-1} and 60° , **d** piece of debris that was collected from

specimen that was subject to neutral water at 40 m s^{-1} and 60° , (d) piece of debris that was collected from the bottom of the tank after a test was carried out in salt water and (e) specimen that was subject to 3.5% salt water at 60 m s^{-1} at 30° . There were very marked differences in the morphological features at the various velocities and impact angles. These are discussed further below.

the bottom of the tank after test in salt water and **e** specimen that was subject to 3.5% salt water at 60 m s^{-1} at 30° and **f** specimen that was subject to 3.5% salt water at 60 m s^{-1} at 60°

at 60° angle of attack with a mass loss of 0.041 g that is equivalent to a 0.04% decrease in mass. The minimum mass loss was at 30 m s^{-1} at 15° angle of attack with a mass loss of 0.0003 g that is equivalent to a 0.0028% decrease in mass for half an hour of a test run. As shown in Fig. 5c, the trend was somewhat similar, but no surface damage was found in our earlier studies of the tidal turbine blade on this material in pure water [11, 12]. This can be attributed to the higher impact and velocity of the droplets. This partially different erosive behaviour of the fibre-reinforced composite for wind and tidal turbine blade laboratory simulated conditions lead to assume that the devices, test parameters and environments play an important role in the performance of materials as well.

In order to understand how the material was being ejected from the specimen, an SEM analysis was carried out on the debris that was left at the bottom of the tank after a test in a salt solution. It was observed that the material segments that had broken off were larger than expected. As shown in Fig. 5d, there is a large block of epoxy with various glass fibres still woven into the resin. This would suggest that once the top layer of epoxy on the specimen is infiltrated, the glass fibre matrix under the surface becomes very vulnerable and is likely to break off in relatively large segments.

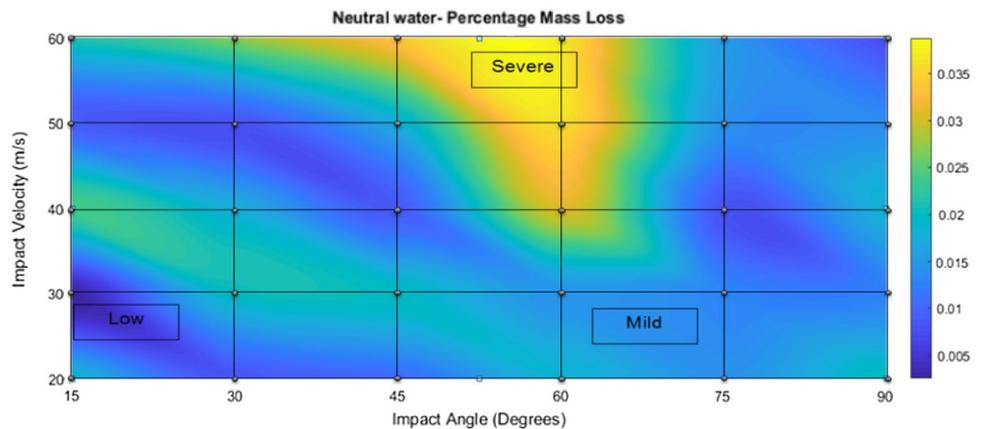
Fig. 6 Erosive wear-mode map in simple water

The erosive wear map illustrates the mass loss of a specimen due to the impact of simple water droplets on the exposed surfaces of the specimen (Fig. 6). On this map, the yellow areas indicate the most erosion and the darker blue is the least erosion for the various combinations of impact velocities and angles of attack.

The wear map generated for the simple water erosion coincided with the erosion observed in Figs. 2 and 3. The most predominant patterns exist between 45° and 75° and the impact velocity exaggerated this, as more mass was lost at higher speeds. The mass loss mechanisms were observed using the SEM techniques. As shown in Fig. 5c, the top layer of the material has been removed by erosion and the glass fibres have been exposed. The pre-existing pin holes in the epoxy have expanded when exposed to liquid droplet impact. In areas where the epoxy is thinnest above the weave, an oval erosion pattern developed by exposing the fibres. Similar erosion behaviour of the fibre-reinforced polymer composites can be seen in the literature [22].

gain was at 50 m s^{-1} at 75° angle of attack with a mass gain of 0.019 g that is equivalent to a 0.019% increase in mass. On both maps, shown in Figs. 6 and 7, the green to blue areas show an increase in overall mass and the yellow areas show a decrease in mass. Moreover, the droplet erosion behaviour varies for each combination of impact velocity and angle of attack. SEM images of the exposed surfaces in salt water have shown severe erosion effects on this material (Fig. 4, 5b, e, f). As far as mass gain and surfaces damage are concerned, similar results were found in our earlier studies on this material in salt water for tidal turbine blade application [11–13].

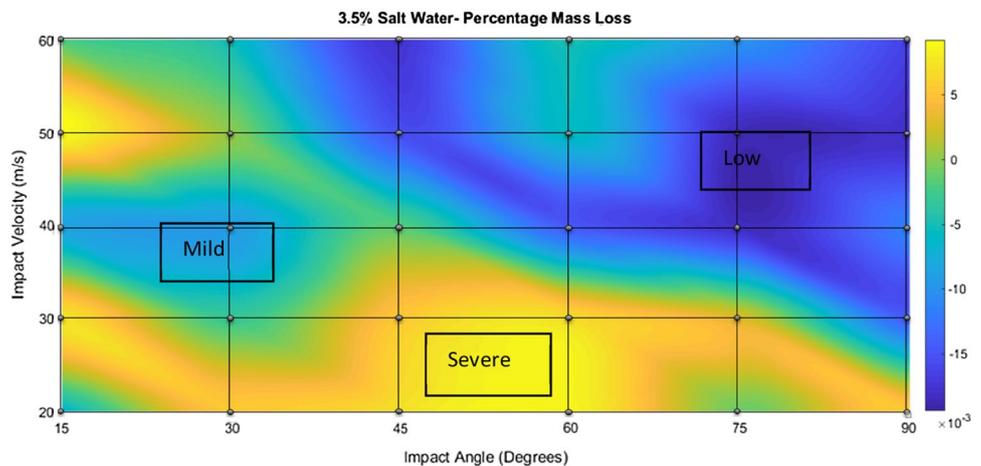
Fig. 7 Erosive wear-mode map in 3.5% salt water

The erosive wear map for 3.5% salt water, to simulate the offshore rain conditions of the wind turbine, illustrates the different erosion regimes for the range of tip speeds and angles of attack (Fig. 7). The wear map suggests that there was no mass loss of the specimen due to erosion at higher impact velocities and higher impact angles. According to Bitter’s theory of erosion, based on the assumption that up

to < 10° impact angles, the erosion is controlled by the cutting process of the erodent. At 90°, erosion is controlled by deformation. For the other impact angles, i.e. 10°–90° erosive wear is progressed by the combined, cutting and deformation action of the erodent [23, 24]. The results from the SEM images show that for saltwater droplets seem to follow this theory and erosion occurred due to the impact of the droplet, which results in more damages of the exposed surface instead of the mass loss. As shown in Fig. 5f it is clear that erosion has occurred due to the smooth curves of the top surface and the material removed; the same is shown in Fig. 5e as the liquid impacts have completely broken apart the internal glass fibre weave and removed material. This can be explained due to the crystallisation of saltwater on the surface, leaving salt deposits all across the specimen. The salt crystals can be determined very easily using the SEM as they form quadrilateral shapes [21] as shown in Fig. 5b. This was confirmed using the EDX analysis shown in Fig. 4, and the results of the analysis tabulated in Table 2, to identify the sodium and chlorine elements present on the surface. When this image is compared to the control sample shown in Fig. 5a, it is very clear that the magnitude of salt that crystallised on the surface was fated to skew the results.
