Article

Investigation of Chemical and Physical Surface Changes of Thermally Conditioned Glass Fibres

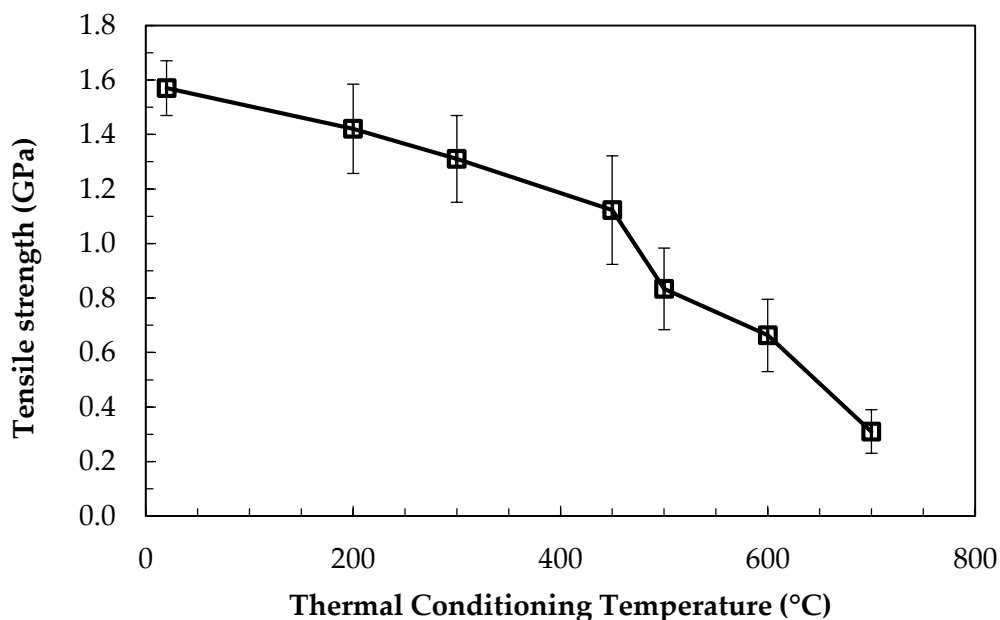
Figure 1. Tensile strengths of bare fibres after thermal conditioning at 200–700 °C for 25 min.

A trend of strength loss with increasing thermal conditioning temperature was found. A temperature of 300 °C was required for a significant decrease with respect to the initial strength of the fibres to occur, as measured by 95% confidence limits. The most significant strength loss occurred when the conditioning temperature exceeded 450 °C: after treatment at 500, 600, and 700 °C approximately 50, 40, and 20%, respectively, of the initial strength remained.

The strength values in Figure 1 represent the average of at least 20 individual tensile tests, with the exception of the data point at 700 °C. The retained strength of these heat treated fibres was very low, and it approaches the lower limit that was possible to measure when using the standard method. Many fibres break before testing at the points at which they are glued to tensile card templates; they are unable to withstand the minimal bending and twisting stresses related to the cutting of the card template that allows the fibre to bear load during testing. Additionally, some fibres failed at the edge of the gauge length, rather than in the middle portion. This is also likely to be attributable to slight bending at the beginning of the test as tension is first applied to the fibre. The standard practice is to discount such tests from the final analysis, as it is presumed that their inclusion causes an under-estimation of the average fibre strength.

The results presented in Figure 1 describe the fundamental strength loss of bare E-glass fibres due to only thermal effects. The single-fibre heat treatment process used minimises possible surface damage to fibres by mechanical means, such as fibre–fibre or fibre–surface interactions. The latter can be avoided in any fibre testing procedure, provided that sufficient care is taken, but the former will inevitably occur if thermal conditioning is performed on fibre bundles. It has been shown that the method of heat treatment selected has a significant effect on the retained fibre strength over a wide temperature range of 200–600 °C [7]. Additional mechanical damage can occur when single fibre tensile specimens are extracted from heat-treated bundles, adding to the fundamental strength loss from thermal effects.

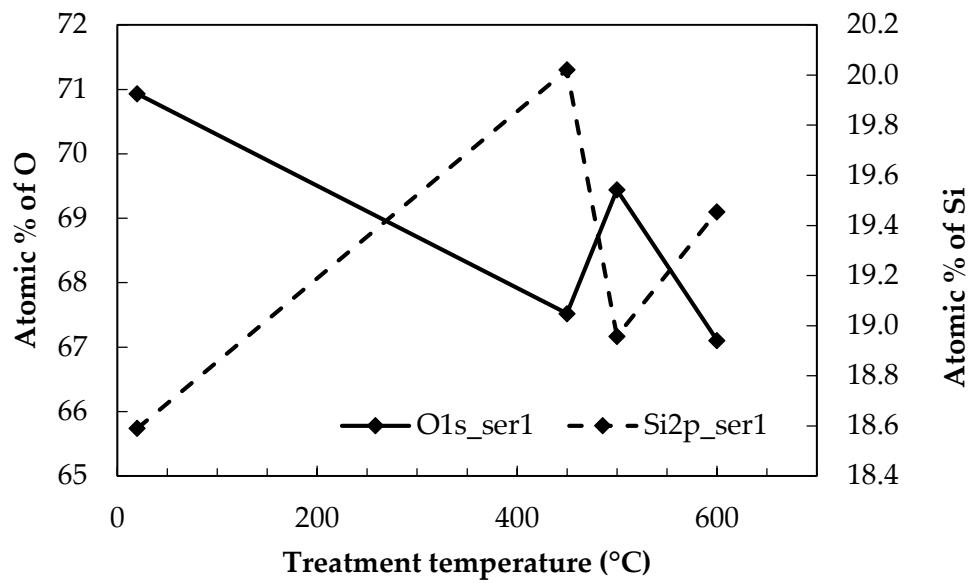
It was found that the variability in Si and O, the two constituents with the highest at. %, were inter-related. The data in Figure 2 show that when the at. % of oxygen increased, for example, from 450 to 500 °C, there was a corresponding decrease in the at. % of Si. It is probable that changes in oxygen content, due to differing surface contamination levels between samples, exert an influence over other constituent elements, which all have significantly lower at. %

Figure 2. Atomic percentages of Si and O at the E-glass surface with respect to the thermal conditioning temperature.

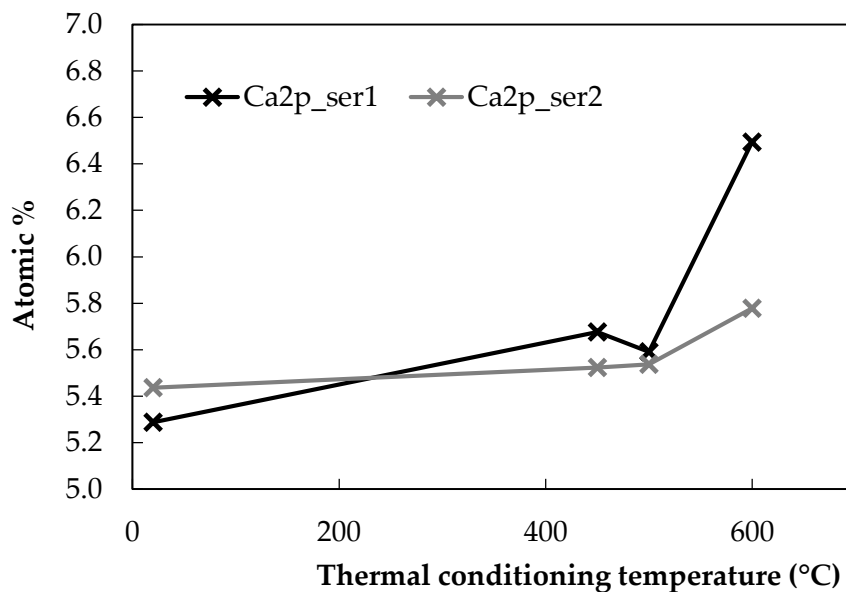
In contrast to the other elements measured in the analysis, Ca demonstrated a relatively consistent trend with the conditioning temperature, as shown in Figure 3. In each of the series of measurements carried out, an increase in Ca at the fibre surface was observed after conditioning at 600 °C, while its at. % was largely stable throughout the rest of the temperature range investigated. The increase was more pronounced in the first series than the second.

Figure 3. Atomic percentages of Ca at the E-glass surface with respect to the thermal conditioning temperature.

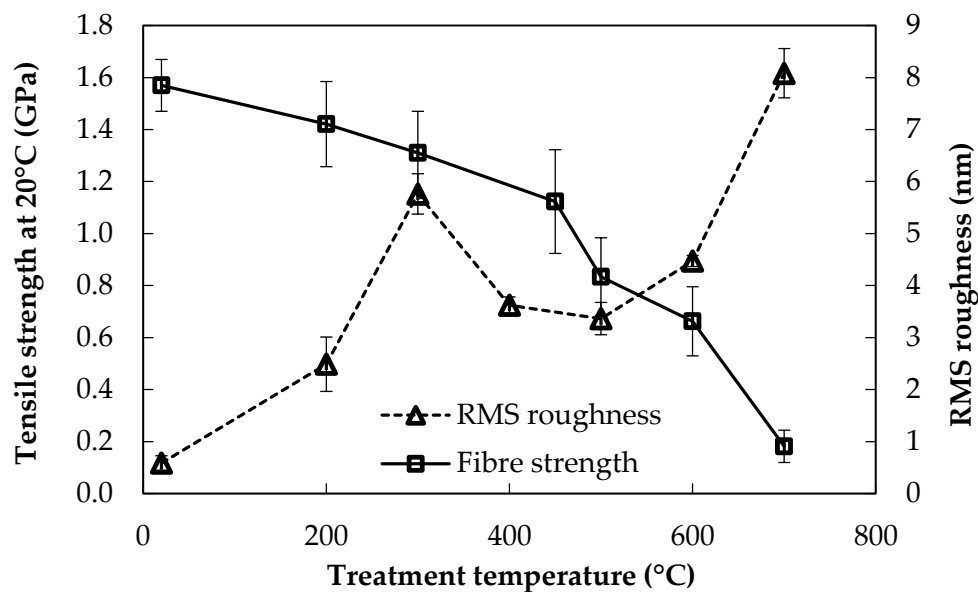
The average RMS roughness of bare E-glass fibres is presented in Figure 4, alongside the strength-loss behaviour of the fibres from Figure 1.

Figure 4. Average fibre tensile strength at room temperature, and fibre surface RMS roughness after thermal conditioning.

It was observed that fibre surface roughness increased with increasing conditioning temperature, while fibre strength decreased. Aside from this general trend, the correlation between these data was not close. For example, surface roughness increased significantly following treatment to only 200 °C, whereas fibre strength was not significantly different from the baseline value at these low treatment temperatures. The region of most significant strength loss occurred for conditioning temperatures in excess of 450 °C: of the total strength loss between room temperature and 600 °C, around 50% of the loss occurred between 450–600 °C. Over a similar range of thermal conditioning temperature from 400–600 °C, there was only a relatively small increase, however, in RMS roughness. A close inverse correlation between the retained tensile strength and the surface roughness was observed at the higher end of the conditioning temperatures investigated between 500–700 °C. Fibre strengths decreased precipitously, while the fibre surface roughness increased very rapidly, more than doubling from 500 to 700 °C.

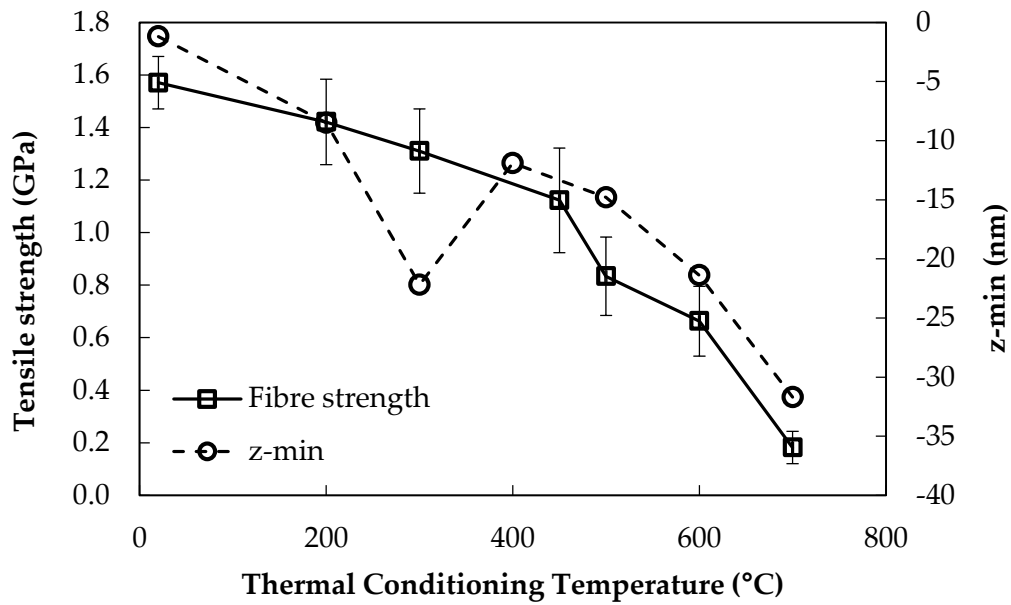
If, instead of RMS roughness, the maximum depth below the $z = 0$ plane (labelled z_{\min}) was plotted against the heat treatment temperature, the graph obtained was approximately the inverse. It should be noted that the values of z_{\min} were obtained directly from the raw topographical data. The $z = 0$ plane is established automatically by the Nanoscope software after polynomial fitting, and it lies at the mean of all of the height data points. The values of z_{\min} represent the deepest flaws, pits or slots at the fibre surface that could be detected. These data are plotted with the retained fibre tensile strength in Figure 5.

Figure 5. Average fibre tensile strength at room temperature, and average minimum topographical feature in the z-direction after thermal conditioning.

The data in Figure 5 show that the trend for the average z_{\min} of topography at each treatment temperature correlated relatively well at higher treatment temperatures with fibre strength loss, but there was an obvious disparity at 300 °C. The decrease in z_{\min} between 400–500 °C was only relatively small in comparison, with a significant decrease in fibre strength over the same temperature range.

The minimum height measured below the $z = 0$ plane in topography plots, labelled z_{min} , was analysed, and the data are presented in Figure 5 and Table 3. The two datasets in Figure 5 correlate relatively well across the temperature range used. At lower treatment temperatures the fibre tensile strength was relatively stable but the average z_{min} fluctuated greatly between room temperature (untreated) and 400 °C. The most critical strength loss began after heat treating to 450–500 °C, whereas the flaw depth over the same approximate range increased only slightly. The region in which the trend was relatively similar was 500–700 °C in which both the fibre tensile strength and the average flaw depth decreased rapidly. Table 3 shows that the magnitudes of the average z_{min} measured by AFM were significantly smaller than those that would be required to produce failure at a stress consistent with the average values measured and presented in Figures 1, 4 and 5. The disparity between the theoretical strength, based on Equation (2), and using the average z_{min} depth as the critical flaw, and the measured strength was at least 2, but generally of the order ≥ 4 . The disparity in theoretical flaw size is even greater at around ≥ 16 , due to the square root in Equation (2).

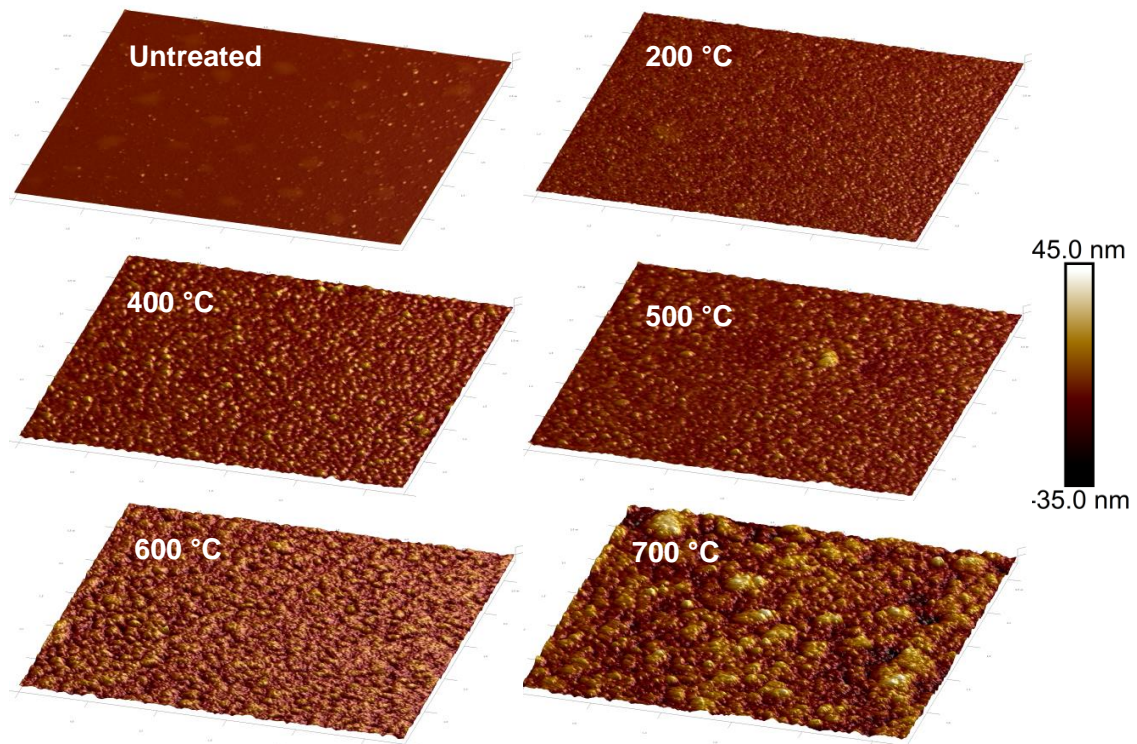
Figure 6. Three-dimensional topography plots of bare E-glass fibre: untreated and thermally conditioned at 200–700 °C.

The surface of untreated fibres was mostly flat, but two types of surface features were observed. Raised circular or ovoid areas of between 100–200 nm in diameter were found; phase plots indicated that these were part of the glass and not a contaminant on the surface. Very small contaminant particles of no more than a few tens of nm in size, identified by a clear phase contrast with the glass, covered the surfaces of all samples. The heat treatment process appeared to remove these contaminant particles. Changes to the surface topography as the roughness increased were generally homogenous across the surface of fibres: Figure 6 shows the typical topographic plots of fibres thermally conditioned between 200 to 700 °C. The additional images obtained at each conditioning temperature were similar to those presented; this was reflected in the size of the error bars in Figure 4, as the average roughness was calculated using all of the available topography data.

After thermal conditioning at only 200 °C, the fibre surface changed completely in comparison to the untreated fibre. A uniform textured appearance was observed, and the maximum height in the z-direction almost doubled in comparison to the untreated fibres. It is possible that this new rougher surface structure obscured the circular mounds that were previously found, but this was not tested. Alternatively, these features could also be a product of some surface contamination that was removed when the fibres were thermally conditioned. This explanation, however, seems less likely, as the mounds were not discernible in the AFM phase data, suggesting that they have similar mechanical properties to the glass surface.

As all of the topography plots in Figure 6 are presented using the same z-scale, the progressive increase in z-range that corresponds with increasing roughness through the range of conditioning temperatures can be clearly observed. Approaching the critical temperature range for strength loss at 400 and 500 °C, the fibre topography was mostly unchanged, reflecting the constant roughness. The surface of the fibres, particularly those conditioned at 400 °C, showed the development of numerous small but well-defined peaks measuring approximately 50–70 nm in the x–y plane. At the highest conditioning temperatures of 600–700 °C, individual peaks were no longer visible, and the entire fibre surface instead appeared to be mottled. The average z-range of the analysed areas increased by almost an order of magnitude from the initially untreated fibres to those conditioned at 700 °C.

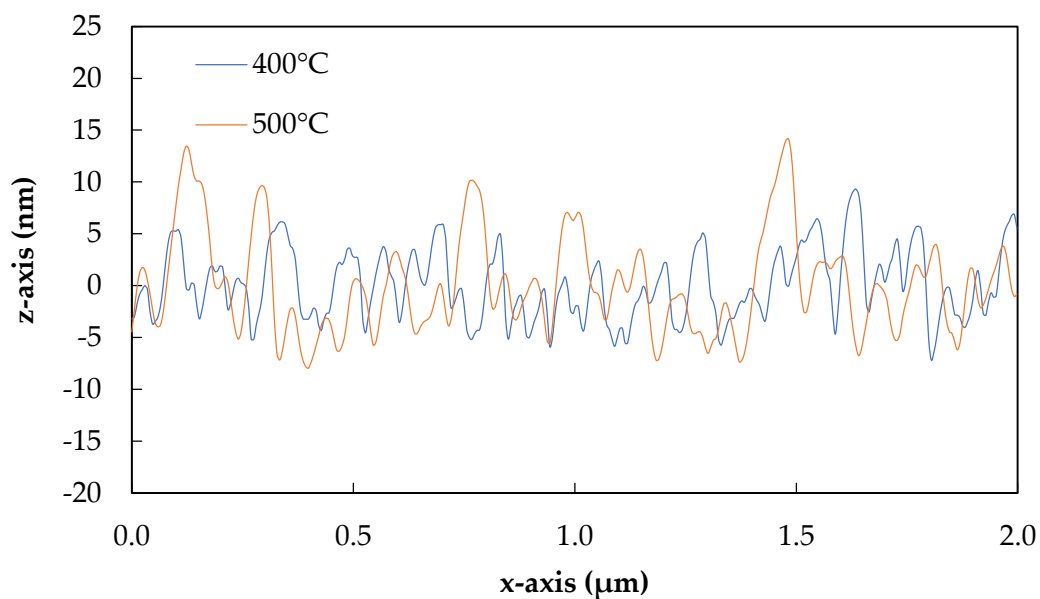
Figure 7. Typical 2D sections of the surface topography after heat treatment at 400 and 500 °C.

The slight differences in the surface morphologies of fibres treated at 400 and 500 °C can be more clearly observed in Figure 7. A greater number of smaller peaks were observed for 400 °C treated fibres than 500 °C, although the heights of these were approximately the same overall. Fibres treated at 600 °C began to lose smaller well-defined peaks, as can be seen in Figure 8, and this process was clearer yet for fibres treated at 700 °C. In this latter case, the peaks appeared to further coalesce together in groups, and the heights of the features again increased significantly.

The 2D topography graphs presented in Figures 7 and 8 bear resemblance to those in [27]: the heights of the peaks increased with the severity of the heat treatment, and the number of peaks per μm decreased. This is shown most clearly at 700 °C (Figure 8), where the coalescence of smaller individual peaks into only a few larger ones was observed. Significant differences remain between these data, and those that might be described as an ‘ideal’ example of phase separation. This may be explained, however, as the glass fibres used in our investigation were not etched in hydrofluoric acid, which is commonplace in similar studies [27,28]. A clear height contrast due to differential etching rates of phases was therefore not achieved in the topography plots reported here. It is also possible that the process observed was not fully developed, as the heat treatment time of approximately 20 min was relatively short.

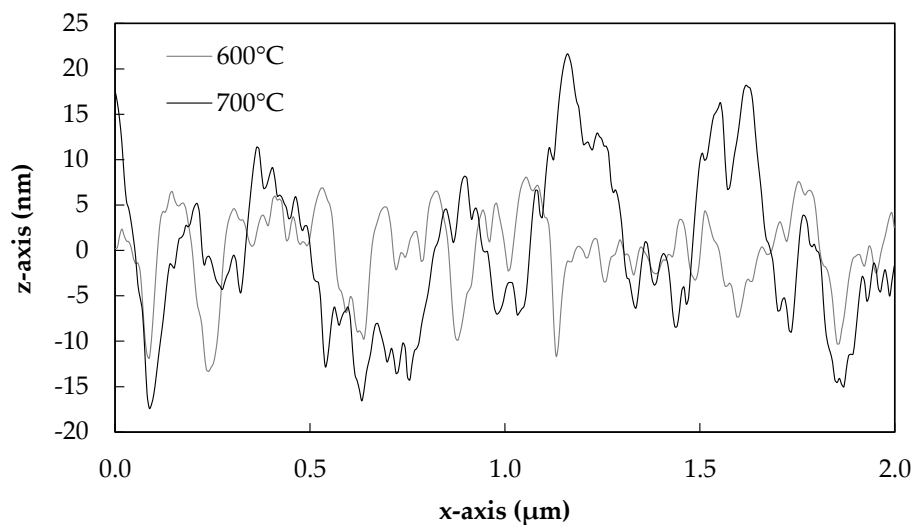
Figure 8. Typical 2D sections of the surface topography after heat treatment at 600 and 700 °C.

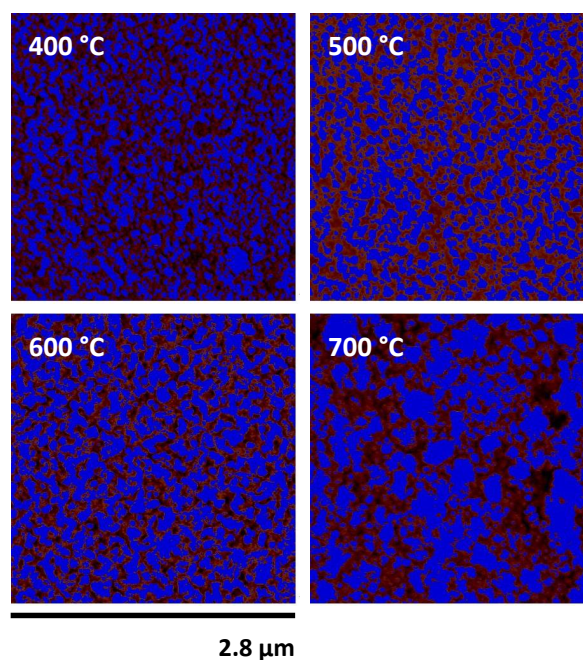
An estimate of the total surface area covered by the developing surface topography was obtained by using the built-in capabilities of NanoScope Analysis. The half-height of each topographical image was calculated by using the raw data, after the exclusion of features due to surface contamination, using the simple equation $\frac{1}{2}(z_{\max} - z_{\min})$. A mask was placed at this height, and the surface coverage of the features lying above the mask was measured. A selection of heat-treated fibres with these features identified by the software is shown in Figure 9.

Figure 9. Fibre topography of heat-treated fibres masked to identify the coverage of the structure (sample areas approx. $2.8 \times 2.8 \mu\text{m}$).

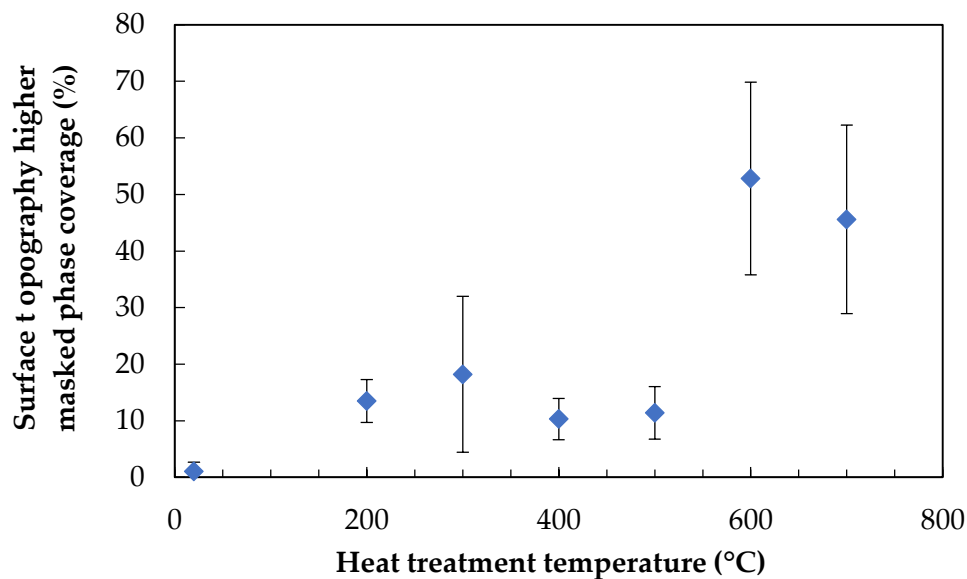
Figure 10. Coverage of the higher (masked) phase of surface topography as a percentage, over heat treatment temperature.

A step change in the coverage percentage was noted; similar values were calculated for lower treatment temperatures of 200–500 °C, followed by a significant increase to 600 and 700 °C, which themselves were similar to one another. This somewhat reflects the observations of the 3D topography plots, in which the appearance of 600 and 700 °C treated fibres were somewhat alike. It is notable, however, that the coverage percentages calculated for 200–500 °C were approximately constant, despite the relatively dissimilar fibre surface topographies. These data highlight a clear step change which occurred between the 500 and 600 °C treatment temperatures.

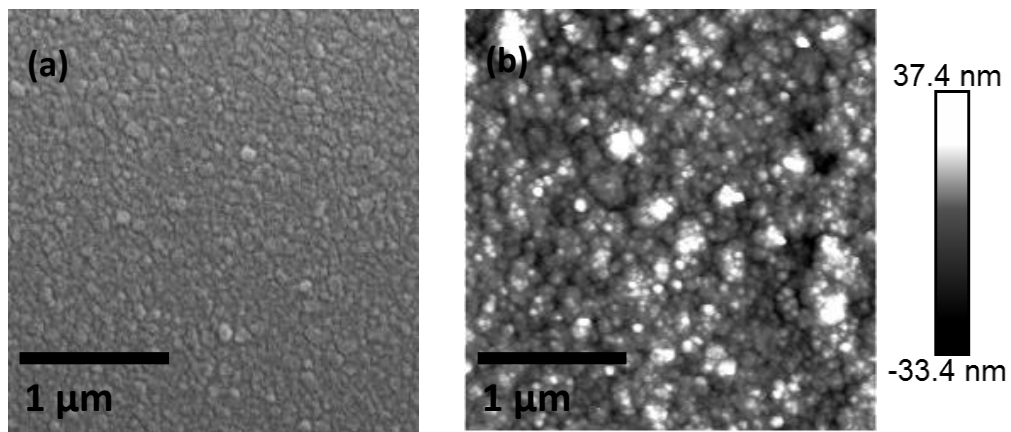
Images of the fibre surfaces were obtained using SEM, in an attempt to complement the image data from AFM. The consequent loss of quantitative topographical data was compensated by the ability to image large areas of the fibre surface quickly, in contrast to the slow rate of data generation using AFM. Two images of fibres identically thermally conditioned at 700 °C are shown in Figure 11; one obtained using SEM and the other by AFM. From close visual inspection of the images, it appeared clear that the same surface topography was visible, regardless of the method of microscopy used. In image (b) obtained by AFM, a significantly greater contrast in the z-axis was evident, as expected.

Figure 11. Images of 700 °C conditioned fibres obtained using (a) Scanning Electron Microscopy (SEM) and (b) Atomic Force Microscopy (AFM).

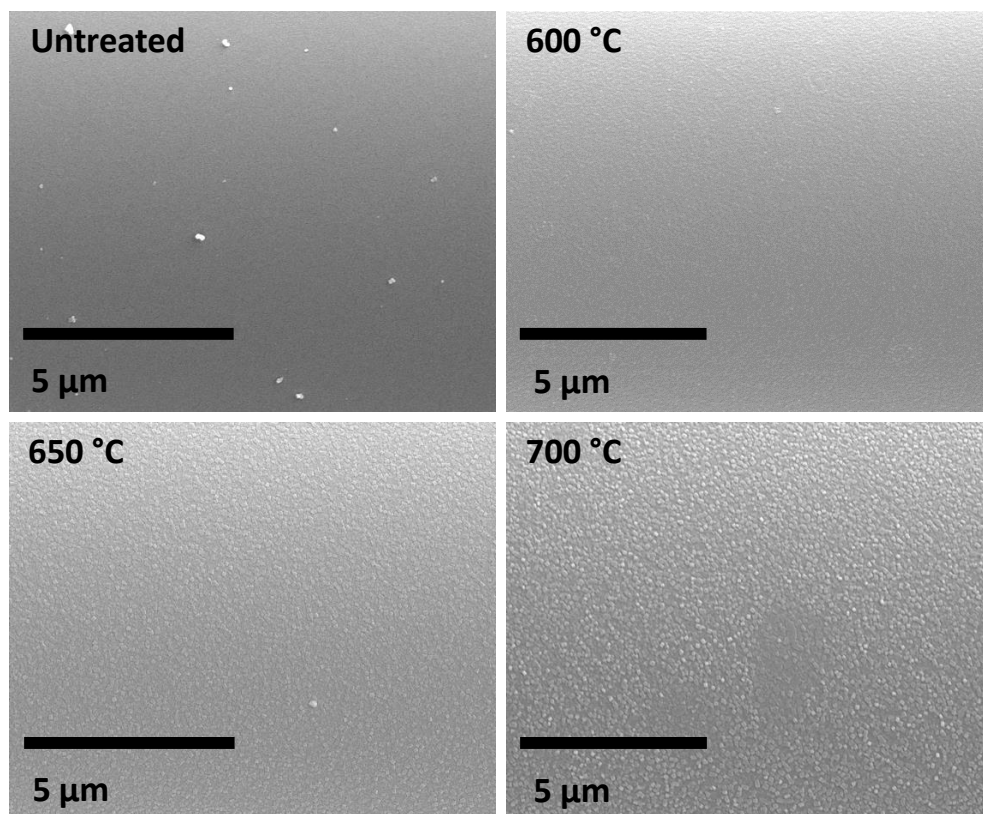
The surface of the thermally conditioned fibres over a range of temperatures was imaged using SEM. No consistent change of the fibre surface was visible until a temperature of at least 600 °C was used. Although the AFM results showed that roughening occurred at temperatures as low as 200 °C, the resolution of SEM was not sufficient to discern the features until they were of several tens of nm in height. It is possible that this is due in part to the need to coat fibres with a conductive material. Four images of fibre surfaces are presented in Figure 12.

Figure 12. SEM images of E-glass fibre surfaces: untreated and following thermal conditioning at 600, 650 and 700 °C.

The SEM image of the surface of untreated bare glass fibres was found to be largely featureless, except for some small contaminant particles of sub-micron dimensions. Similar particles were observed

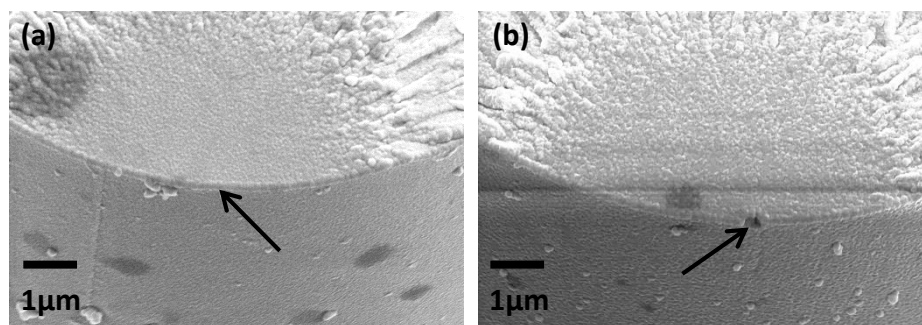
The fracture surface of both as-received and heat-treated fibres following tensile testing were imaged using SEM. In line with established methods [16] the fractures were examined for visible indications of flaws at which failure was initiated. An example of both non-visible and visible flaws at the fracture origin is presented in Figure 13.

Figure 13. Fracture mirror region of 450 °C heat-treated fibres; (a) no visible flaw and (b) visible semi-circular flaw at the origin of fracture.

A few visible flaws were found during fractography; an example is given in Figure 13b. In this case, the flaw dimensions give an almost perfect agreement between the theoretical fibre strength—according to Equation (2)—and the measured strength from testing, which are both 1.2 GPa. While it is occasionally possible to identify such surface flaws on fracture surfaces, they have never been identified on pre-fracture glass fibres. The AFM study of heat-treated fibres that were not tensile-tested was intended to discover if surface flaws could be imaged, in addition to providing data on any other changes in surface topography and roughness.
