# Remediation Challenges in the Arctic – Lessons from Alaska's North Slope

Keith Torrance<sup>1</sup>; Birgit Hagedorn<sup>2</sup>,  
<sup>1</sup>University of Strathclyde, CEE, Glasgow  
<sup>2</sup>Sustainable Earth Research, Anchorage, Alaska

# Case Study 1. Former Naval Arctic Research Laboratory, Utqiagvik

## Case Study 2. Red Devil Mine

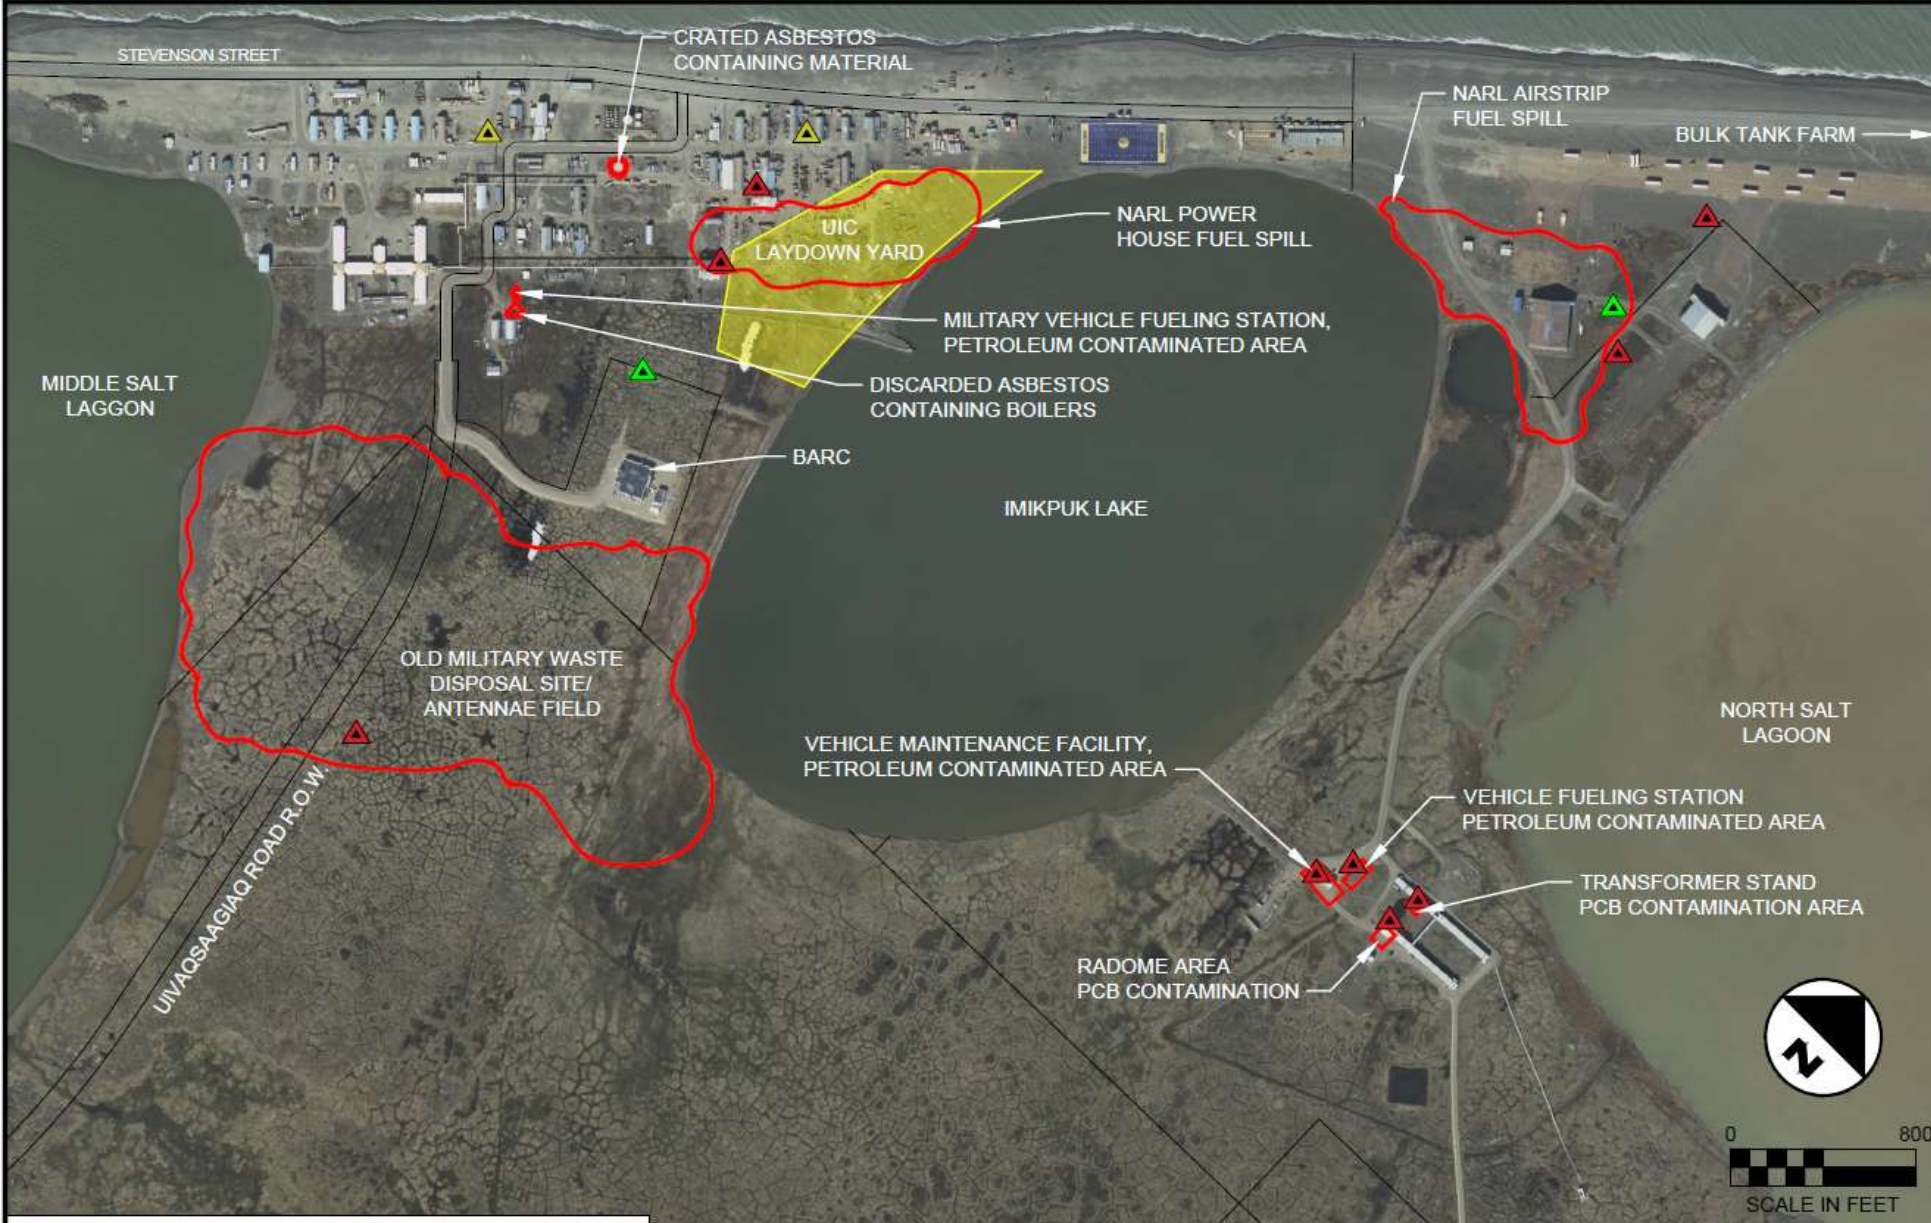
**NARL MASTER PLAN**  
**UIC NARL CONTAMINATED AREAS**

- HISTORICAL CONTAMINATED AREAS
- ▲ CONTAMINATED AREA - ACTIVE
- ▲ CONTAMINATED AREA - CLEANUP COMPLETE
- ▲ CONTAMINATED AREA - CLEANUP COMPLETE, INSTITUTIONAL CONTROL

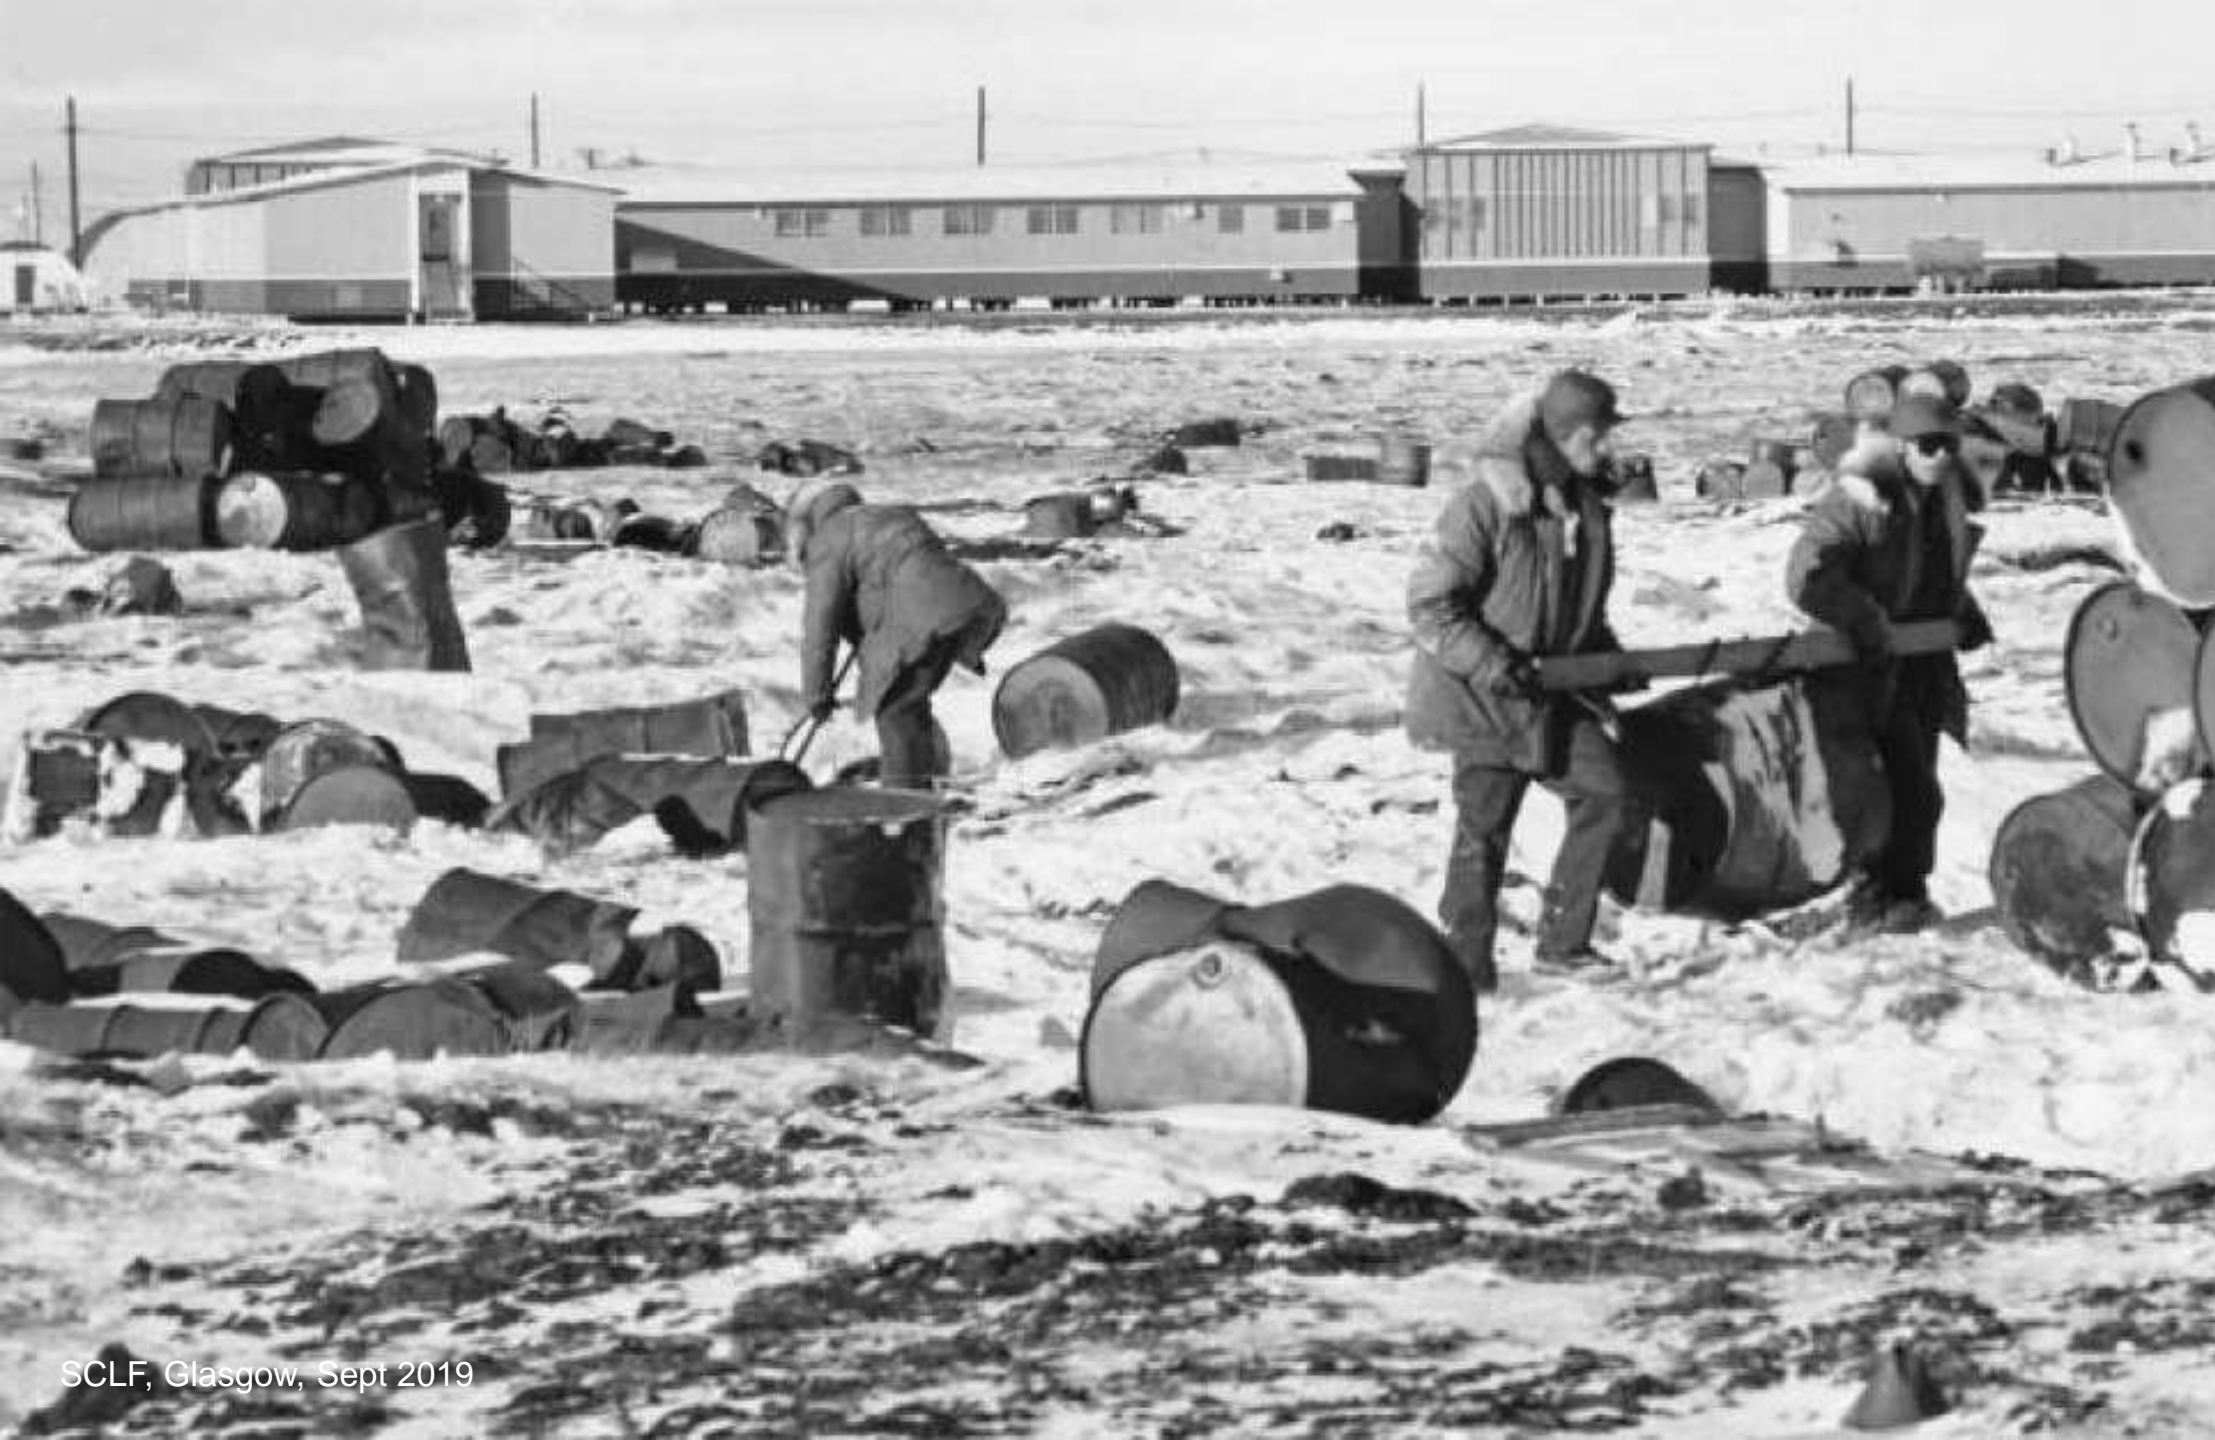
- Surface topography is flat – minimal hydraulic gradient.
- Underlain by continuous permafrost.
- Shallow active layer in summer allows contaminant migration.

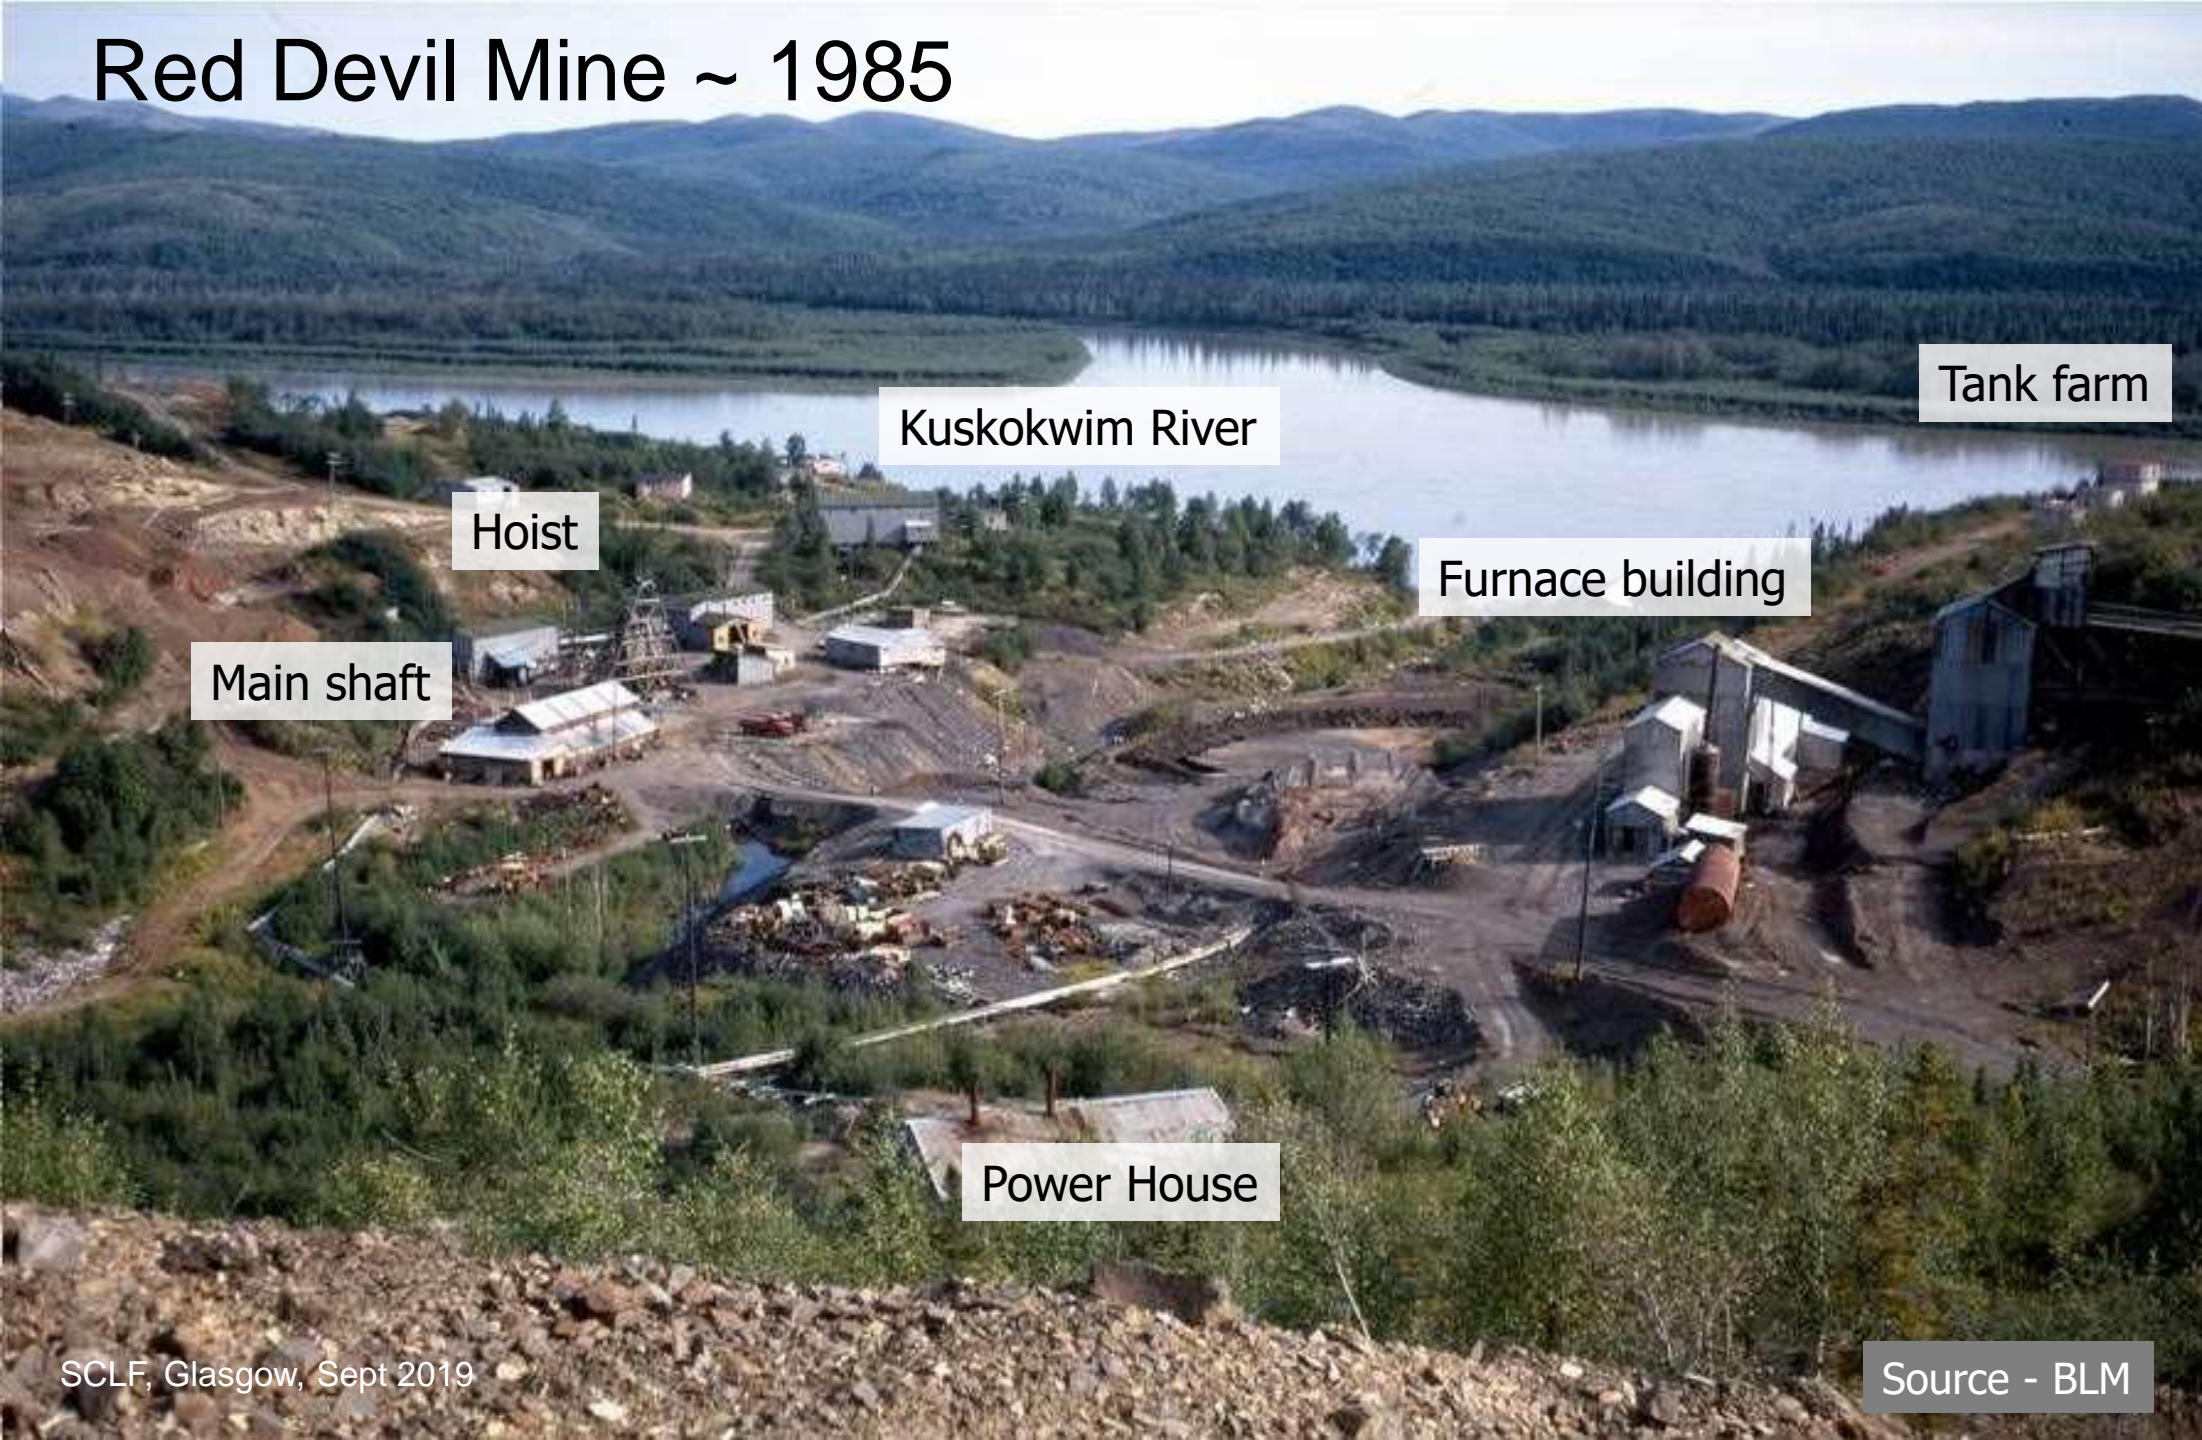
# Red Devil Mine ~ 1985

Kuskokwim River

Tank farm

Hoist

Furnace building

Main shaft

Power House

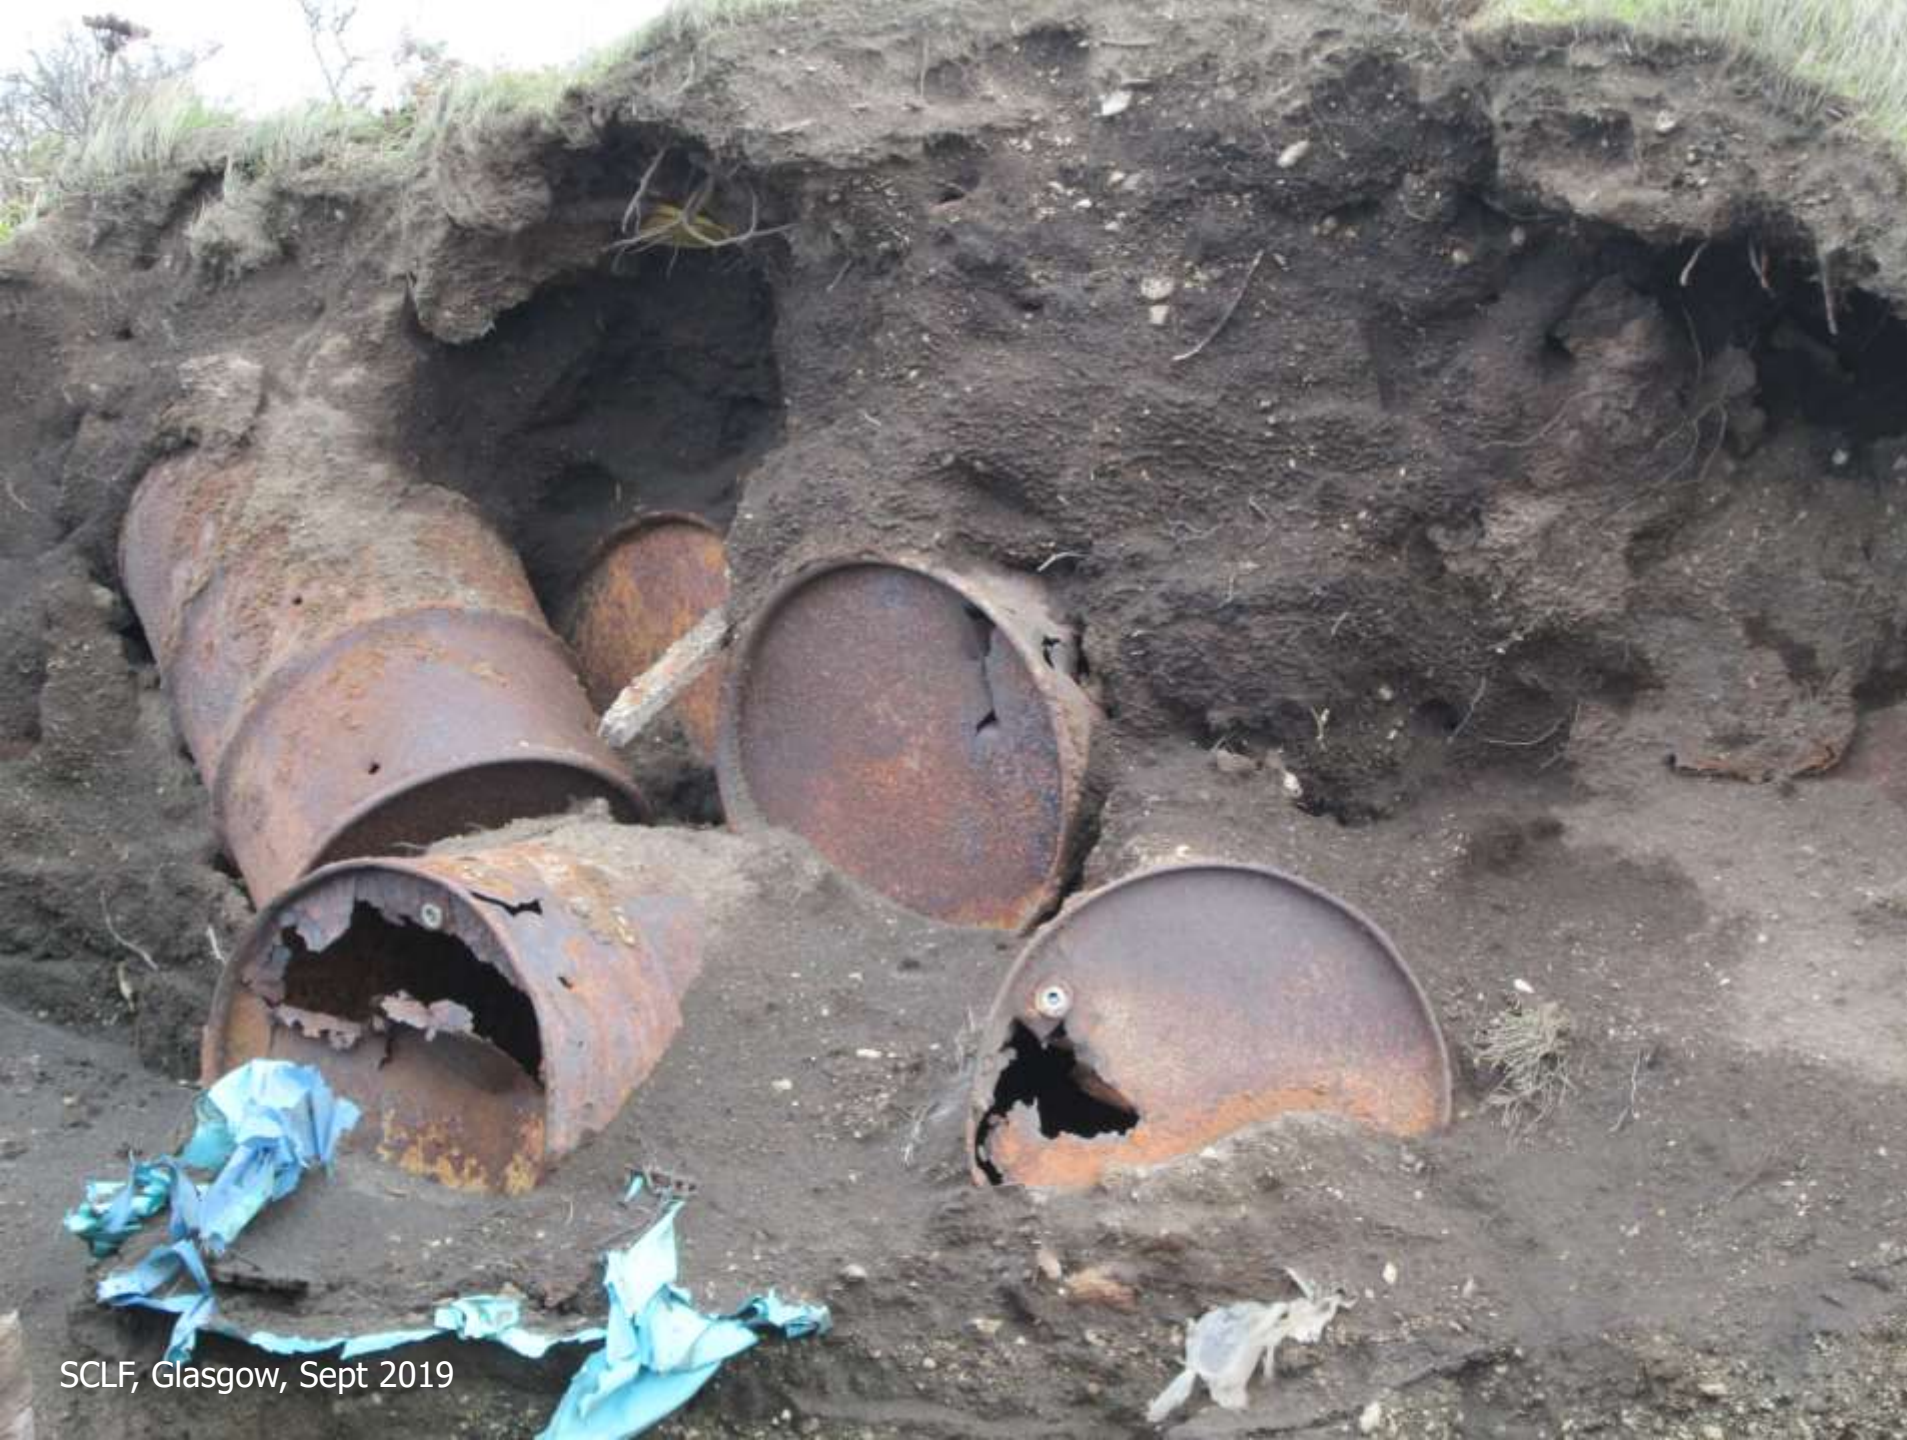
Increased  
coastal  
erosion  
leading to  
exposure of  
landfills

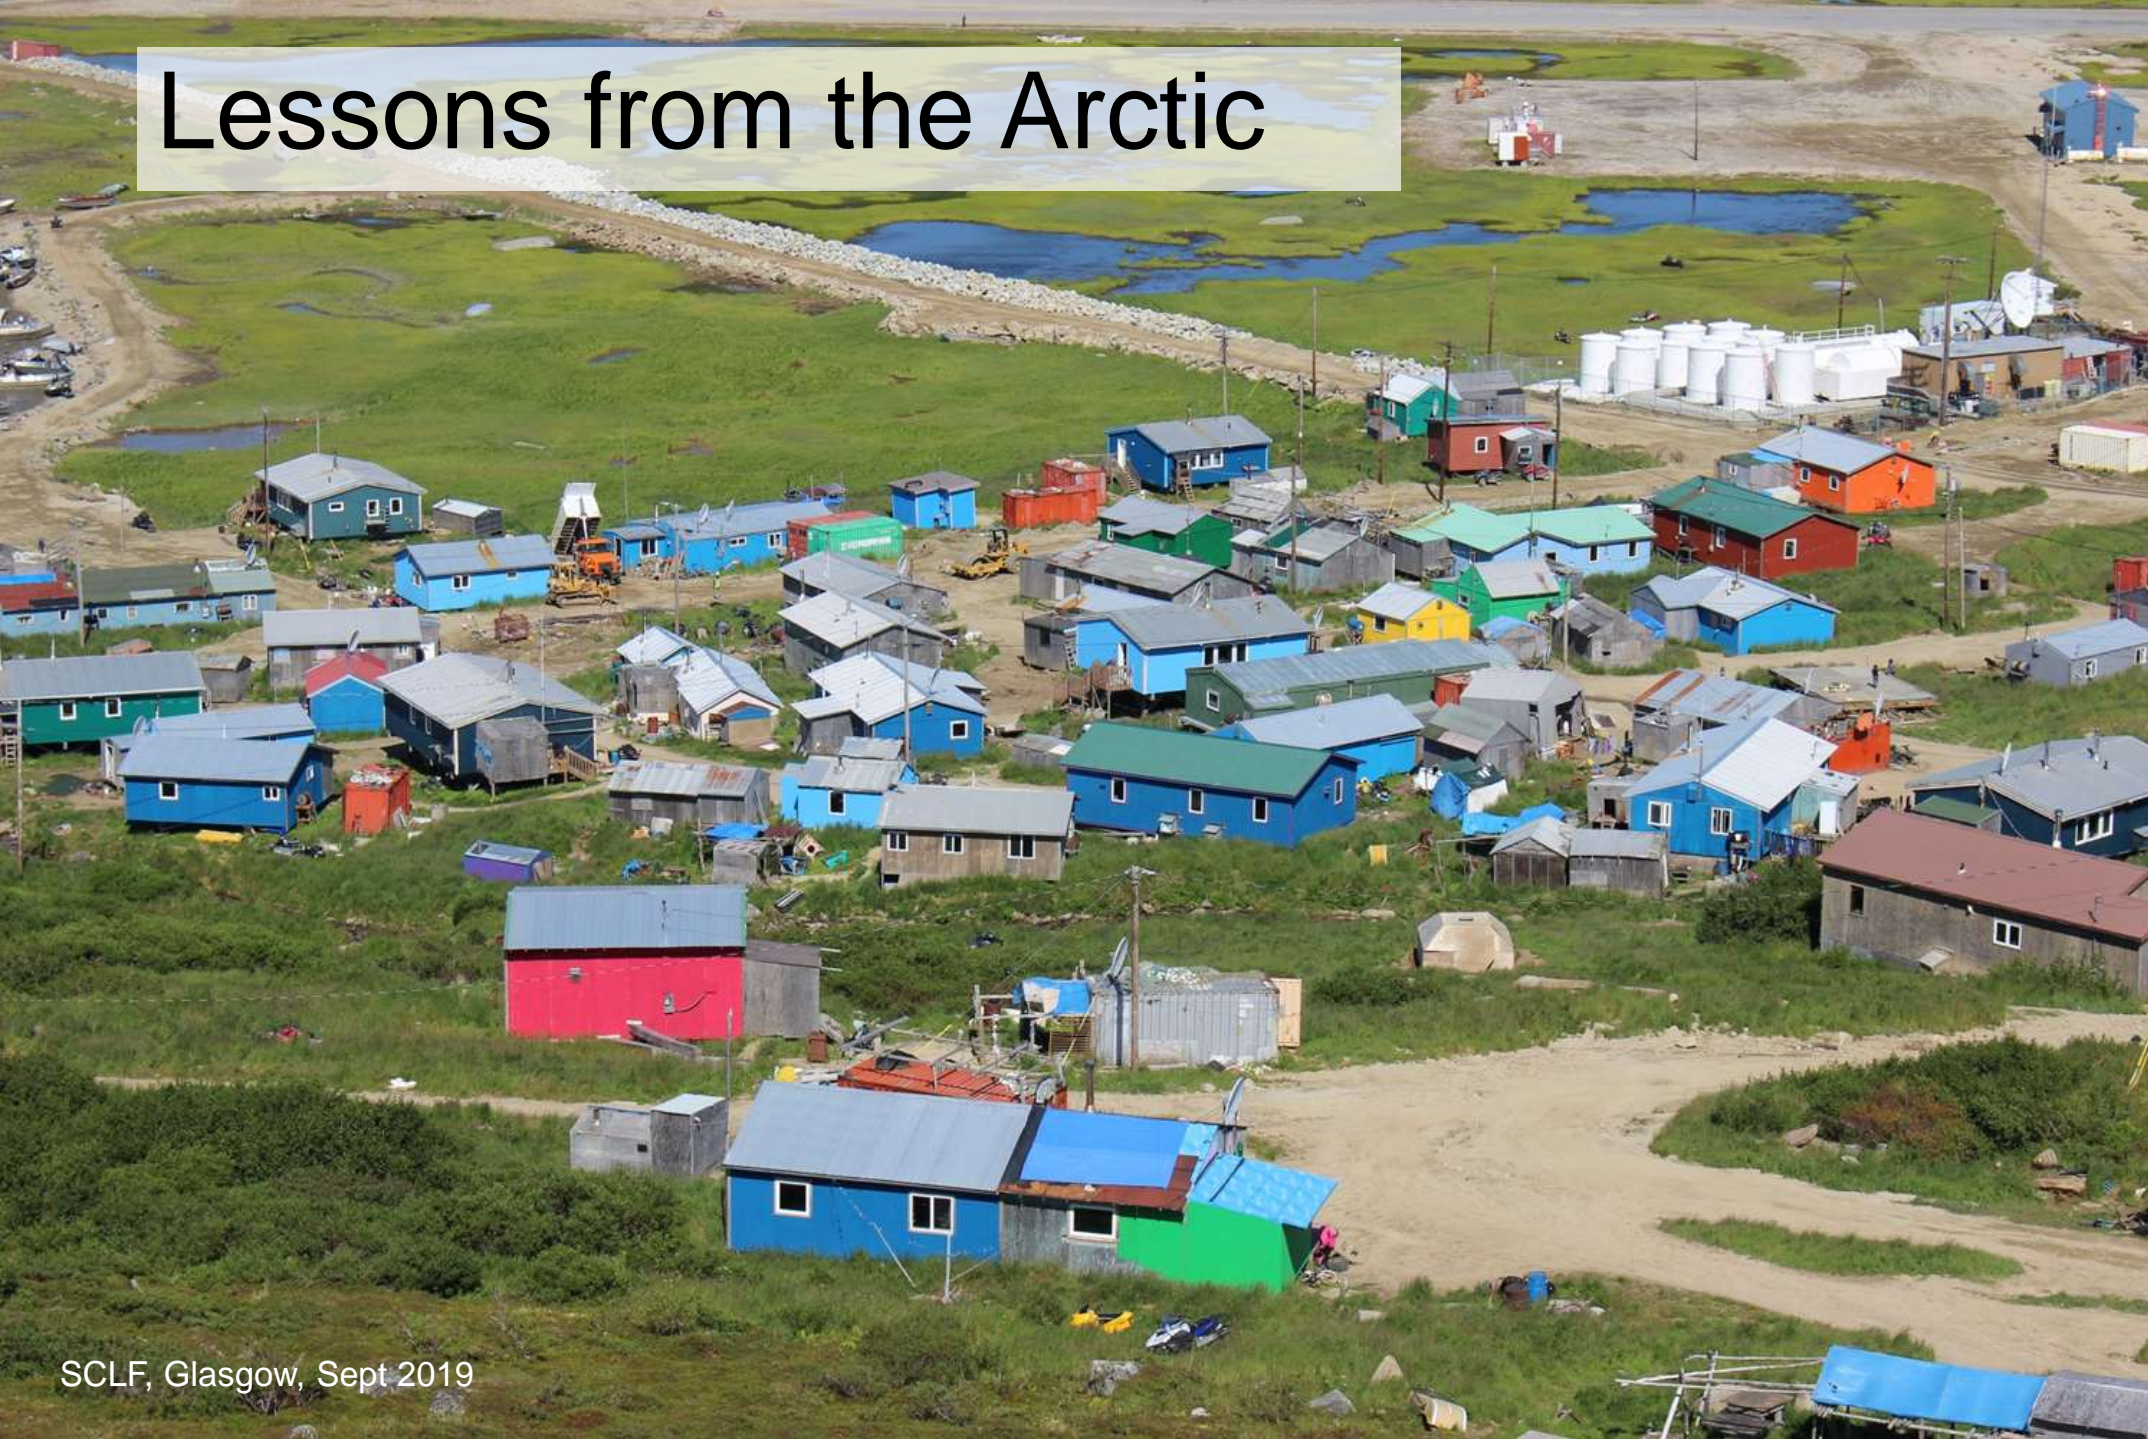
- Climate change is changing previous assumptions.
- Don't discount alternative remediation strategies.
- Focus needs to switch from site characterisation of to active remediation.
