# 1 **Quantifying Impacts on Remote Photogrammetric Inspection**

## 2 **Using Unmanned Aerial Vehicles**

3 Dayi Zhang\*, Robert Watson, Gordon Dobie, Charles MacLeod, Aamir Khan, Gareth Pierce

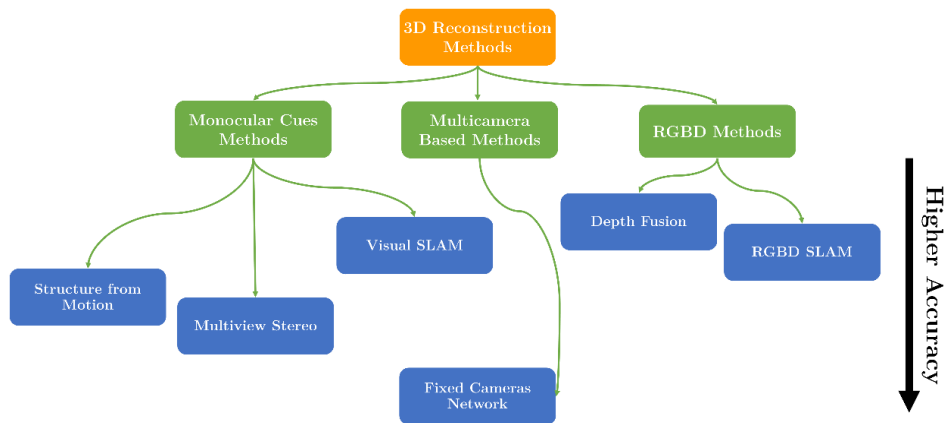
Figure 1 Approaches for 3D Reconstructions

19 placed at various pre-planned positions. Compared with the single camera solutions, multiple cameras with known  
 20 camera positions do not require mathematical approaches to estimate camera poses, which improves the  
 21 reconstruction accuracy. Considering the physical limitations of the UAV and accuracy requirements of the  
 22 inspections, SfM and Multiview Stereo are utilised in this paper.

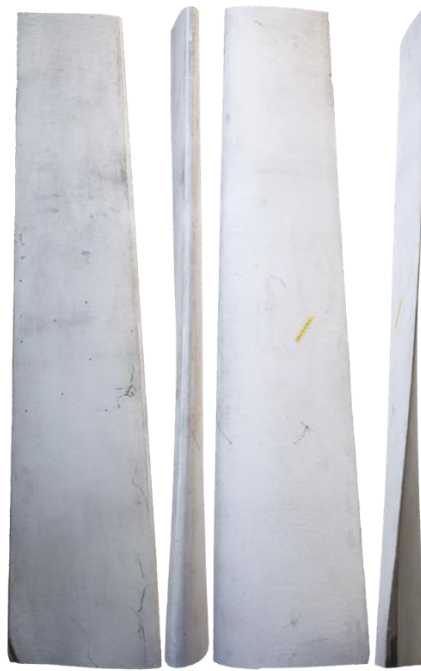
13  
14 Figure 4 Reconstructed 3D model for the wind turbine blade

15 Figure 4 shows an example of a reconstructed model from the Agisoft PhotoScan software. In the best-case  
16 scenario, reconstructions achieved by this UAV system for photogrammetric inspection present with the mean  
17 error below  $0.25\ \text{mm}$  relative to the GOM reference model. Peak-to-peak error and standard deviation are below  
18  $4.3\ \text{mm}$  and  $0.92\ \text{mm}$ , respectively.

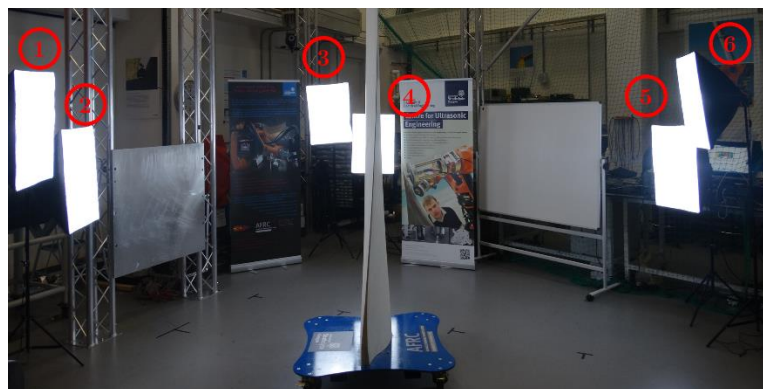
21  
22  
Figure 5 External lights Setup

8 Image brightness is one of the parameters influencing image quality and reconstruction accuracy [28]. The images  
9 captured under low light intensity lost the detailed features of the target surface leading to the failure of image  
10 feature extraction algorithms and hindering the reconstruction process. Undertaking the experiments in a  
11 laboratory environment allows the ambient light levels to be fully controllable by the use of diffuse supplementary  
12 lighting. Within the laboratory and in the absence of additional illumination, the light intensity was measured by  
13 a calibrated lux meter as  $65 \pm 5$  lx. To quantify the impact of the light intensity on reconstruction accuracy, six  
14 additional 135 W lights with a colour temperature of 5500 K were set-up at suitable locations around the wind  
15 turbine blade, as shown in Figure 5. These external lights introduce additional illumination of the blade surface

16 and permit increase in environmental light levels by a factor of three, from 65 lx to approximately 200 lx. By  
17 comparison, the ambient environmental light measured by using the lux meter outdoors on a cloudy day is around  
18 2000 lx. This laboratory lighting environment, therefore, provides a good facility to investigate the impact of the  
19 environmental brightness parameter on reconstruction in such conditions as may be encountered in practice during  
20 markedly poor weather.

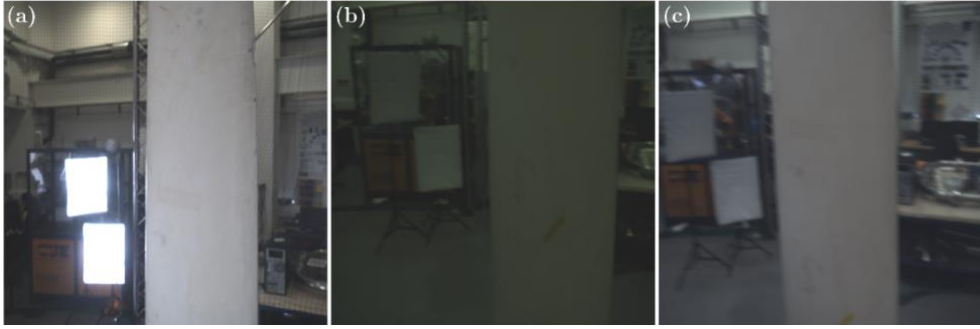
Figure 6 UAV captured images under: (a) 30 ms shutter with supplementary lighting, (b) 30 ms shutter without supplementary lighting, (c) 60 ms shutter without supplementary lighting.

19 trial, to demonstrate the impact of shutter time on reconstruction accuracy and create similar image brightness to  
20 the well-lit trial, the camera shutter speed was changed to 60 ms. Figure 6 displays raw images taken at similar  
21 locations for comparison between the three image sequences, captured under different light intensity and varying  
22 shutter speed. The deviation maps and the errors of reconstruction models under each of the three setups are  
23 illustrated in Figure 7 and Table 1. The quality of the images from the inspections with three setups are plotted in  
24 Figure 8. The image qualities from each trail are quantified by using the matching feature density metric, as  
25 explained below. A fourth image sequence using the 60 ms exposure time and additional lighting is not conducted  
26 as this leads to overexposed images from which no meaningful results may be extracted.

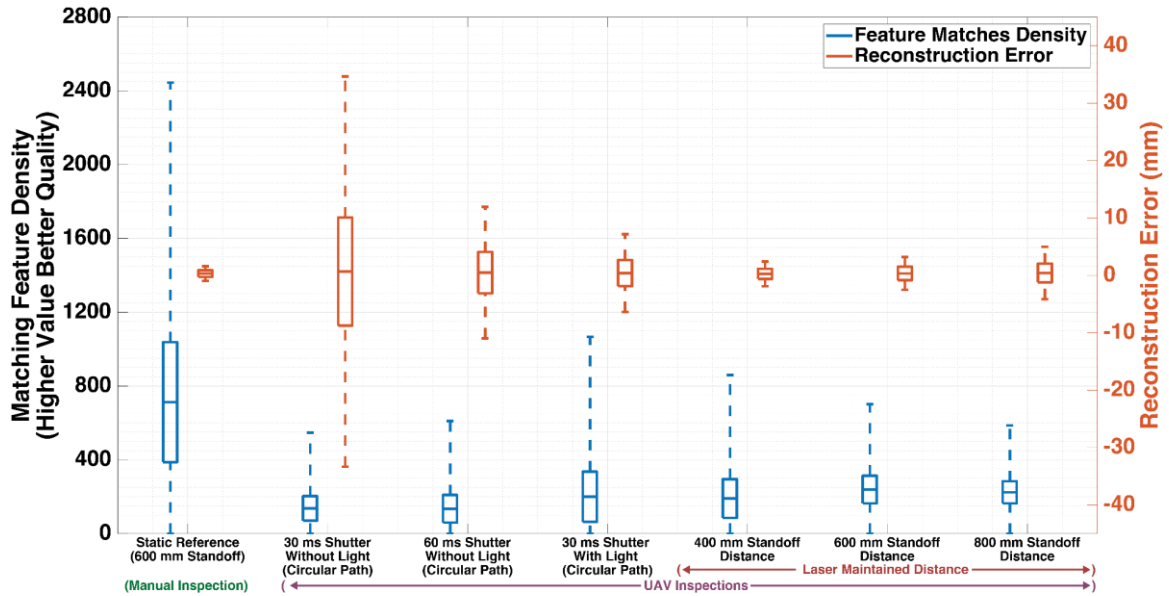
Figure 8 Image quality and reconstruction error under different experimental setups. The reconstruction errors are plotted by using the mean errors and standard deviations.

Image feature matches are the key factors in the 3D reconstruction process. Correlation between increased feature matches and a better quality of reconstructed model has been previously established [19]. Similarly, the percentage of image overlap is well recognised to influence the number of feature matches between consecutive images. Matching feature density is thus introduced as a comparative metric describing the number of the matched features in an overlapping region and quantitatively assess how this impacts the quality of the final reconstruction. It is calculated by dividing the number of the matched features between two subsequent images by the area of their overlap, with this area expressed as a percentage of the full image size. Using the matching feature density to quantify the quality of images obtained during autonomous UAV inspections, image sequences captured with different optical setups can be directly compared and evaluated. Higher density implies that an image had more matching features and is thus indicative of better image quality.

The image quality distribution across all image sets (as presented in Figure 8) shows that those captured under the lowest light intensity, without supplementary external lighting had the worst quality. Correlating with the intuitive outcome, the average quality was improved with the increase of camera shutter speed and environmental light intensity.

22 As shown in Figure 8, the images captured during the manual inspection had better qualities than the images taken  
23 during the UAV flight with the same 600 mm standoff. The reconstruction accuracies listed in Table 2 show the  
24 motion blur from the autonomous UAV slightly increased the mean alignment error. Moreover, the addition of  
25 motion blurring leads to the increase of the standard deviation and peak-to-peak error by almost a factor of two.  
26 Motion blur causes distortions in the image and so induces error in the reconstruction results. However, due to the  
27 nature of UAV flight, these motion blur effects cannot be fully eliminated, only compensated for by the informed  
28 selection of camera settings (e.g. faster shutter speed) and a higher-performance flight controller to counteract the  
29 UAV instabilities.

1 Figure 8 illustrates how the image sets taken from 400 mm standoff distance exhibited large variation in image  
2 quality expressed in terms of the matching feature density metric. Additionally, it highlights a relationship  
3 between the image quality variation and UAV standoff distance. The shorter standoff distance entails that more  
4 details are taken from the surface of the inspection object, improving reconstruction quality. However, the closer  
5 proximity also causes an exponentially narrower depth of field of the camera, requiring a tighter control of UAV  
6 position and leading to additional focal blurring, as discussed in Section 4.3, manifesting in Figure 8 as increased  
7 variation in image quality. Furthermore, the UAV was observed to be unstable when flying at 400 mm standoff  
8 owing to near-structure aerodynamic effects, causing further motion-based blur to appear in the images. In

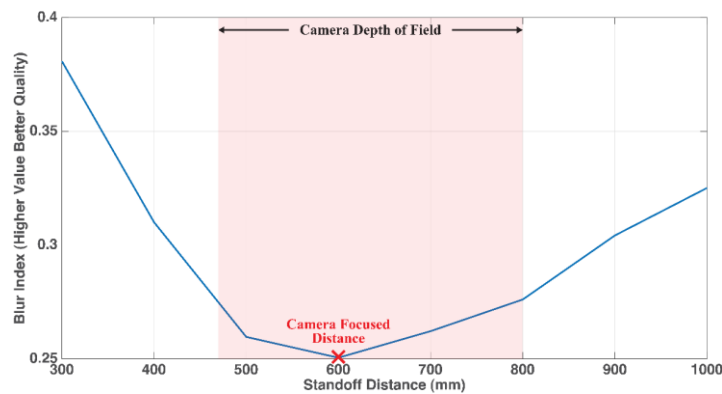
20  
21 Figure 10 Image qualities at various standoff distances (camera is fixed focused at 600 mm)

13 An open source blur metric function, evaluated within the MATLAB data processing software environment, was  
14 utilised to quantify the degree of blur present in the captured images. This blur metric function described by Cr  t  -  
15 Roffet et al [49] is based on a percentage similarity comparison between the original image and image after passing  
16 through a low-pass filter and functions as a relative comparison between two images of the same subject. The  
17 quality of the images captured at different standoff distances evaluated using this metric is plotted in Figure 10.  
18 A higher value of blur index implies poorer image quality. As expected, the camera captured the best quality in  
19 the focal point and quality became worse with the standoff distance away from the focal point.

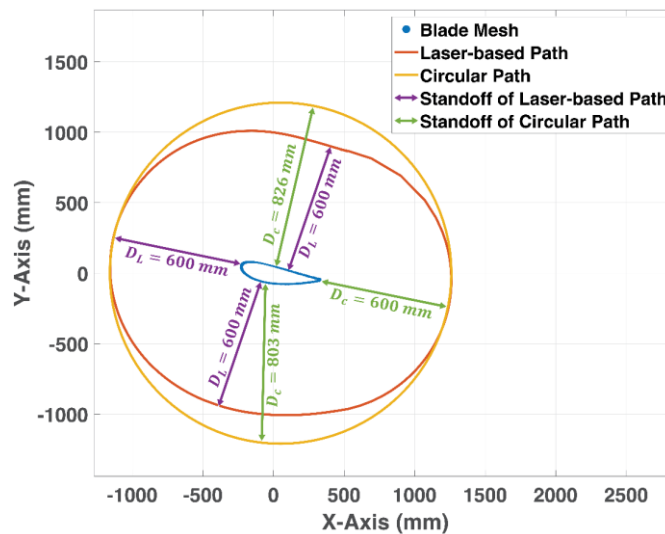
1 Figure 11 Comparative diagram of the circular and laser-based paths when executed about the aerofoil cross-section of a wind turbine blade.  
 2 To demonstrate the accuracy of the laser scanner maintained distance, an idealised flight path is generated in  
 3 MATLAB based on the highly accurate reference model obtained using the GOM ATOS Triple Scan system. The  
 4 path is generated by slicing the mesh of the turbine blade at regular height intervals, forming a perimeter at each  
 5 interval, then expanding these perimeters to the correct standoff distance. This defines the ideal flight trajectory  
 6 with 600 mm standoff distance to the blade surface. The UAV flight path as executed in both cases is recorded  
 7 utilising the Vicon tracking system (as indicated in Section 3.1) and is plotted in Figure 12. Path standoff errors  
 8 are calculated between the desired path and executed path and plotted in Figure 13, illustrating the performance

13 When comparing the circular and laser-based paths, as in Figure 11, the most prominent difference is the standoff  
 14 distance between the UAV and the targeted inspection asset (i.e. the wind turbine). The circular path entails a  
 15 varying standoff distance (between 600 and 826 mm) owing to its nature as a pre-planned heuristic path, generated  
 16 with minimal a priori knowledge. Inspections relying on such algorithms will experience focal blurring in the  
 17 images taken at points where the flight path diverges most from the inspection surface geometry, granting a  
 18 significant degradation in cases of complex asset geometry. In contrast, given the same level of a priori knowledge,  
 19 the laser-based adaptive control strategy can, in real-time, ensure that the camera remains at the correct standoff  
 20 distance to retain the asset surface within the well-focused depth of field. Thus, regions of increased focal blur are

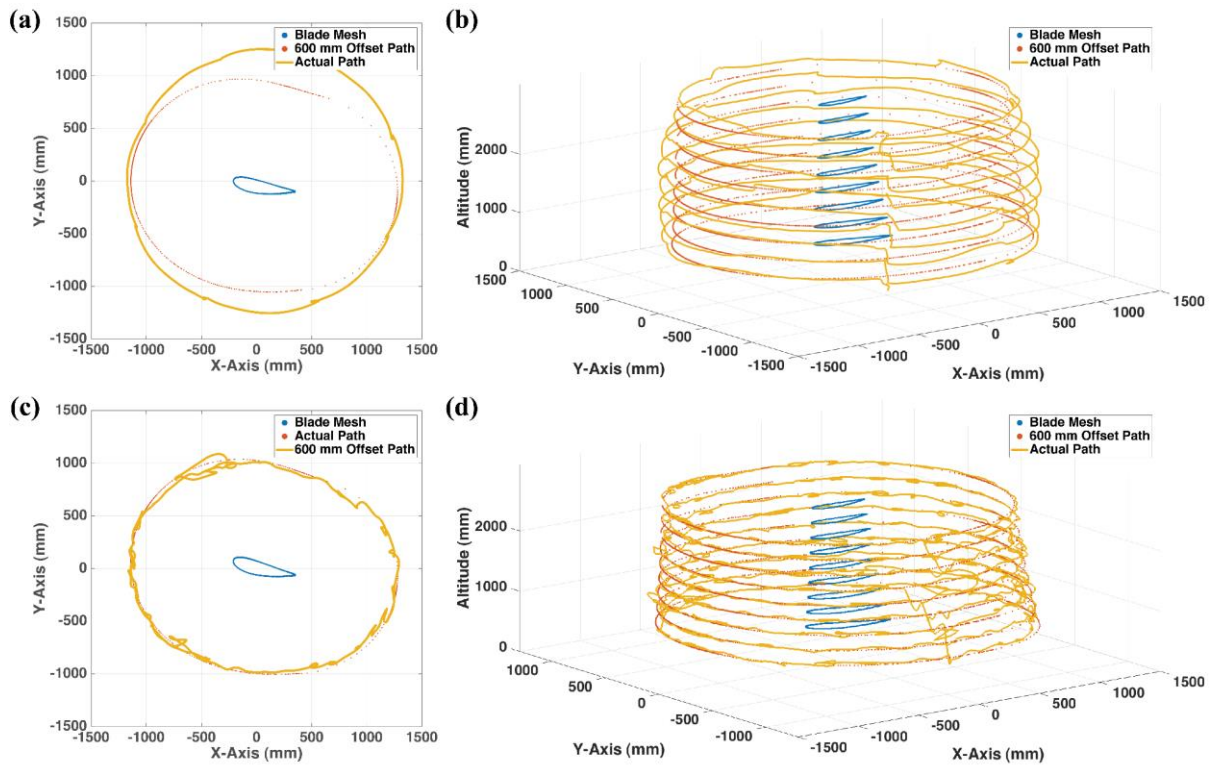
12  
 13 Figure 12 This figure includes slices of the blade mesh (blue), a MATLAB generated path with 600 mm standoff distance (red) and executed  
 14 path (orange). (a)(b) pre-planned circular trajectory (c)(d) laser-based adaptive trajectory

9 of each strategy. The distribution of error magnitudes demonstrates that when utilising the adaptive path, the UAV  
 10 equipped with a laser scanner successfully placed the sample surface within the camera's depth of field and was  
 11 able to maintain this positioning while encircling the component under examination.
