Microstructure and Mechanical Performance of FSWed Joint of T2 Copper and AA 1061

Welding of copper and aluminium has been problematic with tradition fusion method. The friction stir welding (FSW) was employed to butt weld the T2 copper and 1061 aluminum alloy plates. The welding parameters were planned by the orthogonal experiment design method. The samples obtained in experiments were investigated in the aspects of microstructure, tensile strength, fatigue performance and micro-hardness. Sound weld with the best tensile strength and fatigue life was produced under the welding parameters of rotation speed, 1100rpm and welding speed 50mm/min. The tensile strength was 193.16MPa, 85% of the base aluminium material. Three intermetallic compounds (IMC) of CuAl, Cu₃Al and Cu₉Al₄ were detected at the copper-aluminium interface in XRD analysis.

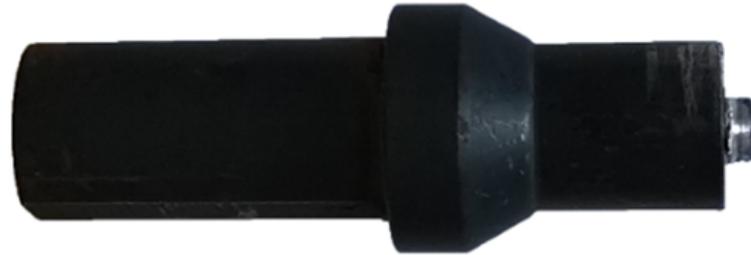
Figure 1 FSW tool shape and geometry

Shoulder diameter: 18 mm Pin shape: cylinder
 Pin diameter: 4.5 mm Pin length: 2.6 mm
 Total tool length: 77 mm

welding, the W6Mo5Cr4V2 (M2) high-speed steel was selected to make the tool. The shape and main sizes of the tool used in this paper are shown in Figure 1.

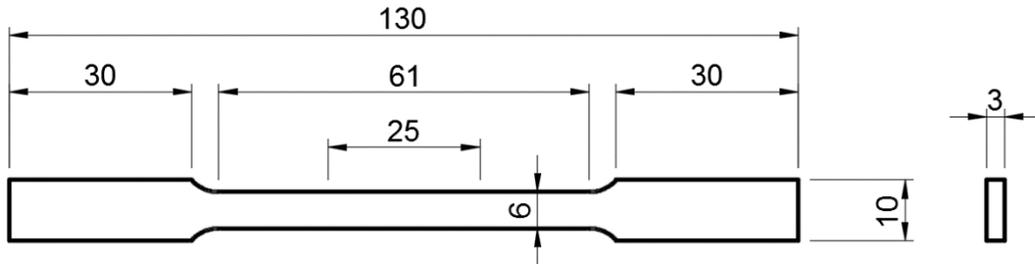
Figure 3 Geometry of tensile specimen, unit: mm

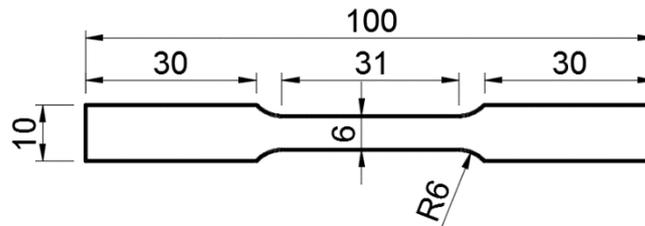
Figure 4 Geometry of fatigue test specimen, unit: mm

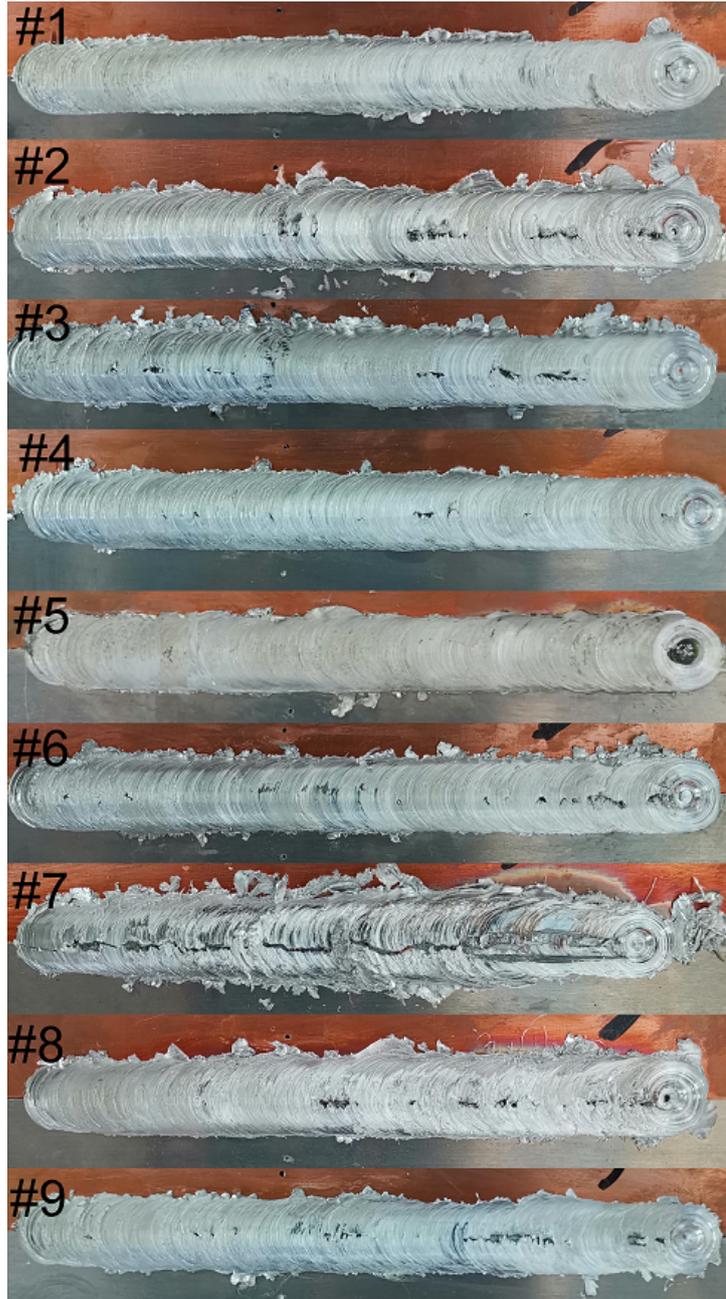
The morphology of the welding area was significantly affected by welding parameters. It can be seen from the Figure 5 that there were intermittent groove defects in tests # 2, # 3, # 6, # 8 and # 9. The tests # 1 and # 5 produced relatively smooth weld surfaces, this can also be reflected from the recorded axial loads of tests # 1 and # 5, Figure 6 (a, c). During the steady welding process (e.g. from 100s to 200s), the load values were more stable than those in the tests with defects, Figure 6 (b, d). Excessive heat input can also cause defects. Test #7 had the highest ratio of rotation speed to welding speed, and the highest heat input resulting in the worst weld morphology. There was a crack along the welding line and material flash was scattered irregularly. From the axial load history, Figure 6 (d), it can be seen that the applied force gradually increased with the time, and the maximum force was far higher than those in other tests. The surface of the weld area was covered by silver-white color metals with slight burrs,

Figure 5 Weld appearance for all the tests

indicating aluminum was stirred and squeezed by the tool to the surface of the plates. This was related to the fact that the density and melting point of aluminum are smaller and the flowability is better than that of copper. To examine the inside of the weld, the sample # 4 was cut across the weld. The hole defect was found at the copper-aluminium interface, a cross-section view was shown in Figure 7. Due to the rotation of tool, the dissimilar materials were stirred into each other, and the interface changed from a straight line into zigzag lines.

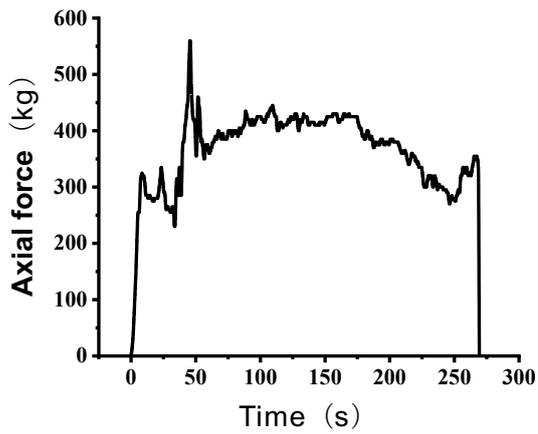
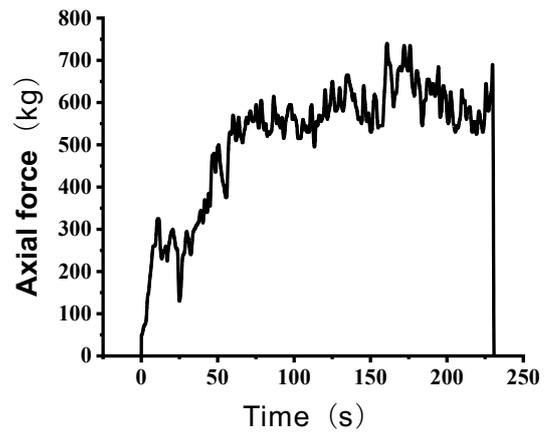
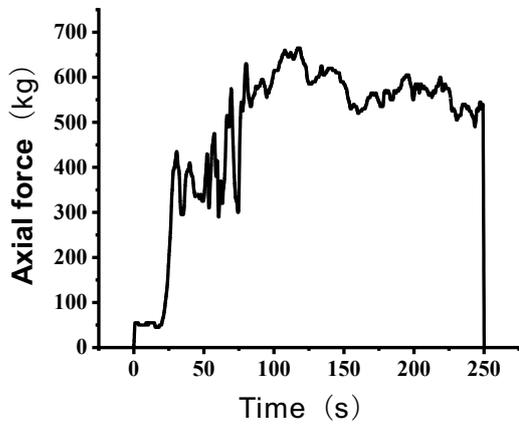
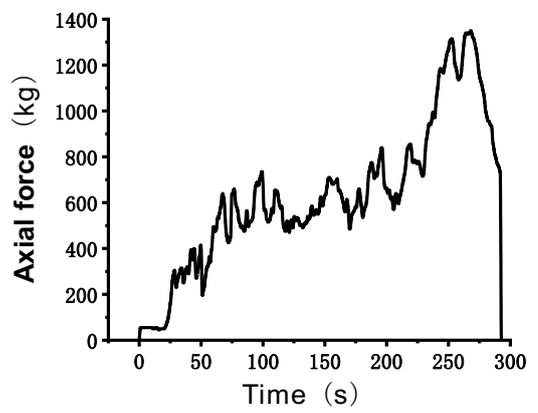
Figure 6 Axial force histories: (a) test # 1; (b) test # 2; (c) test # 5; (d) test # 7

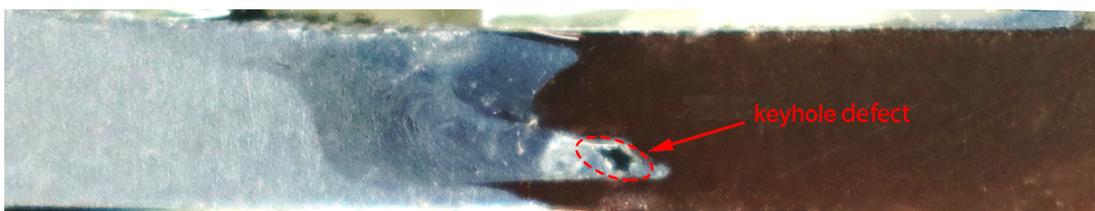
Figure 7 The weld cross section of the sample in test # 4

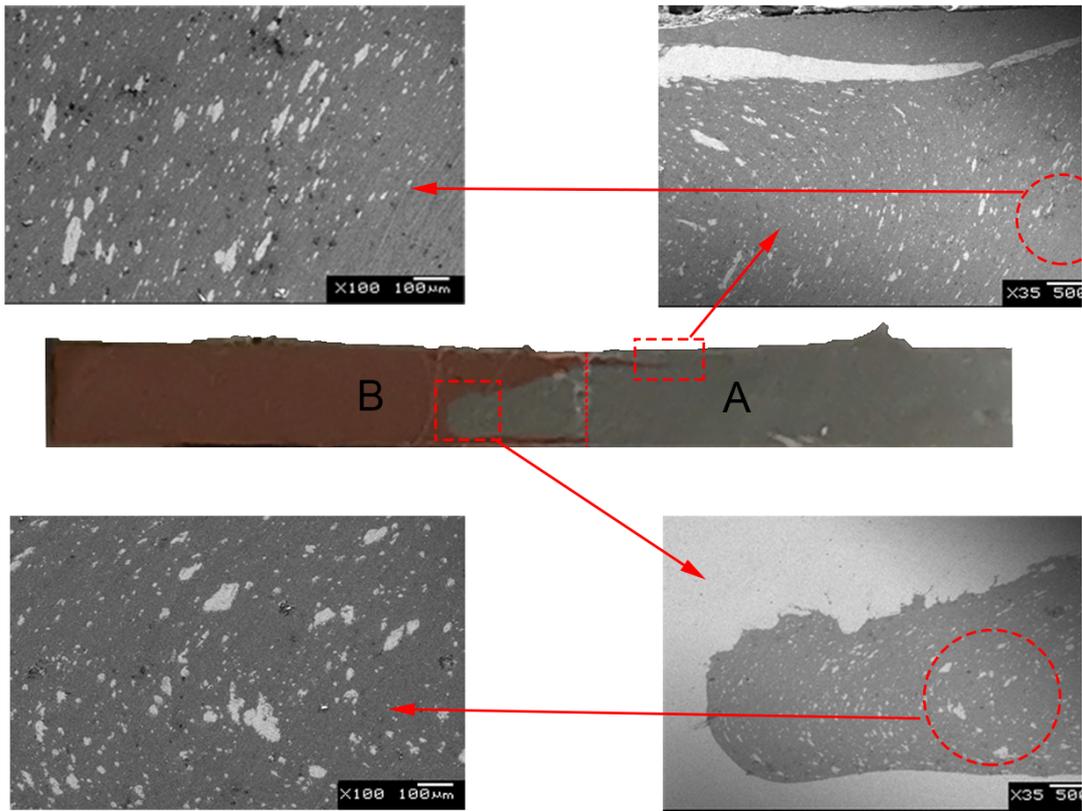
Figure 8 presents the cross-section view of the welded plate in test # 5, no defect was found. There was a clear boundary between the copper and aluminium parts shown in different colors. By observing two enlarged zones A and B, the top layer of the stirring area was aluminum dominate. A small copper slice in the upper area entered into the aluminum side, as indicated in zone A. In zone B, a large amount of aluminum was forced into the copper side. In the further enlarged views, judging from material colors, small copper particles were distributed in those aluminum materials, forming aluminium matrix metal composite. This was also proved by the EDS results shown in Table 2. The detection position was illustrated in Figure 9. A certain amount of copper was detected in all the five positions, among which the positions 4 and 5 were inside the aluminate dominate region. From the enlarged view of positions 1-3 along the interface of aluminium dominate region and copper bulk region, the mechanical locking can be noticed with small hook structures, implying the good bonding formed in the weld.

Figure 8 Optical microscope observation of the weld cross section

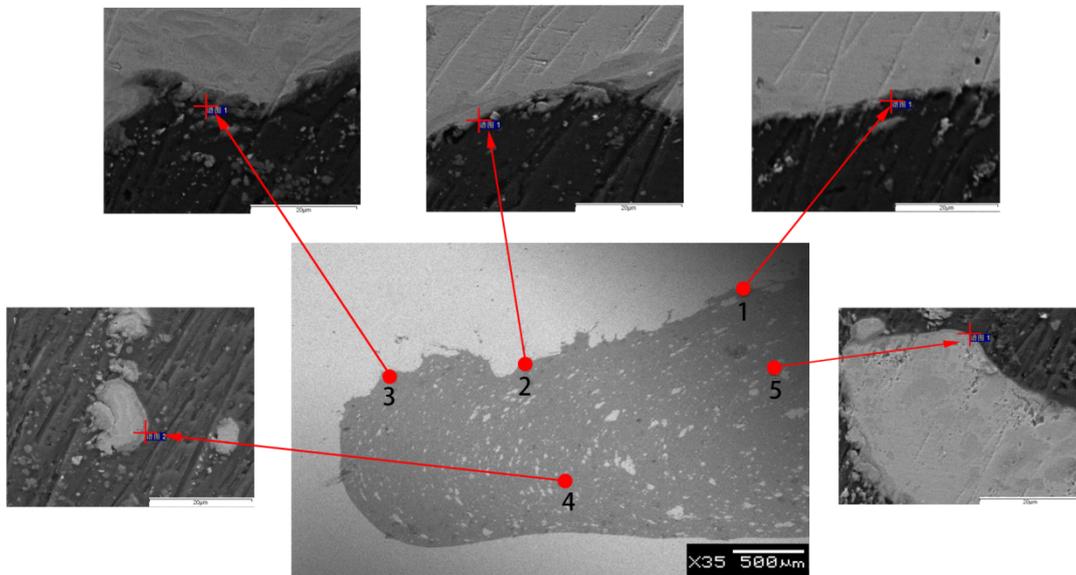
Figure 9 EDS test location

Positions	Al (at%)	Cu (at%)
1	89.25	10.75
2	86.91	13.09
3	96.40	3.60
4	84.34	15.66
5	67.25	32.75

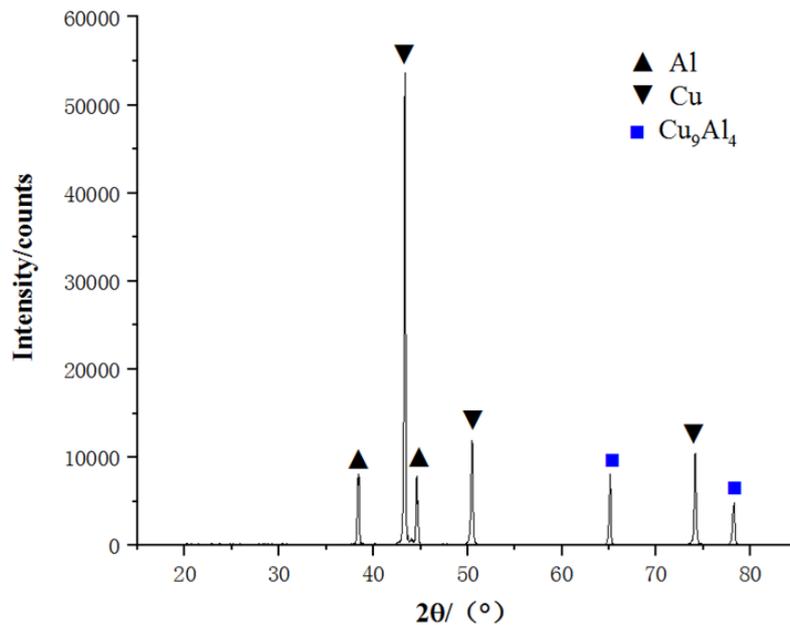
Due to the high temperature and intense plastic deformation in the mixing zone of aluminium and copper, the intermetallic compounds (IMC) can be easily produced [5, 14]. The X-ray diffraction (XRD) scan analysis was then performed to analyze the material components in the weld area. In current study, depending on the welding parameters, three intermetallic compounds of CuAl, Cu₃Al and Cu₉Al₄ could be produced. Sample # 4 had two IMCs, CuAl and Cu₃Al, but samples #5 and # 6 had only one IMC, Cu₉Al₄ and Cu₃Al, respectively. The detailed XRD results for samples #5 were provided in Figure 10. The FSW parameters in the three tests had same rotation speed, but different welding speed. There was no clear trend of IMC formation with the change of welding speed. Among the three samples, only sample #5 had no defect. Cu₉Al₄ was frequently reported in the literature [7-11, 14].

Figure10 XRD scan results for sample # 5

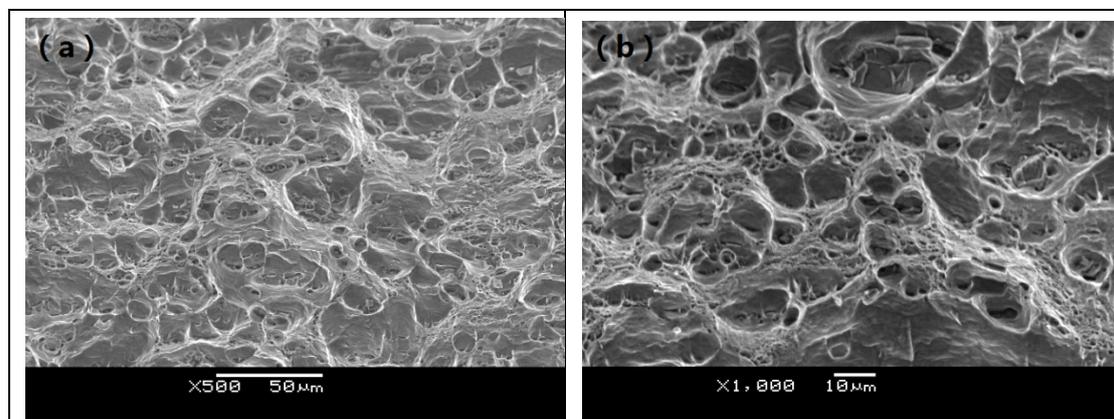
The fracture of the tensile specimen under the optimum welding parameters occurred at the aluminium side of the weld. The bonding interface of copper and aluminium remained sound and the tensile strength was purely dependent on the aluminium material in the heat affected zone and thermo-mechanically affected zone. The fracture surface analysis was performed using JSM-5610LV5610LV scanning electron microscope. The SEM images with two different magnifications were shown in Figure 11. The fracture surface was characterized by a large number of dimples, which means the specimen experienced a ductile fracture. Dimples are traces left by micro-void coalescence during fracture. In general, the ductile fracture can be divided into three phases: micro-void nucleation, micro-void expansion and micro-void coalescence. When loaded with external force, the specimen exhibited plastic deformation and necking. It can also be seen that the dimples had different sizes (diameter and depth). The larger size indicated larger grains, larger precipitates and higher shear ductility [21].

Fig.11 SEM image of the tensile specimen of FSW test # 5

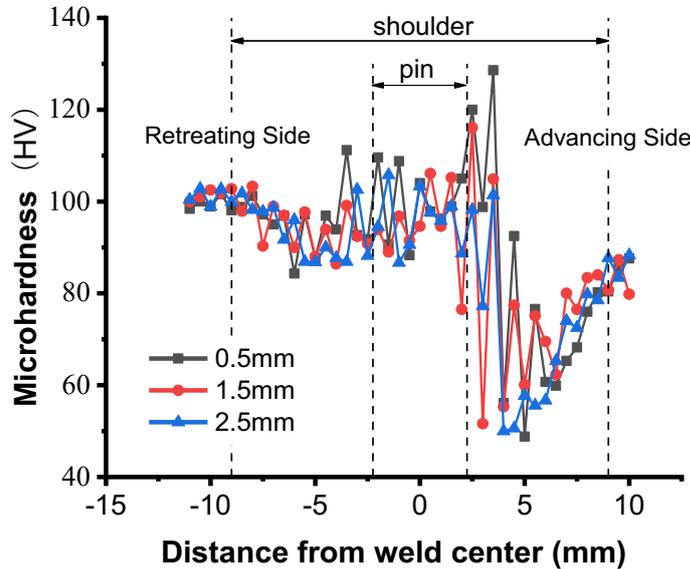
The micro-hardness of cross section for sample # 5 was measured at 135 points in three rows, illustrated in Figure 2. The distribution of hardness was plotted in Figure 12. It can be seen that the average hardness on the retreating side (copper plate) was much higher than that on the advancing side (aluminum plate). But in the nugget zone (-2.25 ~ 2.25 mm), the hardness was similar on both sides. The hardness was slightly higher than that of the copper side, mainly due to the strong plastic deformation of the grains. The material in the nugget zone had undergone a dynamic recrystallization process, and the grain size was refined, leading to the increase of hardness. The top row points gave higher hardness around pin region than the middle and bottom row points due to the intense friction and stirring by the tool. In the regions around -5 mm and 5 mm, the hardness dropped because the heat affected zone and the thermo-mechanically affected zone experienced the influence of thermal

cycling. The grain size was coarsened and the hardness decreased. Towards the parent material, the effect of thermal cycling declined, thus the hardness increased.

Figure 12 Micro-hardness distribution of Cu-Al welded joints
