# Identifying Defects in Aerospace Composite Sandwich Panels Using High-Definition Distributed Optical Fibre Sensors

**Abstract:** Automated methods for detecting defects within composite materials are highly desirable in the drive to increase throughput, optimise repair program effectiveness and reduce component replacement. Tap-testing has traditionally been used for detecting defects but does not provide quantitative measurements, requiring secondary techniques such as ultrasound to certify components. This paper reports on an evaluation of the use of a distributed temperature measurement system—high-definition fibre optic sensing (HD-FOS)—to identify and characterise crushed core and disbond defects in carbon fibre reinforced polymer (CFRP)-skin, aluminium-core, sandwich panels. The objective is to identify these defects in a sandwich panel by measuring the heat transfer through the panel thickness. A heater mat is used to rapidly increase the temperature of the panel with the HD-FOS sensor positioned on the top surface, measuring temperature. HD-FOS measurements are made using the Luna optical distributed sensor interrogator (ODISI) 9100 system comprising a sensor fabricated

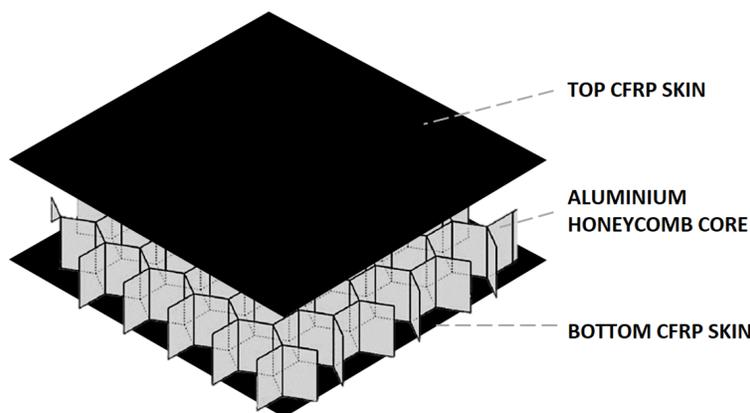
**Figure 1.** Structure of composite sandwich panel with two outer skins of carbon fibre reinforced polymer (CFRP) and inner core of aluminium honeycomb.

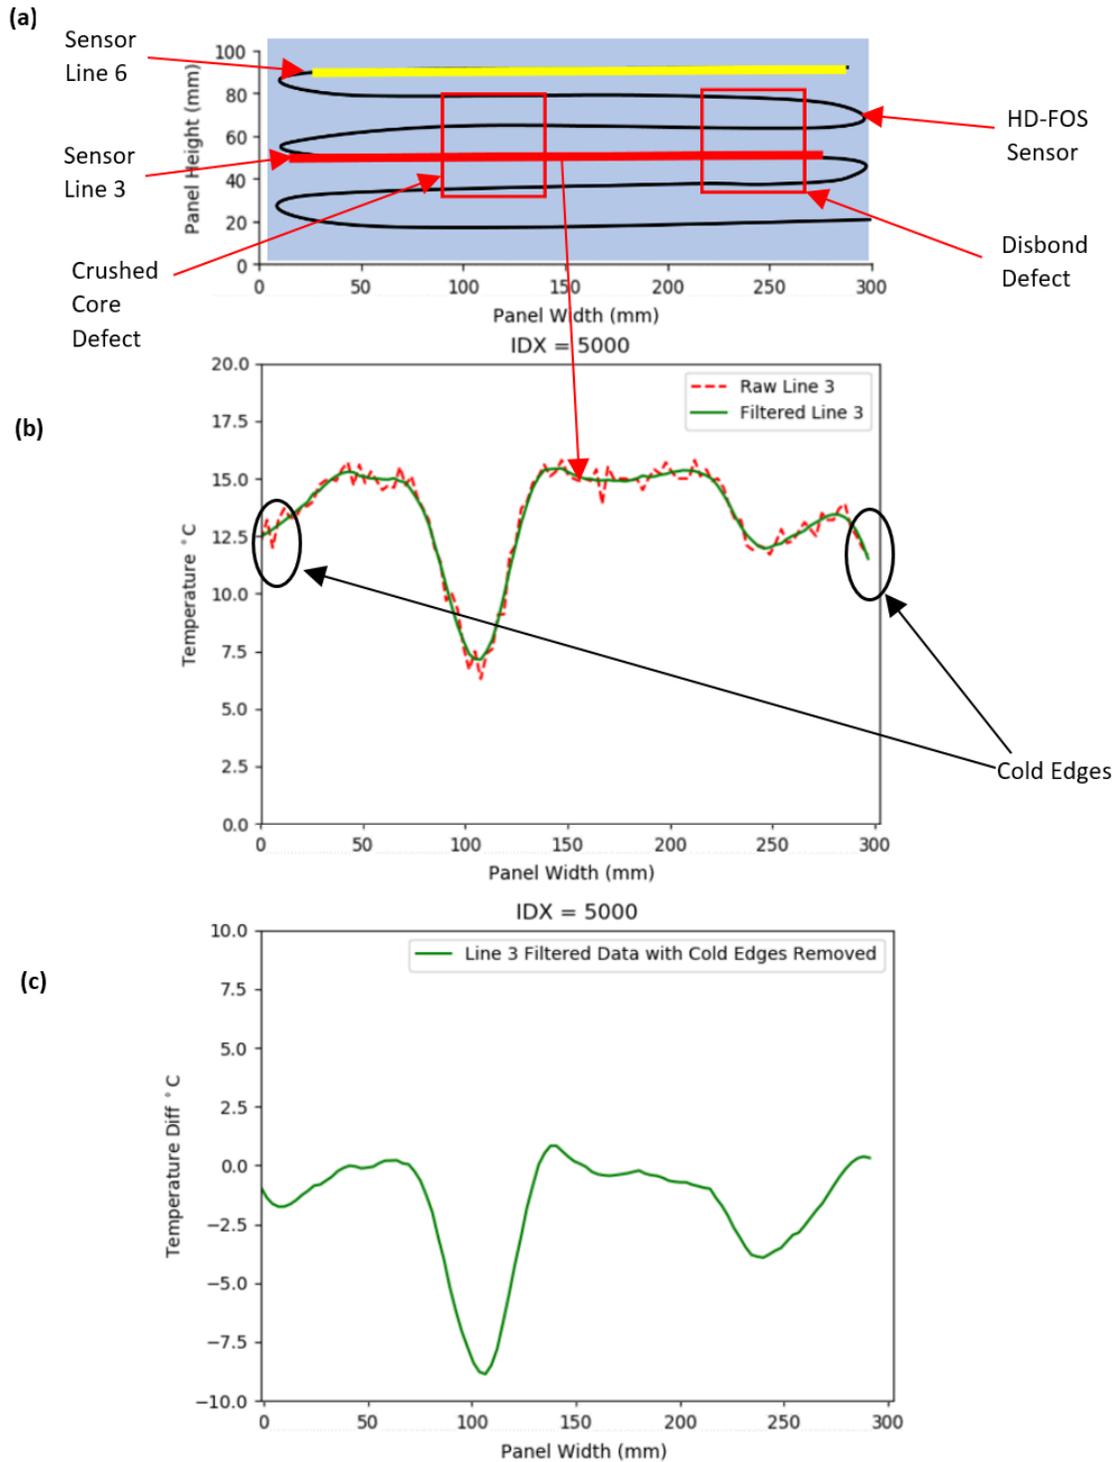
**Figure 5.** (a) Annotated segment of the composite sandwich panel top surface with defects and HD-FOS sensor shown. (b) Sensor Line 3 raw data and Savitzky–Golay filtered data comparison with cold edges highlighted. (c) Sensor Line 3 Savitzky–Golay filtered data with cold edges removed.

Figure 5b shows the raw measurement data from Sensor Line 3, shown in Figure 5a. The data was filtered using a Savitzky–Golay Filter, with a window length of 15 and a degree-3 polynomial, to smooth noise, selected as it provides excellent performance without loss of key data features, e.g., peaks and troughs, when compared with moving average filtering [41]. An example of the output of the filtering is shown in Figure 5b. The IDX (index) value represents the data set number, out of the total 73,018 data sets collected. A value of 5000 equates to 3 min and 20 s after the heater mat was turned on.

As a result of convection, the “cold” edges of the panel were more prominent than expected, potentially masking defects on the colour-mapping of the component. Thus, the uppermost sensor output (unaffected by defects), shown as “Sensor Line 6”, was used as a datum from which the temperature differences of the other five sensors were recorded. As shown in Figure 5c, the methodology successfully removed the cold edges from the data.

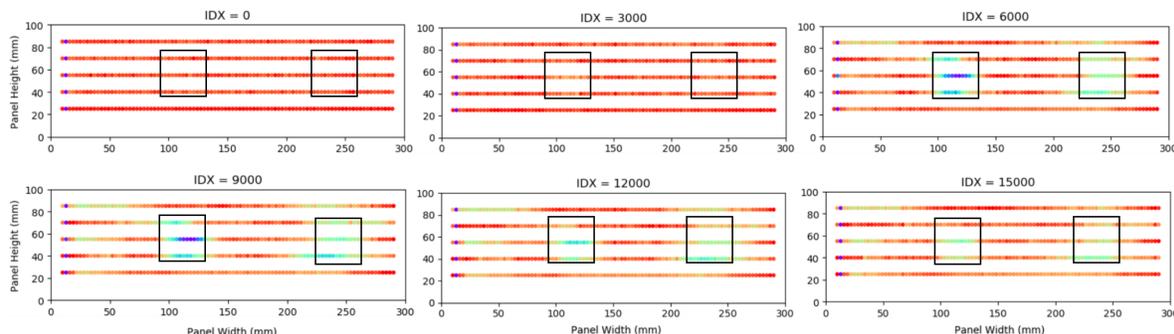
**Figure 7.** Colourmap graph series showing the temperature differences of Sensor Lines 1–5 from Sensor Line 6 (datum) indicating defect locations. Defect locations have been superimposed onto the graphs.

Figure 7 depicts the data on a colour map, highlighting the locations of the defects. The lengths and approximate widths of the crushed core and disbond defects were estimated from the data. The crushed core has a length of 39 mm and width of approximately 26 mm; the disbond has a length of 54 mm and an approximate width of 39 mm. The PTFE inserts used for the disbond were  $38.1 \times 38.1$  mm and the crushed core area was approximately  $38.1 \times 38.1$  mm. The derived area of the crushed core is accurate;

however the disbond defect area is larger than expected, attributed to slippage between the PTFE inserts resulting in a larger thermographic silhouette.
