1 **Microseismic monitoring illuminates phases of slope failure in soft soils**

2
3 **G. Yfantis¹, S. Pytharouli¹, R.J. Lunn¹ and H.E.M. Carvajal²**

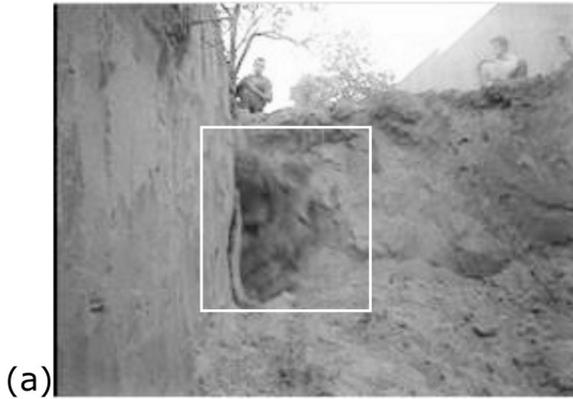
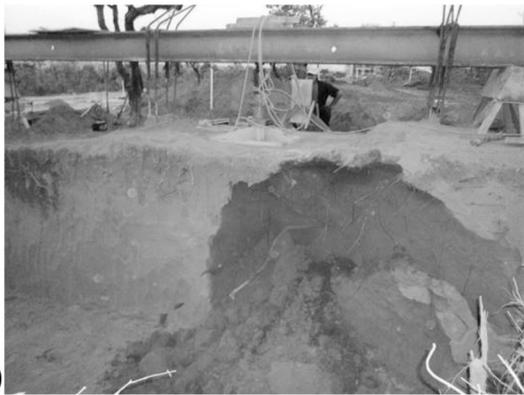
Figure 4: Soil block topple and fall: After cracking, a volume of soil was detached from the vertical face. This type of failure involved soil blocks (a) toppling (area highlighted within the square) and, (b) falling on the ground surface. For scale, the full depth of the excavation is 2.5m and the photo in (a) was taken looking towards the south face of the excavation, while the photo in (b) looking towards the North-East direction.

265 (2) Topple and Fall type failure: this involves soil block toppling and falling (Figure
266 4) as well as shear within the soil mass, occurring immediately after cracks were fully formed
267 on VF1. The cracks encircled the area where a topple and fall failure subsequently took place
268 as the vertical displacement kept increasing. The cohesion of the soil was retained after the
269 detachment of the soil volume from VF1, with the soil mass forming soil blocks that initially
270 toppled before reaching the ground. This failure type occurred twice during the full duration
271 of the experiment and resulted in the largest failed soil volumes, estimated between 1.8 m³
272 and 2.5 m³, based on the dimensions of the failed soil mass.

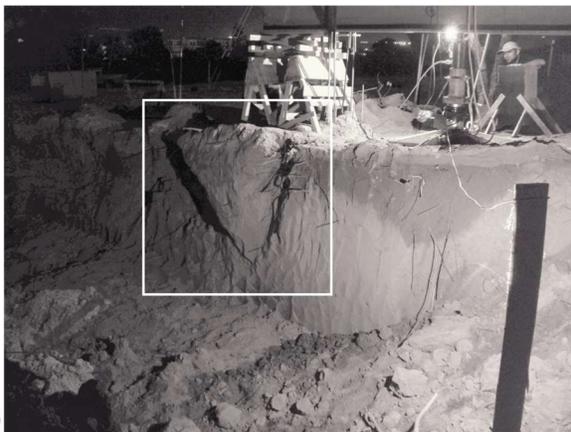
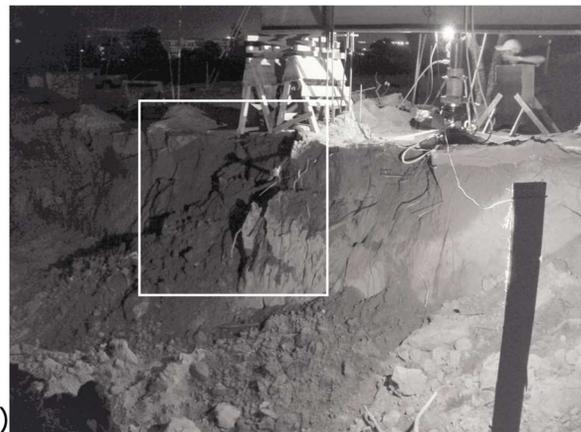
Figure 5. Photos of a Soil Block Fall during loading of VF2 (a) before, and (b) after failure. The white box indicates the soil block that fell inside the excavation. This event was the biggest observed for this type of failure. For scale, the full depth of the excavation is 2.5m and the photos were taken looking towards the North-East direction.

273 (3) Soil Block Fall type failure (without toppling): This was the most common failure
274 type observed during the field experiment. It involved having parts of both Vertical Faces
275 (VF1 & VF2) falling inside the excavation (Figure 5).

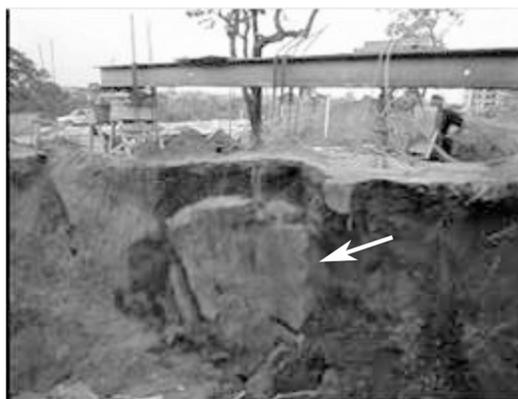
350 **Figure 7.** VF1 as seen from a North-East direction during the second soil block topple and
351 fall event (left side of the loading mechanism). An arrow indicates the failing block. For scale,
352 the full depth of the excavation is 2.5m and the photo was taken looking towards the North-
353 East direction.

337 before any failure events on the left side of the loading mechanism is shown in Figures 3a-b
338 and 3f. After these two failures, no further cracks could be visually observed due to poor light
339 conditions. Figure 7 shows the second full failure for VF1 occurring on the left side of the
340 loading mechanism. Other smaller in scale failure events followed; these were formed at
341 least 1m above the foot of the face propagating upwards towards the face's crown.
