Environmental Influences on Wellbeing within the Hospice

Evaluation of The Prince & Princess of Wales Hospice at Carlton Place

Executive Summary
Joanne Kinloch
29th February 2020

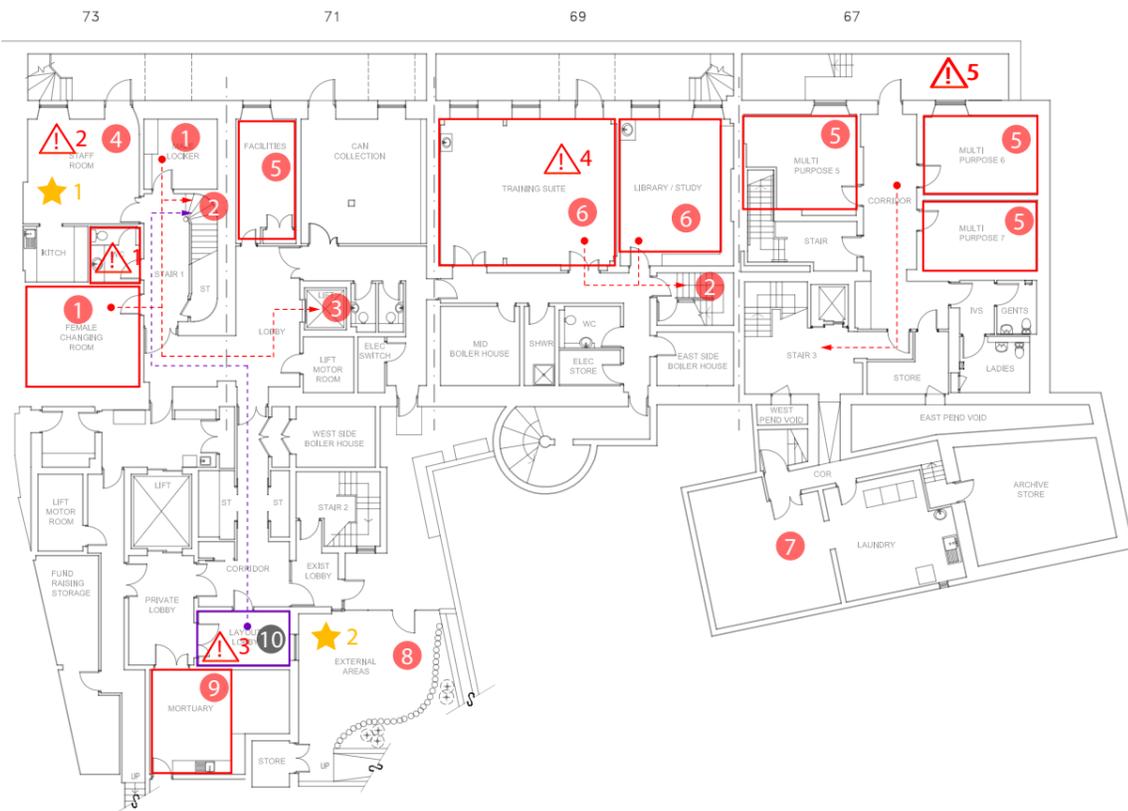
Basement Floor Plan

Issues

- ⚠️ 1 Broken staff shower
- ⚠️ 2 Staff room too far from IPU, poor views and dark
- ⚠️ 3 Layout room was 'back of house' and not a nice route for families
- ⚠️ 4 The two meeting room were often booked
- ⚠️ 5 Bars on windows of office and view of wall

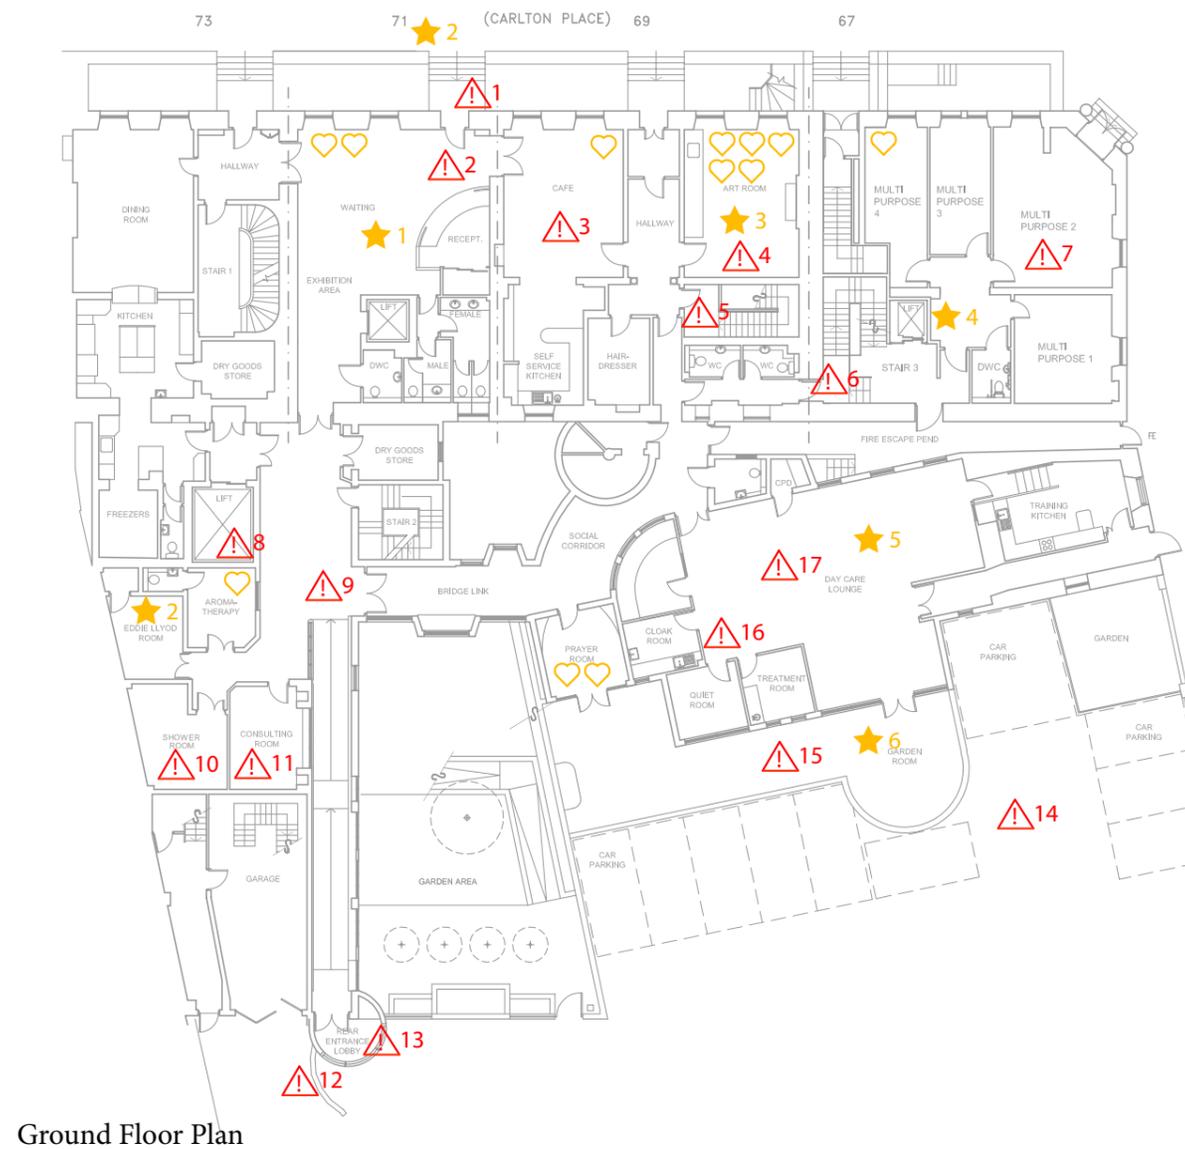
Figure 2.3. Ground floor plan showing issues and positives

Issues

- ⚠️ 1 Front entrance: not accessible
- ⚠️ 2 Reception: can be congested at the desk, due to sign in process and loud
- ⚠️ 3 Private conversation could take place in cafe, where there was no privacy.

- ⚠️ 4 Art Room: limited space for accessibility
- ⚠️ 5 Appearance of route to meeting rooms wasn't great
- ⚠️ 6 Staff w/c: located off the ward and issues with tight corridor/doors

- ⚠️ 7 Butterfly Room: decor not suitable for demographic
- ⚠️ 8 Large bed lift: takes patient straight up to the ward - can be disorientating
- ⚠️ 9 Rear ramp: although accessible very long and not same positive experience as front entrance

- ⚠️ 10 Large patient shower room: takes staff off ward
- ⚠️ 11 Isolated location of consulting room
- ⚠️ 12 Visibility of ambulances and undertakers
- ⚠️ 13 Pressing access buzzer can be difficult for those with limited dexterity

- ⚠️ 14 Poor access to parking
- ⚠️ 15 Accessibility restrictions within garden patio
- ⚠️ 16 Noise transfer between rooms within day lounge, which can impact on people who are distressed or having upsetting conversations

- ⚠️ 17 Old-fashioned appearance of day lounge and patterned carpet

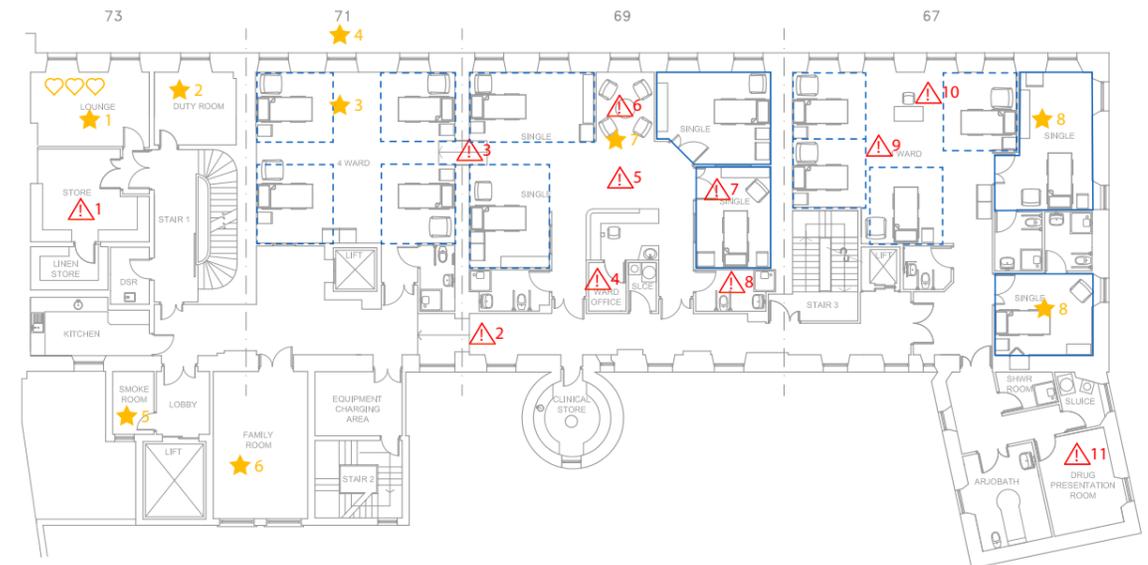
Figure 2.5. First floor plan showing issues and positives

Issues

- 1 Large Store: away from ward
- 2 Narrow corridors in certain areas
- 3 Small ramp between ward sections
- 4 Ward office: small and one computer
- 5 Inconsistent ward temperature and high noise levels on ward at night
- 6 Seating area: used for handover
- 7 Single room: has no windows
- 8 Shower room: used for storage
- 9 Limited space for overnight visitors within the ward
- 10 Nurse station: distracting and no privacy
- 11 Drug room: disconnected from ward

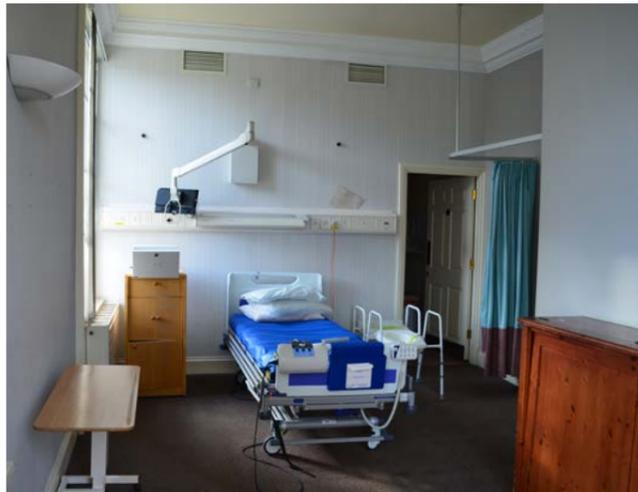
Figure 4.1. Photo of a single room within ward 2

- Staff commented that patients and families would be more candid within the single rooms, as they created the ideal environment for carrying out private conversations (see Figure 4.1): *I think you're able to ask a bit more about sensitive stuff and patients are maybe a bit more open...because obviously the one thing about curtains is they are not soundproof.* This could allow patients more freedom to express themselves, and establish more trusting and supportive relationships with staff.

- The ward areas did not lend themselves to privacy and sometimes patients overheard confidential conversations because staff did not have a private space near the ward to do handovers or discuss notes (see Figure 4.1): *'I think in the morning is important [to have space for private conversation], when you're doing the handover, because we are sitting at the desk and you've got family members and patients in a close proximity to where we do the handover. And we need to discuss every single patient.'* The questionnaire data corroborates these comments with 33% of patients felt they 'sometimes' overheard private information that wasn't related to themselves (See Graph 4.5).

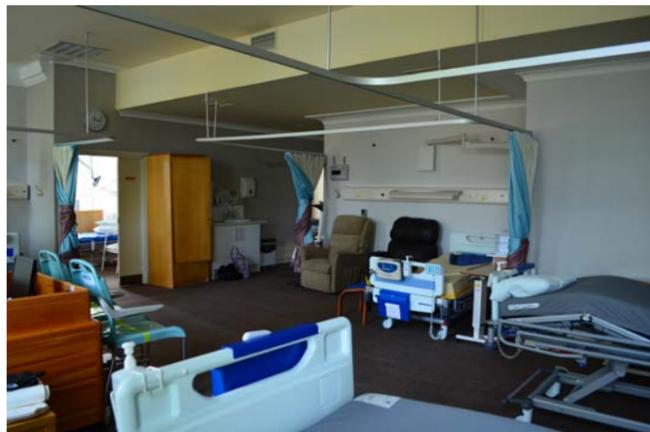
Figure 4.3. Photos of the open plan ward space

- If patients were in the ward for end of life care then staff commented that they could see this impact on the other patients and their families (see Figure 4.3). This could affect the atmosphere of the whole ward and does not offer privacy or dignity to the patient or family. One staff member commenting on lack of privacy on the wards, *'I feel that sometimes visitors see too much and hear too much, but again this is just my opinion. I feel that if somebody is dying, their breathing changes, it's becomes*

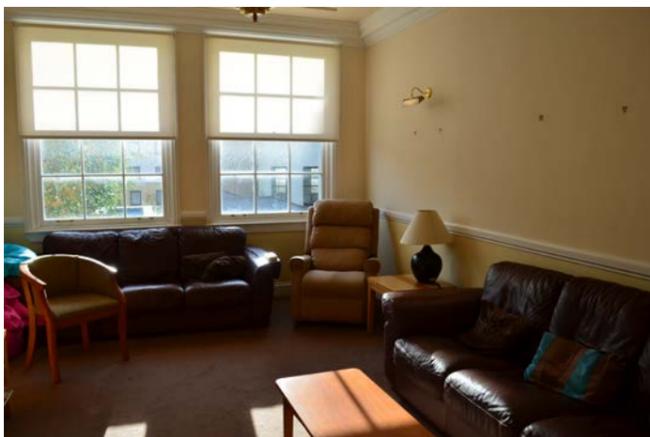
Figure 4.4. Photo of large family room within the IPU

- Sometimes family meetings were held within the family rooms, which was not ideal as they are open to everyone to use, which could interrupt discussions (see Figure 4.4).

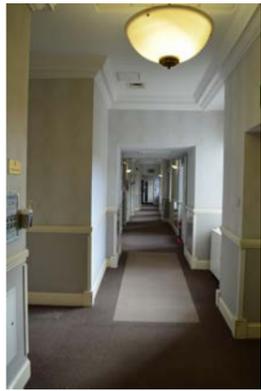
Figure 4.5. Photo showing the main corridor within the IPU, where patients would be taken along to access the wards from the large lift

- Within all of the departments there was not a private or secondary exit, which means that often patients or clients would have to be taken through public routes when they would rather have more privacy (see Figure 4.5).

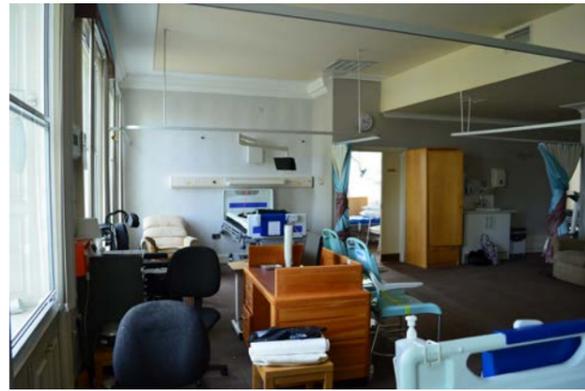
Figure 4.6. Photo of the nurse desk within ward 2, which was located within the centre of the bed areas

- The desk in the centre of ward two did not afford visual or auditory privacy (see Figure 4.6), which could be detrimental for staff writing notes or having confidential discussions: *'if you're on the computer and you're trying to do stuff and patients are talking to you or their relatives will come in and talk to you and interrupt you. Then equally if you're trying to speak to the nurse about somebody and you just can't do it there because there's just no privacy - it's very open and exposed.'*

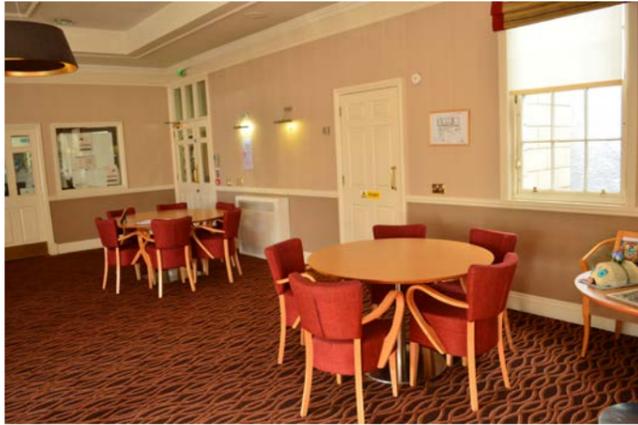
Figure 5.1. Day services showing the social space, which provides patients with an opportunity to engage with various activities

- There were no dedicated staff showering facilities, as the current shower was broken. This has deterred some staff from cycling to work, as the only other shower facility was shared with families and was not guaranteed to be available before the start of their shift. Staff had expressed a desire to run multiple activities at once within the day services lounge; however due to the open-plan layout that was not possible (see Figure 5.1).

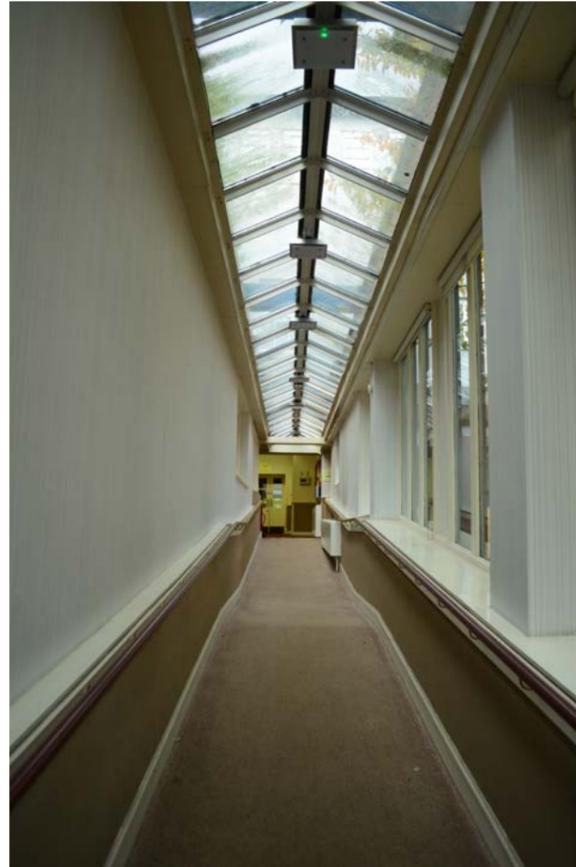
Figure 5.5. Photo showing the rear entrance ramp

- The front entrance was not obvious or accessible, and often people had difficulty getting to the rear entrance by car, due to the one-way roads. Staff mentioned that this could be a cause of stress, especially as this was the first visit and people might already be apprehensive.
- When people were using the rear entrance, the reception could be difficult to locate due to inadequate signage and the fact that the most obvious route is through an open corridor with no doors, which led round to day services (see Figure 5.4). There was normally two people on reception and one would go round to greet people at the top of the rear entrance ramp; however this was difficult when only one person was on reception, where reaching the top of the ramp could cause some disorientation and could result in not everyone having the same experience of being greeted right away (see Figure 5.5).

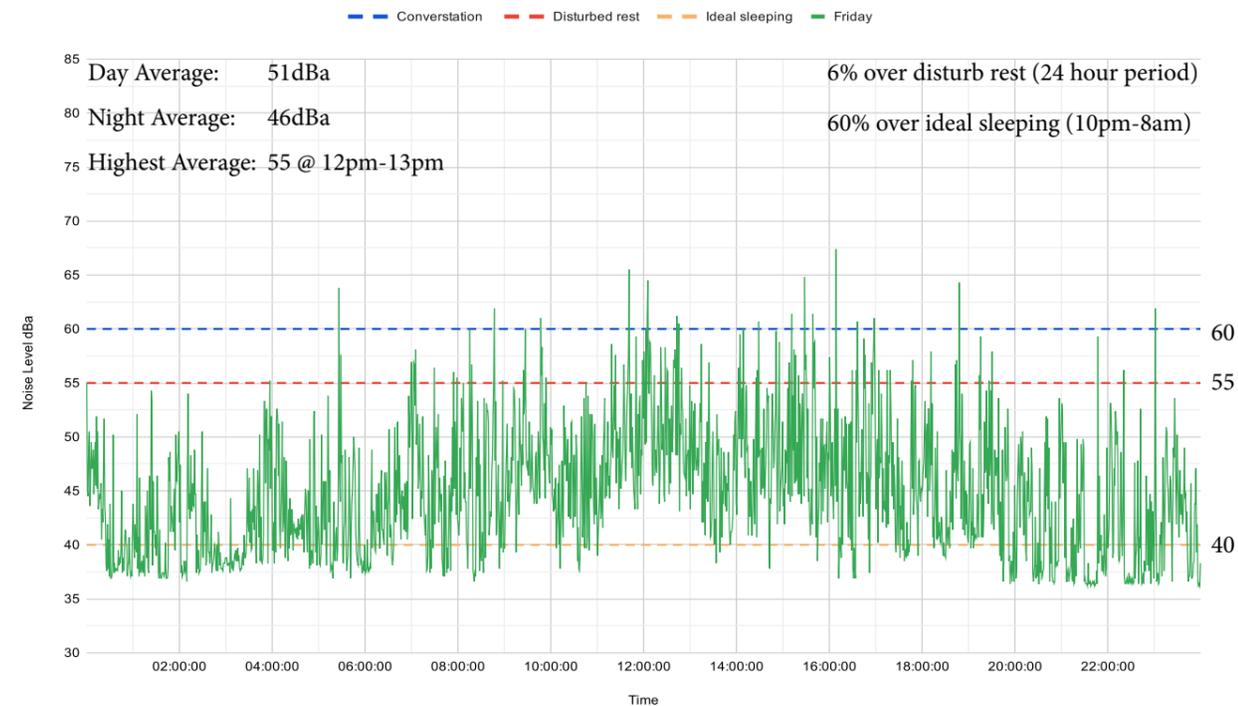
Figure 6.1. Graph showing noise measurements within the ward over a 24hr period

- The single rooms were more effective than the ward areas at keeping an average noise level below the ideal sleeping condition range of 55dBa, making them less disruptive for sleep (see Figure 6.1).
- In terms of the level of noise, 83% of patients felt that the noise level was 'just right' and 48% of staff felt the same (See Graph 6.1 & 6.2).
- Patients felt that 83% and staff and volunteers felt that 71% of the time they were 'rarely' or 'never' bothered by noise. Although 8% of staff and volunteers felt that they were 'often' bothered by noise (See Graph 6.3 & 6.4), which could impact on stress levels. It was positive that 67% of patients felt they 'never' had a hard time hearing or understanding comments due to the noise levels (See Graph 6.6).

- Between 10am and 8pm, the ward noise levels reached beyond ideal sleeping conditions 60% of the time; the frequency for single rooms was 34%, meaning it was at the range that causes sleep to be disturbed, which could significantly impact on patients' rest (see Figure 6.1).

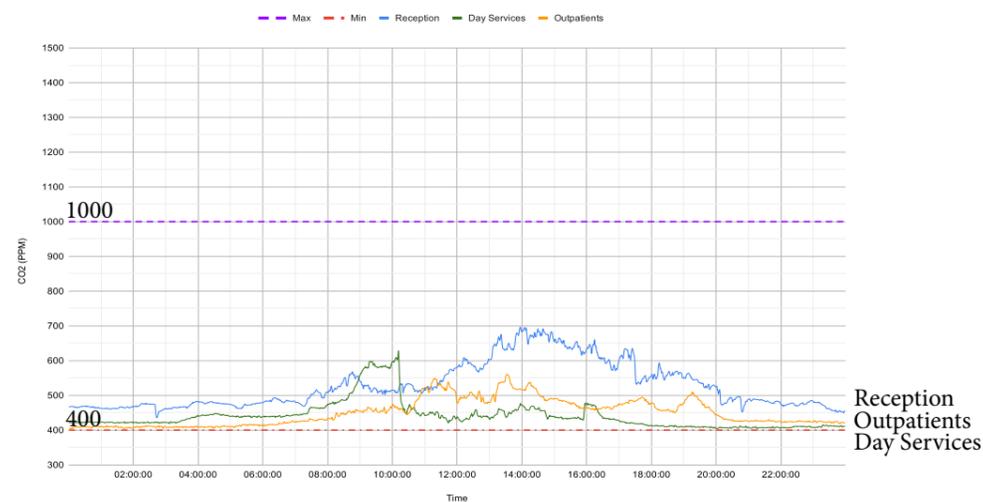
Figure 7.5. Graph showing CO2 levels measured in patients spaces within the building over a 24hr period

- Measured levels of relative humidity and CO2 fell within the standard range of acceptable levels for most areas, see Figures 23 and 24 for a sample of results.

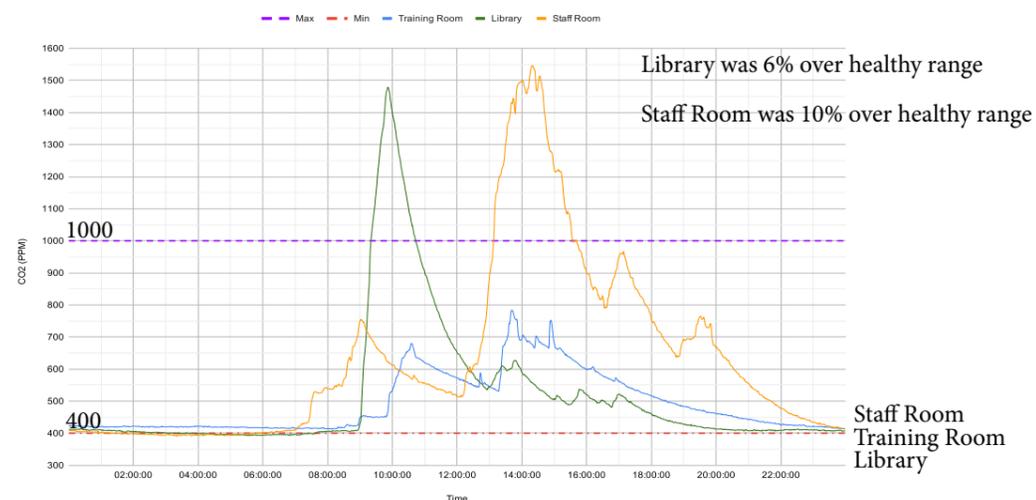
Figure 7.6. Graph showing CO2 levels measured in staff spaces within the building over a 24hr period

- Measured levels of CO2 were shown to reach over the healthy upward limit of 1000 6% of the 24hr period within the library and 10% within the Staff Room, see Figures 7.6. This indicated a poor ventilation rate for the number of people or type of activity within the rooms and as they are situated below ground level than this could also reduce the amount of air circulating. Reaching beyond 1000ppm could lead to drowsiness and reduced concentration.

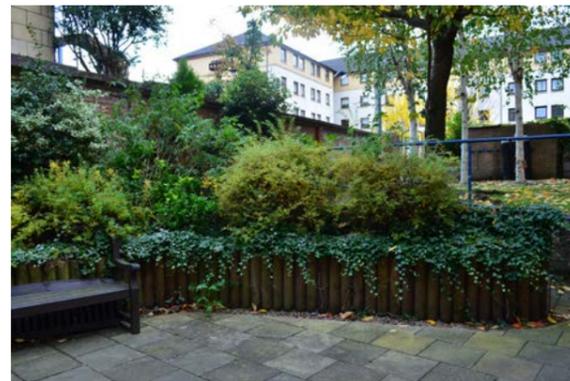
Figure 8.4. Photo of the garden area that staff could access from the basement

- Some staff mentioned an outside area that was accessed from the basement (see Figure 8.4), where they would sit alone or with colleagues during their breaks: *'we would put some benches out there and staff would maybe sit out there, maybe take their packed lunch out there and sit out there or in really good weather and there was no day patients I would maybe sit out in the garden space with a packed lunch... but I don't think everybody knew about that space.'*

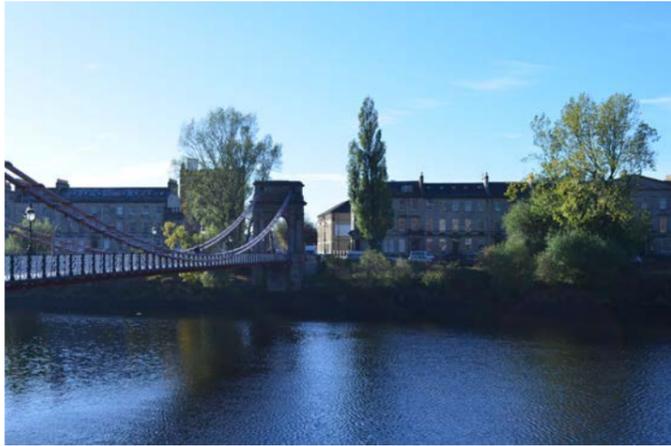
Figure 8.5. Photo of the areas outside of the hospice, on the other side of the river

- Some of the staff mentioned that they like to get out the building at lunch time and they had the opportunity to do so (see Figure 8.5): *'I quite like to go into town and things on my lunch or go out for a walk just around the block or whatever to get some fresh air and I sometimes think if you sit in the dining room you can get completely caught and then it takes away your opportunity to go out and get fresh air so that's why I go down to the staff room. I can just eat quickly, take whatever it is back up and then I can get out.'*

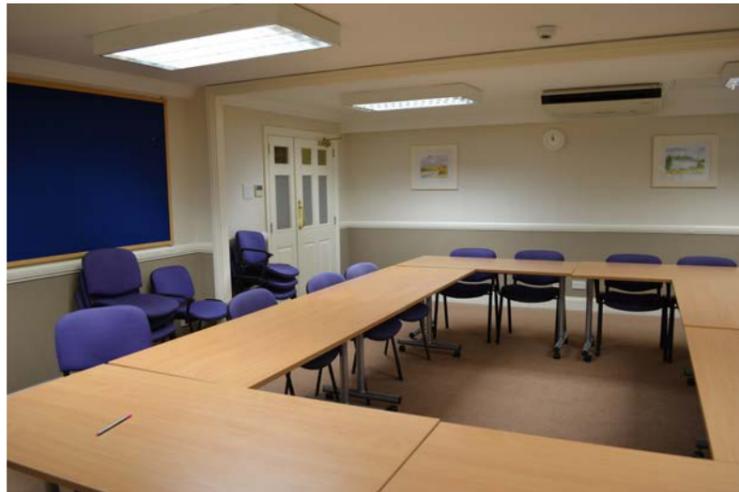
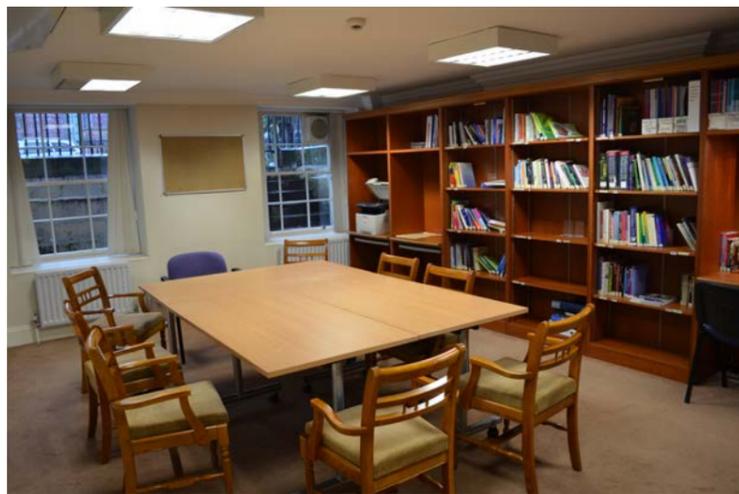
Figure 9.10. Photos of the training room

Figure 9.11. Photos of the library meeting room

- The location of the consulting room could feel isolating for the staff, potentially leaving them feeling vulnerable and unsafe in that space.
- There was a lack of meeting rooms, with the only two being the training room and the library, with staff often finding it difficult to get a booking. The route to reach them was not practical or visually effective for external visitors, as it was through the public café and then into a dark and narrow corridor to the basement (see Figure 9.10 & 9.11).

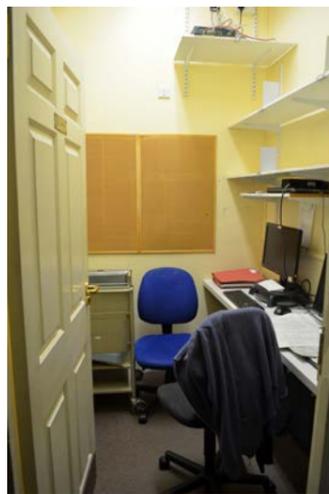
Figure 9.12. Photo of office within ward 1, located behind the nurse's station.

- Access to the computer within inpatient unit could be difficult as it was not always available and this was further impeded by the tight office space, meaning only one person could be in there at the one time (see Figure 9.12). Someone commented, *'if you need to get on [a computer] now, to access patient records, and then you can't get on it, and you have to wait, and that obviously interferes with providing care as well'*.
