Investigation on characteristics of tensile damage and microstructure evolution of steel AISI 316L by nonlinear ultrasonic Lamb wave

Abstract: In view of the high sensitivity to microstructure evolution of higher harmonics generated by the nonlinear ultrasonic method, the tensile damage in the stainless steel AISI 316L was evaluated by nonlinear ultrasonic Lamb wave. The effect of different degree of tensile deformation on nonlinear ultrasonic response in 316L was analyzed by considering the microstructure evolution and the test results. First, the power-law relation of nonlinear ultrasonic parameter and plastic strain is proposed. Meanwhile, martensitic transformation and the increasing of dislocation density can be observed in the micrographs of specimens with the increase of plastic deformation. Then, the same variation tendency of intergranularly averaged Kernel Average Misorientation (KAM), as well as the relative nonlinear ultrasonic parameter, demonstrated that the nonlinearity due to tensile damage is controlled by the evolution of microstructure that directly affects higher order elastic constant of stainless steel 316L. Furthermore, based on continuous damage mechanics,

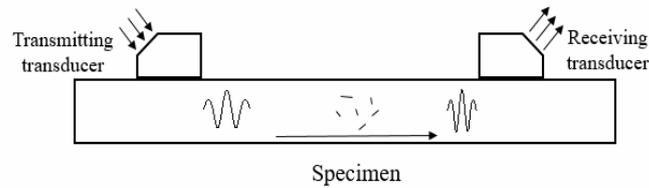
Figure 1. High-order harmonic generation

There are many studies suggest that nonlinear ultrasonic technique has high sensitivity to the early microstructure evolution around the internal damage of metal components [10, 11]. The early damage of metallic materials is mainly due to the microstructure evolution at micro/nano scale, such as slip line enrichment, dislocation initiation and proliferation, cavity nucleation and growth at grain boundaries[12], etc. When the high-intensity ultrasonic wave input into the specimen and interacts with internal micro defects, the displacement and stress-strain relationship of the particle at the defect will change, resulting in the distortion of the ultrasonic waveform and the generation of high-order harmonic signals [10]. The detection mechanism and the generation of high-order harmonic are shown in Figure 1. Thus, the wave distortion has been considered for evaluating the microscopic damage since the value of the distortion intensity was depended on the variation of microstructure. The quantitative measurement of this wave distortion is given by nonlinear ultrasonic parameter β [13], as shown in Eq.(1

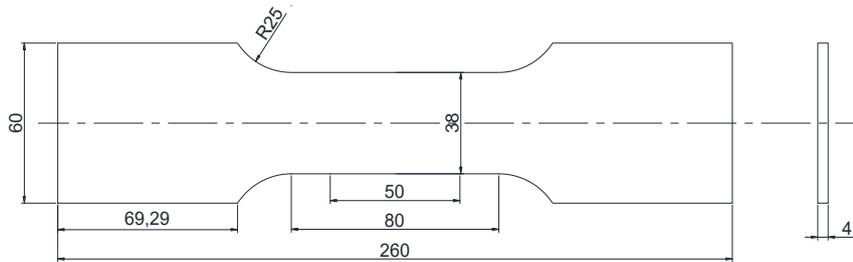
Figure 2. Dimension of flat dog-bone specimen (all dimensions are in mm .

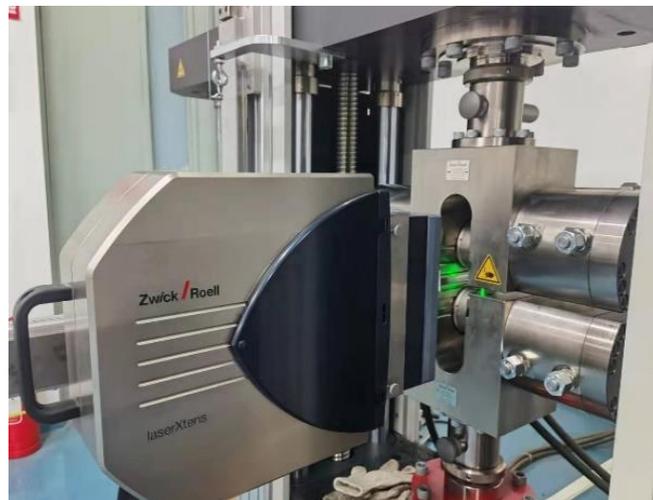
Figure 3. The experimental equipment used in this study (ZwickRoell-Z250

As shown in Figure 3, all tensile tests were performed on the ZwickRoell-Z250 with tensile rate of 1 mm/min. The monotonic tensile test for obtaining the mechanical property of the experimental materials and cyclic loading tensile tests (with 10 cycles and total strain of 50% for obtaining the damage variable of the material during the deformation) were carried out. The tensile curves are shown in Figure 4, which can be seen the yield strength and tensile strength of the material were 271.3 MPa and 605.27 MPa, respectively. There is little difference between the material properties obtained by single tensile and cyclic tensile tests, so the subsequent analysis can match the damage degree of the cyclic tensile test with the sample under the same tensile degree.

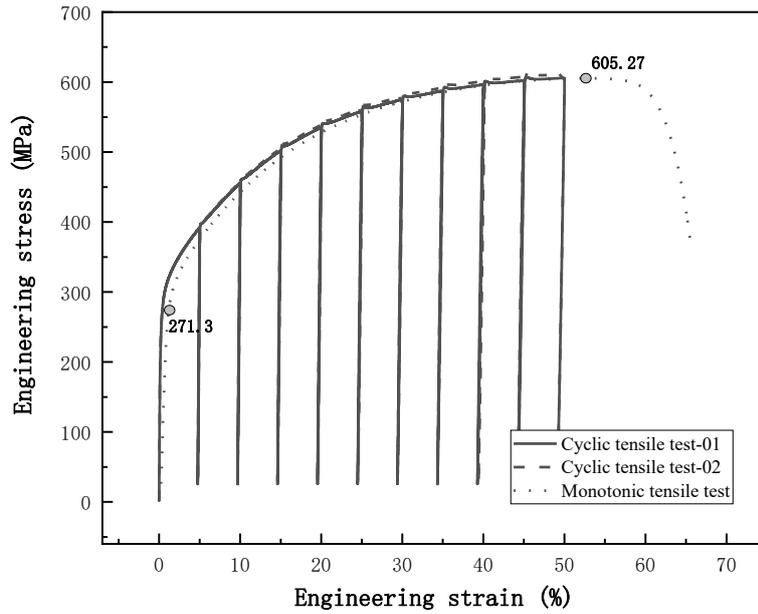
Figure 4. The stress-strain rupture curves and cyclic tensile curves of 316L

For producing the tensile damage of different degrees, the interval tensile strain is divided into 7 times according to the strain value corresponding to tensile strength (5%-10%-15%-20%-25%-30%-40% . After each tensile test, the specimen shall be subjected to nonlinear ultrasonic test. Then, considering the effect of residual strain, the tensile test shall be carried out to the next strain value on the specimen. The necking stage is not considered in strain division, this is because only the relation between early damage caused by plastic deformation and nonlinear ultrasonic wave is studied in this paper.

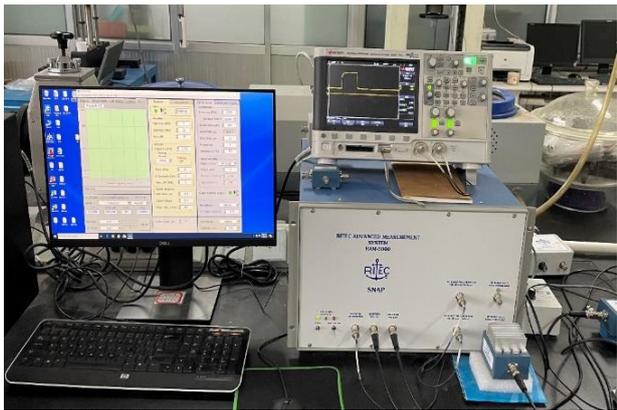
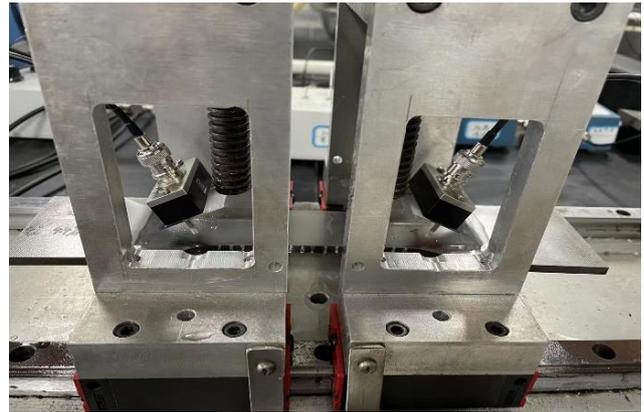
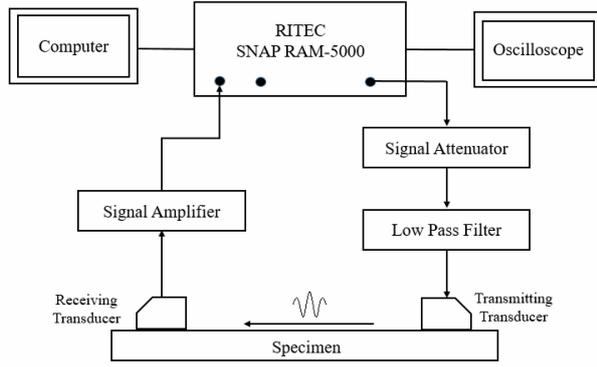
Figure 5. (a) RITEC SNAP RAM-5000 high power ultrasonic system (b) Fixed device of the nonlinear ultrasonic testing (c) Frame diagram of the Lamb wave-based nonlinear ultrasonic testing system

Figure 5(a and 5(c) show the RITEC SNAP RAM-5000 high power ultrasonic system and the frame diagram of the Lamb wave-based nonlinear ultrasonic testing system. The system outputs a high-voltage tone burst signal of 20 cycles at the excitation frequency of 2.25 MPz, while a center frequency of 2.25 MHz piezoelectric transducer (Olympus V403) was used as the transmitter. The 5MHz piezoelectric transducer (Olympus V405) acted as the receiver for obtaining the fundamental wave and second harmonic components. Glycerol was used for coupling between transducer and wedge, also wedge and specimen (the oblique angle of the wedge is 27° [21]), while using a customized fixed device (shown in Figure 5(b) to give a constant pressure on the wedge for each measurement.

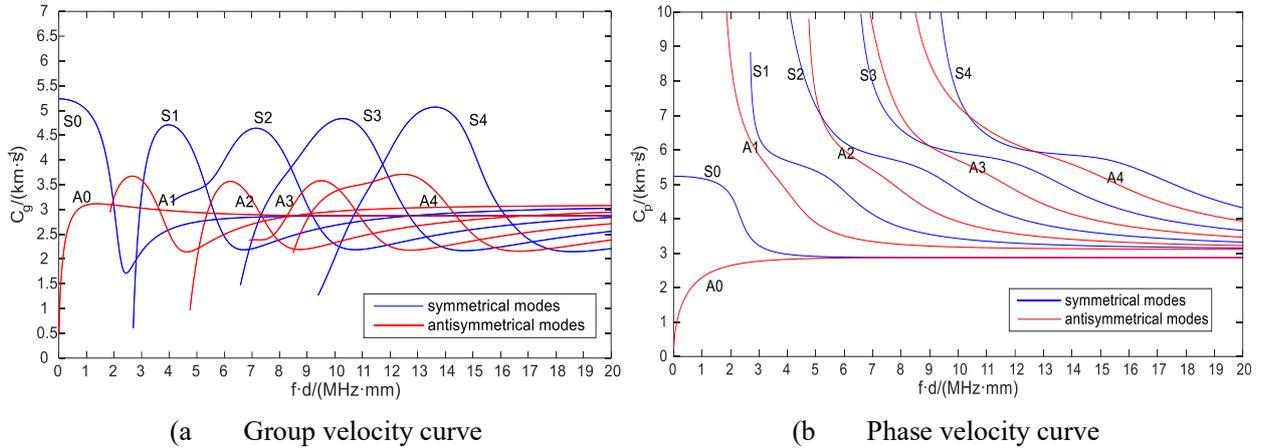
Figure 6. The dispersion curves of the 4mm thick 316L

The phase velocity and group velocity dispersion curves of Lamb waves for the 4 mm thick stainless steel 316L, drawn by MATLAB 2014b, are shown in Figure 6. In order to excite the second harmonic of the Lamb wave as well as to avoid the separation of the harmonic packet and the fundamental packet in the propagation process, the phase velocity and the group velocity of the selected mode pair need to be matched [22]. Thus, the synchronous S2-S4 mode pair have been selected for higher harmonic measurement in this study.

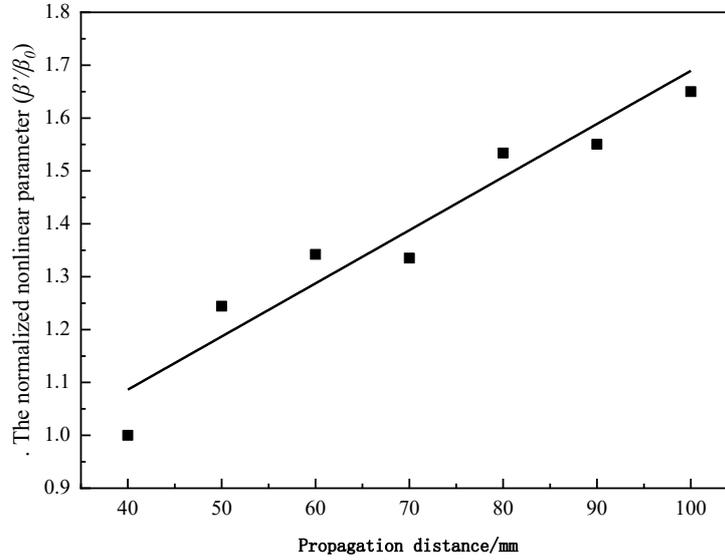
Figure 7. The relationship between the propagation distance and normalized nonlinear parameter

The normalized nonlinear parameter can be described as (β'/β_0) , where β_0 is the nonlinear parameter of the original specimen. The linear increase of the normalized nonlinear parameter with x is presented in Figure 7, which indicates the cumulative effect of second harmonic and confirms that the material nonlinearity dominates the instrumental nonlinearity in this testing. To avoid wave overlap caused by short test distance and ensure no abrupt structure in the test section, the initial test distance is set as 80 mm. The subsequent tests were carried out at the marked position. For the reliability of the experimental results, each experiment was repeated 5 times.

Finally, the time domain signal measured during the testing was digitally processed and subjected to fast Fourier transform (FFT) in order to obtain the amplitude of the fundamental frequency A_1 and second-harmonic frequency A_2 . The normalized nonlinear parameter (β'/β_0) can be calculated with the Eq. (2) and β_0 .

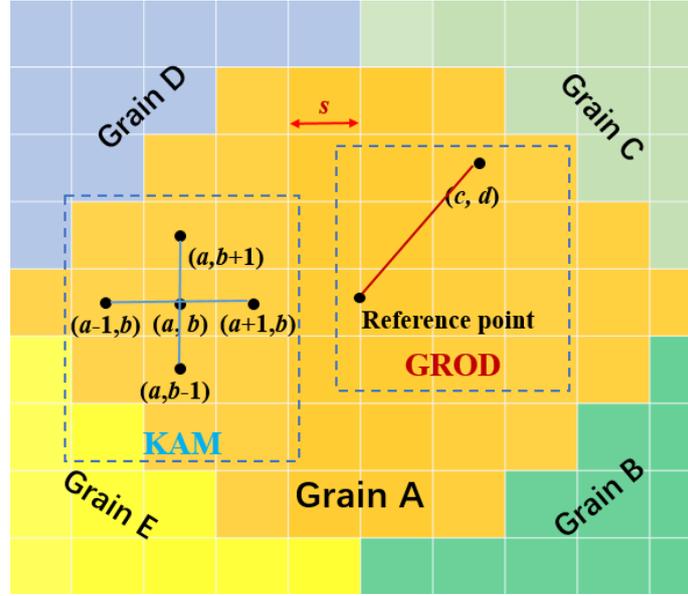
Figure 8. The definition of KAM and GROD [29].

Two types of important intragranular misorientation parameters, KAM (Kernel Averaged Misorientation) and GROD (Grain Reference Orientation Deviation), can be obtained by EBSD scan. KAM, defined as average misorientation between the measurement point and the surrounding adjacent points which belong to the same grain,

represents the orientation gradient at local points inside the grain. GROD is defined as the misorientation between the measurement point and its internal reference point of the grain and is used to characterize the degree of orientation inhomogeneity inside the grain. Figure 8, Eq. (4) and Eq. (5) show the definition of KAM and GROD which have been programmed into the post-processing software of EBSD and can be obtained directly [25]. The intragranular misorientation parameters have been widely used for grain distortion analysis and damage evaluation of the expiring metallic structural materials [26]. In addition, the intergranularly averaged KAM and GROD (i. e. $\overline{\text{KAM}}$ and $\overline{\text{GROD}}$, the average value of all grain in the observation area) are proved in some studies that they show a good linear correlation with the macro uniaxial plastic deformation [27, 28].

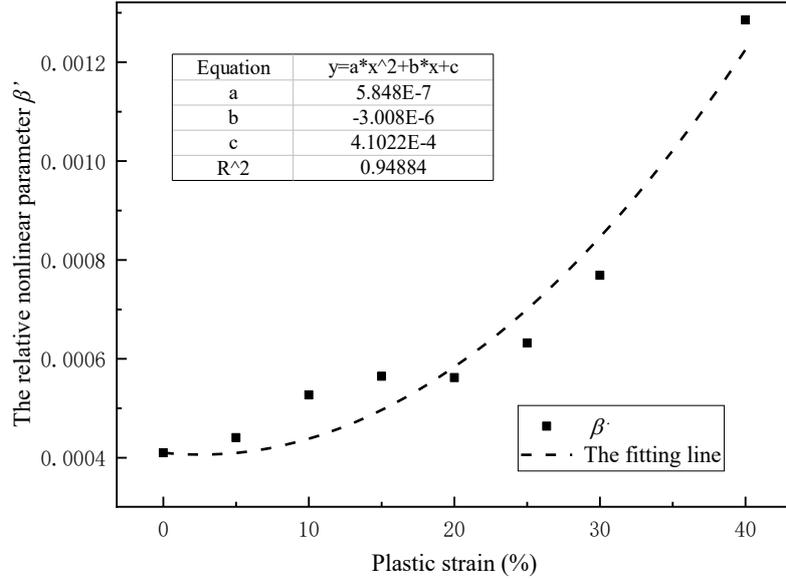
Figure 9. Variation of the relative nonlinear parameter β' with different plastic strain.

The variation of the average value of β' (five measurements per point) calculated by Eq.(2) with the plastic strain is plotted in Figure 9, which shows clearly that the relative nonlinear ultrasonic parameter increases with the increasing plastic strain. A power-law relation between β' and plastic strain obtained in this study, shown as the fitting line and the Eq.(6), is basically consistent with the result presented by Viswanath et al.[17] in studying the AISI 304 stainless steel. It is seen that initially up to 20% plastic strain there is a slow increase in relative nonlinear parameter β' but started increasing rapidly from 20%, the β' for the 316L specimen with 40% plastic strain is about 3.2 times of that for the initial specimen.

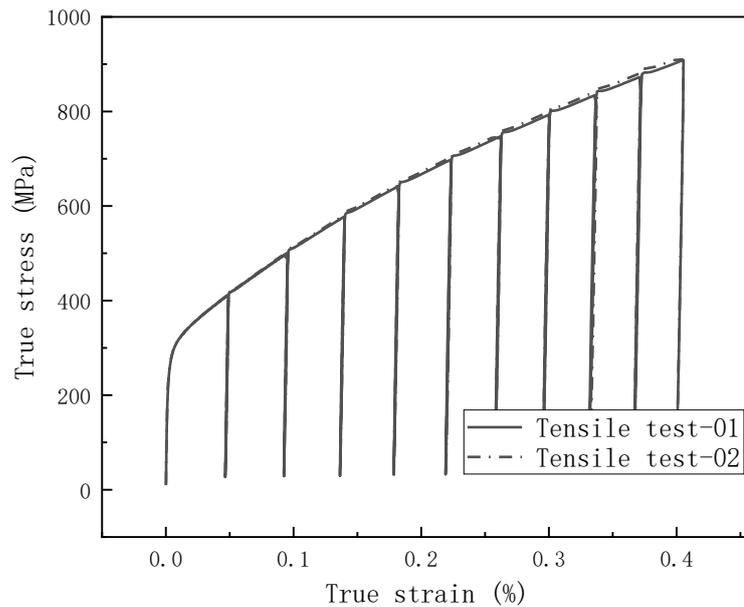
Figure 10 The true stress-strain curves of the 316L from 10 cyclic and unloading tensile test

The true stress-strain curves of 316L from 10 cyclic loading and unloading tensile test are shown in Figure 10. The yield strength of samples with different degrees of deformation can be obtained from the engineering stress-strain curves in Figure 4, while Young's modulus E can be calculated from the unloading section of true stress-strain curves of each tensile test ($E=\sigma/\varepsilon$, only the first 40% data of unloading section was used to avoid the effect of back stress relaxation [30] and take the average of the two experimental value as the result). With that, the damage variable D of 316L, which can be calculated by Eq.(7) [31], is listed in Table 2.

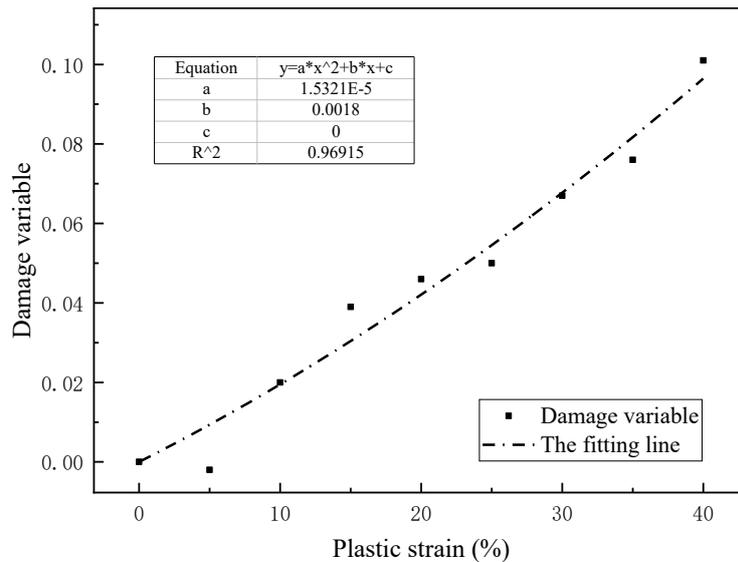
Figure 11. The variation of Young's modulus and damage variable with plastic strain

As shown in Figure 11, Young's modulus decreases with the increase of plastic strain while the corresponding damage variable increases. According to continuum damage mechanics(CDM) [34], the initiation and growth of voids and micro-cracks during tensile tests lead to the decrease of effective bearing area, and thus cause a reduction of effective elastic modulus. In the tensile process of 25%-40%, the change of damage variable is slightly larger than that of the first 20%. Therefore, the nonlinear equation was used to fit the relationship between damage variable D and plastic strain ε_p , and the fitting formula is shown in Eq.(8). Besides, it should be pointed out that the young's modulus of the original is less than the commonly known value for the 316L (about 190 GPa), which might be caused by the use of non-standard specimens.

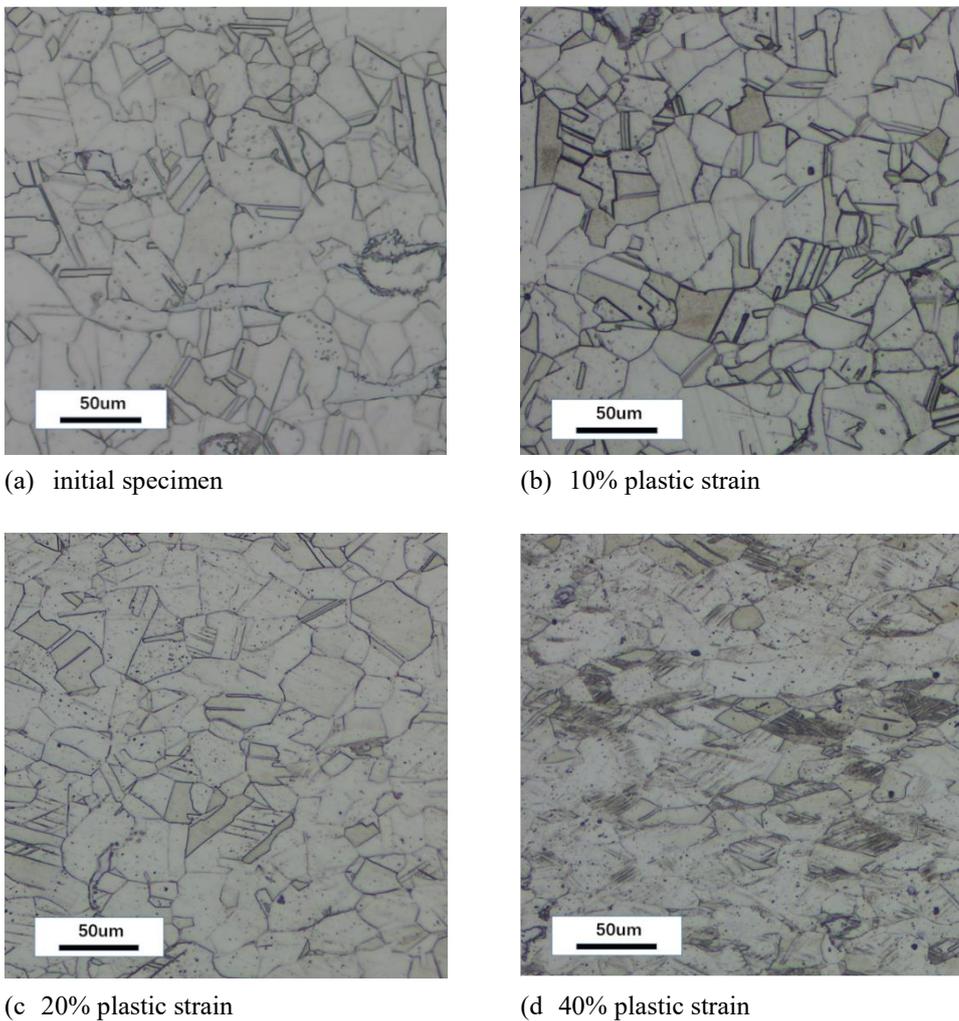
Figure 12. Metallographic observation of specimens with different plastic strains

From Table 2, the yield strength $\sigma_{0.2}$ of the material increases significantly with plastic strain. Combined with the metallographic observation shown in Figure 12, some changes in the microstructure of austenitic materials occur during the tensile process, which include the formation of martensitic phase transformation and the decreased grain particle size. It has been proved that lath martensite is a kind of high strength structure [32, 33]. The generation of phase transformation of the material changes the internal microstructure of grain and increases the resistance of dislocation movement, and then causes the yield strength of the specimen to increase continuously during plastic deformation with the grain refinement.

The metallographic observation, shown in Figure 12, indicates that the microstructure of the original specimen is austenite. From the sample with plastic deformation of 10%, it can be seen that the grain size is relatively small, and some grains are broken due to tensile action. In the sample with 20% plastic strain, it is observed that the grain is gradually elongated. Compared with the initial pattern, the grain size is significantly smaller, and the microstructure began to undergo phase transformation. As the deformation continues to increase, the degree of grain fragmentation

also increases. A large number of lath martensite structures can be obviously observed in the sample with plastic strain of 40%.

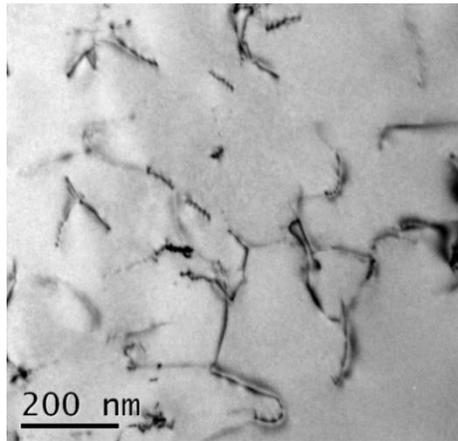
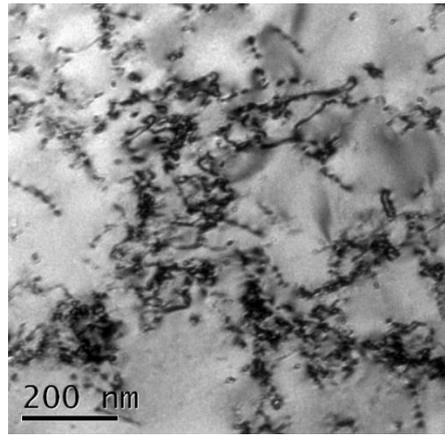
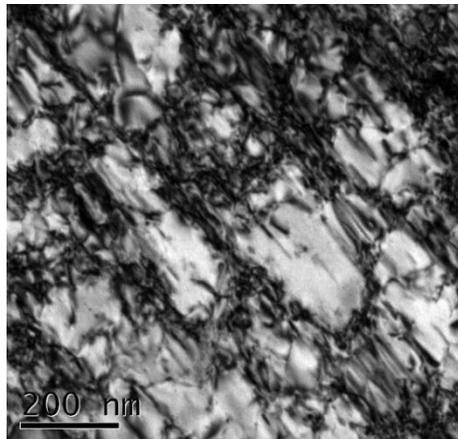
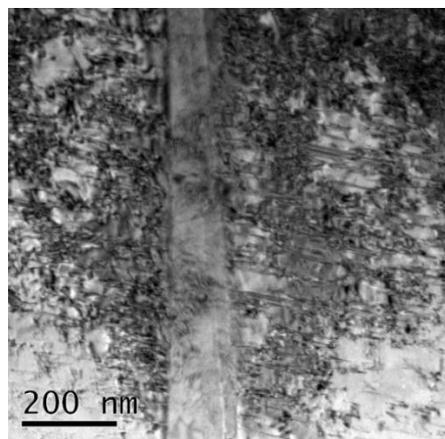
Figure 13. The TEM micrographs of 316L tensile specimens with different plastic strains: (a) 0%, (b) 10%, (c) 20%, (d)

The representative TEM micrographs of the specimens with different plastic strains have been shown in Figure 13 which describe the evolution of dislocations during the deformation. Figure 13(a) shows that only a few dislocation lines are scattered in the original specimen. The dislocation density is low, which is about $0.747 \times 10^{14} \text{m}^{-2}$ according to Eq.(3). As the plastic deformation increases to 10%, the dislocation lines in the sample increase significantly, and some complex dislocation configurations such as dislocation winding begin to appear. The dislocation density calculated with Figure 13(b) is about $1.78 \times 10^{14} \text{m}^{-2}$. For the specimens with 20% and 40% plastic strain, the winding of dislocation lines is more complex and gradually forms a cellular structure. The calculation method of dislocation density by TEM photos is no longer applicable considering the formed dislocation cells and shear band shown in Figure 13(c) and (d). Therefore, based on the rheological method, this paper takes the dislocation density of the original specimen and 10% plastic strain specimen as the reference, and uses the flow stress formula (Eq.(10) to calculate the dislocation density ρ of the samples with 20% and 40% plastic strain. The calculation results are $3.11 \times 10^{14} \text{m}^{-2}$ and $4.58 \times 10^{14} \text{m}^{-2}$, respectively.

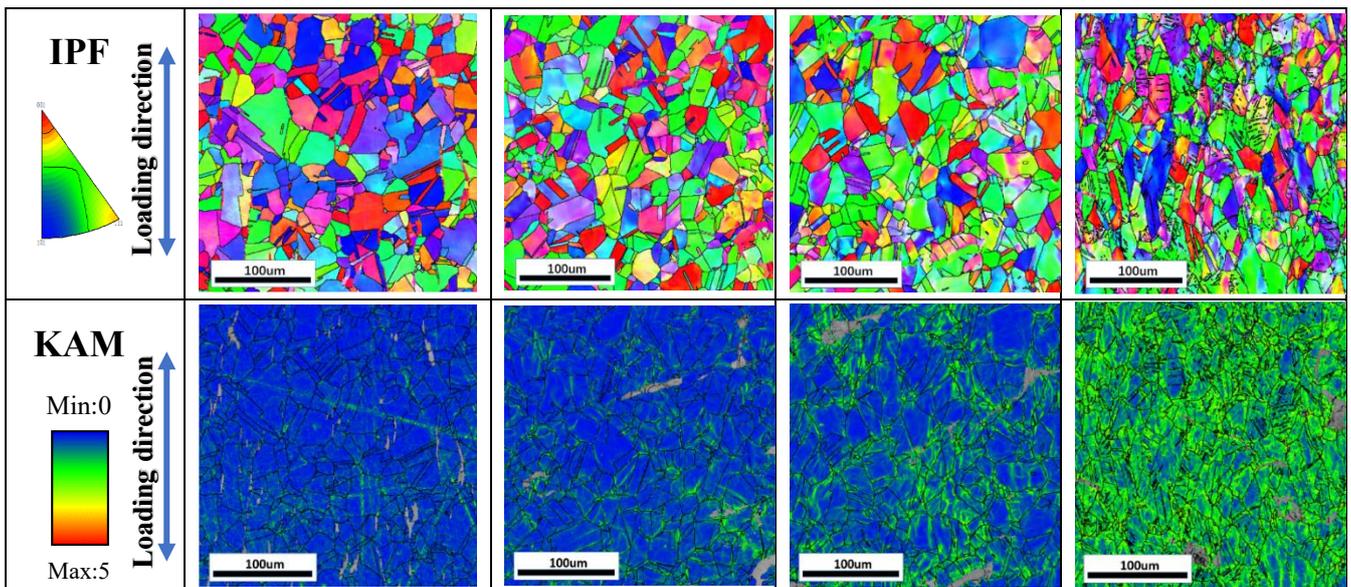
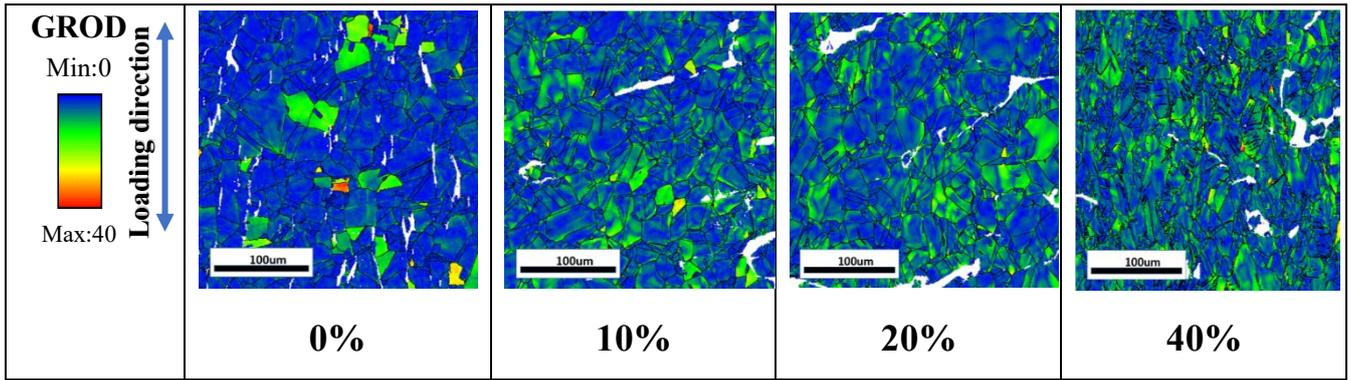
Figure 14. The IPF images, KAM and GROD maps obtained from EBSD scans of the different plastic strains specimens

Figure 14 shows the IPF images, KAM and GROD maps observed by EBSD scan of the different plastic strains specimens. The IPF image shows the grain size of sample with 10% plastic strain became smaller, and the grains of 20% and 40% plastic strain samples showed obvious elongation and fragmentation along the loading direction. Overall, according to the qualitative analysis in Figure 14, the value of KAM and GROD increase significantly with the increase of macro plastic deformation. Due to the different orientations of individual grains in the observation area, the local deformation of crystalline materials is non-uniform. Therefore, in this paper, intergranularly averaged $\overline{\text{KAM}}$ and $\overline{\text{GROD}}$ are used to quantitatively characterize the deformation degree at grain scale. Figure 15 shows the evolution law of the two intragranular misorientation parameters of 316L specimens during plastic deformation. When the specimen was stretched to 10% plastic deformation, $\overline{\text{KAM}}$ increased with a slow growth, while the greater plastic deformation lead to a rapid increase of the value. As for $\overline{\text{GROD}}$, it is generally linear with plastic deformation. Both $\overline{\text{KAM}}$ and $\overline{\text{GROD}}$ establish a positive correlation with macro plastic deformation, which verifies the two-dimensional tensile model of polycrystalline materials proposed by Rui et al. [35], shown in Eq.(11) and Eq.(12). From Eq.(11), the $\overline{\text{KAM}}$ values is directly correlated to the EBSD scanning step s and average geometrically necessary dislocation density $\bar{\rho}_{\text{Gnd}}^e$. The further suggests that, the $\overline{\text{KAM}}$ values can be used as an approximate measure of the real dislocation density if the step s is constant. From Eq.(12), the $\overline{\text{GROD}}$ values are not affected by the above variables. Thus, the $\overline{\text{GROD}}$ can be used for measuring of plastic deformation of specimen.

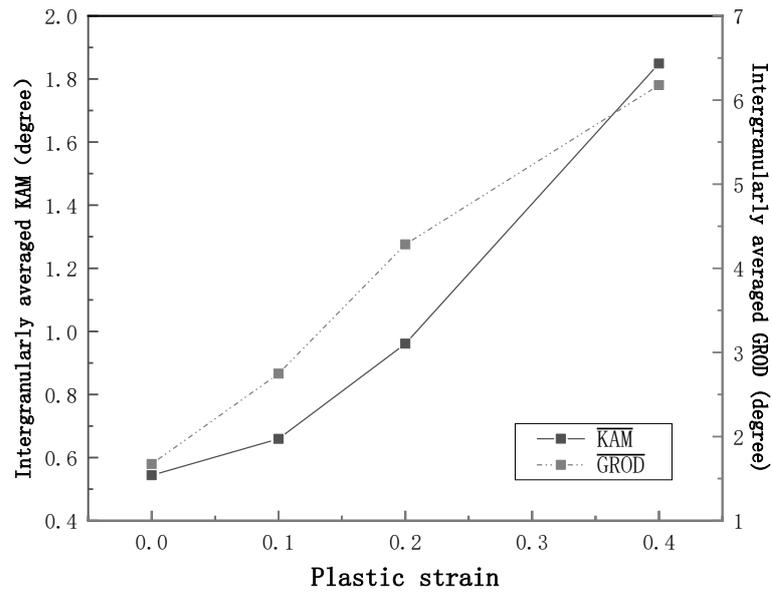
Figure 15. Variation of \overline{KAM} and \overline{GROD} values with the plastic strain

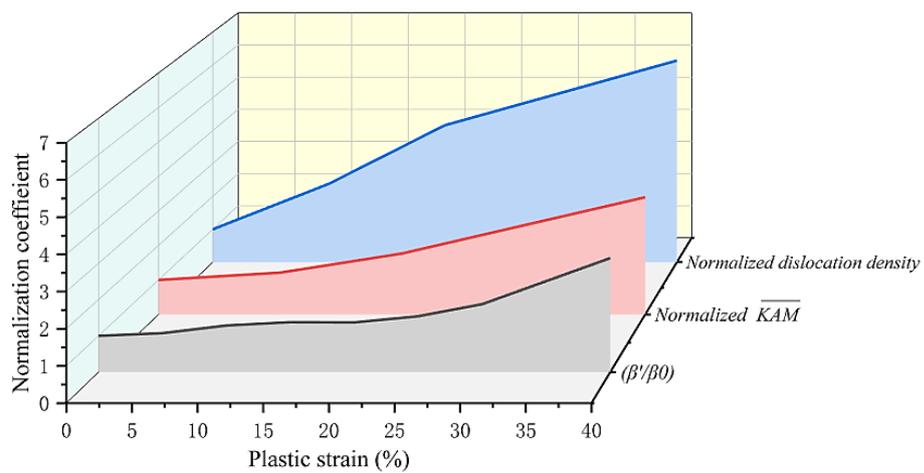
Figure 16. Comparison of variation trend of the β'/β_0 , normalized \overline{KAM} and normalized dislocation density with plastic strain.

To study the relationship between the evolution state of microstructure and the ultrasonic nonlinearity of 316L during the damage process, the relative nonlinear parameter β' , \overline{KAM} and dislocation density of the sample with different plastic strain were normalized respectively, and the variation of them were plotted in Figure 16. Although it can be seen that the variation trend of dislocation density is roughly consistent with the nonlinear parameter, it should be noted the increase of nonlinear dislocation density is greater than that of the other two parameters, and the slope of the curve changes at the strain of 20%. This may be due to the different calculation methods of dislocation density between the first two samples and the latter two samples. The complex microstructure such as dislocation entanglement and phase transition cannot be performed by the method of calculating dislocation density from TEM micrograph, which leads to a smaller calculation result.

As an approximate measure of dislocation density, \overline{KAM} could more accurately characterize the microstructure evolution at the grain scale (including the dislocation proliferation, phase transformation etc. by obtaining the information regarding strain distribution of local grain. Figure 16 clearly shows that the variation of the normalized \overline{KAM} values follow the same trend as β'/β_0 basically, as well as the amplitude. Combined with the observation of microstructures, it can conclude that the damage in 316L due to tensile is controlled by the microstructure changes such as the dislocation proliferation, martensitic transformation and phase boundaries etc. which directly affects nonlinear response of materials. From the damage evolution mechanism, it further demonstrated that the nonlinear ultrasonic parameter β can accurately evaluate the plastic damage and state of microstructure evolution of 316L.
