# A Novel Approach for Wind Turbine Blade Erosion Characterization: An Investigation Using Surface Gloss Measurement

Grant Leishman <sup>1</sup>, David Nash <sup>1,\*</sup>, Liu Yang <sup>1</sup> and Kirsten Dyer <sup>2</sup>

**Citation:** Leishman, G.; Nash, D.; Yang, L.; Dyer, K. A Novel Approach for Wind Turbine Blade Erosion Characterisation: An Investigation Using Surface Gloss Measurement. *Coatings* **2022**, *12*, 928. <https://doi.org/10.3390/coatings12070928>

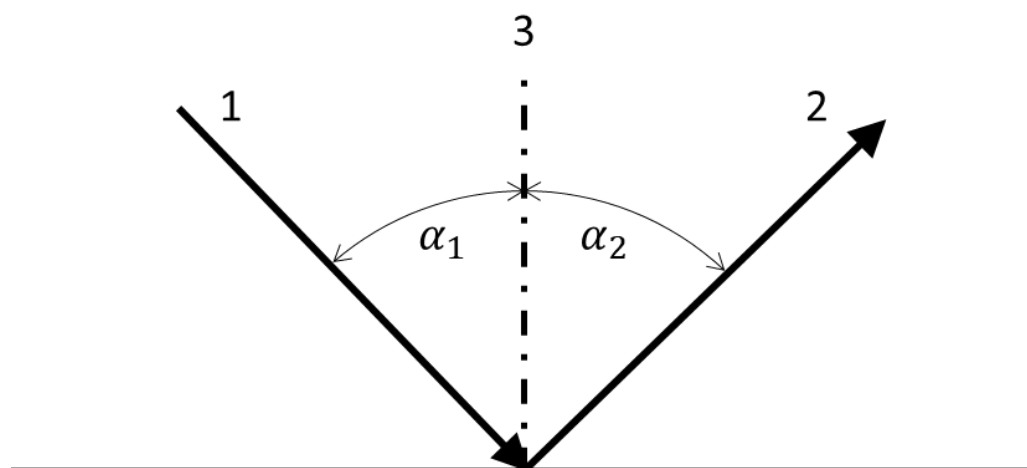
**Figure 1.** Spectral reflectance.

The angle of measurement for gloss is also an important parameter to consider. Typically, for plastic materials, angles of 20°, 60°, and 85° are used [15]. The angles refer to the incident angle of the beam of light, where in Figure 1, line 1 with angle  $\alpha_1$  is the incident angle and line 2 with angle  $\alpha_2$  is the specular reflection, which for a perfectly smooth surface is always the same as the incident angle,  $\alpha_1 = \alpha_2$  for specular reflectance. Line 3 is the normal line, a perpendicular line to the measured surface.

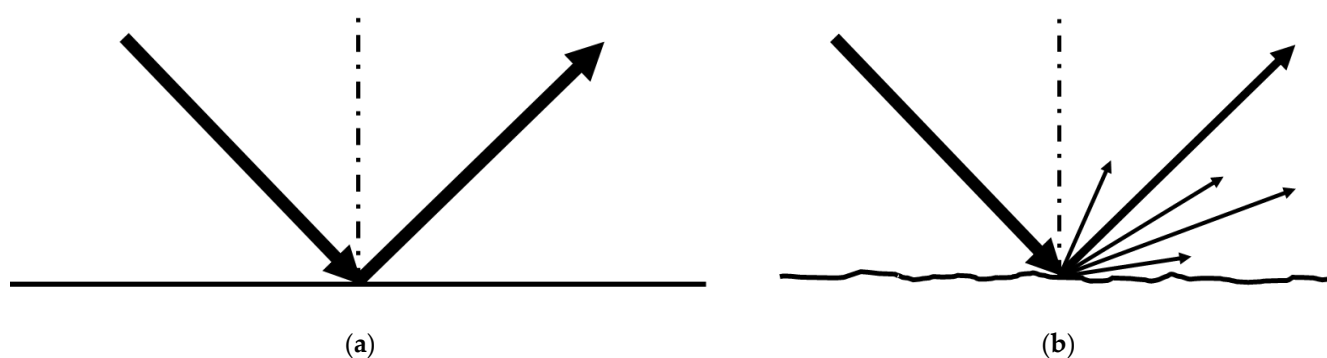
The intensity of the specular reflection is dependent on the surface which the beam is reflected off. If the surface is smooth and uniform, a high quantity of the incident beam is reflected as the specular reflectance and has a low diffuse reflectance as shown in Figure 2a. If the surface is uneven or has an irregular or unsmooth pattern, the amount of the incident beam reflected as specular reflection is low and there is a high diffuse reflectance as in Figure 2b.

**Figure 2.** (a) Low diffuse reflectance; (b) high diffuse reflectance.

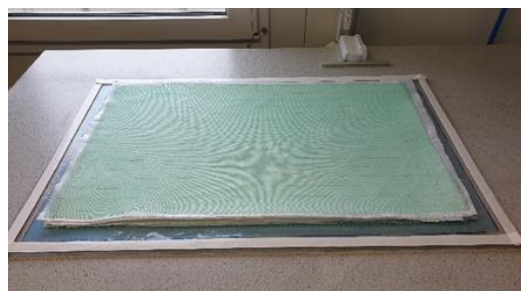
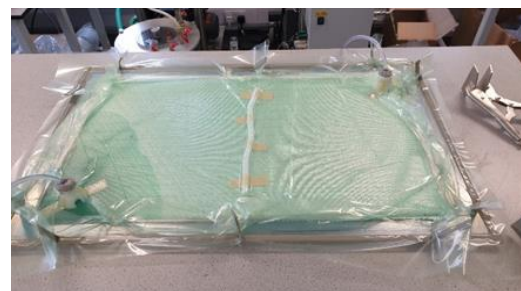
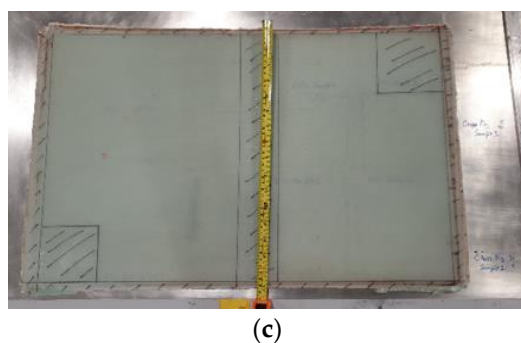
The substrate of the test specimens used within this experiment were constructed using two layers of 591 g/m<sup>2</sup> uni-directional (UD) glass fiber sheet and four layers of 616 g/m<sup>2</sup> bi-axial (BX) glass fiber sheet, each supplied by Cristex Composite Materials, Blackburn, UK. The fiber sheets were arranged in a layup of BX/UD/BX/BX/UD/BX, shown in Figure 4a. The layup, measuring 600 mm × 400 mm, was then impregnated using an epoxy resin in a vacuum-assisted resin infusion process, as displayed in Figure 4b. The epoxy resin system used was Hexion resin M135 with Hexion hardeners M134 and M137, and was supplied by PRF Composite Materials, Poole, UK. The epoxy resin impregnated panel was cured in an oven at 50 °C for 24 h. The finished glass fiber epoxy composite substrate measured 2.7 mm thick, and any unusable sections of the panel were removed, as shown in Figure 4c, prior to coating application.

**Figure 4.** (a) Substrate fiber layup on mold; (b) substrate fiber layup under vacuum with resin injection; (c) completed substrate with unusable sections marked for removal.

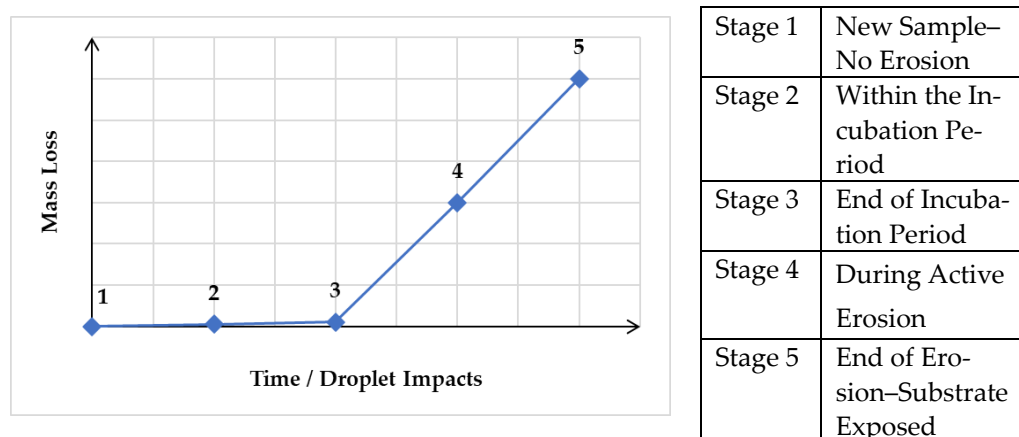
A staged approach to rain exposure testing has been proposed by the authors [18] where stages of erosion were identified and assessed, and the specimens were exposed in the rig until a specific erosion stage was reached. The staged approach to erosion testing can be visualized on Figure 5, where the plot of the number of droplet impacts vs. specimen mass loss is used. The erosion stages range from 1 to 5, where stage 1 is a specimen with no erosion at all—a new, fresh sample with a pristine surface; stage 2 is within the incubation period, the period where the specimen is exposed to RET but no visual damage or mass loss is observable; stage 3 is at the end of incubation period/the beginning of active erosion; stage 4 is during active erosion; and stage 5 is towards the end of active erosion where the composite substrate of the specimens begins to be exposed.

**Figure 5.** Erosion stages outlined on a mass versus test time/droplet impacts plot.

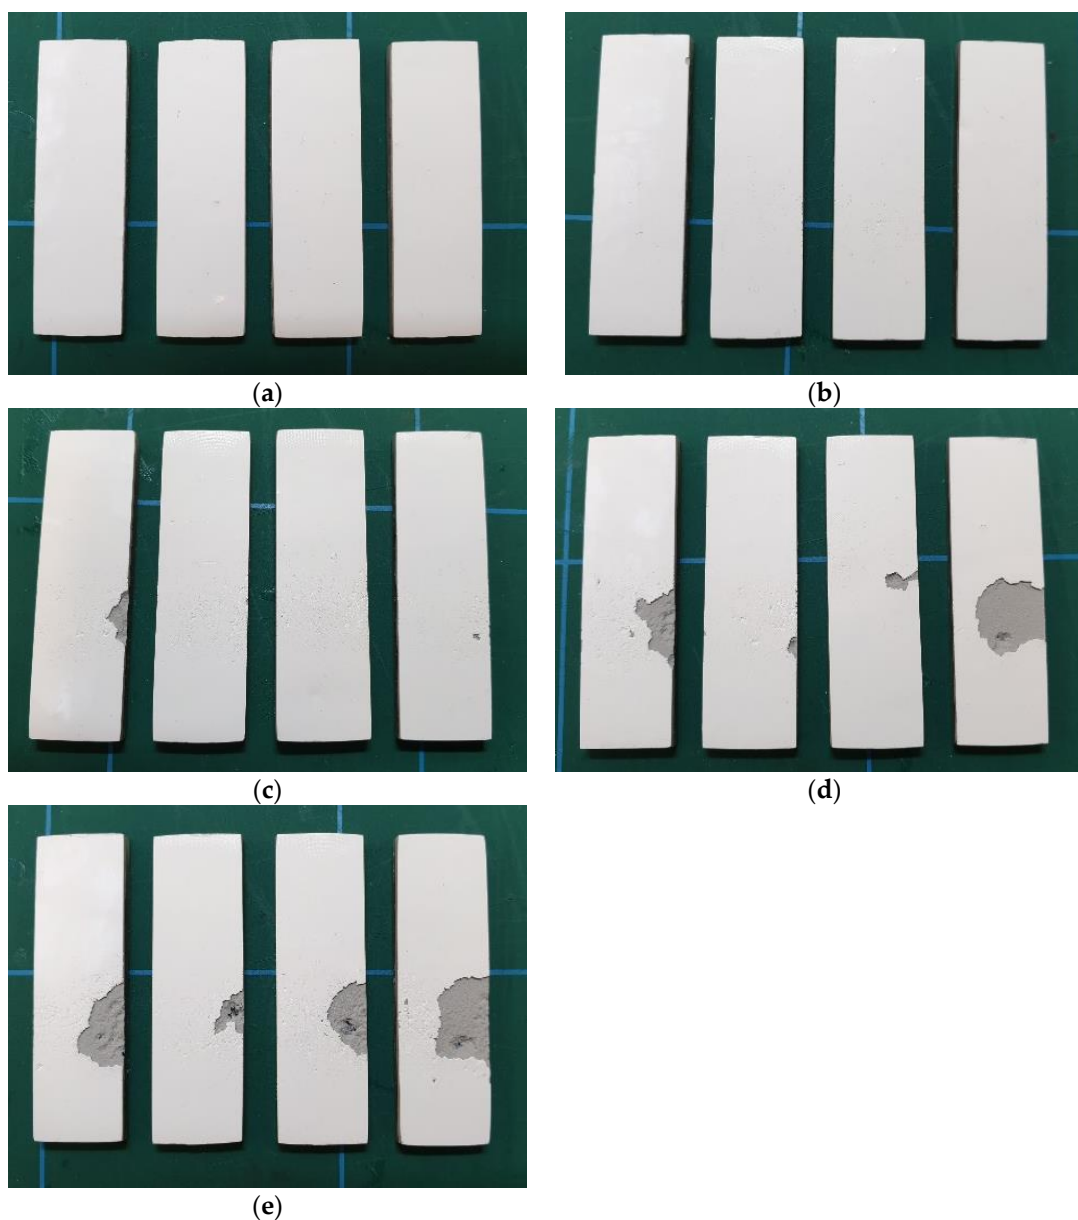
Figure 6 presents images of four individual specimens with coating A after each erosion stage.

**Figure 6.** (a) Samples with coating A at stage 1; (b) samples with coating A at stage 2; (c) samples with coating A at stage 3; (d) samples with coating A at stage 4; (e) samples with coating A at stage 5.

From consideration of Figure 6 showing coating A, Figure 7 showing coating B and Figure 8 showing coating C, it is clear that as the specimens spend a greater amount of time in the RET, their surface condition changes drastically due to progressive coating erosion. Current methods of assessing coating erosion rely mainly on visual inspection, a qualitative measurement. A quantitative measurement of coating erosion provides more valuable information on the state of erosion, as it allows for the direct comparison between stages of erosion, but more importantly directly indicates the onset of erosion and identifies which erosion stage the specimen currently experiences.

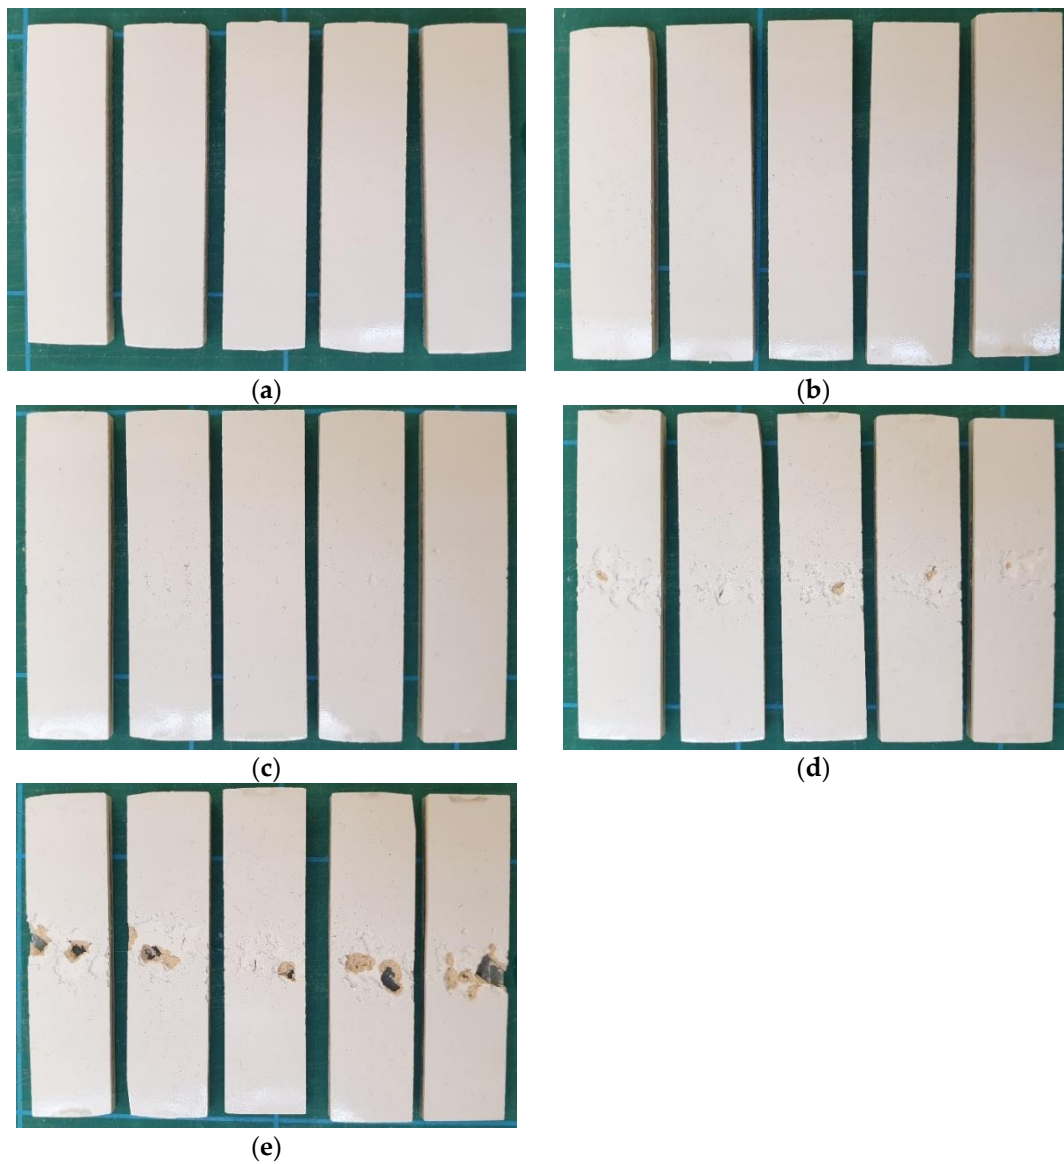
Figure 8 presents images of five individual specimens with coating C after each erosion stage.

**Figure 8.** (a) Samples with coating C at stage 1; (b) samples with coating C at stage 2; (c) samples with coating C at stage 3; (d) samples with coating C at stage 4; (e) samples with coating C at stage 5.

Considering coating C, Figure 8a–e, this coating has eroded in the most predictable manner of those tested. The samples at each erosion stage are as expected, with no samples prematurely eroding. From the microscopy, Figure 11a–e, it is evident that before any erosion, Figure 11a, the surface is not perfectly smooth nor uniform. There are small surface defects and although they are not visible to the naked eye, they can be detected using a microscope. As with coating A, these initial surface defects are most likely due to the coating application, whether this is due to the application method by roller or brush, or due

With coating C stage 2 erosion, Figure 8b, the surface appears similar to stage 1, and there is **no observable change to the naked eye**. However, examining the microscopy image, Figure 11b, there is a clear change in the surface condition. The defects which were present in stage 1 have widened and deepened, turning them into pits on the coating surface. This change in the coating surface is also observable from looking at the gloss measurement for this stage, 66 GU, a drop of over 10 GU from stage 1. The average mass lost between stage 1 and stage 2 is 0.0988 g. By comparing the gloss measurement and the mass loss, both against the impact energy, Figure 13 and Figure 15 respectively, it is clear that there is a larger deviation from stage 1 to stage 2 using gloss rather than mass lost. This allows for a larger measurement range, thus providing a more accurate measurement. Additionally, the samples do not require to be dried out prior to measurement if the gloss technique is used, whereas with the mass lost approach, the samples must be fully dried in order to obtain a realistic measurement.

Considering coating C erosion stages 3, 4, and 5, Figure 8c, 8d, and 8e respectively, visible coating damage begins to be observable to the naked eye and progresses through to coating loss and substrate exposure. The microscopy of stage 3, Figure 11c, shows that the small pits which were created in stage 2 have now collated and deepened, leading to much larger pits which are now visible to the naked eye as observable in Figure 8c. The erosion progresses through to stage 4 where chunks of the top coating layer have been removed and the filler layer of the coating system is visible, Figure 8d. As the erosion further progresses, the filler layer is eroded leading to the substrate exposure at erosion stage 5. Again, comparing the gloss measurements to the mass loss measurements, the gloss provides greater accuracy, owing to a larger difference in gloss units between stages than that of the mass loss.

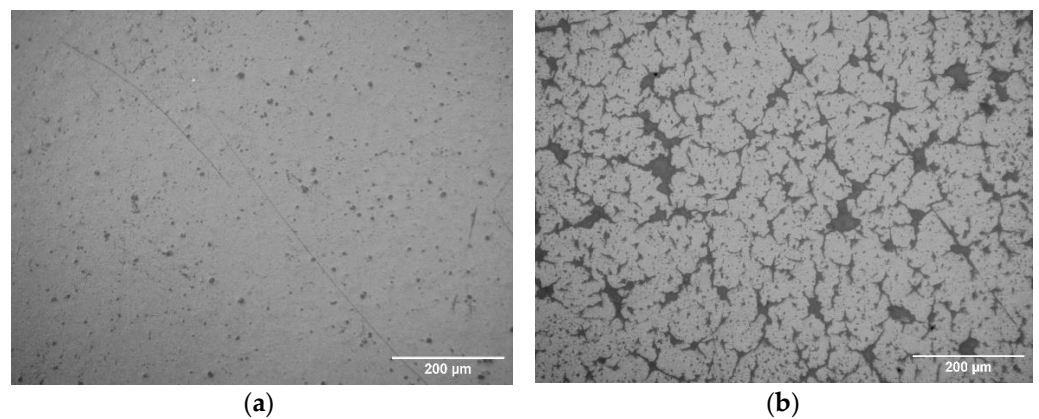
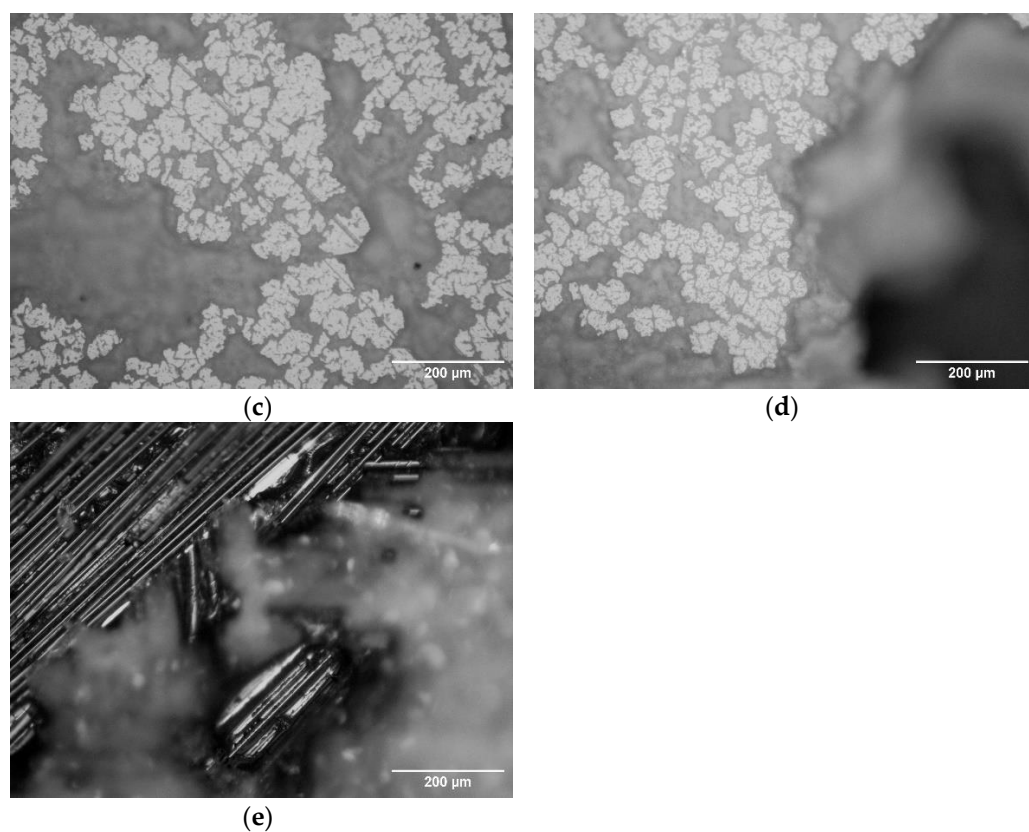
Figure 9 presents a microcopy image of a representative sample with coating A after each erosion stage.

**Figure 9.** Microcopy image of representative sample with coating A at (a) stage 1; (b) stage 2; (c) stage 3; (d) stage 4; (e) stage 5.

Examining coating A stage 1 under the microscope, Figure 9a, shows that the surface is not perfect. There are small pinholes/defects present on the coating surface, which are likely due to trapped air bubbles as a result of the application method of the coating and the coating consistency at the time of application. The coating manufacturers application guidelines were followed as per recommendations and it is recognized that some level of surface roughness is to be expected. Air bubbles present in the coating are known to have a negative effect on erosion performance [20]. It is noted however to the naked eye, as shown in Figure 6a, the surface appears in good condition with no observable pinholes/defects. The average gloss measurement for this stage is 76 GU.

As the erosion progresses to stage 2, the incubation period, Figure 9b shows a total change in the surface texture. The surface has changed from showing small pin holes and bubbles to small cracks which have joined up between the pin holes and bubbles. Here, the surface change is **not visible** to the naked eye, as observed in Figure 6b. However, the surface change from stage 1 to stage 2 is clearly defined by the gloss measurement, Figure 12, the gloss measurement drops by around 20 GU. This quantifiable change in the coating surface is detected by the glossmeter due to a change in the surface texture of the coating. This surface change causes more of the incident light beam from the glossmeter to be dispersed, as illustrated in Figure 2b, thus lowering the amount of light received at the spectral reflectance detector and in turn the gloss unit measurement.

Figure 9c–e show the specimen's surface after erosion stages 3, 4, and 5, respectively. It is evident that the surface texture changes as the erosion progresses, causing increases in the number of cracks and pits which collate and deepen, ultimately leading to layers of the coating system being removed. This surface texture change is directly shown in the glossmeter measurements as the gloss unit value of the coating decreases when the surface roughness increases.

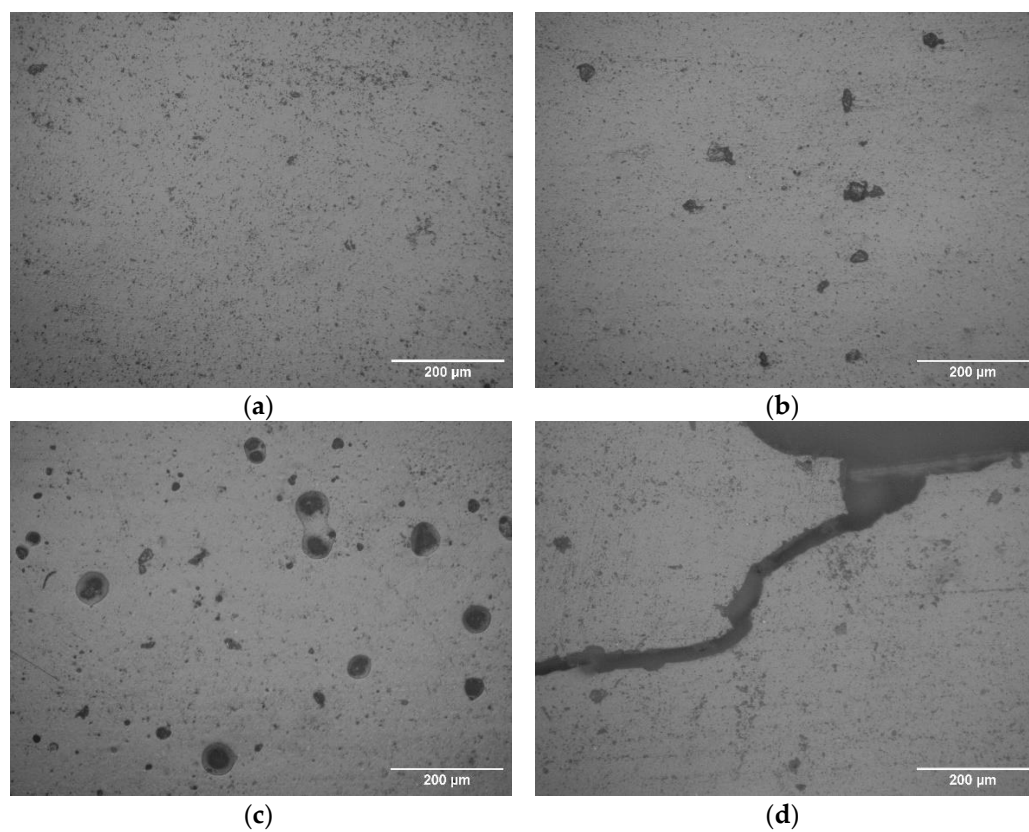
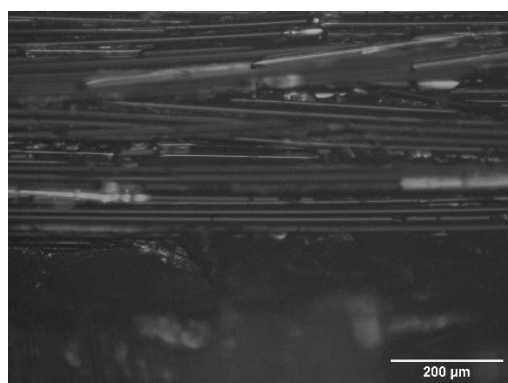
Figure 10 presents a microcopy image of a representative sample with coating B after each erosion stage.

**Figure 10.** Microcopy image of representative sample with coating B at (a) stage 1; (b) stage 2; (c) stage 3; (d) stage 4; (e) stage 5.

Using microscopy for surface examination, it is clear there are major changes in the surface texture as erosion takes hold and progresses as shown in Figure 9 presenting coating A, Figure 10 presenting coating B and Figure 11 presenting coating C.

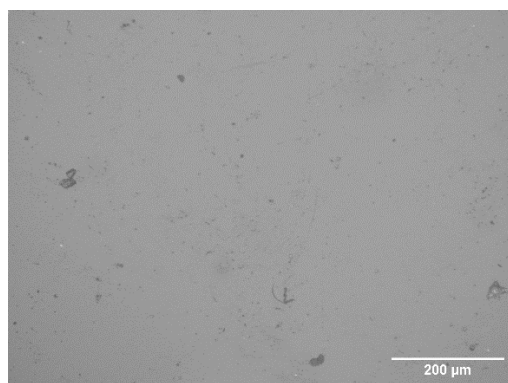
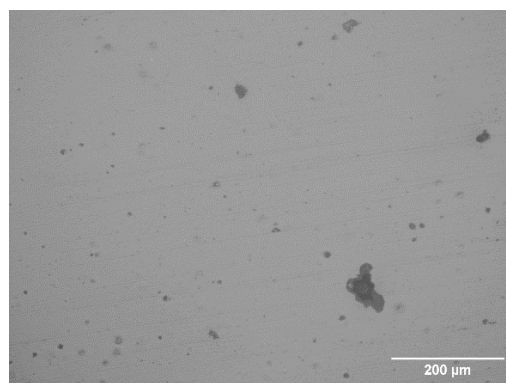
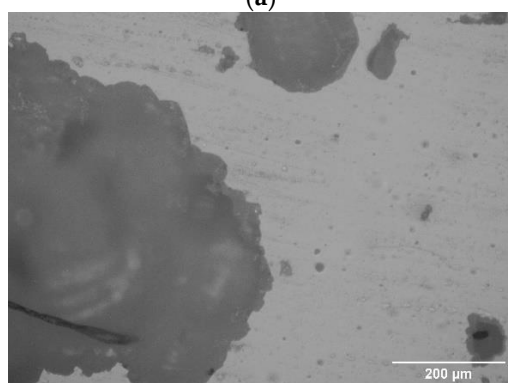
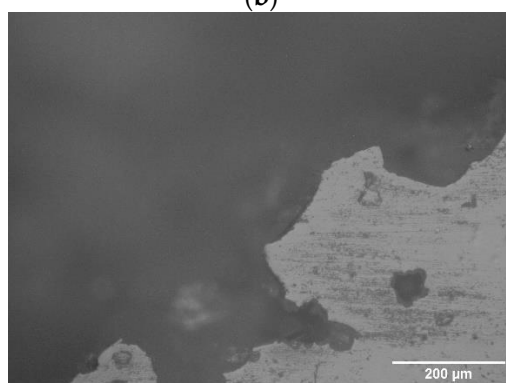
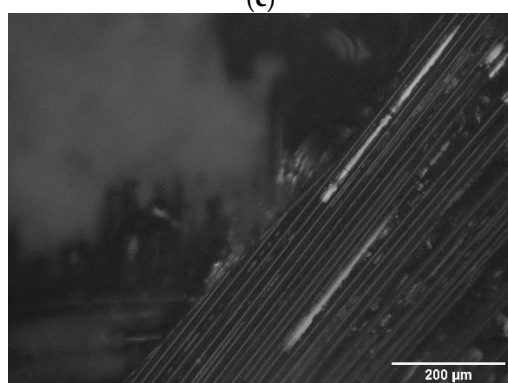
Figure 11 presents a microcopy image of a representative sample with coating C after each erosion stage.

**Figure 11.** Microcopy image of representative sample with coating C at (a) stage 1; (b) stage 2; (c) stage 3; (d) stage 4; (e) stage 5.

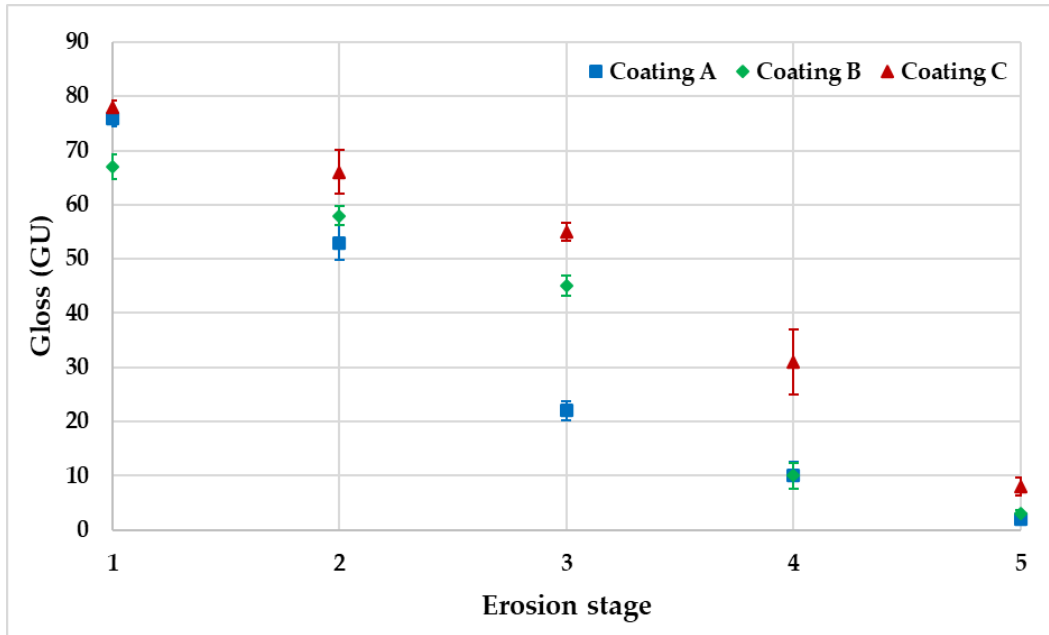
Figure 12 presents the gloss data recorded at each erosion stage, and Figure 13 presents the gloss data recorded at a given impact energy on the specimen. Error bars represent a 95% confidence limit on the results.

**Figure 12.** Coating surface gloss at each erosion stage for coatings A, B, and C.

The decline in gloss unit value as erosion progresses is clearly seen from Figure 12. This allows for a quantitative measurement, with clearly defined boundaries, of coating erosion at each stage.

For any given coating system, if the gloss values at each erosion stage are known, as in Figure 12, then this could be used as an assessment tool for erosion characterization on

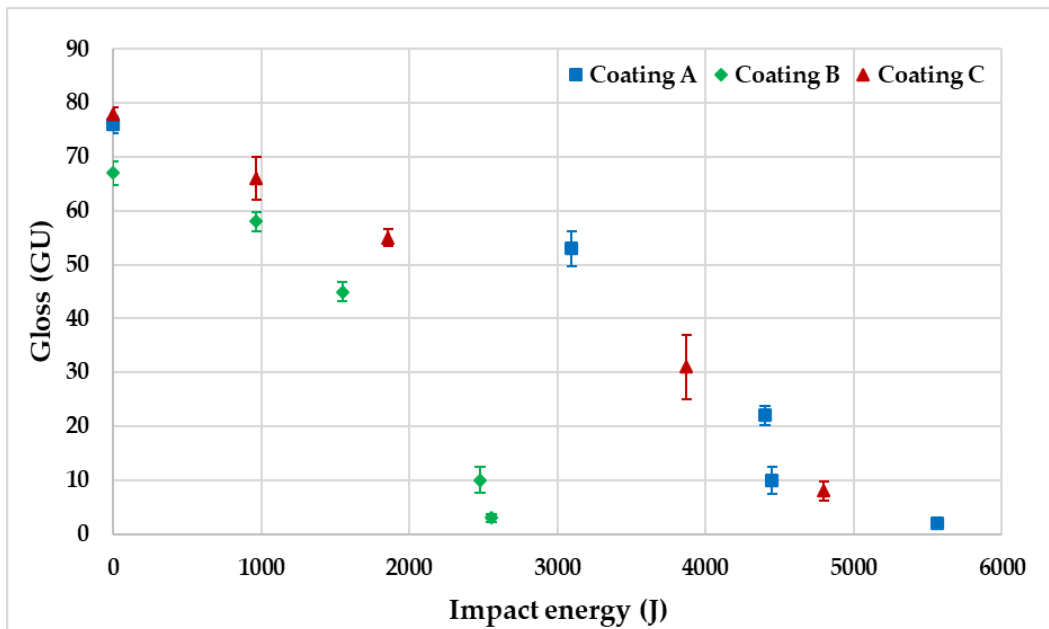
**Figure 13.** Coating surface gloss at impact energy for coatings A, B, and C.

Figure 13 shows the gloss unit value of all three coating systems plotted against erosion progression in the form of impact energy. It is evident that coating B did not perform as well as coating A or coating C. Coating B required less impact energy to reach erosion stage 5, meaning that coating B required less droplet impacts to erode the coating and expose the substrate. Both coatings A and C were able to withstand a much greater number of impacts, approximately double that of coating B, until the coating was fully eroded and the substrate exposed.

The gradient of a best fit straight-line on plots of gloss units versus impact energy, Figure 13, may be used as a performance indicator of the assessed coating system. The gradient indicates how much impact energy the coating has received and the associated gloss unit value—which translates into surface texture and damage due to erosion. The gradient of this best fit straight-line can be considered as a coating system property. A shallower slope indicates a better performing coating system. It is noted that the stoppage interval of the RET plays an important role in the erosive mechanism.

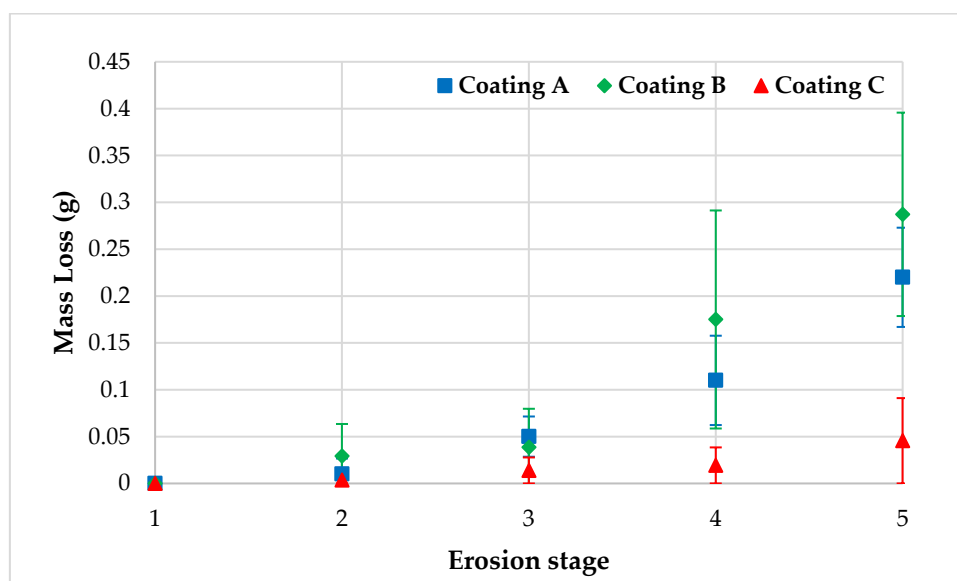
Figure 14 presents the mass loss data at each erosion stage. Figure 15 presents the mass loss data at a given impact energy. Error bars represent a 95% confidence limit on the results.

Figure 14. Sample mass loss at each erosion stage.

The mass loss of coatings A, B, and C at each defined erosion stage are shown in Figure 14, and the mass loss with impact energy is shown in Figure 15. The first observation to be made is that the size of the error bars on coating B is large. This is due to the high variation in measurements obtained for mass at each stage, mostly due to the unpredictability of the erosion on the coating. Second, the change in mass in coating C at each erosion stage is small, giving a narrow range for identification of each erosion stage. Coating A has a larger range of mass loss at each erosion stage, allowing for easier stage identification.

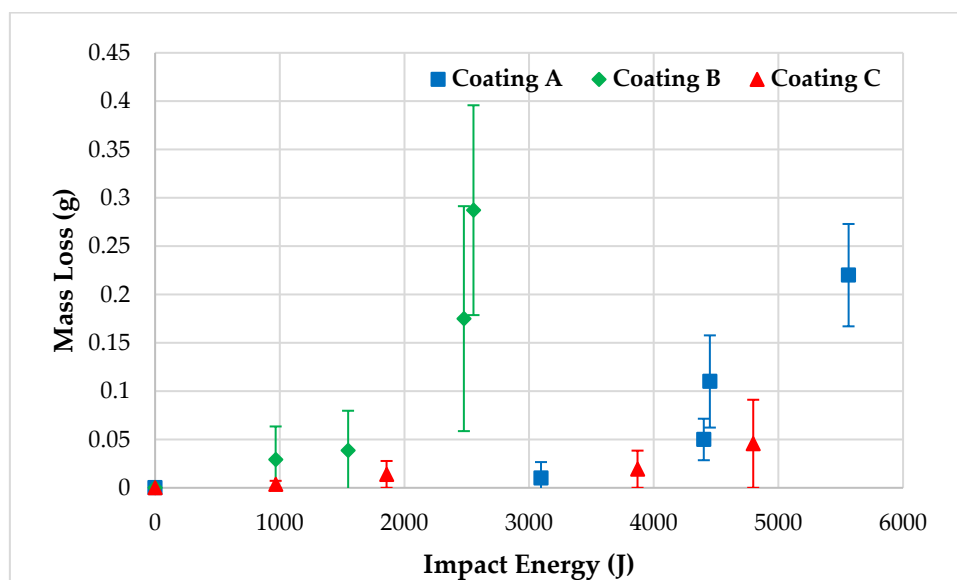
Figure 15. Sample mass loss with impact energy.
