Subsurface Condition Assessment of Critical Dam Infrastructure with Non-invasive Geophysical Sensing

This study presents for the first time the investigation of the condition of three reservoir dams in Scotland with the application of two complementary non-invasive geophysical methods coupled with visual inspection. Electromagnetic (EM) sensing was initially employed to provide an assessment of the upper soil layers of the crest and downstream shoulder of the dam. Electrical Resistivity Tomography (ERT) arrays were then installed on the crest to assess the subsurface conditions of the dam based on the resistivity signatures. The analysis of the geophysical models identified weak zones within the body of dams associated with high resistivity patterns associated with potential animal burrowing activity and fissuring on the crest of the dam. The electrical resistivity surveys revealed low resistivity zones influenced by seepage conditions inside the body of dams but also provided an indication of potential internal erosion areas. Finally the geophysical models provided an insight of the homogeneity of the fill material and determined the dam foundation characteristics. The geophysica

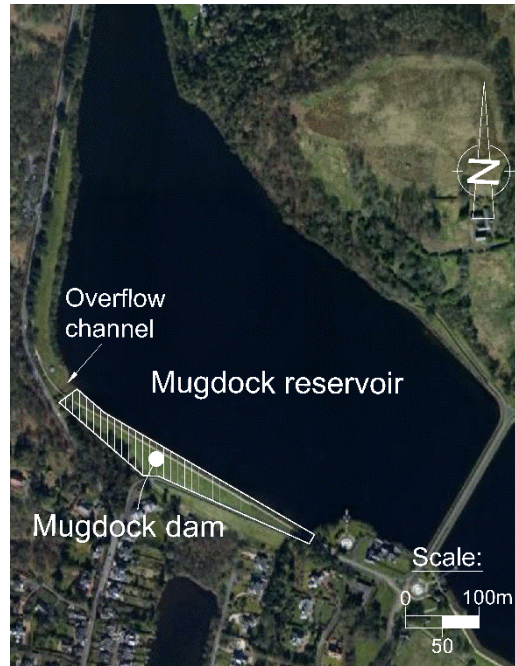
The Mugdock reservoir, shown in Figure 3, was constructed in 1859 and is presently one of the main feed reservoirs to Glasgow city. It is enclosed by an earth-fill dam with crest length of approximately 380 m at an altitude of 101 m AMSL. The upstream face of the dam is protected against deterioration and wave action with rip-rap. The maximum height of the dam from the foundation level is 21 m with the top water level at 97.07 m AMSL.

Figure 3: Mugdock reservoir enclosed by an earth-fill dam on south side with an overflow channel located on the south-west side of the area.

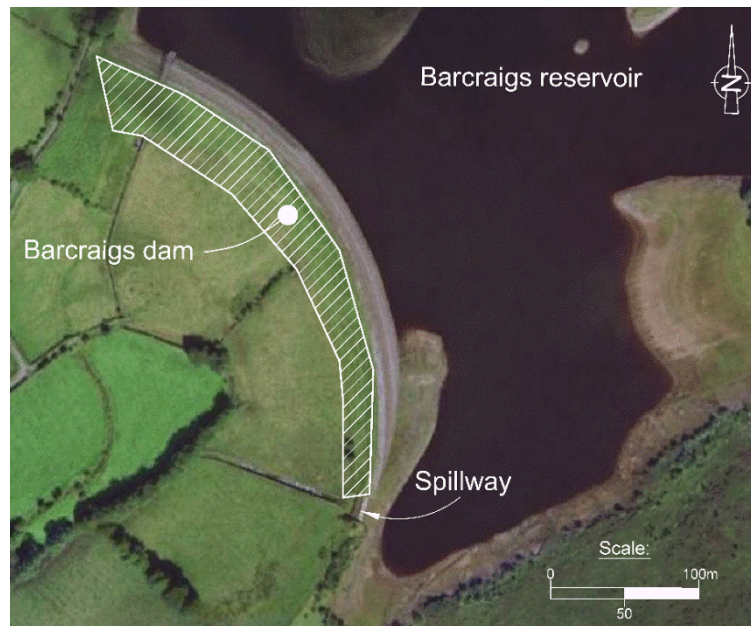
The Barcraigs reservoir was constructed in 1916 and is enclosed on the south side by an earth-fill dam with crest length of approximately 400 m at an altitude of 151 m AMSL (see Figure 4). The spillway is located on the south-east side of the embankment while the upstream face of the dam is protected against deterioration and wave action with rip-rap. The downstream shoulder has a moderate slope which is gradually increased approximately at mid-length of the embankment where its maximum height is recorded.

Figure 4: Barcraigs reservoir with the earth-fill embankment and the spillway on the south-west side of the area.

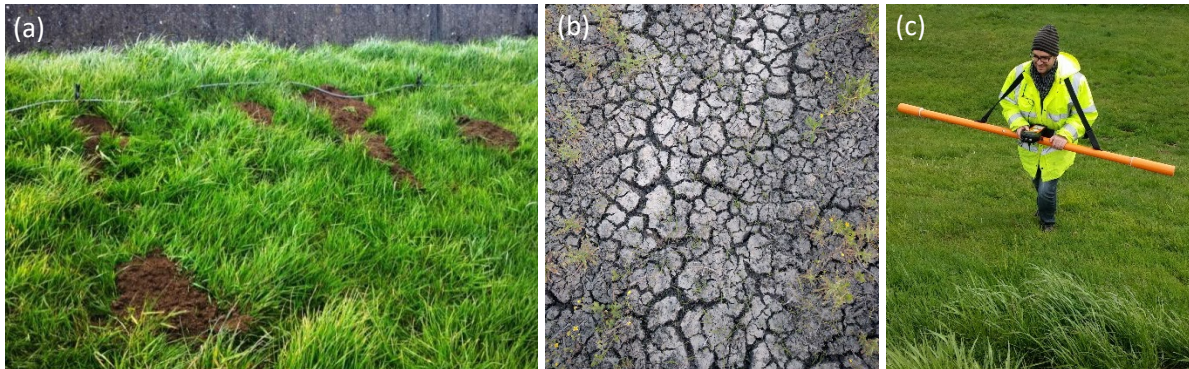
The visual inspection carried out prior to geophysical survey identified animal activity on the east-side of the downstream shoulder of Holl dam, as presented in Figure 5 (a). This activity is related with the presence of mole animals, usually found in earth-fill dams, that develop micro-tunnels and, in many cases, extensive burrow systems which in the long-term can potentially affect the structural integrity of the embankment. On the north-east side of the dam soil fissuring along the crest was also observed as presented in Figure 5 (b). The EM survey was

carried out covering the surface of the whole embankment area (see Figure 5 c) and was completed in two parts on the same day which was combined into one dataset producing the resistivity distribution recorded over the whole body of the dam.

Figure 5: (a) Visual signs of excavated soil indicating the presence of mole-hills located in the upper part of the downstream shoulder of the embankment, (b) clay fissuring detected on the north-east side of the dam (c) EM survey carried out over the surface of Holl dam.

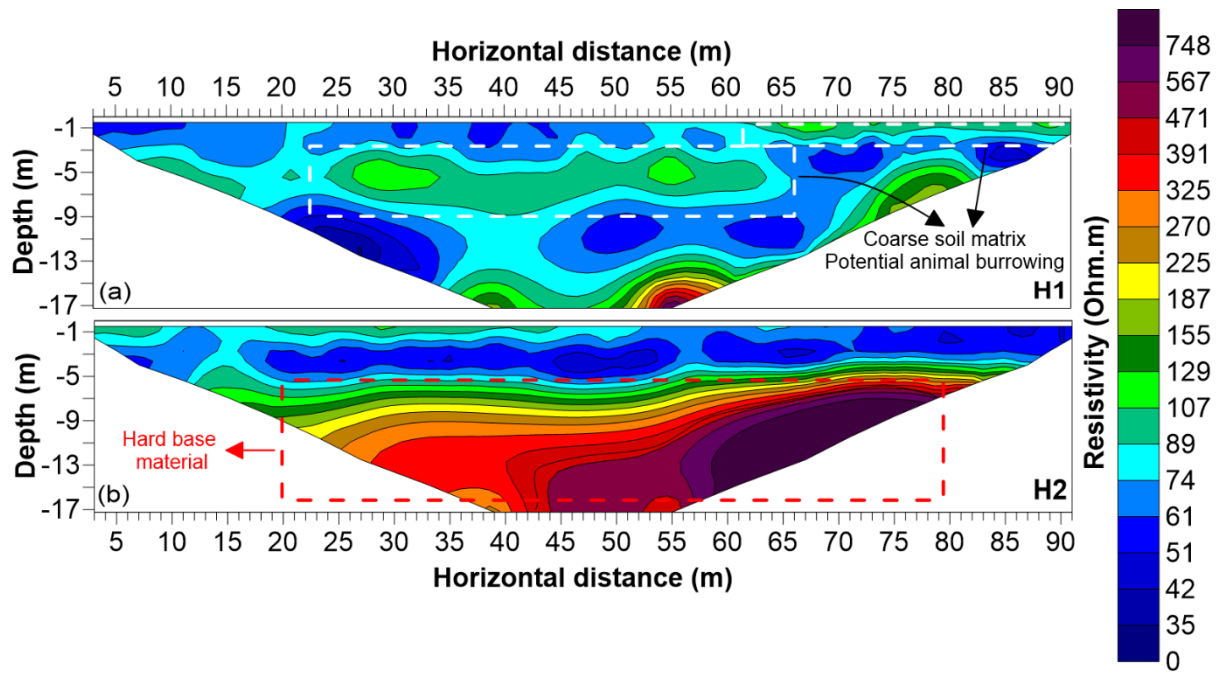
Based on the findings of EM survey, the ERT investigation was focused on areas of interest where a higher range of resistivity values was detected. The inverse resistivity models obtained for ERT arrays H1 and H2 are presented in Figure 8. Lower resistivity soil matrix was detected throughout the cross section depicted in H1 and H2 models (ranging from 0 to 152 Ohm.m) down to a maximum depth of 15 m and 6 m respectively. In the H1 model minor resistivity anomalies (< 152 Ohm.m) are detected at the depth range 4 m – 7 m, potentially associated with animal burrowing activity and/or the presence of drier or coarser soil matrix. A high resistivity uniform signature (> 192 Ohm.m) is also detected at depth > 6 m throughout the H2 cross section, which indicates different fill material potentially associated with the presence of the dam foundation towards the spillway. The main findings of the dam assessment in Holl reservoir are also summarised in Table 1.

Figure 8: The ERT models for arrays (a) H1 revealed resistivity anomalies beneath the crest of the embankment at depth range 4-7m and for (b) H2 high resistivity signatures at depth > 6m.

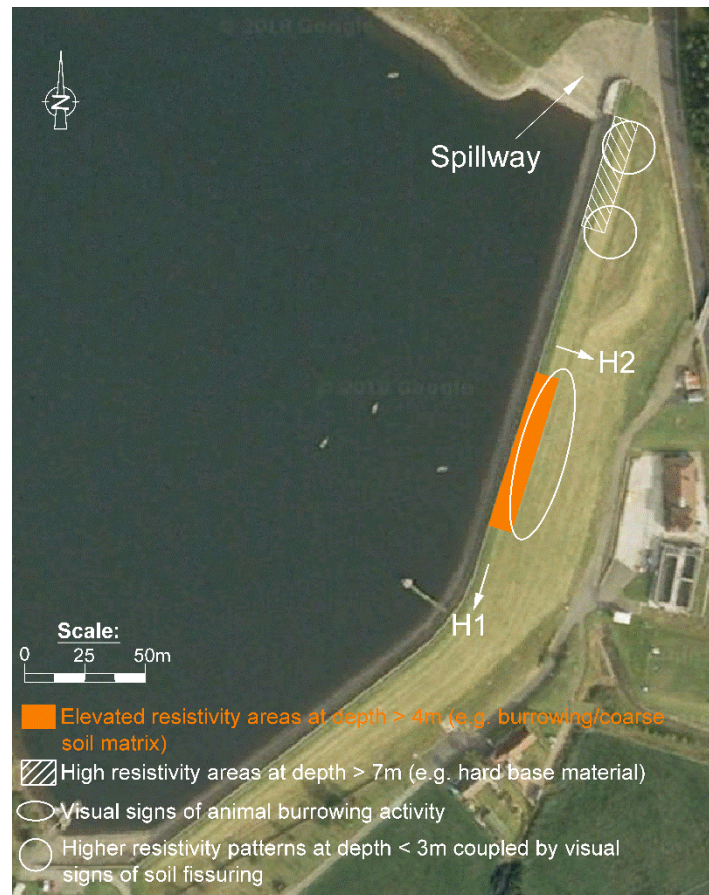
A visual correlation combining the findings of the visual inspection and the geophysical survey is also presented in Figure 9. The elevated resistivity areas at shallow depths are in agreement with the animal burrowing activity that was identified during the visual inspection. High resistivity patterns towards the north-east side of the embankment are potentially influenced by soil fissuring that was detected during the visual inspection.

Figure 9: Visual correlation of findings derived from visual inspection and geophysical assessment of Holl reservoir dam.

The complementary geophysical methods that were applied at Holl dam provided for the first time an insight of the subsurface conditions inside the body of the earth fill structure. Animal burrowing activity and signs of clay fissuring were initially identified by the visual inspection on the north-east side of the dam. These areas were in agreement with the higher resistivity patterns, potentially influenced by the presence of coarser soil matrix in the upper soil layers, based on the results obtained in both EM and ERT investigations. The non-invasive ERT investigation also revealed the presence of hard base material towards the spillway of the embankment which is evident by the high resistivity anomalies as presented in the analysed models.

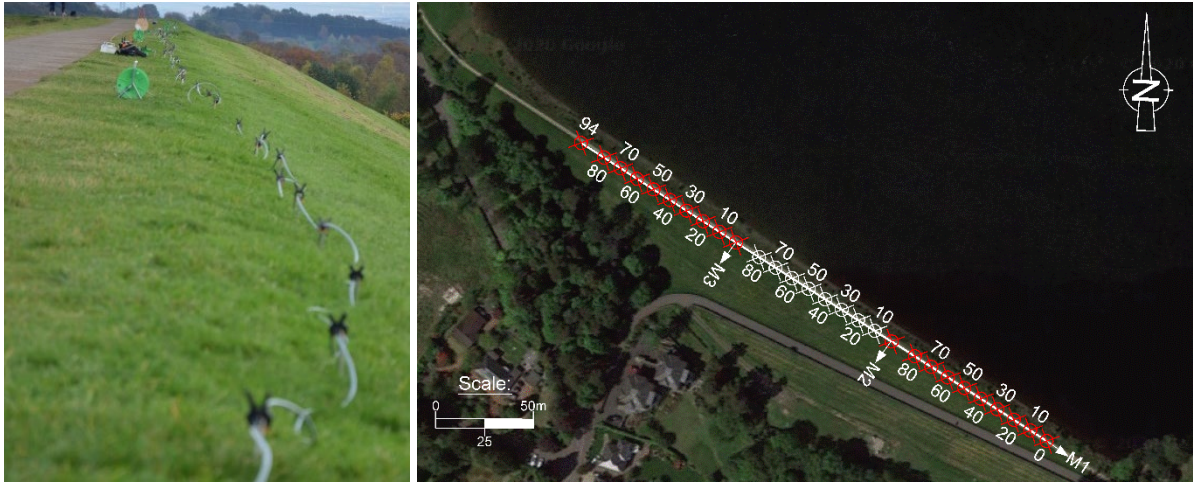
the upper soil layers. Three ERT arrays (M1, M2 and M3) were subsequently installed on the boundary between the south side of the crest and the downstream shoulder of Mugdock dam, as shown in Figure 10. All ERT arrays had a length of 96 m with 2 m interval spacing between electrodes, which enabled greater penetration depths providing a complete subsurface characterisation of the dam.

Figure 10: (a) Non-intrusive geophysical investigation with ERT arrays installed on the crest of Mugdock reservoir dam, (b) ERT arrays (M1, M2 and M3) with length of 96 m and electrode spacing intervals of 2 m covering part of the length of Mugdock dam.

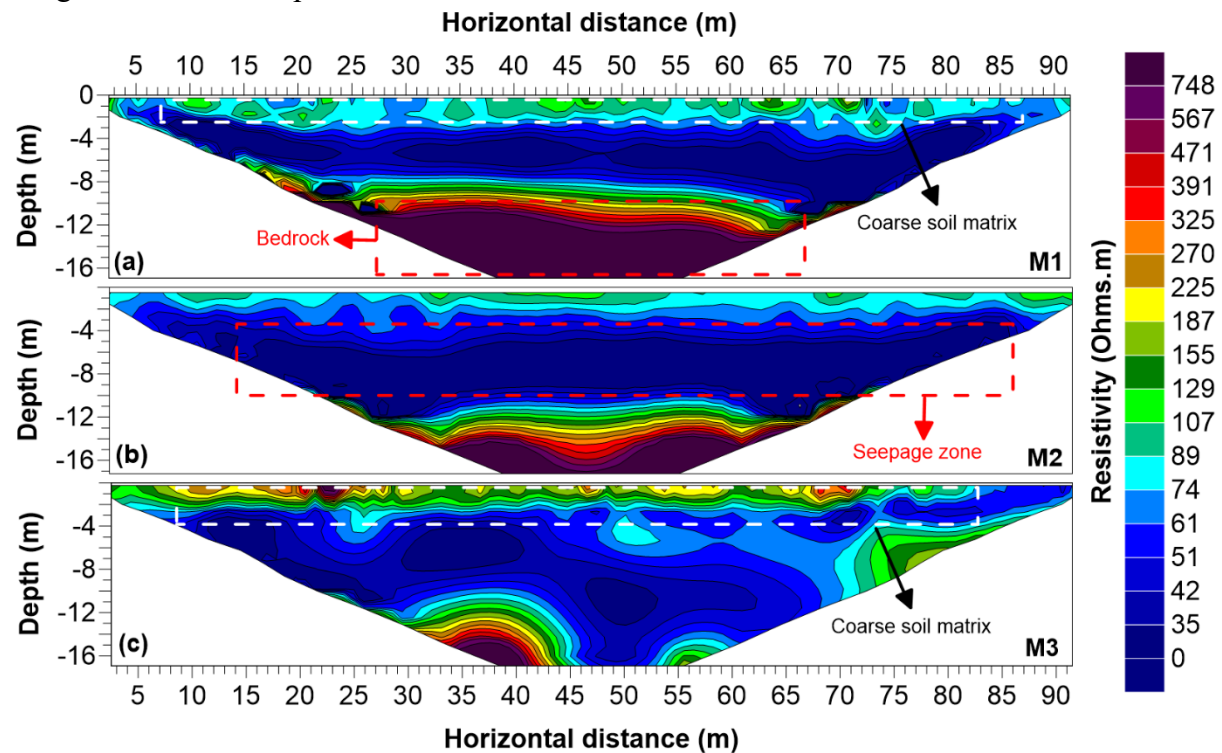
The M1, M2 and M3 ERT models indicated elevated resistivity areas ($> 107 \text{ Ohm.m}$) on the upper soil layers ($< 3 \text{ m}$) of the dam, as presented in Figure 12. These results are in agreement with the resistivity range obtained from the EM survey. These high resistivity

signatures are potentially related to drier/coarser soil matrix (e.g. gravel, clay, sand) and are not attributed to burrows, considering that animal activity was not observed on the crest and the downstream face of the dam during the visual inspection. The analysis of the results obtained from the three ERT arrays also revealed low resistivity signatures ($< 24 \text{ Ohm.m}$) that are located beneath the upper soil layers. These resistivity areas are associated with saturation zones in clay sediments influenced by the seepage pattern inside the body of the dam. Higher resistivity signatures up to 748 Ohm.m are detected at depth $> 10 \text{ m}$ attributed to the presence of hard base material (e.g. bedrock foundation). The results obtained from the ERT models also provide useful information with regards to the fill material which for the layers beneath the upper soil surface of Mugdock dam is characterised as homogeneous, and is particularly evident in models M1 and M2. A summary of the main findings of the dam assessment in Mugdock reservoir is provided in Table 2.

Figure 12: ERT models for arrays (a) M1, (b) M2 and (c) M3 indicated resistivity signatures potentially associated drier/coarser soil matrix in the upper soil layers, followed by zones influenced by seepage activity and hard base material.

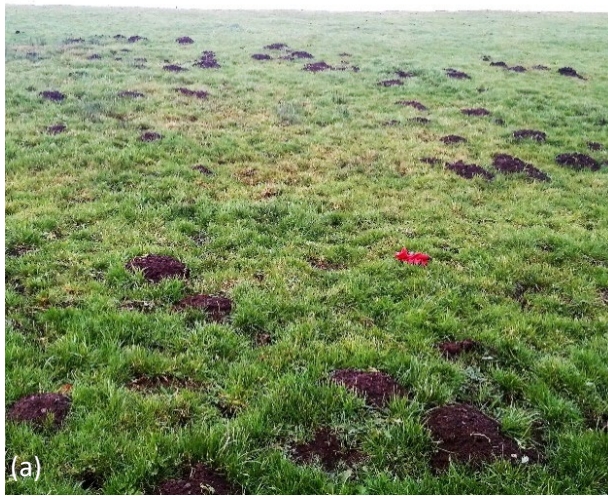
At the time of the inspection no significant settlements along the length of the crest were identified. Animal activity and burrows were observed in many areas mainly located on the upper part of the downstream face towards the crest. On an area located on the north-west side of the downstream face of the dam, soil deposits were detected, as shown in Figure 14 (a), without evidence of animal activity. This observation was accompanied with detection of wet

patches and short reed vegetation that were observed in other areas on the downstream face of the dam. The aforementioned observations are potential signs of internal erosion, suffusion and seepage processes that usually occur inside the body and provide similar visual warnings on the downstream face of earth-fill dams. However, further investigation is required to identify whether these findings were associated with climatic conditions (e.g. extreme rainfall) or with seepage activity. Visual inspections also revealed areas with minor slope instabilities and circular slip surfaces, as presented in Figures 14 (a) and (b). It is noted that most of the slope instabilities were identified in areas towards the toe of the dam. A circular slip surface was observed towards the spillway on the south-east side of the dam which highlighted an area of interest for further investigation.

Figure 14: (a) Soil deposits on the west side of the downstream face of the dam. Slope instability on an areas located at (b) the toe of the dam and (c) towards the spillway.

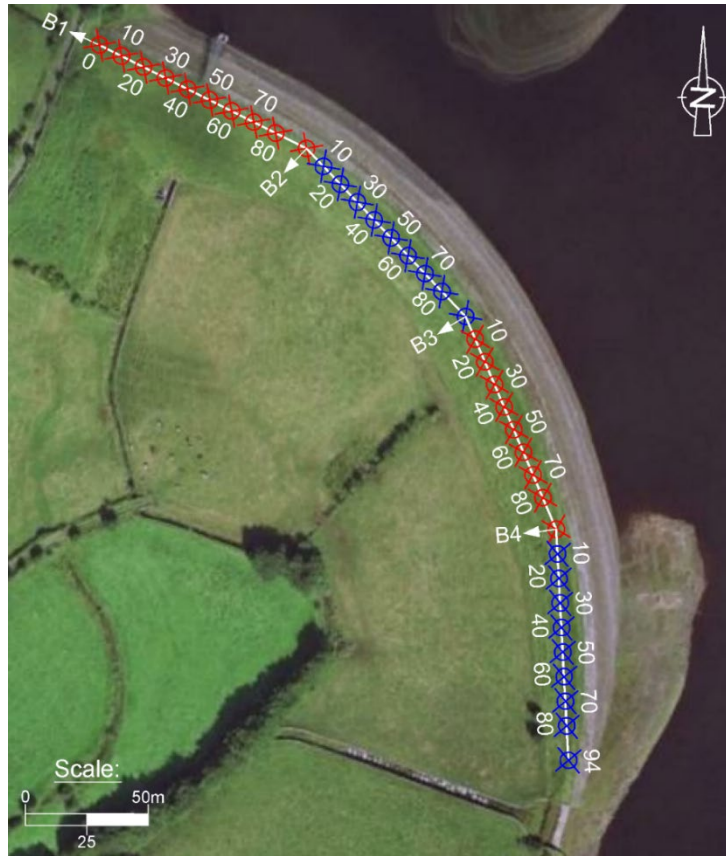
An EM survey was initially carried out scanning the soil resistivity at 3 m depth below the crest and the downstream slope to detect any anomalies beneath the dam surface. Four ERT arrays (B1, B2, B3 and B4) were then installed on the boundary between the south side of the crest and the downstream face of the dam, as shown in Figure 15.

Figure 15: Non-intrusive ERT arrays (B1, B2, B3 and B4) 96m long with 2m electrode spacing covering the crest length of Barcraigs dam.

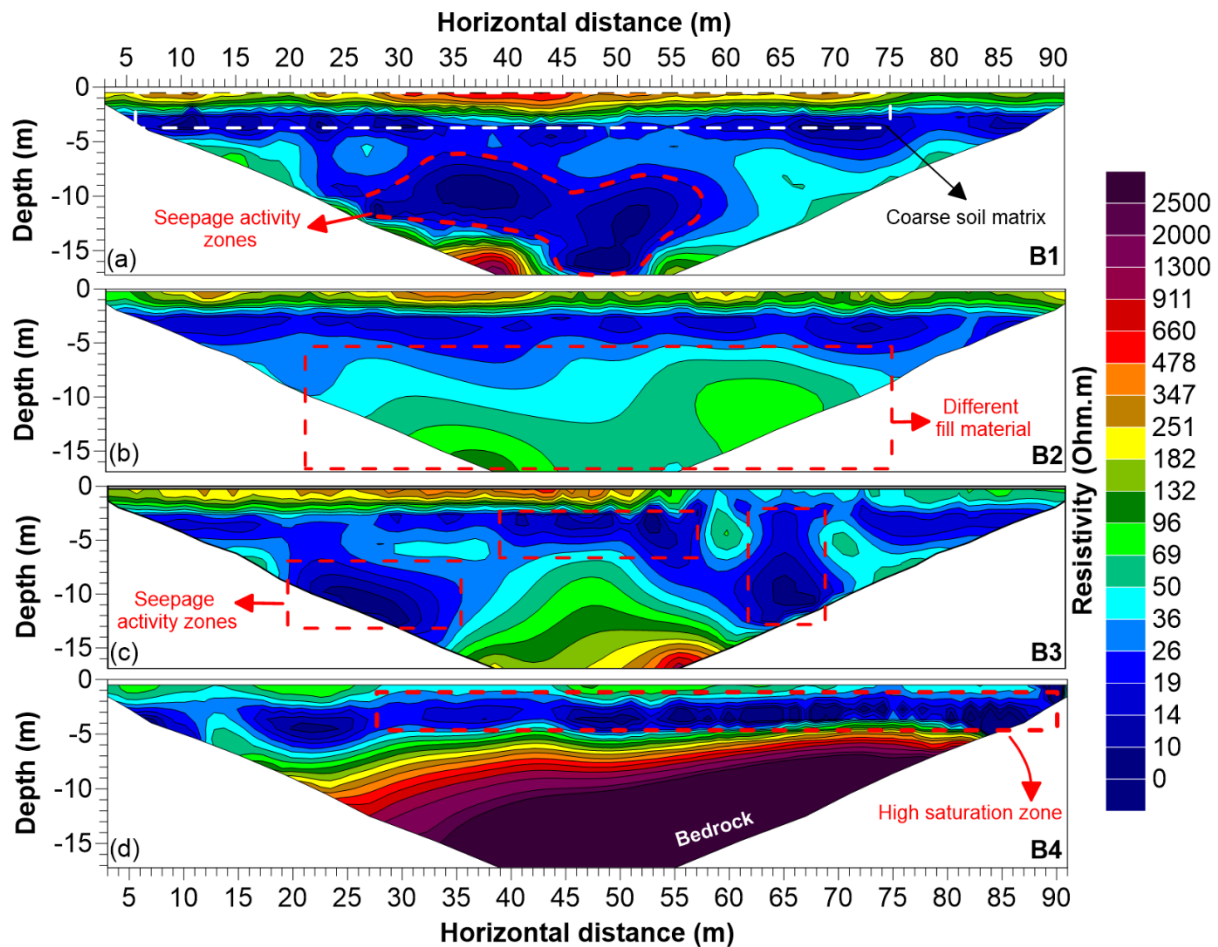
The analysis of the ERT data obtained in Barcraigs dam revealed high resistivity areas (up to 478 Ohm.m) on the upper soil layers (< 2 m) of the embankment as shown in Figure 17. These high resistivity signatures are potentially related with the presence of drier/coarser soil matrix (e.g. gravel and/or sand sediment) and sand/air-filled ‘pockets’ caused by animal burrows. Low resistivity zones (< 24 Ohm.m) were identified beneath the crest which were particularly evident in models B1 and B3, as presented in Figures 17 (a) and (c) respectively. These areas indicate high saturation zones in clay sediments, potentially influenced by seepage paths inside the body of the dam. The horizontal distance of these zones also correspond to areas where signs of internal erosion and seepage were detected during the visual inspection on the downstream face of the dam (refer to Figure 14a). The different resistivity patterns that are detected throughout the cross sections in models B1 and B2 are attributed to variation in the fill material of the dam or to the presence of seepage activity in model B1. A saturation zone identified in model B4 at shallow depth (< 5 m) towards the spillway is potentially influencing the formation of the circular slip surface that was observed in the same area. A high resistivity region (> 660 Ohm.m) was detected in model B4 towards the spillway and is associated with the presence of hard base material (e.g. bedrock). The main findings of the dam assessment in Barcraigs reservoir are summarised in Table 3.

Figure 17: ERT model for arrays (a) B1, (b) B2, (c) B3 and (d) B4 revealed circular low resistivity signatures which are potential associated with seepage patterns inside the body of the dam and a higher resistivity anomaly which is related with the presence of bedrock.

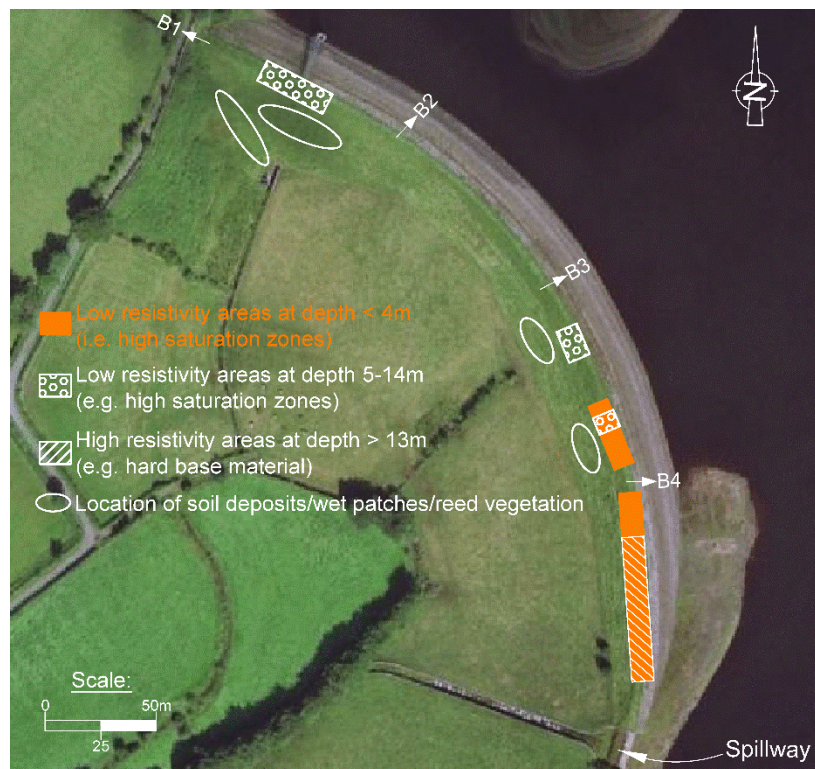
Figure 18 presents the visual correlation between findings obtained from the visual inspection and the geophysical surveys. It is pointed out that visual degradation signs along the downstream slope of the dam are in agreement with the location of low resistivity zones observed at depth 5-14m, potentially attributed to abnormal seepage activity inside the core of the dam.

Figure 18: Visual correlation of findings derived from visual inspection and geophysical assessment of Barcraigs reservoir dam.

The geophysical investigation in Barcraigs reservoir dam indicated areas of interest where potential signs of degradation were observed within the body and surface of the dam. The ERT models provided a low range of resistivity signatures and an insight of seepage and internal erosion signs which were agreement with the findings obtained by the visual inspection. Considering that the investigation was carried out after a period of intense rainfall and flooding, further geophysical monitoring and validation with long-term rainfall and reservoir water level datasets is necessary to identify whether the findings are attributed to

weather effects (i.e. rainfall) or to seepage patterns inside the body of the dam, that will be mostly influenced by reservoir water level fluctuations. Potential air and sand-filled ‘pockets’ caused by suffusion or animal burrowing were also detected in the ERT models, highlighted by the circular elevated resistivity zones. High saturation zones with low resistivity areas towards the spillway of the embankment were also found to influence the formation of minor slip surface failure modes of the downstream slope of the dam.
