# Load Bearing Capacity and Failure Analysis of Fibrous Plaster Wads

Fibrous plaster is a culturally significant material used in high-status buildings from the late nineteenth century. Fibrous plaster ceilings are typically suspended using load-bearing fibrous plaster wads, which are attached to roof structure components. Understanding the behaviour of wads is highly significant, with important safety implications emphasised by the partial collapse of the Apollo Theatre ceiling in 2013. This study demonstrates an original, innovative test method for fibrous plaster wads that enables quantification of load capacities, with manufactured specimens representative of historic *in situ* wads. The methodology is rigorously evaluated for traditional and alternative wad designs, reinforced with hessian scrim or continuous fibre glass (CFG) mat, with and without steel wires in looped (untwisted) or looped-twisted configurations. Tensile tests generated load-displacement characteristics and determined failure modes including cracking of plaster, deformation and tearing of fibrous reinforcement, and if present, plastic failure of a wire. Results demonstrate that hessian performs better than

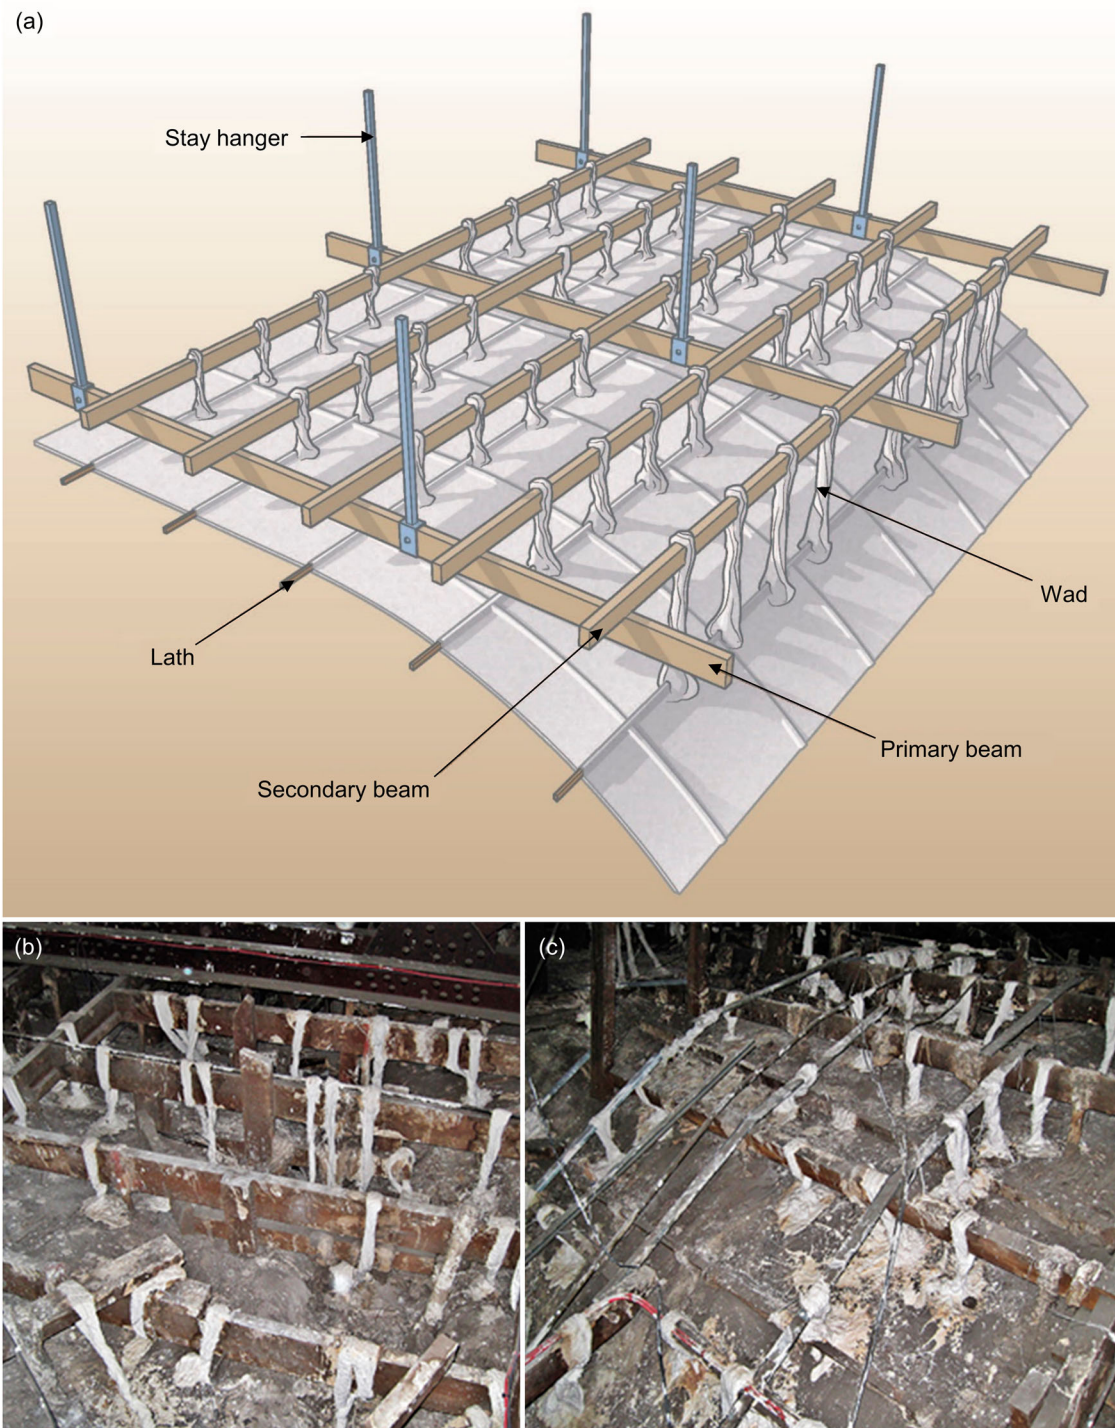
**Figure 1.** (a) Schematic diagram of fibrous plaster ceiling installation (© Historic England); (b) Top of a fibrous plaster flat ceiling within a roof void, showing fibrous plaster wads (white) used to fasten ceilings to the timber or steel structural framework flat ceiling; and (c) Domed feature as part of the fibrous plaster ceiling.

As well as flat panel elements, a ceiling could possess a distinguishing feature such as a dome, which would also be suspended from roof beams using fibrous plaster wads. A schematic diagram of a typical fibrous plaster ceiling installation is shown in Figure 1(a). Wads within a roof void in a historic building are shown in Figure 1(b) (level ceiling) and 1c (topside of a dome feature). It can be observed that spacing between historical wad centres is inconsistent, suggesting placement was governed by practical ease of access considerations. The oldest surviving suspended fibrous plaster ceilings date mainly from the 1880s, demonstrating the longevity of the fibrous plaster composite system if ceilings are monitored and repaired regularly within water-tight buildings. However, inherent long-term vulnerabilities within the composite system may cause failure, which can be exacerbated by irregular maintenance or a non-watertight building envelope. In historic ceiling installations, aged wads used to suspend ceiling panels have been found to be the element most at risk of degradation, leading to a reduction in overall structural integrity. Wads can break, fracture, or spilt in the middle, in-between the roof beam element and the topside of the ceiling, in addition to degradation occurring where the wads meet the topside of the ceiling or are draped over a supporting beam. Both plaster cracking and hessian scrim degradation can be accelerated by physical damage caused by building alterations or environmental factors such as moisture or fungal ingress (Maundrill et al. 2023).

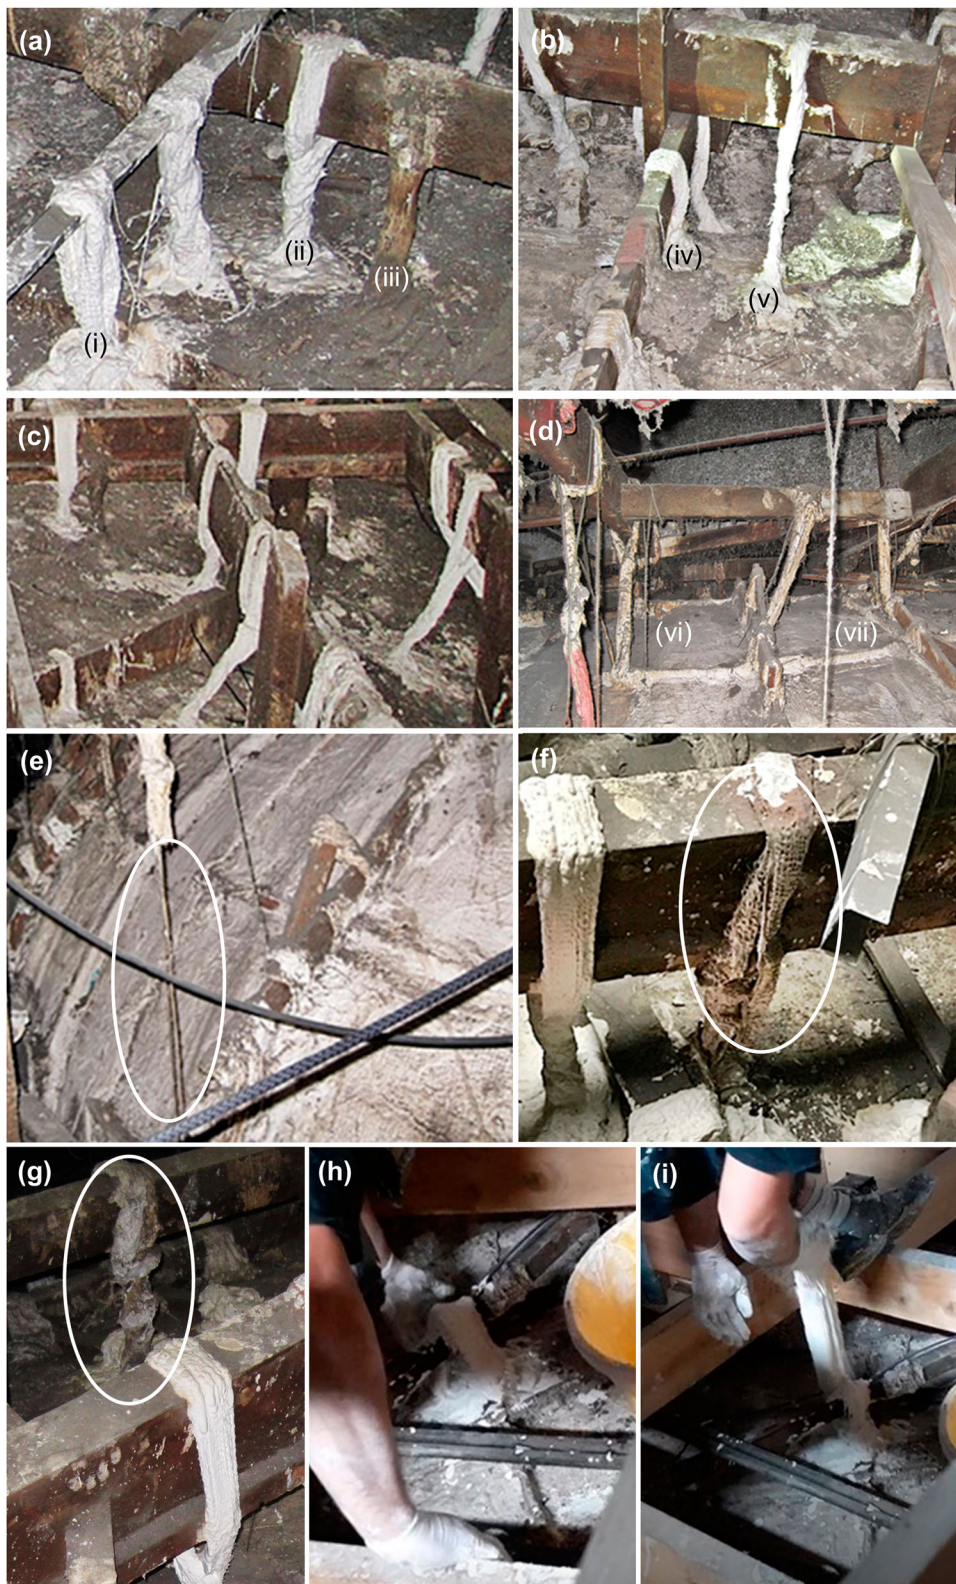
**Figure 2.** Close-up view of differing fibrous plaster wads *in situ*: (a) (i) Repair wad with visible scrim pattern, (ii) repair wad with twists of plaster-soaked scrim, and (iii) a historic degraded wad left in place; (b) Repair wads over a structural timber beam, (iv) short and (v) long wads; (c) Repair wads at angles – less efficient in carrying load; (d) (vi) and (vii) *In situ* exposed looped-twisted steel wires, note the dust layer on wads and wires; (e) Degradation of wad along the length showing exposed wire; (f) Degraded wad with exposed scrim (Barrett 2019); (g) Historic wad degraded along the length in contrast with a new repair wad; (h) and (i) Operative placing a new, repair wad *in situ*.

Close-up images of the condition of wads within the roofspace of historic buildings can be observed in Figure 2. Images include both original and repair wads. Figure 2 also reveals considerable variations in the size and layout of wads and their fixation, even across the same panels. Figure 2 also shows evidence of degradation in wads due to broken plaster and degraded

hessian scrim, exposing looped-twisted steel wires. Wads were also found to be previously installed diagonally at varying angles, resulting in lower load carrying efficiency. It is clearly evident that degradation – and ultimately failure – in wads can occur along the length of the suspended wad, in between the wad-ceiling interface and contact with supporting beams.

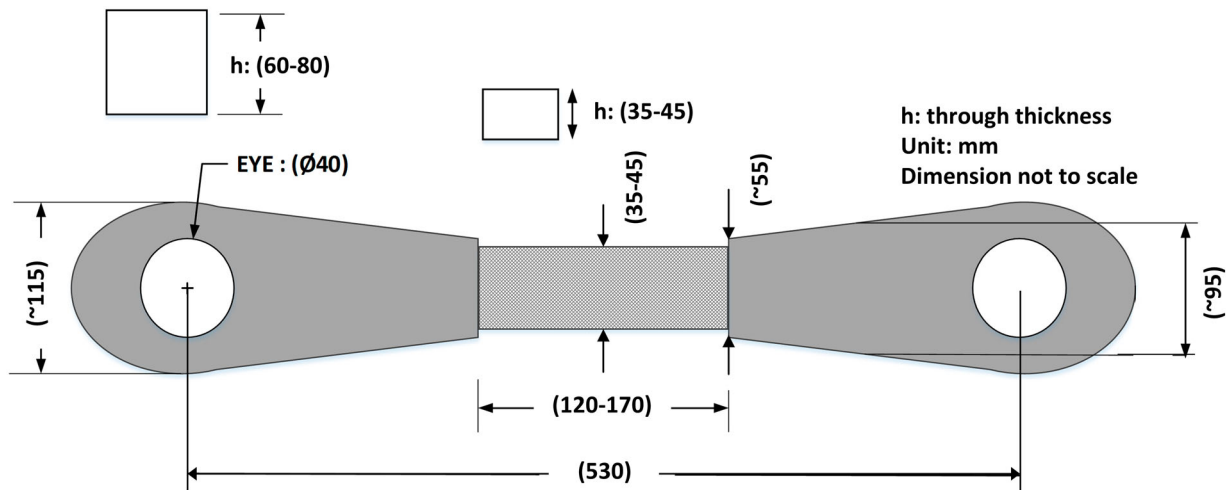
**Figure 3.** Schematic diagram of experimental wad sample showing typical wad dimensions. The central diagonally shaded region represents an *in situ* wad, with the ends reinforced around the 'eyes' (apertures made to affix specimens to the test rig) to ensure failure in the central region.

A schematic diagram showing the design of the wad samples is shown in Figure 3. The shape of the wad sample was designed so that the failure occurred in the middle region of the sample representing the wad length, and not around the 'eye' situated at either end; therefore, the central section serves as an accurate representation of a wad *in situ* and the end sections are reinforced with additional plaster-soaked hessian.

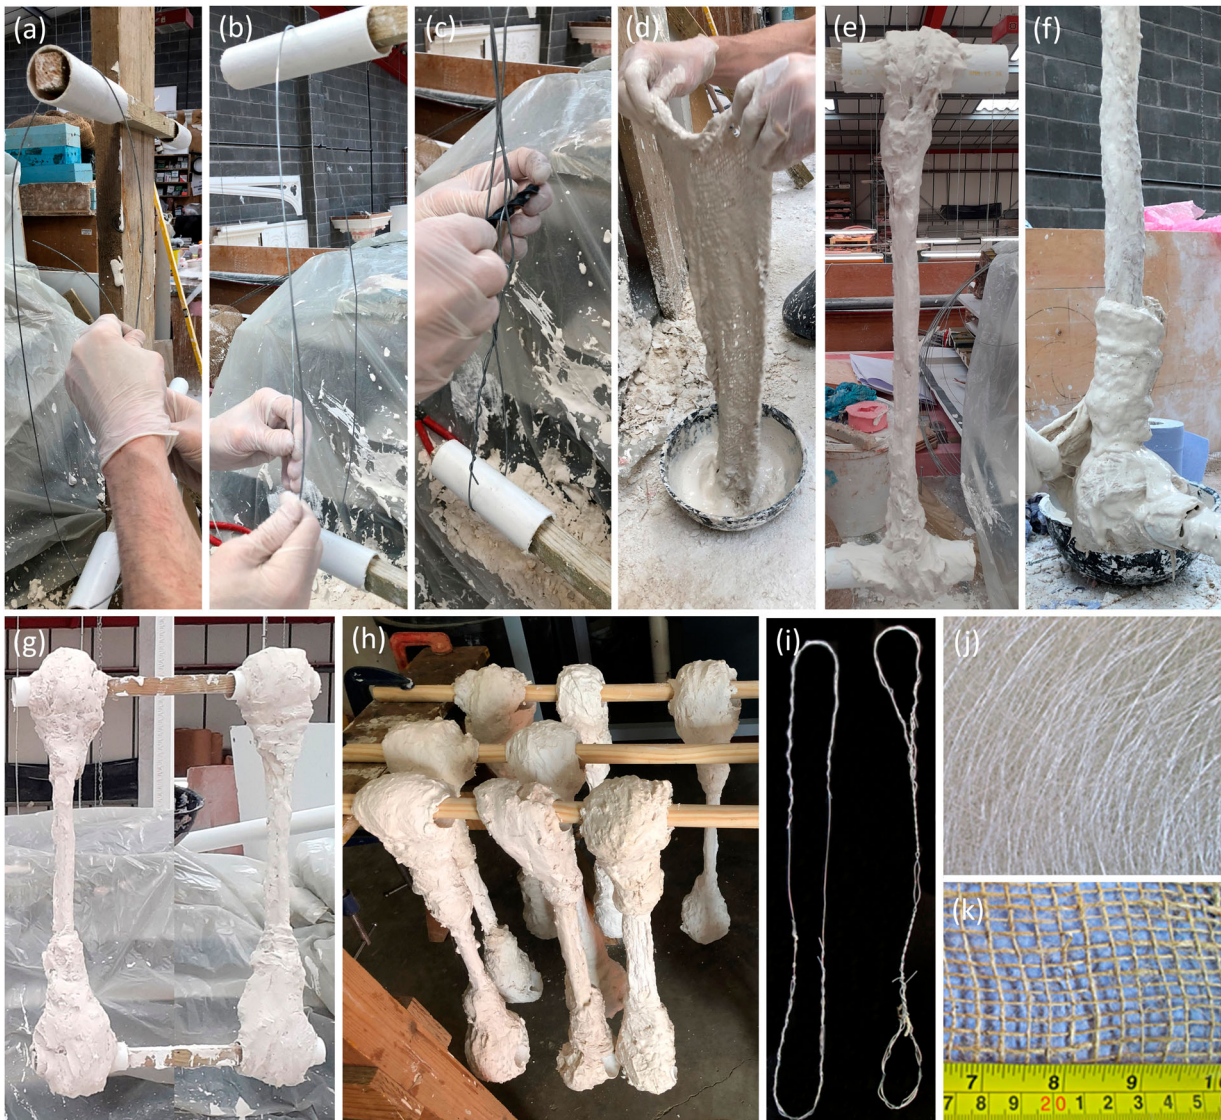
**Figure 4.** Typical steps in fibrous plaster wads fabrication within an industrial workshop environment: (a) Looping a 1.2 mm diameter steel wire length around two pipe lengths positioned on a bespoke timber frame; (b) Hand twisting the steel wire ends to form a loop of wire ('looped'); (c) Using a drill bit length as a tommy bar to twist the looped wire ('looped-twisted'); (d) Soaking hessian scrim with gypsum plaster; (e) Soaked scrim being wrapped and twisted around the steel wire to form a wad; (f) Extra soaked hessian wrapped around to strengthen ends around the eyelets and ensure wad failure occurs in the central section; (g) Completed test specimens curing; (h) Once cured, test specimens were stored prior to testing; (i) Wire specimens looped (left) and looped-twisted (right); (j) Continuous fibre glass (CFG) mat; and (k) Hessian scrim (jute fibres).

The procedure for the manufacture of wad samples is illustrated in Figure 4. A galvanised steel wire was set into position, looped around two lengths of plastic

pipings with a 40 mm external diameter, supported on parallel lengths of timber (Figure 4(a, b)). The lengths of piping were greased to facilitate the removal of the cured wad samples. For some samples, steel wire was twisted about the central axis using an 8 mm diameter metal rod. Twisting is the typical method used for new wad applications in industrial practice (Figure 4(c)). A 970 mm long, 300 mm wide piece of hessian scrim (or CFG scrim) was soaked in plaster while still in a fresh state and wrapped around the steel wire (Figure 4(d, e)) until the hessian covered the whole surface of the steel wire, leaving no wire exposed. Twisted (loop-twisted, twisted-end) and untwisted (looped) wire groups were used in the fabrication of the wad specimens in order to study the effect of these wires on the wad load-bearing capacity. An extra 970 mm length and a 485 mm length of hessian scrim soaked in plaster was applied to each end of a sample and wrapped around to create 'bulkier' ends (Figure 4(f, g)). The samples were then left for a minimum of one hour before transporting to the testing laboratory and then conditioned in the testing laboratory for a period of two weeks, with a temperature of  $20^{\circ}\text{C} \pm 2^{\circ}\text{C}$  to fully dry the wads prior to tensile testing.

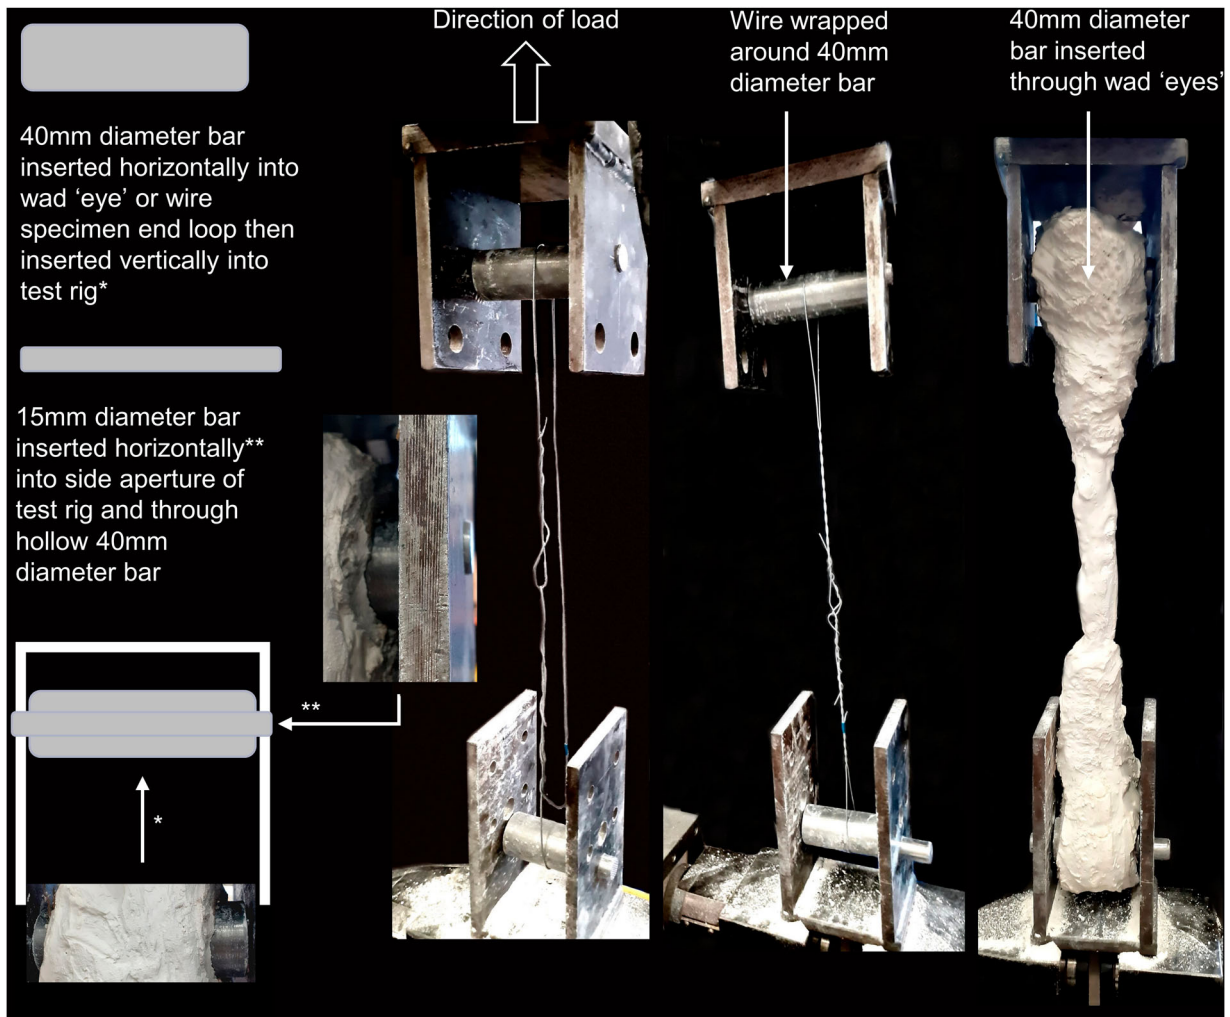
**Figure 5.** Wad and wire tensile test set-up, with a 15 mm and hollow 40 mm diameter steel tubes securing the test specimens to the upper and lower steel test rig components.

The performance of the wads was evaluated by subjecting the manufactured specimens to tensile loading. The displacement-controlled tests were carried out using a Dartec Universal Testing Machine with a 100 kN load cell at a crosshead speed of 2 mm/min until a 10 mm displacement was reached, at which point the loading rate was increased to 10 mm/min until a maximum displacement of 40 mm. A small pre-load ( $0.04 \text{ kN} \pm 0.02 \text{ kN}$ ) was applied after samples had been manoeuvred into position to test correct attachment prior to full loading. If the test specimen broke prior to the maximum displacement, the test was terminated at that point. Load-displacement profiles were recorded for each specimen. Wad and wire specimens were mounted onto the test rig as shown in Figure 5. A length of 40 mm external diameter hollow steel bar was inserted in the wad eyes (Figure 3) at either end to distribute the load evenly within the eye and accommodate any misalignment in the test assemblage. A 15 mm solid external diameter steel rod was inserted through the hollow bar to secure wads and wires within the test rig. Wire specimens in groups 7 and 8 were wrapped around the 40 mm diameter steel bar as illustrated.

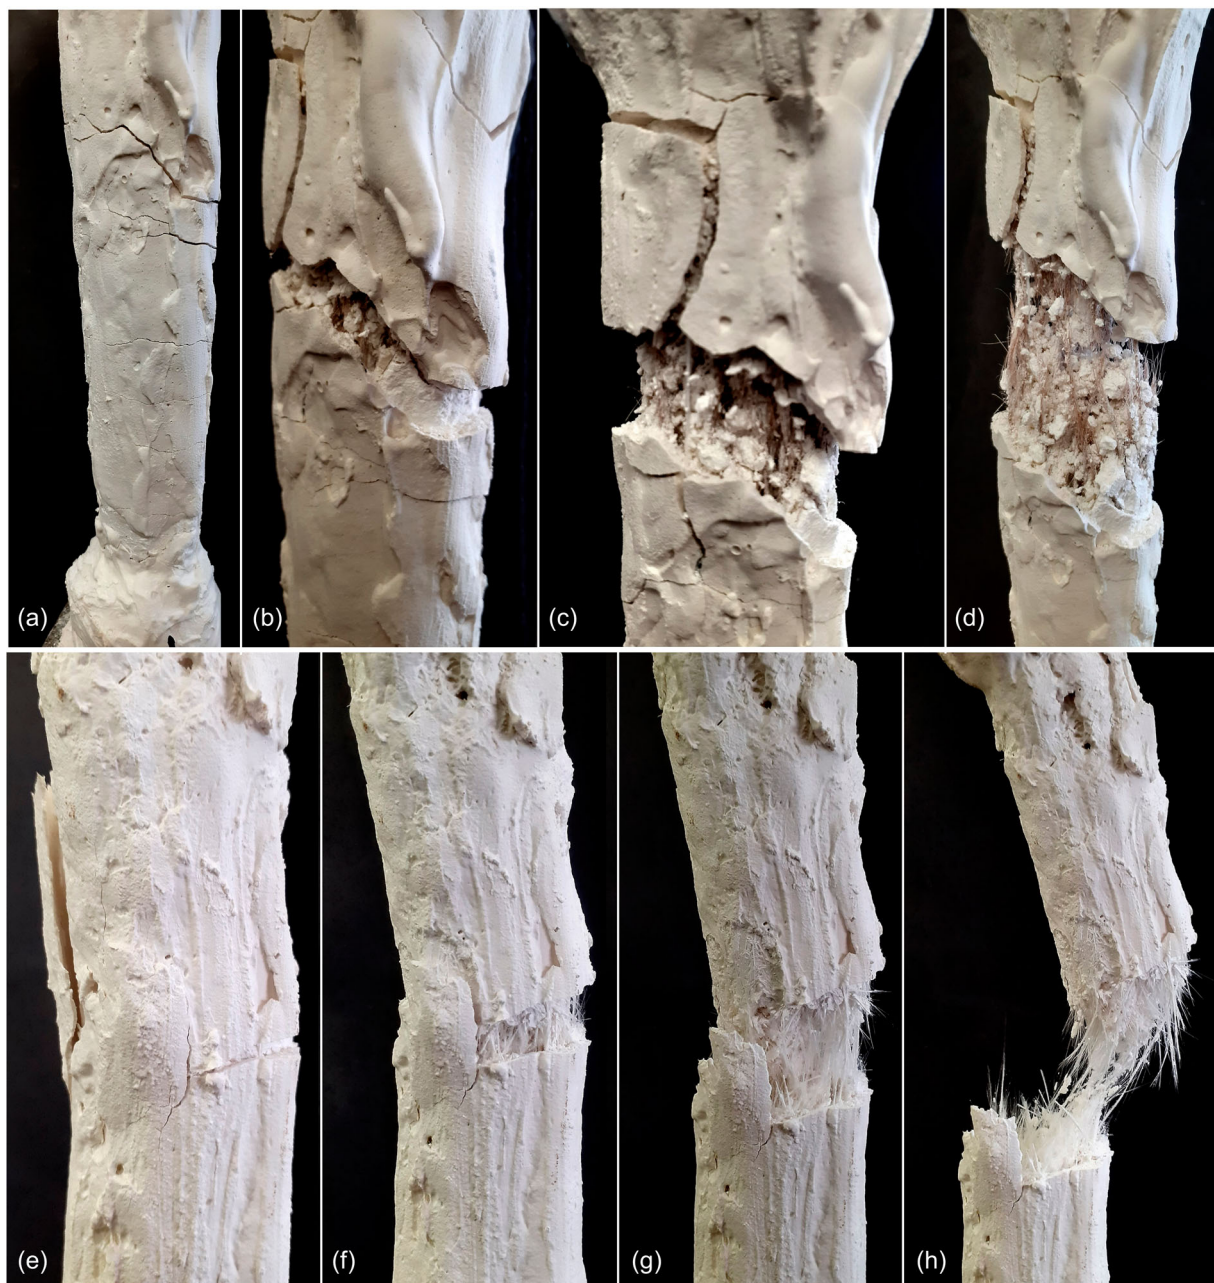
**Figure 8.** Failed specimens from sample groups 1 and 4, with hessian (group 1, a – d) and CFG (group 4, e – h). Hessian fibres did rupture but the wad specimen did not break entirely, continuing to function on a very small loading. CFG scrim did ultimately break the wad specimen into two.

Images of the failed wads in sample groups 1 and 4 are shown in Figure 8. Wad failure in both sample groups was initiated by the gypsum matrix cracking while the loading continued to increase before being controlled by the ability of the reinforcing fibres to resist loading. Failure in all specimens occurred in the central wad section as intended, with no visible cracking around the 'eye' at either end. In the hessian images 8a – d, the gypsum plaster matrix cracks, exposing the hessian fibres, with the fibres elongating and rupturing gradually, with some fibres still intact and able to support reduced loads at the 40 mm displacement test limit. In contrast, in images 8e – h the CFG reinforcement can be seen to entirely rupture, resulting in the wad specimen fracturing into two. The plaster surrounding the hessian reinforcement is more likely to spall or break off in small pieces (as confirmed by the loading profiles), giving warning signs of impending failure.

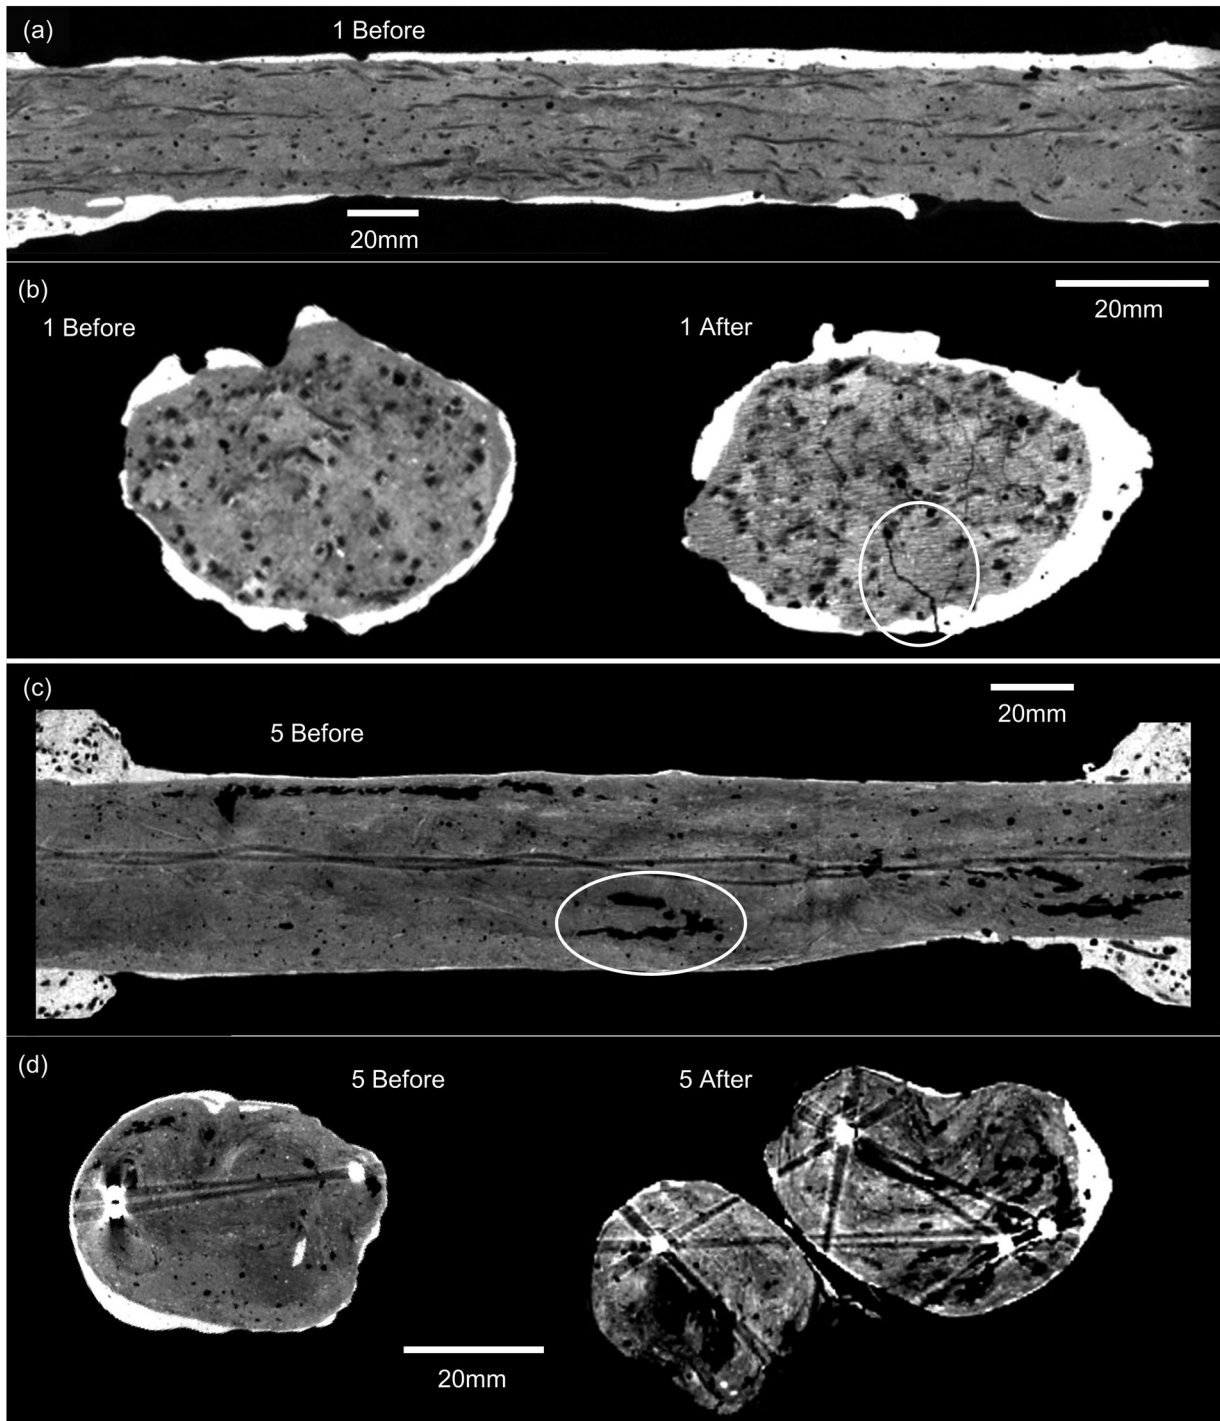
**Figure 9.** XRT images of fibre-plaster distribution and cracking using groups 1 and 5, taken both before and after testing (note: a group 5 image was used as group 4 was not imaged): (a) Group 1 longitudinal image before testing; (b) Group 1 cross-sections before and after testing; (c) Group 5 longitudinal image before testing; and (d) Group 5 cross-sections before and after testing.

Figure 9 shows XRT images of hessian and CFG reinforcement within the plaster matrices of test specimens. The Figure 9(a) image of sample group 1 (hessian) before testing reveals the hessian fibres running in orthogonal directions with the fibres soaked in the plaster with no large voids present. The cross-section sample 1 in Figure 9(b) features cracks in the plaster matrix, with a notable crack (circled) reaching the exterior of the wad specimen. The group 5 specimen longitudinal image (Figure 9(c)) illustrates the plaster-CFG distribution containing notable voids throughout the wad sample (one void highlighted) corresponding with the observation that CFG was more challenging to work with during the wad manufacturing process. Plaster cracks in the

before and after cross-sectional images of sample group 5 (Figure 9(d)) are less apparent, reaffirming that plaster cracking in the hessian samples is more pronounced, but again voids are visible where plaster is not present at all within the wad area; therefore, parts of CFG reinforcement were not in contact with plaster, resulting in decreased composite action. It is reasoned that the superior weight of CFG sample groups in Figure 6(f) is solely down to the superior weight of the CFG scrim as there is typically less plaster within the wad sections of CFG-reinforced specimens.

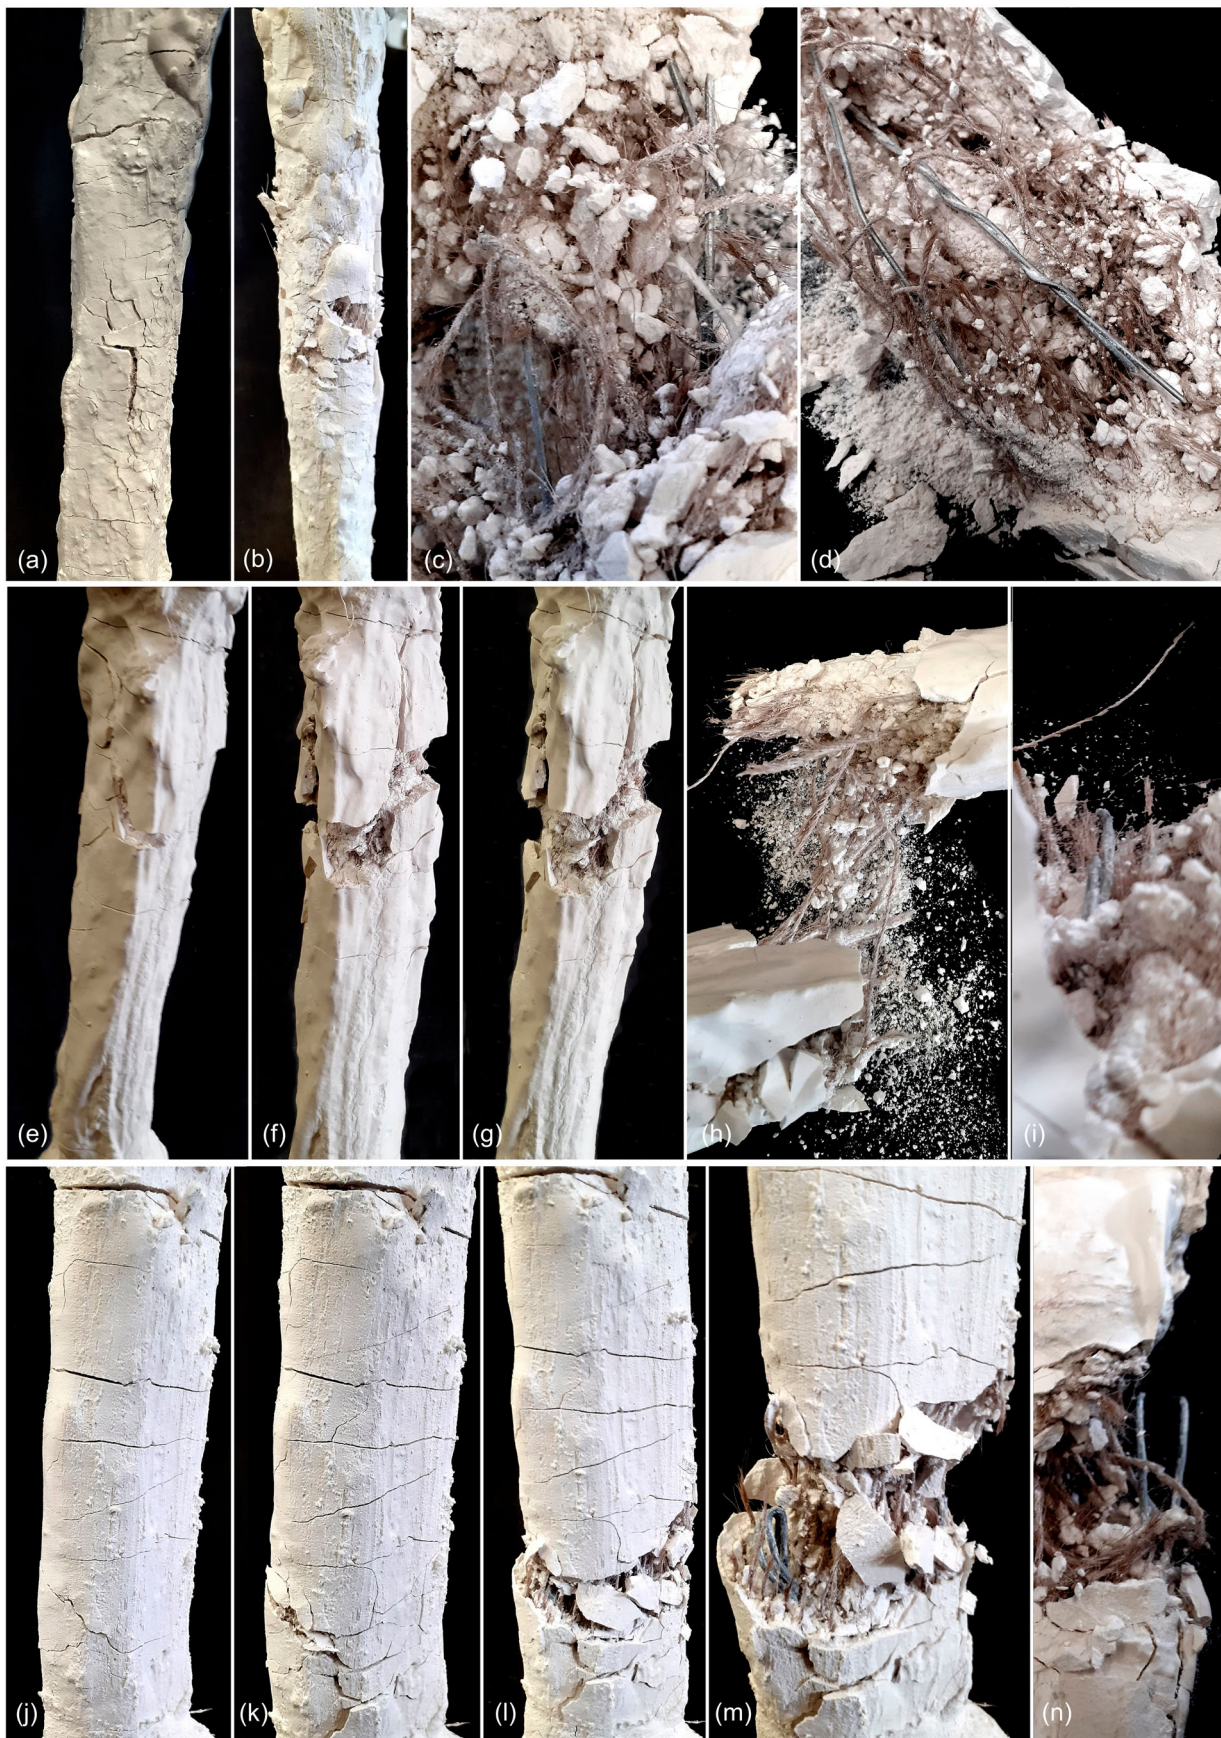
**Figure 10.** Failed specimens of hessian reinforced wads with steel wires – sample groups 2, 3, and 9: looped (group 2, a – d), looped-twisted (group 3, e – i), and twisted-end (group 9, j – n). Group 2 steel wires elongated and typically supported lower maximum loads but did not break. Group 3 and 9 wires could support higher maximum loads, but wires did break.

Figure 10 shows photographs of the failure of wads from groups 2 (a – d), 3 (e – i), and 9 (j – n). The images show multiple cracking of the plaster, and the gradual failing of the fibres with ultimately the steel wire failing in groups 3 and 9 by a visible break in the wire. A breakage in the wire in group 2 is not evident. Figure 11 shows XRT images of a group 2 specimen before and after testing (top) and a group 3 specimen before and after testing below, with the wires highlighted in green and again shown in both isolation

and within the plaster matrix. In group 2, while the wire is twisted and elongated, there is no evidence of breakage in the steel, confirming that the sudden drop in the loading of group 2 can be attributed to the wire unwinding. Whereas in the group 3 image, the breakage of the steel wire is evident, although no further breakage was evident in the image along the full length of the wire. This confirms that of the two sudden drops in loading observed in the load-displacement profiles for group 3, one of these can be

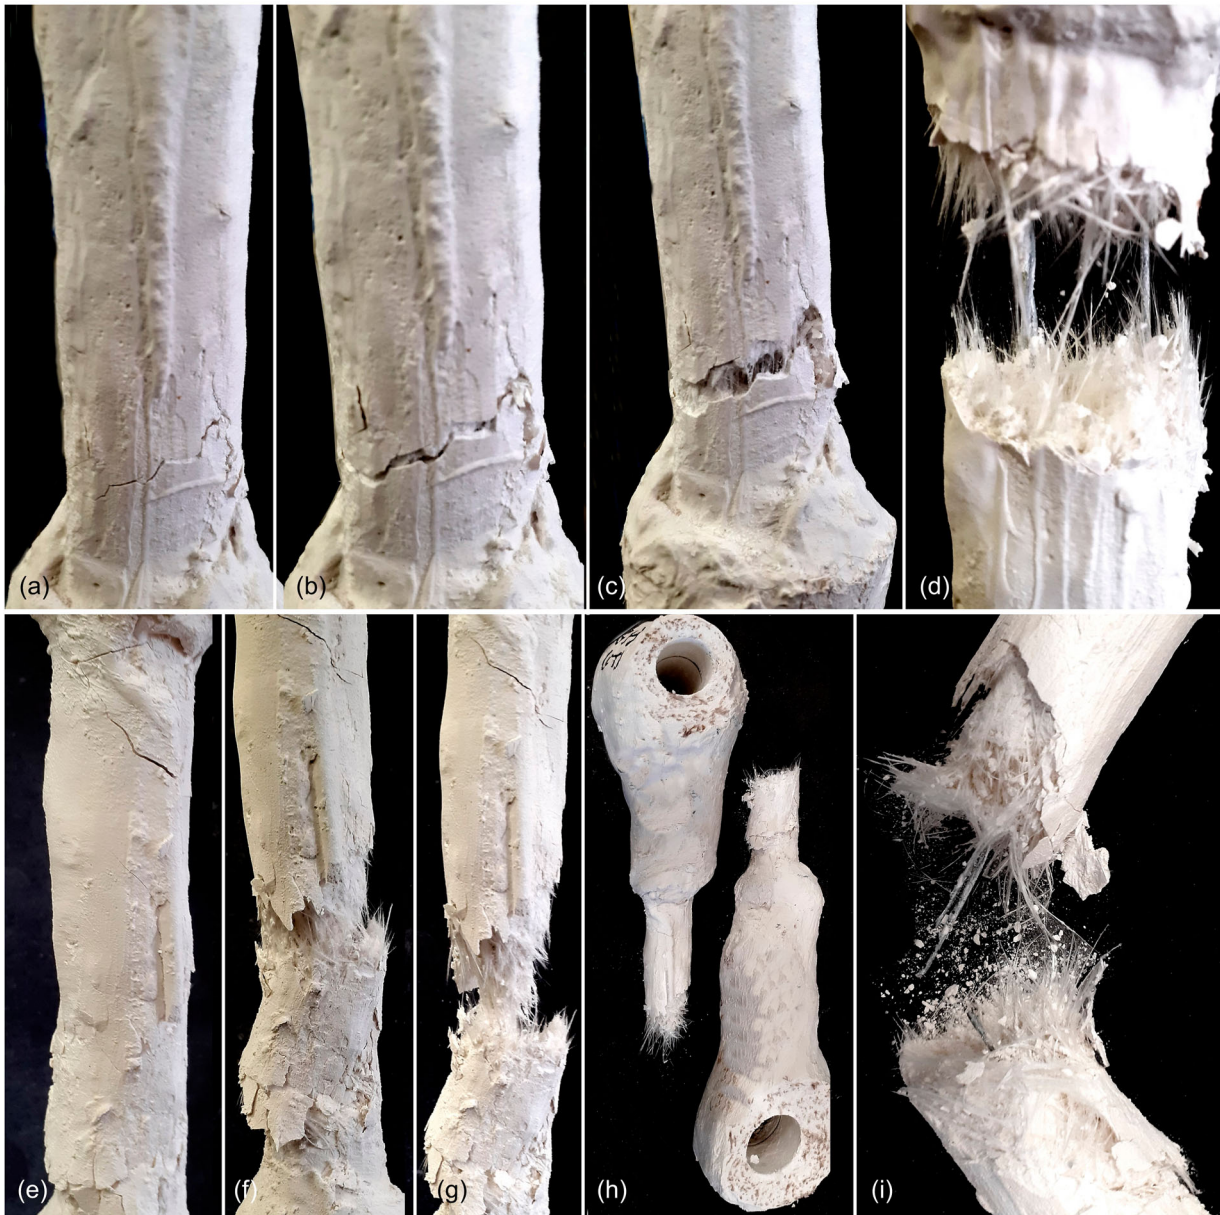
**Figure 12.** Failure specimens of CFG reinforced wads with steel wires – sample groups 5 and 6: looped (group 5, a – d) and looped-twisted (group 6, e – i). Group 5 looped steel wires elongated and typically supported slightly lower maximum loads but did not break (although CFG fibres did). Group 6 wires could support slightly higher maximum loads, but wires did break in addition to the CFG fibres, resulting in specimens entirely broken in two. CFG samples typically displayed less small plaster cracks in multiple locations than hessian groups, but more pronounced primary cracks prior to failure.

In the load-displacement profile (Figure 7(c)), the steel wire in group 5 has clearly not broken in this profile as the sudden decrease can be attributed to unwinding, however, the elongating steel wire could still sustain a load of around 1 kN, suggesting this was not a breakage. Figure 12 shows images of specimens from groups 5 (a – d) and 6 (e – i) failing. It was observed that the plaster matrix in the wads displayed fewer small cracks in multiple locations (which happened in the hessian fibre groups), but instead

developed a singular large crack which ultimately resulted in the complete failure of the CFG mat, breaking entirely, resulting in the wire being exposed. Figure 13 shows XRT images of a group 5 specimen before and after testing (above) and a group 6 specimen before and after testing (below) with the steel wires highlighted in green and shown both in isolation and within the plaster matrix.

In the Figure 12 image, the example load-displacement profile in Figure 7(c) and majority of profiles in Figure 6(e), the group 5 wire did not break, but the Figure 13 XRT images show that a group 5 looped wire within a CFG reinforced wad had the potential to break, as separation was observed. Under these exceptional circumstances, the fibres would have broken entirely transferring the load onto the steel wire, unlike most other hessian fibre samples where some fibres remained intact within the displacement limits of the tests and looped wires unwound but did not break. In all cases the group 6 wires showed a single break, therefore, as with the hessian reinforced sample group 3, the two larger sudden decreases in load can be attributed to one unwinding occurrence and one breakage. Wires did not break towards the ends of the specimens, with breakages of both CFG and wire occurring along the length of the central wad sections of the specimens. It is reasoned by this study that CFG reinforcement is a less suitable modern alternative to traditional hessian scrim for reinforcement of fibrous plaster wad applications. Quadaxial glass fibres are a further modern option and these will be investigated by the authors in an ensuing phase of experimentation.

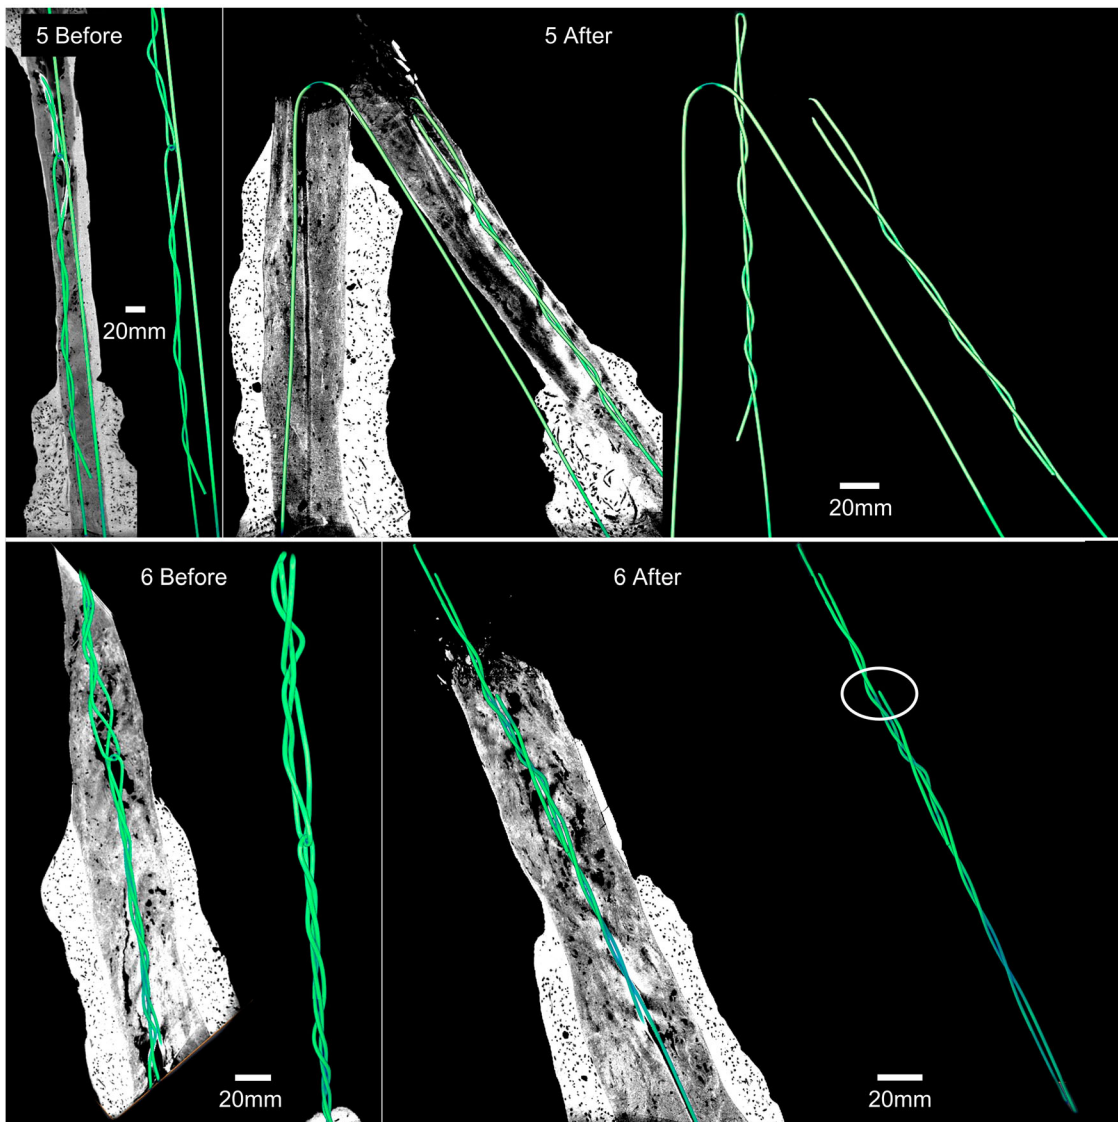
**Figure 13.** XRT images of a group 5 specimen before and after testing (above) and a group 6 specimen before and after testing (below) with steel wires highlighted in green both exposed and within the plaster matrix. In the group 5 image the looped wire has a break in this specimen, which was not typical of group 5 specimens, but showed that in addition to unwinding, the looped specimen can become detached in a CFG reinforced specimen. All wires in looped-twisted group 6 ultimately failed by breaking.

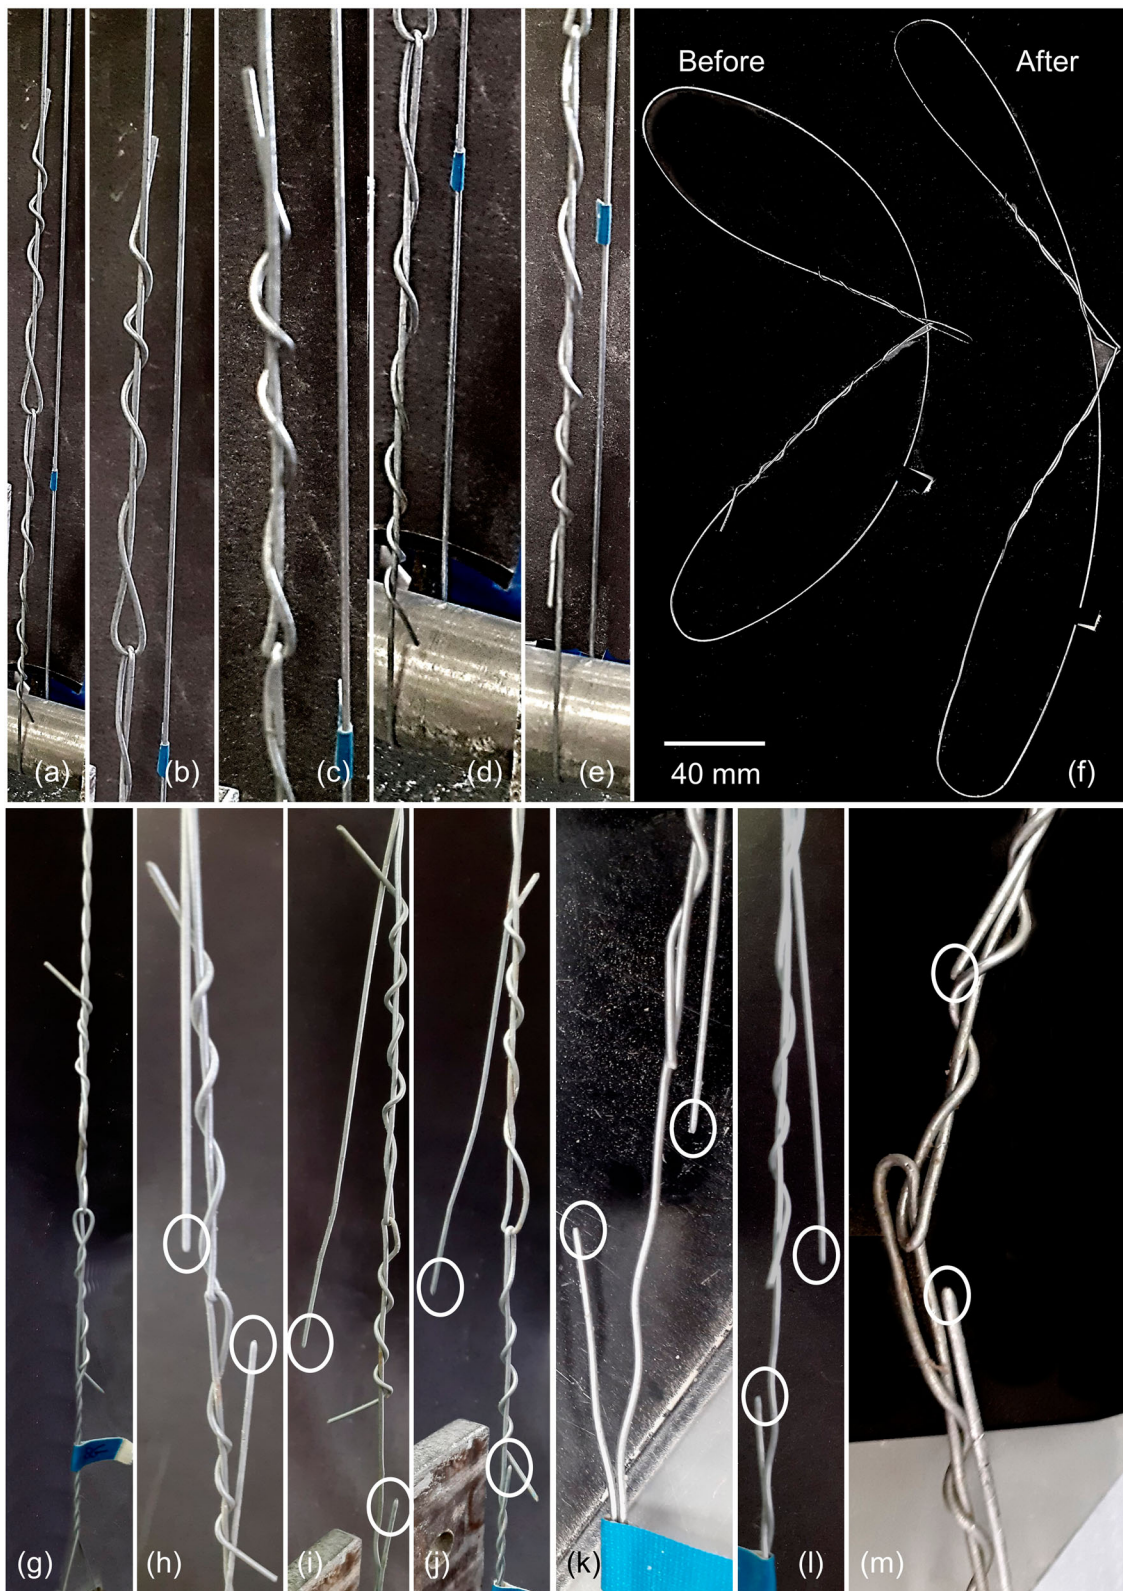
**Figure 14.** Wire tensile test for steel wire sample groups 7 (looped, a – f) and 8 (looped-twisted, g – m). Sample 7 looped wires elongated significantly but did not break, whereas the looped-twisted group 8 wires did break.
