**AN EXPERIMENTAL AND FINITE ELEMENT STUDY OF
THE LOW-CYCLE FATIGUE FAILURE OF A
GALVANIZED STEEL LIGHTING COLUMN**

James Wood^a, Louise A. Alexander^b and Ian Taylor^b

This paper presents the results of a low-cycle fatigue test on a lighting column. The wind induced vibration phenomena responsible for low cycle fatigue in such structures is discussed and the failure mechanism is examined. It was initially thought that poor quality weld detail was the major influence on the fatigue life of such columns. However, the significant role of the galvanised coating in the failure process is also highlighted.

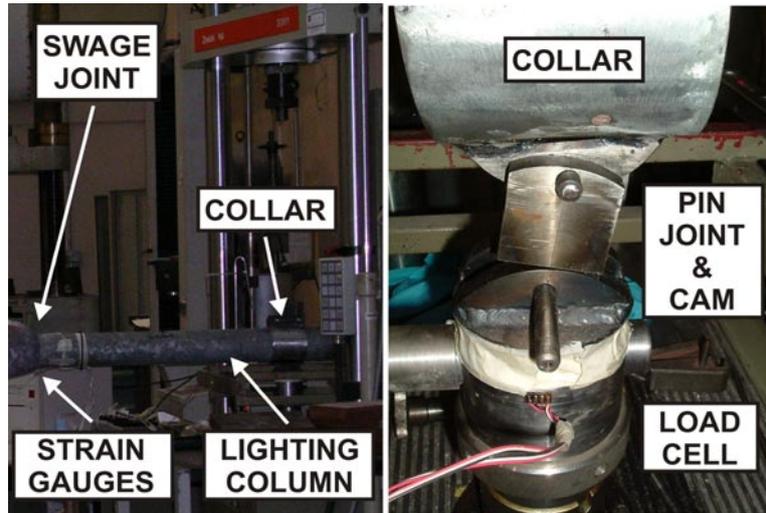
Figure 2: Test set-up showing servo-hydraulic test machine and loading arrangement.

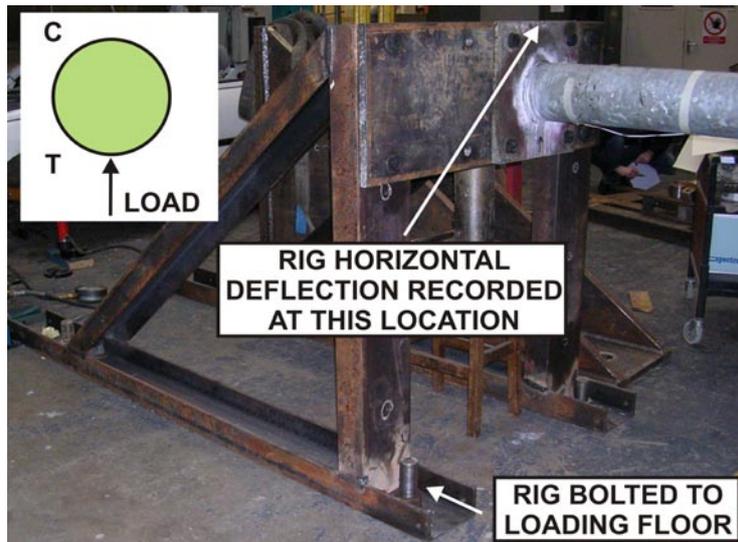
Figure 3: Test set-up showing test frame and lighting column.

The column was mounted horizontally in a test frame and the load was applied via a servo-hydraulic test machine. The shortening of the column was necessary due to the particular capacity of the test machine, in terms of load, cross head travel and cyclic rate.

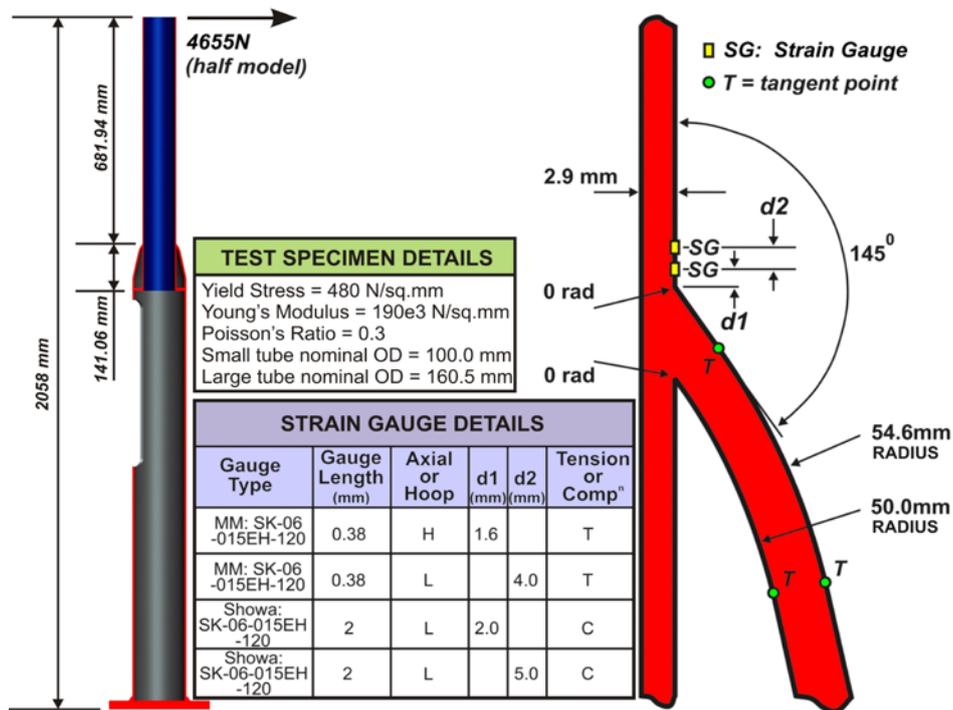
The shortened lighting column was instrumented with strain gauges (on both the tension and compression sides of the column) as shown in Figure 4.

Figure 4: Test specimen and instrumentation details.

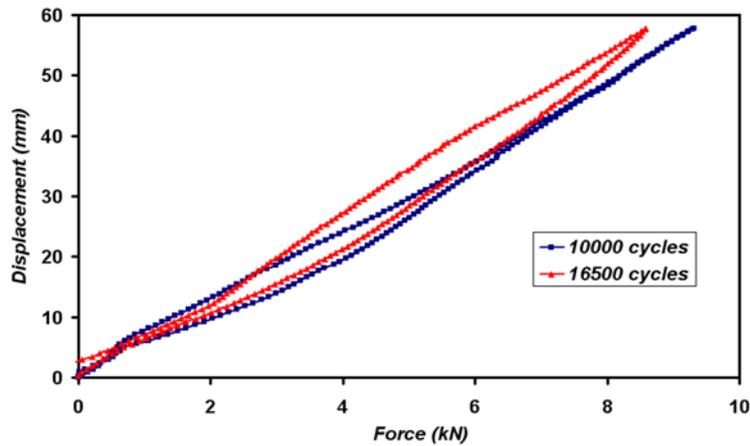
As mentioned previously, this was a displacement controlled test and Figure 6 shows that the load required to displace the column by 58mm had fallen slightly between the 10000 and 16500 cycles. There is also an observable increase in the size of the hysteresis loop, which is to be expected.

Figure 6: Load versus displacement for 10000 and 16500 cycles.

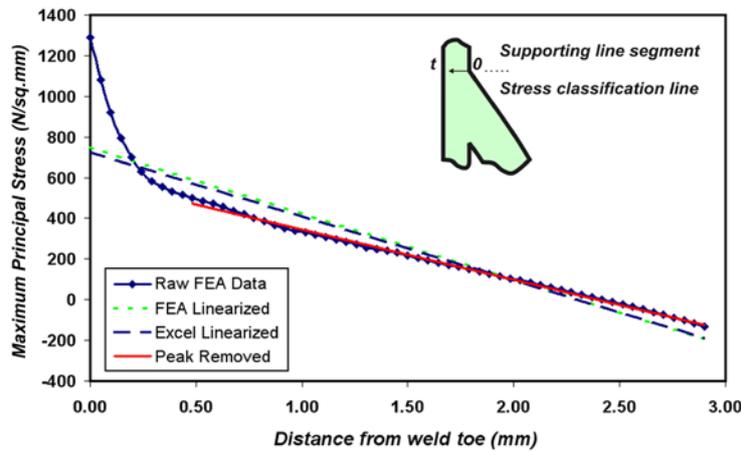
The fatigue data contained in codes of practice for welds already includes the effect of the weld. Assessment therefore requires removal of this component from analysis results, before comparison is made with the S-N data. Through thickness methods which use a linearization process will be influenced by the curved portion of the “Raw FEA Data” line in Figure 11. That is, the slope of the membrane plus bending line obtained will be affected by the linearization process itself. It is in fact this curved portion of the line which must be removed. The logical approach therefore would simply be to fit a linear trend line to the straight portion of this curve and to extrapolate it to the toe position.

Figure 11: Through-thickness Peak Stress Removal Methods.

The Excel Linearized line is simply a best-fit straight line fitted to the entire data. The FEA Linearized line on the other hand, used the linearization algorithm inherent in most FEA systems. In this case the linearization is carried out on a stress component basis, before recombining to obtain the membrane plus bending components of the principal stresses.
