An Investigation of Diesel-Generator Shaft and Bearing Failures.

Abstract: A shaft failure in a 634 kW diesel generator after 4000 hours of operation required investigation, especially when similar sets began to show signs of excessive bearing housing wear. The failure was found to be due to torsional fatigue caused by operation at an unforeseen resonant condition. The damage to the bearing housing of this type of set was also attributed to this behaviour.

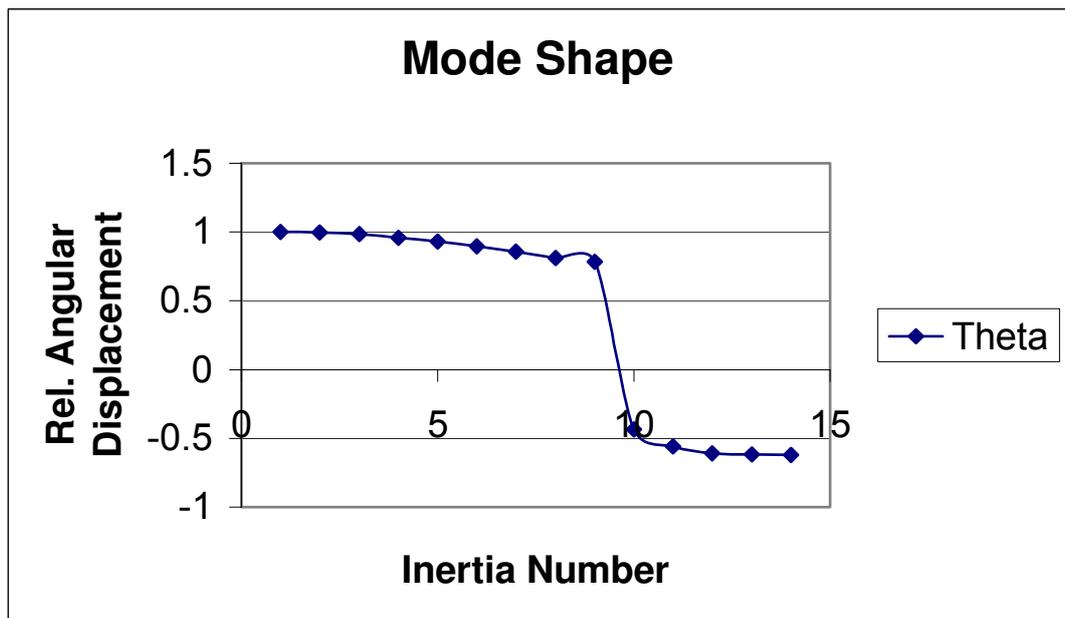
Figure 6 Torsional mode shape for diesel-generator set at full load.

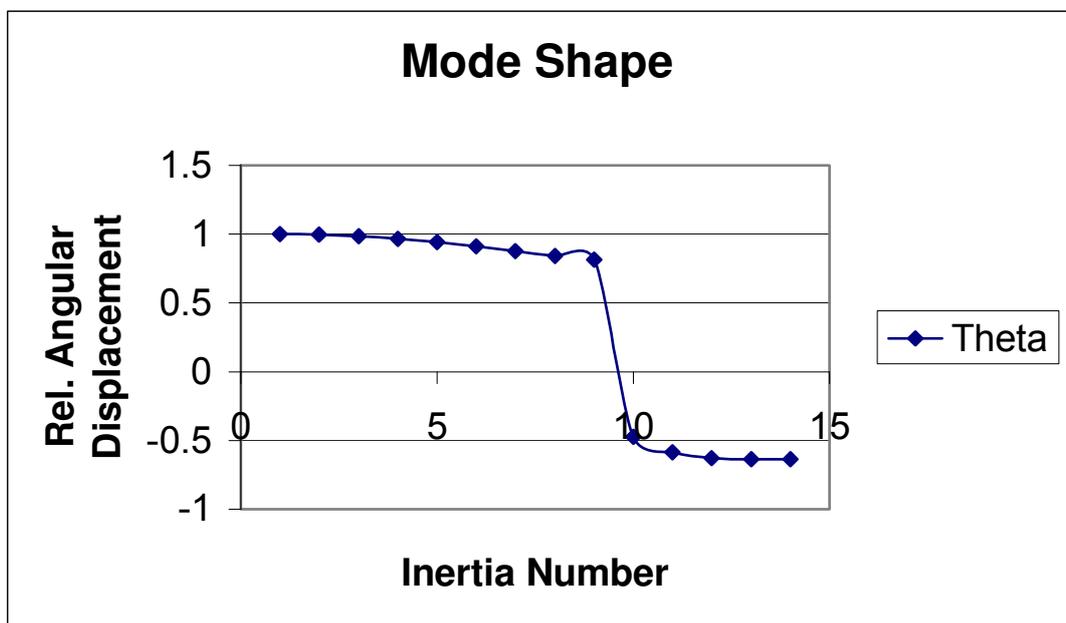
Figure 7 Torsional mode shape for diesel-generator at 89% load.
