1 **Structural integrity monitoring of onshore wind turbine concrete foundations**

2 Magnus Currie^{1*}, Mohamed Saafi^{2*}, Christos Tachtatzis³ and Francis Quail⁴

7 **Abstract**

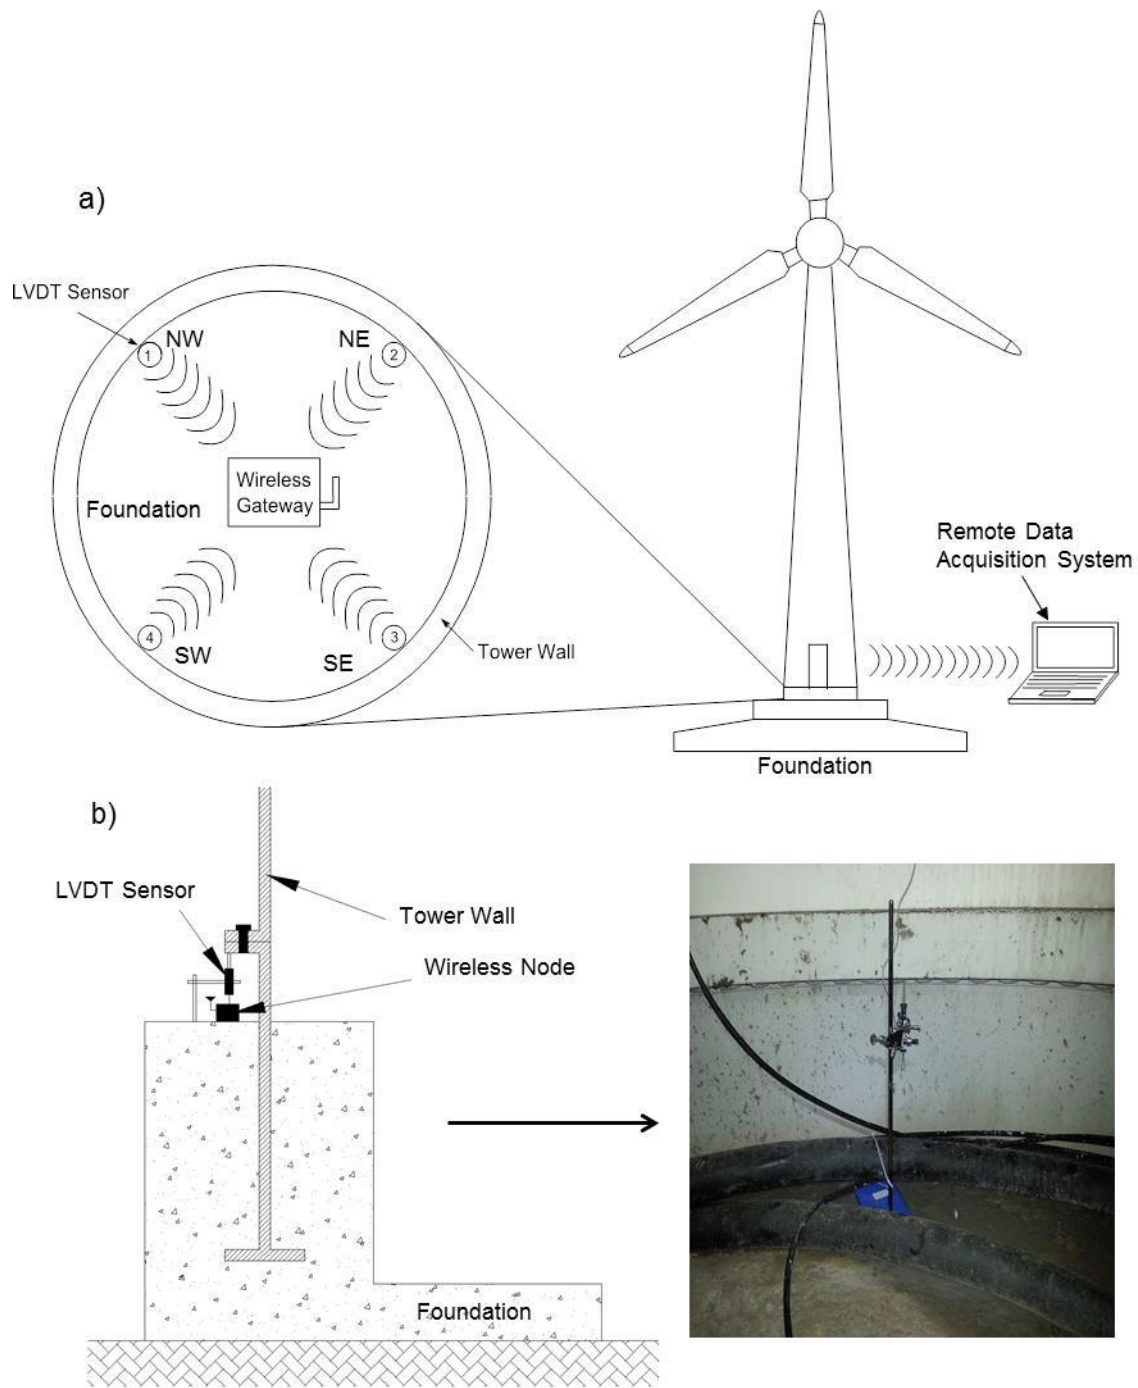
Fig. 4. a) SIM architecture and b) sensor installation.

121 The sensors were positioned equidistant around the foundation (see Fig. 4a). The measurement
122 points are numbered on the figure as 1 NW (North West), 2 NE (North East), 3 SE (South West)
123 and 4 SW (South West). These points were selected because the prevailing wind conditions on
124 the site were south-westerly in nature. Using these measurement points, the sensor array would
125 capture the displacement on planes parallel and perpendicular to the prevailing wind. The LVDT
126 sensors were installed to measure the displacement between the static concrete foundation and
127 the embedded ring. It was essentially measuring the movement of the embedded ring at the
128 connection with the tower. Retort stands were used to keep the sensors with a heavy weight base
129 and the attachments were locked in position using thumbscrews, preventing any movement
130 during operation. The LVDTs were set half compressed, allowing vertical upwards and

131 downwards movements to be recorded. The LVDT installed in the foundation had a maximum
132 stroke of 50 mm; hence they were installed at a set position of 25 mm. Fig. 4-b shows the sensor
133 location along with the method of anchoring the sensor.
