Ultrasonic Imaging of Electrofusion Welded Polyethylene Pipes Employed in Utilities Industry

Abstract

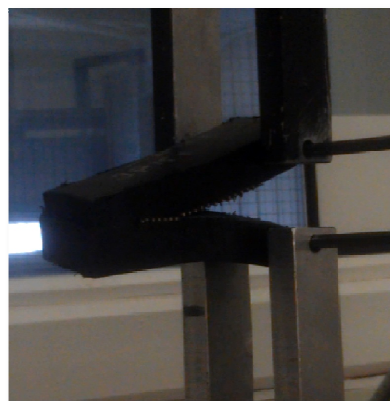
Figure 12: (Left) Instron tensile testing device (Right) Weld being pulled apart during destructive testing

Once the samples were ultrasonically inspected, they were destructively tested by the double cantilever cleavage test. Six rectangular sections of diameter approximately 20 mm were cut from each weld using a band saw, ensuring the pipe and coupling surfaces remained parallel to the axis formed by the weld interface. Two holes were drilled at the cold zone end – one through the coupling and the other through the pipe, to fit metal pins. The *Instron* tensile testing machine was used to pull the joint apart at a constant rate (See Figure 12), with data being logged for the *Force/Displacement* value. From this data, the mean value for a weld is noted and used to determine weld strength.
