An experimental approach to analysing rain droplet impingement on wind turbine blade materials

Craig Siddons^{*}, Calum Macleod^{**}, Liu Yang^{**}, and Margaret Stack^{†**}

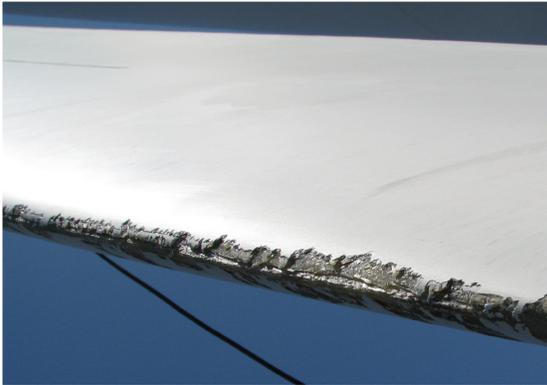
Figure 1: An example of leading edge erosion [2]

Leading edge erosion is an urgent and important issue in the wind turbine industry, and many examples of eroding blades have been observed in the past, an example of which can be seen in Figure 1. The issue is of the up-most importance as the energy yield from the turbine can be substantially reduced as shown by Sareen et al. [1]. In the study, the conditions of different types and severities of erosion were constructed as observed from damaged blades on actual wind farms which included pitting, gauging and delamination. Using the authors calculations, energy production losses were estimated to be between 3.5% and 23.5% with respect to the severity of the damage pattern present. Also, if left unattended the structural integrity of the blade could also be at risk. In reality however, this is not the case and wind turbine blades are regularly maintained to prevent any loss in energy capture/ potential revenue to the owner. Whilst onshore the issue is of lesser importance, offshore turbines suffer from considerably greater logistical constraints. This means that wind farm operators are incentivised to minimise the frequency and severity of maintenance on their turbines, in order to reduce costs.

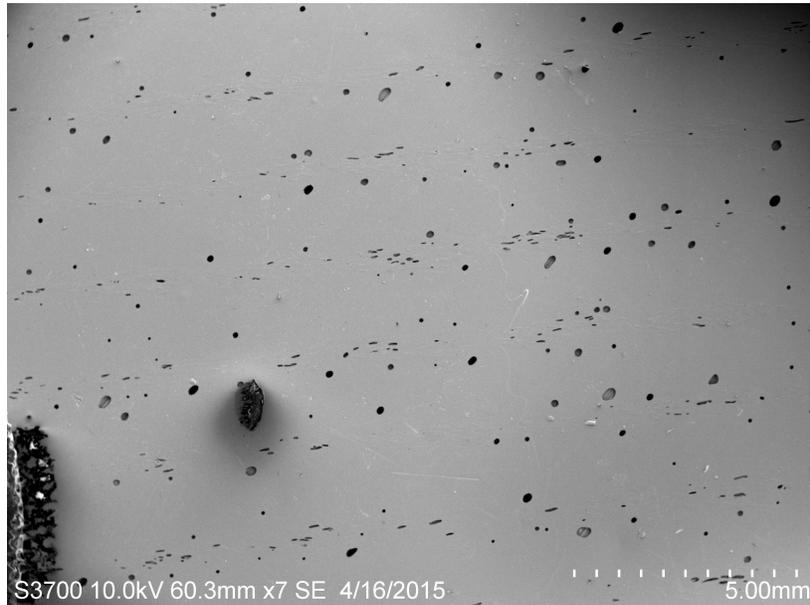
Figure 2: Presence of pre-existing pin holes in the untested sample

SEM analysis was performed on one of the blank samples as shown in Figure 2. Pin holes of approximately 150-270 μ m in diameter can be seen- these pin-holes are an unavoidable consequence of infusion formation process and is the result of small air bubbles caught in the vacuum bag. The vacuum infusion process can minimise these defects compared to other formation

processes, but they can not be wholly avoided.
