Mapping Blade Angle Effects for The Erosion of Polymer Based Composites: An Approach to Developing Smart Materials for Tidal Turbines

Rafee A.R Ahamed, Cameron M. Johnstone, Margaret M. Stack

*Department of Mechanical and Aerospace Engineering, University of Strathclyde
James Weir Building | 75 Montrose Street, Glasgow, G1 1XJ, United Kingdom*

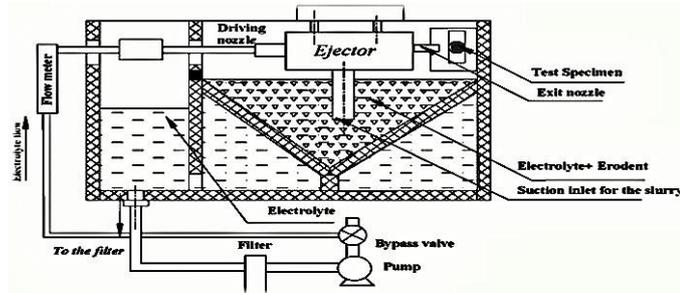
Fig. 1 Schematic diagram of slurry impingement jet rig

A schematic diagram of the slurry impingement jet rig is shown in the figure 1. The rig is equipped with a 'T' shaped ejector and it controls the erosion parameters by setting up the

ratio of inlet nozzle to the outlet nozzle diameter (d/D), and the L - distance [6]. The erosion test was performed at three different impact velocities of 2.5ms^{-1} , 4.5ms^{-1} , and 6.5ms^{-1} and the corresponding combinations of inlet and outlet nozzles are 2.8mm & 6.52mm (2.5ms^{-1}), 3.6mm & 6mm (4.5ms^{-1}) and 3.6mm & 4.48mm (6.5ms^{-1}). The impingement angle was adjusted in the range of $15\text{-}90^\circ$. The slurry mixture consist of 3.5% of the salt and 3% of irregular silica sand as a erodent. Table 2. The silica sand particles were supplied by the Fife Silica Sands Ltd. The samples were tested one at a time by fixing onto the specimen holder and eroding for 30 minutes.

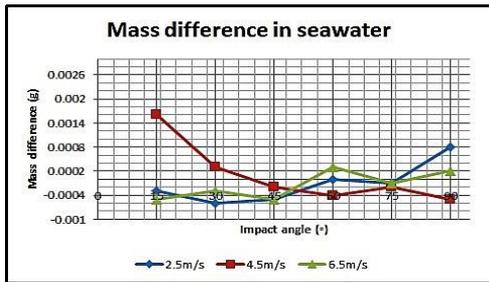
Fig 3. Mass difference as a function of impact angle in seawater

Figs 3 and 4 display the influence of various environments, the impact angle and the impact velocity on the mass difference of the test samples. The test samples from the seawater condition has gained weight, whereas the samples in the test slurry achieved a dramatic mass loss. All the test samples weighed within an accuracy of 10^{-4}g . It is apparent that from the test results that intermediate impact angles have a marked more interaction with the slurry solution and the particles. This is discussed in detail under the effect of impingement angle section below.

Angle of impingement is usually defined as the angle between the trajectory of the solid particle and the specimen surface [9] and therefore typically the angle of attack of the blade through the water. It is a widely studied and important parameter in the erosion study of materials [9]. Figs. 3 and 4 show mass loss as a function of impact angle for three different speeds under 2 conditions. The result shown in fig. 3 indicate that, the test samples seem to gain weight at certain angles and varies accordingly. Fig. 4 indicates that there is a significant amount of mass loss. Increases in impact velocity dramatically increases the mass loss. For example the mass loss is found to attain a peak at 4.5ms^{-1} (0.21g) at 60° . The change of environment has a significant impact; factors such as erodent particle, impact angle and the impact velocity increases the mass loss, this attaining a peak at intermediate impact angles [10], [11]. The reduction of the mass change at higher velocities i.e. 6.5ms^{-1} may be due to frictional heating leading to a more ductile response to the erosion impacts and to the absorption of more salt on the composite at the higher velocities.

The combined effect of the impact velocity and the impact angle of the particles is clear in the Figs. 3 and 4. Other parameters such as hardness of the erodent particle, their distribution and the exposure time should be considered. Previous studies on the behavior of GFRP materials indicate that so-called “ductile” and “brittle” erosion behaviour of the test samples is generally observed at an acute angle ($15\text{-}30^\circ$) and (90°) [11], [12].

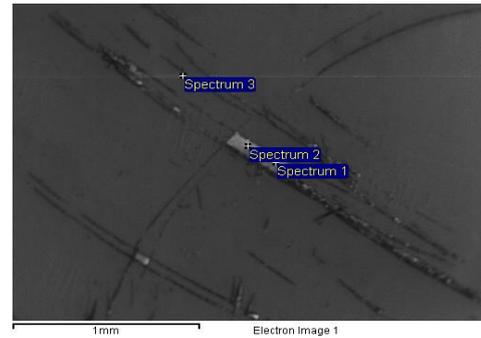
Fig 6. SEM surface image of the eroded sample under seawater condition at 60°

eroded in the speed of 2.5ms^{-1} at 60° . This phenomenon was observed on the other samples tested in the seawater condition with different impact velocities. The impact velocity is the key factor and it heavily influences the crystal deposition on the surface. Fig. 6 justifies the above phenomenon and clearly indicates the salt crystals dried on the surface of the samples and suggests that it increases with the impact velocity. In order to support the evidence, table 3 accounted the percentage of the salt deposited on the surface of the sample and it is noted that 5.98g of sodium and 6.84g of chloride are present on the surface. There was no indication for the presence of erosion under this condition on any of the samples.

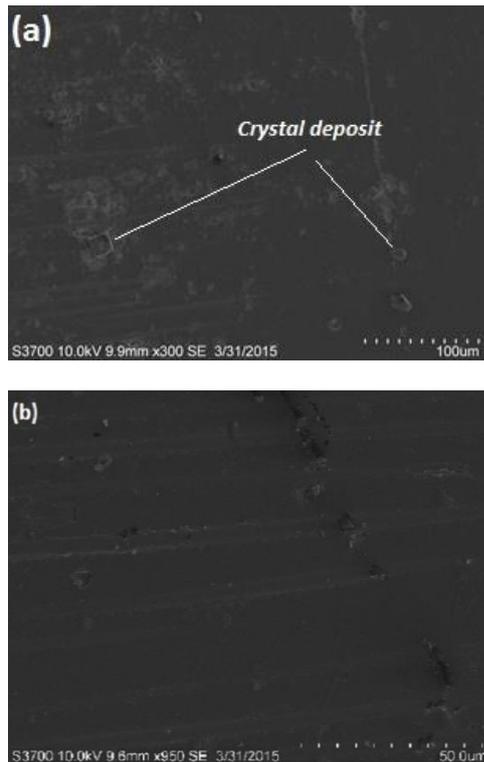
Fig 5. (a) A close image of a surface in seawater at 60° , (b) A close view of a surface in test slurry at 60°

Fig. 5 (a) clearly indicates the deposition of salt on the surface of the test sample whereas, the Fig. 5 (b) shows the initial formation of indentations/cracks. Both surfaces were

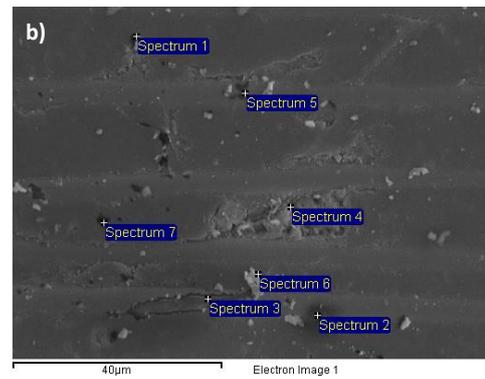
Figure 7 - SEM surface images of eroded a) 6.5ms-1 b) 4.5ms-1 at impingement angle 60°

samples at three different impact velocities for the fixed impact angle of 60° . On magnifying the samples, Fig 7 (a & b) clearly shows the formation of a large crater shaped cavity, and a multiple indentation marks associated with some linear scratches. These phenomena were consistent with other samples under similar conditions. Further results with different impact angles shown different mechanisms of erosion. Fig. 8 (a) shows a significant extruded region on the surface whereas, the Fig. 8 (b) shows an extended platelet formation. Fig. 9 (a) demonstrates a significant amount of lateral cracking and the presence of fragmented silica particle scattered over the eroded surface, Fig. 9 (b). The formation of a large crater is possibly associated with fiber fragmentation. Fig. 10 (a) shows the formation of fiber fracture along with some evidence of minor indentations. Fig. 10 (b) indicates platelet like morphologies with fiber fragmentation over the eroded surface.

Further research to understand the solid particle erosion on the test samples was undertaken through testing at multiple impact velocities and impact angles. Fig 7 indicates the surface morphologies of the eroded samples at three different impact velocities for the fixed impact angle of 60° . On magnifying the samples, Fig 7 (a & b) clearly shows the formation of a large crater shaped cavity, and a multiple indentation marks associated with some linear scratches. These phenomena were consistent with other samples under similar conditions. Further results with different impact angles shown different mechanisms of erosion. Fig. 8 (a) shows a significant extruded region on the surface whereas, the Fig. 8 (b) shows an extended platelet formation. Fig. 9 (a) demonstrates a significant amount of lateral cracking and the presence of fragmented silica particle scattered over the eroded surface, Fig. 9 (b). The formation of a large crater is possibly associated with fiber fragmentation. Fig. 10 (a) shows the formation of fiber fracture along with some evidence of minor indentations. Fig. 10 (b) indicates platelet like morphologies with fiber fragmentation over the eroded surface.

The surface morphology of eroded surfaces indicates the modes of erosive wear occurred on the surface of the test samples. Hence, scanning electron microscopy (SEM) studies are used to determine the wear mechanism at $15\text{-}90^\circ$ impingement angles. Fig. 7 (a & b) show the micrographs of eroded surfaces at two different speeds (6.5 and 4.5ms^{-1}) at fixed 60° impingement angles. It is evident from the micrograph that the material removal in the composite is dominated by the formation of a large crater shaped cavity, and multiple indentations associated with some linear scratches. A similar effect was observed in the samples tested at the 2.5ms^{-1} impact velocity. Fig. 8 (a & b) demonstrates the micrographs at 45° impingement angle at 6.5ms^{-1} & 4.5ms^{-1} impact velocity; the process of material removal gradually starts increasing at 45° and it reaches the peak at 60° impingement angle, whereupon the test samples experience significant erosion penetration. In order to understand the transitions at lower impact angles i.e. between the ($15\text{-}30^\circ$), Fig. 10 (a) shows the formation of fiber exposure along with moderate indentation over the entire surface, with Fig. 10 (b) indicating evidence of fiber fragmentation over the eroded surfaces, with an absence of formation of deeper cracks on the composite surface. Therefore, for the conditions above, the reinforced composites exhibit a semi- ductile behaviour having the maximum erosion rate in the range of $45\text{-}60^\circ$ [16].

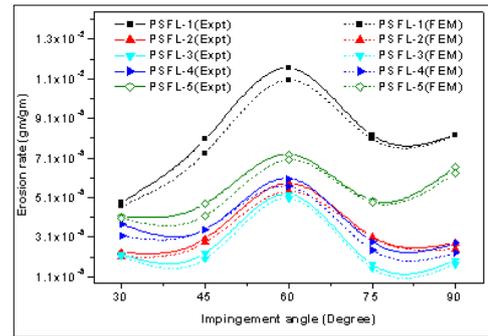
Fig. 11 Semi ductile erosion behaviour[15]

are often seen in the literature: brittle and ductile erosion [13]. “Ductile” erosion describes material removal due to cutting and ploughing, while “brittle” erosion involves material removal due to the formation of cracks. Generally, for polymer composite materials, with a combination of ductile matrix and brittle reinforcement, behaviour intermediate between these modes is observed in the literature, dependent on the fabrication process, the properties of the composite and the erosion footprint defined by the erosivity of the impacting particles [14], [15]. As it is shown in Fig. 11, the semi ductile erosion behaviour of GFRP was also reported by Patnaik et al. [15] in which the maximum erosion appeared at 60° at various fiber volume fractions. This indicates that achieving the maximum erosion rate in the range of $45\text{-}60^\circ$ is not unexpected and the results above are consistent with such observations.

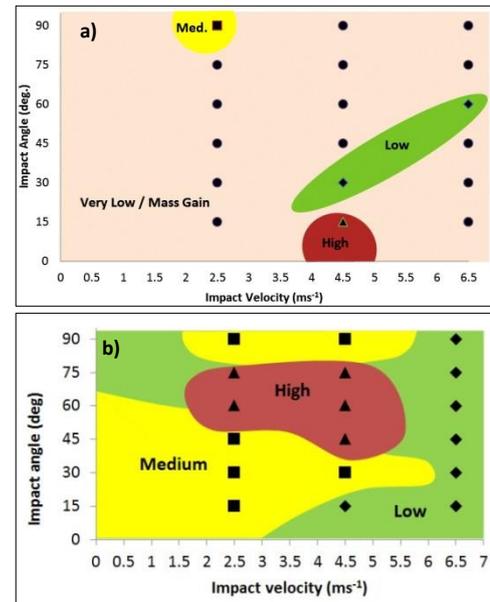
Fig. 12 Wear mode map for test conditions (a) Seawater (b) Particles + seawater

Wear maps indicate mechanistic changes on the degraded surfaces of the test samples over a range of operating conditions [18]. The construction of wear mode maps assists in understanding and identifying the mechanisms involved in the material degradation and the chemical effects involved in the surface. Wear mode maps highlight the wastage rates and indicates the potential safe operation conditions for the material chosen [19]. Fig.12 shows the wear mode maps for two different conditions. The wear modes are classified into four distinct regimes, namely (a) very low / mass gain, (b) low, (c) medium, and (d) high. The wear mode boundary limits are as below:

- a) Very Low/Mass gain $\leq 2.1 \cdot 10^{-4}g$
- b) $2.1 \cdot 10^{-4}g < Low \leq 6.3 \cdot 10^{-4}g$
- c) $6.3 \cdot 10^{-4}g < Medium \leq 1.47 \cdot 10^{-3}g$
- d) $1.47 \cdot 10^{-3}g < High$

Fig. 12 (a) maps the wear mode regimes for the seawater condition only and it clearly indicates the dominance of very low mass loss / mass gain. As a result of comparison, there is almost no evidence indicating potential unsafe operating condition under seawater testing only for the limits set above, and for the experimental conditions evaluated in this study. Therefore, the combination of the very low / mass gain and low wear zones can be regarded as the safe operation zone for this material. Fig. 12 (b) shows the wear mode regimes for the slurry test condition. A very different behaviour is now observed. It is clear from the map that medium wear dominates the wear mode regime, with high wear being observed at intermediate impact angles and velocities. This indicates that in the presence of particles, very significant increases in wear can be identified over such exposure conditions, limiting the performance of the material. This wear mapping methodology for tidal turbine materials enables the optimum operating window to be identified for the exposure conditions and is a first step approach towards developing smart materials for the exposure conditions. Further work will be to include additional factors such as different distributions of erodent particles, erosion exposure time and properties of the composite to understand the important factors which change the regime transitions above.
