# Impact Angle Effects on Erosion Maps of GFRP: Applications to Tidal Turbines

Rafee Abdulmajeed Rafee Ahamed<sup>1</sup> · Cameron M. Johnstone<sup>1</sup> · Margaret M. Stack<sup>1</sup>

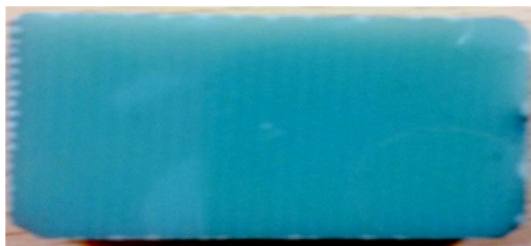
Fig. 2 Rectangular specimen (36 mm × 25 mm × 6 mm)

A schematic diagram of the slurry impingement jet rig is shown in Fig. 1. The rig is equipped with a 'T'-shaped ejector, and it controls the erosion parameters by setting up the ratio of inlet nozzle to the outlet nozzle diameter ( $d/D$ ), and the L-distance [9]. The erosion test was performed at three different impact velocities of  $2.5$ ,  $4.5$  and  $6.5 \text{ ms}^{-1}$ , and the corresponding combinations of inlet and outlet nozzles are  $2.8$  and  $6.52 \text{ mm}$  ( $2.5 \text{ ms}^{-1}$ ),  $3.6$  and  $6 \text{ mm}$  ( $4.5 \text{ ms}^{-1}$ ), and  $3.6$  and  $4.48 \text{ mm}$  ( $6.5 \text{ ms}^{-1}$ ). The impingement angle was adjusted in the range of  $15^\circ$ – $90^\circ$ . The slurry mixture consists of  $3.5 \%$  of the salt and  $3 \%$  of irregular silica sand as an erodent (Table 2). The silica sand particles were supplied by the Fife Silica Sands Ltd. The samples were tested one at a time by fixing onto the specimen holder and eroding for  $30 \text{ min}$  (Fig. 2).

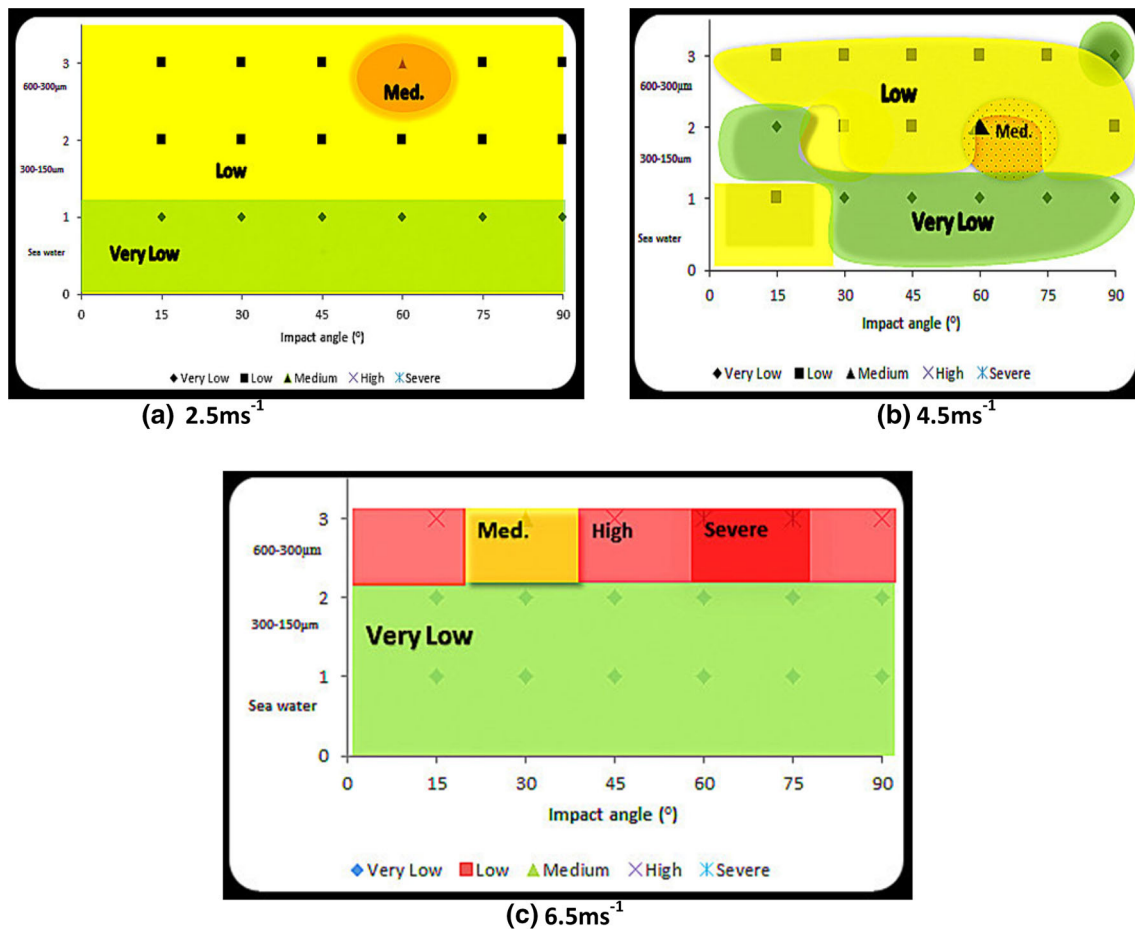
**Fig. 19** Wear mode map for three test conditions **a**  $2.5 \text{ ms}^{-1}$ , **b**  $4.5 \text{ ms}^{-1}$ , **c**  $6.5 \text{ ms}^{-1}$

Figure 19 maps the wear mode regimes for the three different conditions, and they are seawater only, seawater with 300–150 µm of SiC and seawater + 600–300 µm of SiC. The maps have been clearly drawn for three different speeds, and they are, respectively, indicated as (a) 2.5 ms<sup>-1</sup>, (b) 4.5 ms<sup>-1</sup> and (c) 6.5 ms<sup>-1</sup>. Figure 19a indicates the rig has been operated, and the sample materials were eroded under 2.5 ms<sup>-1</sup> at three different conditions. It clearly indicates the presence of medium wear, and it occurs at 45°–60°, and the seawater + two different test slurries share the boundary. The dominance of very low/mass gain wear can also be seen under the seawater condition, and the wear rate increases as the impact velocity increases. A very different behaviour is now observed, and Fig. 19b shows the occurrence of medium wear in the seawater + 300–150 µm. Although it shares the boundary with seawater + 600–300 µm, it mainly occurs in the lower region, and it is due to the intermediate operating

speed, which is  $4.5 \text{ ms}^{-1}$ , and it can be resolved by plotting error maps and also by surveying the comparative analysis between the error maps. As a result of comparison, there is almost no evidence indicating potential unsafe operating condition under seawater testing only for the limits set above, and for the experimental conditions evaluated in this study. Therefore, the combination of the very low/mass gain and low wear zones can be regarded as the safe operation zone for this material. Figure 19c shows the wear mode regimes for the maximum operating speed  $6.5 \text{ ms}^{-1}$ . A very different behaviour is now observed. It is clear from the map that very low wear dominates the wear mode regime, with severe wear being observed at intermediate impact angles and velocities. However, the medium and high wears occur at the low and high impact angles and velocities. This indicates that in the presence of particles, very significant increases in wear can be identified over such exposure conditions, limiting the performance of the material.
