A Database Model for the Analysis and Assessment of Historic Timber Roof Structures

ABSTRACT

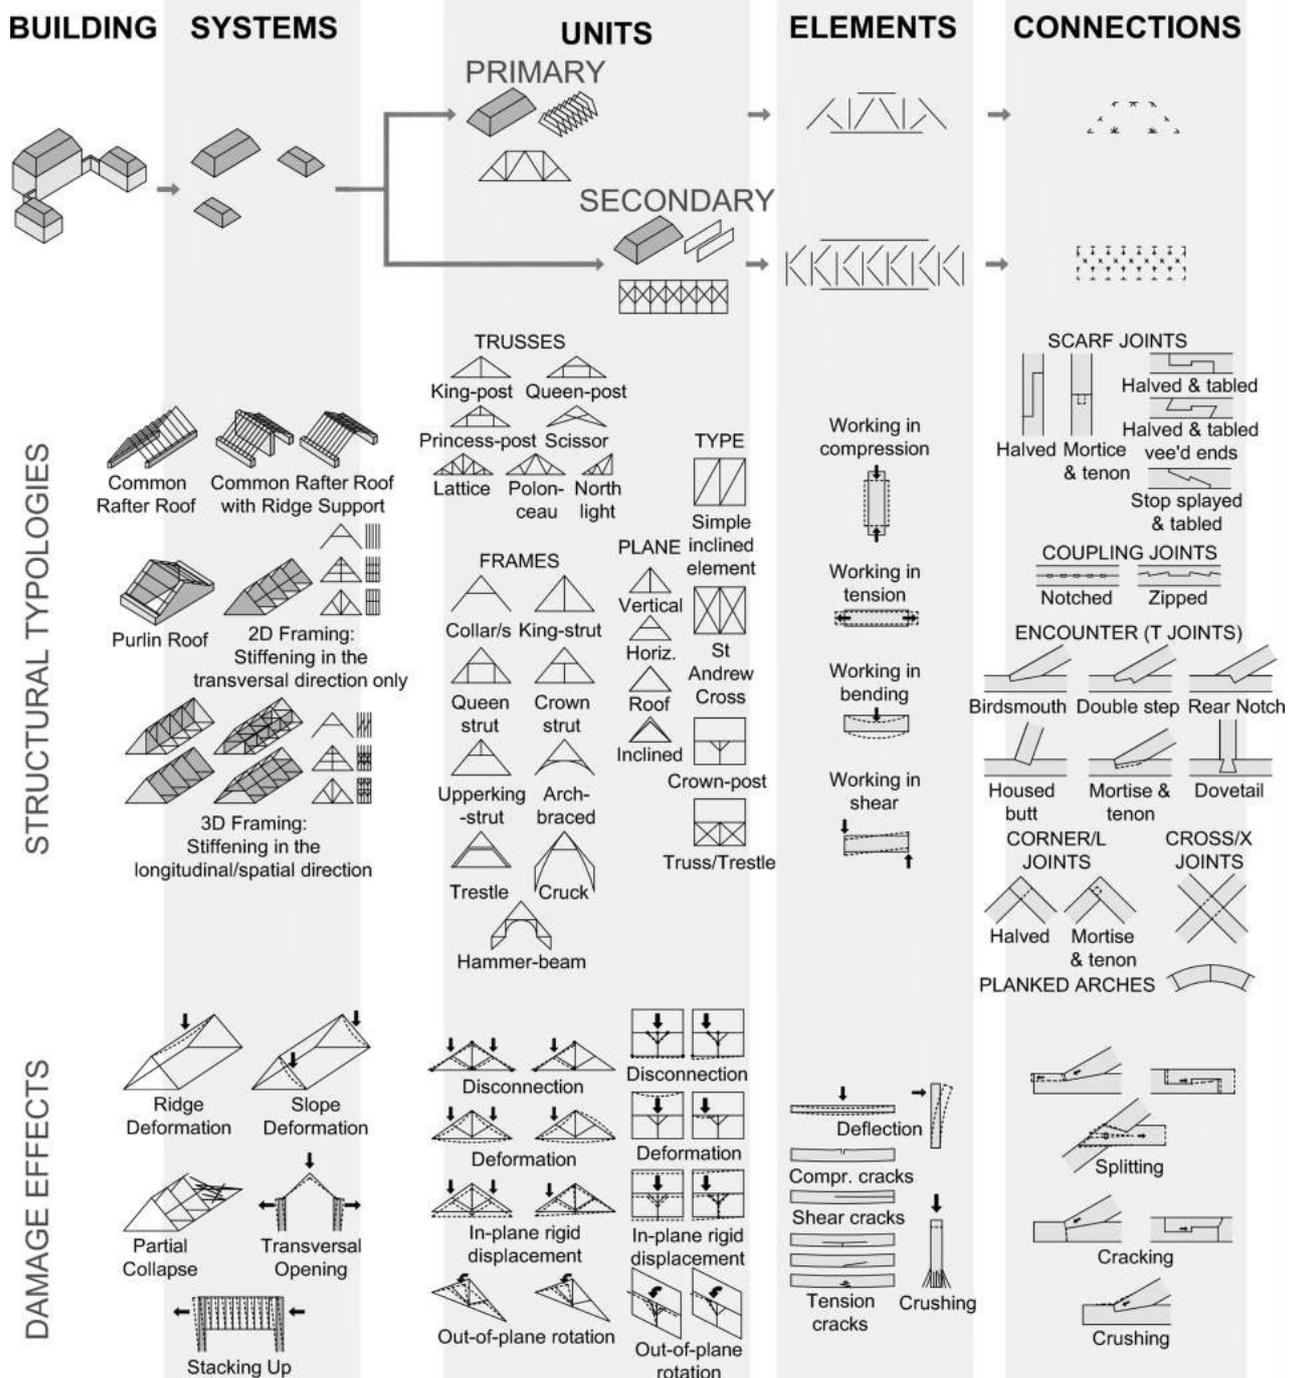
Fig. A1: The tree-like organization of the form, with structural types and damage effects.

The part on connections and secondary structure is organized in the same way, the only difference being the types of connections, bracing systems and damage (Fig. A1).
