Capacitive Imaging of Impact Damage in Composite Material

Maxim Morozov, William Jackson and S.G.Pierce

Department of Electronic and Electrical Engineering, University of Strathclyde

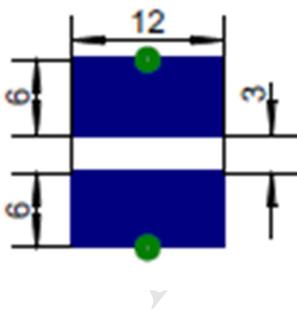
Figure 2. Drawing of the capacitive probe

The capacitive probe consisted of two coplanar rectangular electrodes parallel to the sample surface, as shown in Figure 2. An impedance analyser Agilent 4395A was used to measure impedance variation (series resistance and series capacitance) of the coplanar capacitor in the range of swept excitation frequencies from 100kHz to 500MHz. The CI probe was moved above sample surface in a stepwise motion utilising a XYZ scanner. The scanned area was 70mm × 70mm. The steps were 1mm in X and 2mm in Y directions.

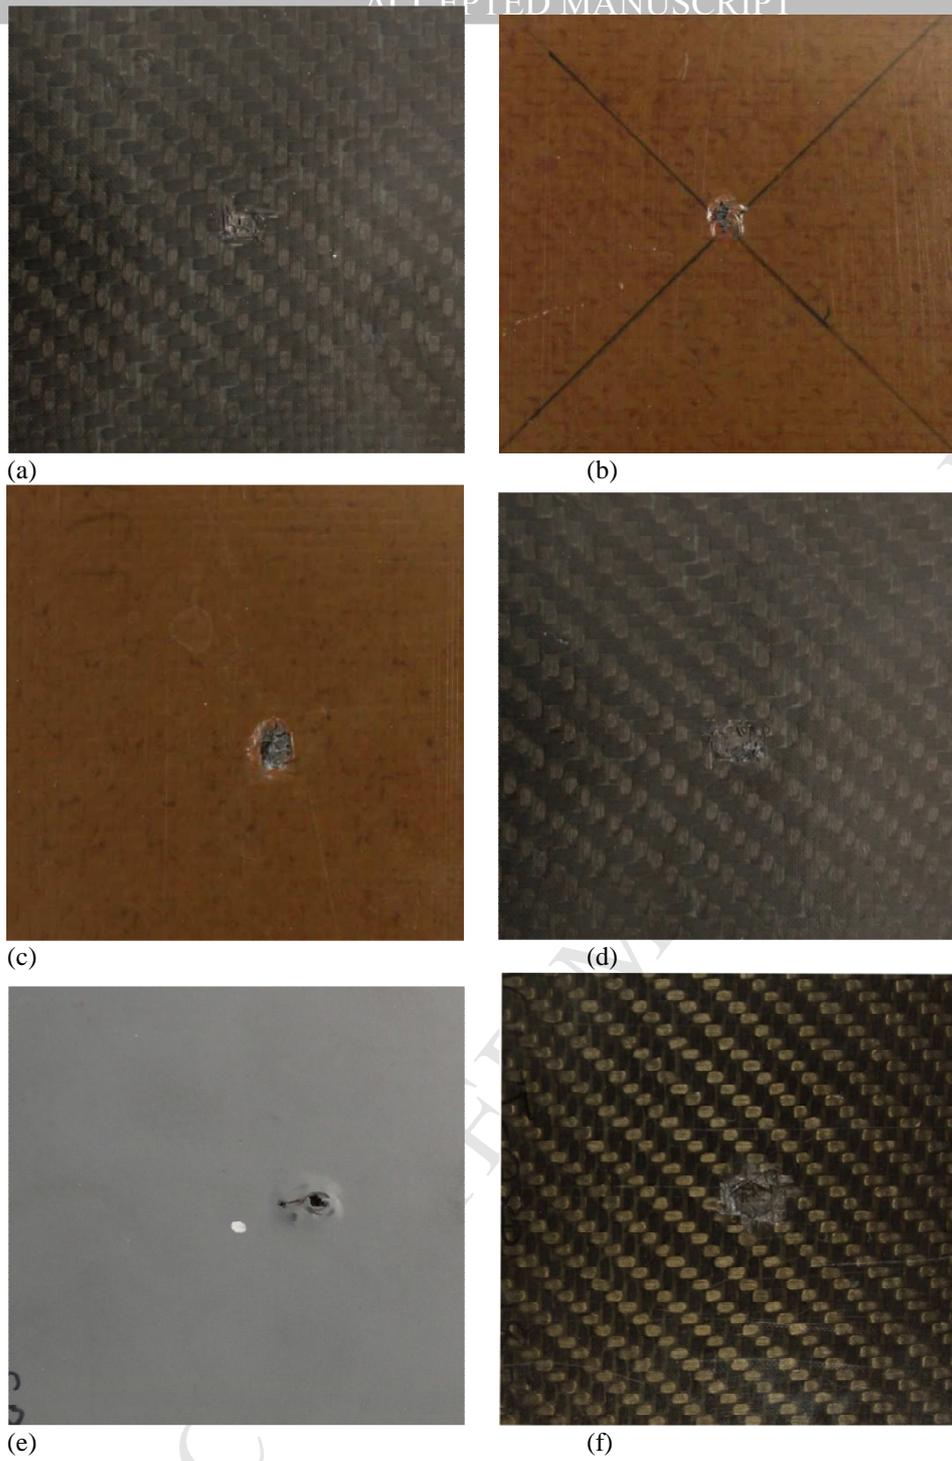
Figure 1. Photographs of the CFRP samples, impact side: (a) IG4J-08A, (b) IG4Q-04H, (c) IG4Q-04N, (d) IG4J-08G, (e) IG4A-01C, (f) IG4J-08B

Samples represented square slabs of woven fabric CFRP with side of 100mm and thickness of 10mm. Each sample had 25 layers of twill weave fabric with alternating orientation. Three of the samples had a polymer film applied to the impact surfaces. Figure 1 shows photographs of the CFRP samples taken from the impact side. Table 1 shows impact energies for each sample. A woven fabric CFRP sample with drilled holes of 6mm diameter has been capacitively imaged for reference. Comparison of capacitive

Notice that samples (b), (c) and (e) which had polymer films on the impact surfaces (see Fig. 1) have peak amplitude backgrounds which differ from the rest of the samples due to reduced acoustic impedance on the interfaces with the films.

Figures 8(a&b) show capacitive images of drilled holes in a CFRP slab: serial resistance and serial capacitance, respectively. The holes had diameters of 6mm, which roughly correspond to the size of the biggest impact dent in Figure 1(f). The CI signatures of the drilled holes have diameter of circa 6mm at half height. This confirms conclusion that capacitive images of the impacted samples show signatures of subsurface defects, that is delaminations.

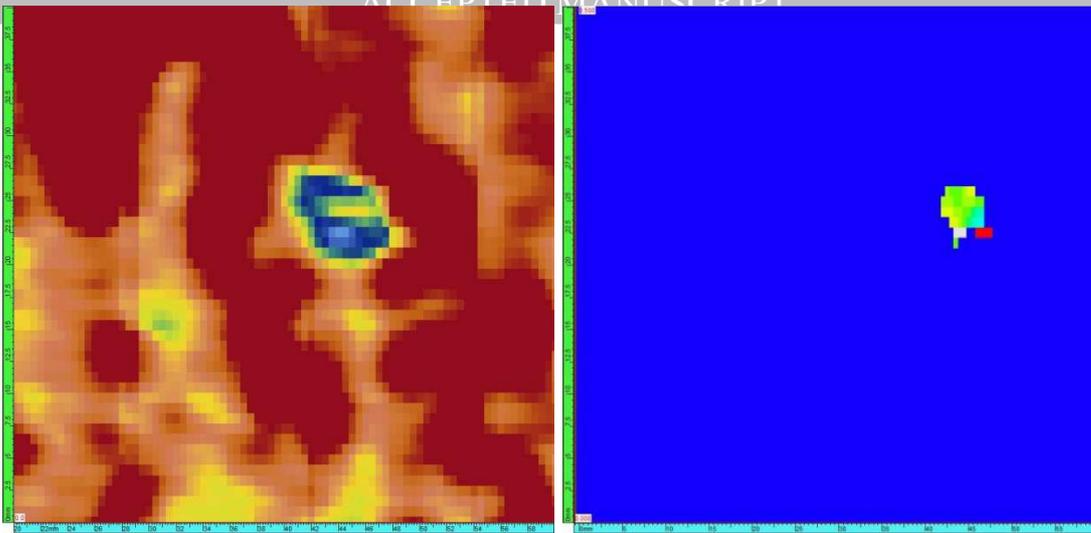
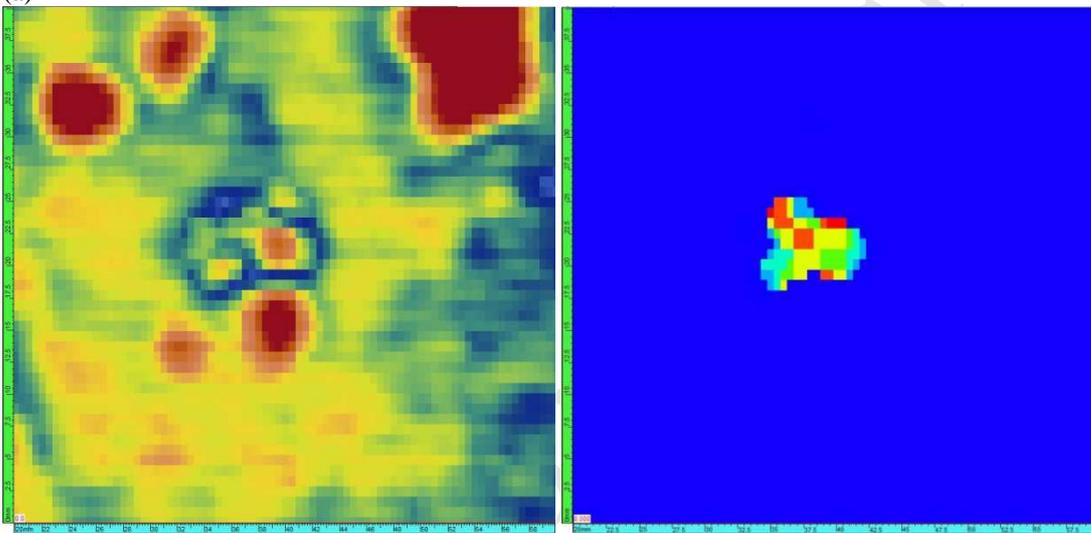
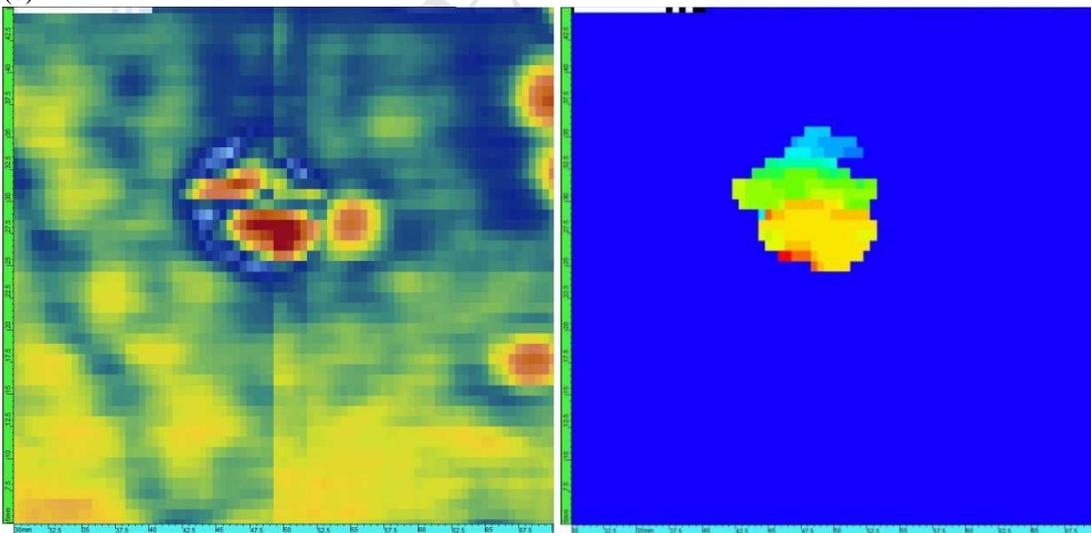
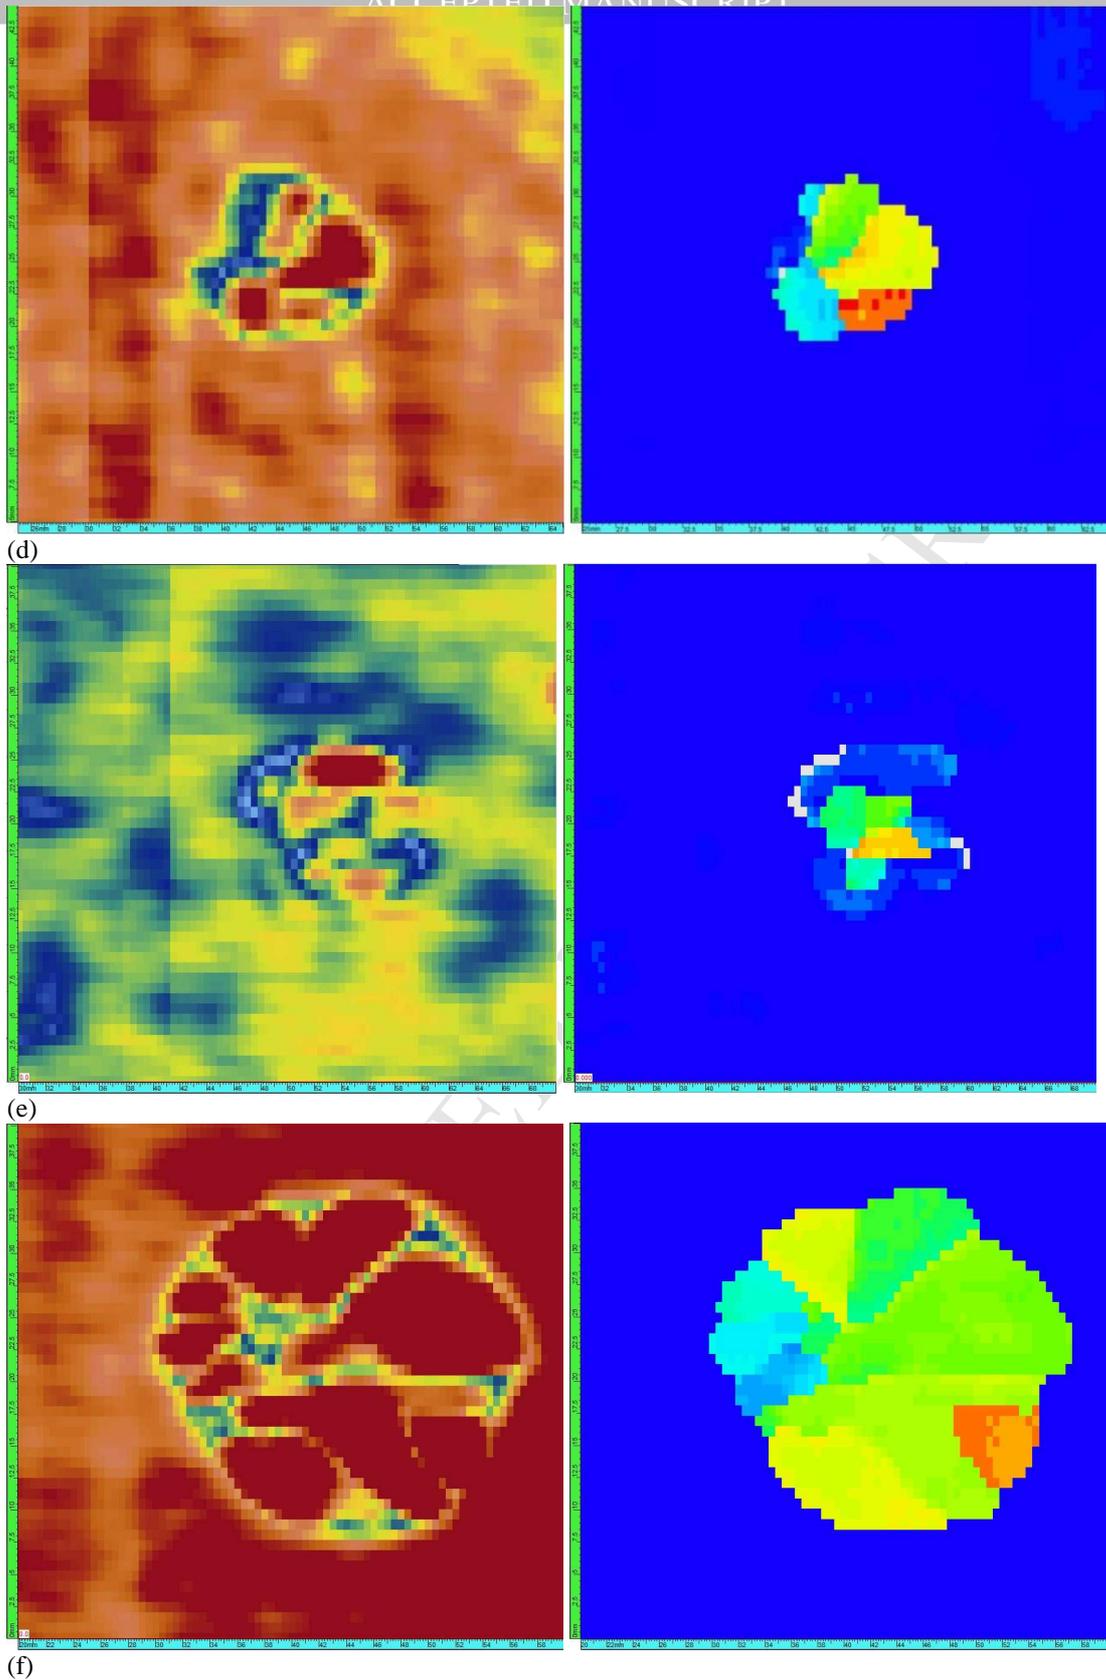
Figure 3. Ultrasonic C-scans (40mm X 40mm) of delamination due to impact in the CFRP samples, left column represents peak amplitude, right column represents thickness: (a) IG4J-08A, (b) IG4Q-04H, (c) IG4Q-04N, (d) IG4J-08G, (e) IG4A-01C, (f) IG4J-08B

Figure 3 shows ultrasonic C-scans of delaminations due to impacts in the CFRP samples acquired from the reverse sides of the samples. Areas of the C-scans are 40mm X 40mm. Left column represents peak amplitude and right column represents thickness C-scans. The delamination area grows with increasing impact energy.

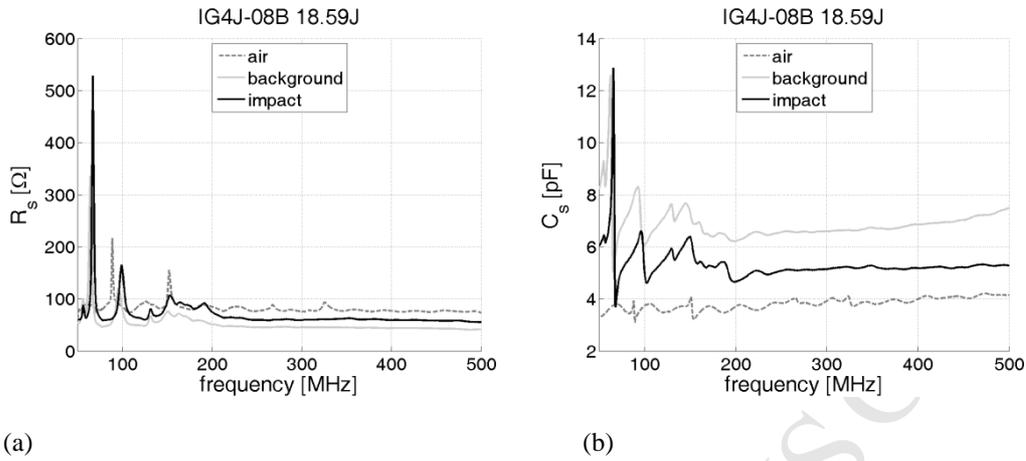
Figure 4. Frequency responses obtained in an undamaged location (background) and in the centre (impact) of sample IG4J-08B: (a) serial resistance, (b) serial capacitance

Responses of the CI transducer are obtained in form of a capacitor impedance $\underline{Z} = R_s + 1/j\omega C_s$, where R_s is the series resistance (real part), $\omega=2\pi f$, f being the excitation frequency, C_s is the series capacitance. Figures 4(a&b) show frequency responses obtained in an undamaged location (background) and in the centre (impact) of sample IG4J-08B: serial resistance and serial capacitance, respectively. As expected, capacitance between the coplanar electrodes increases with approach of a dielectric material. Resistance also increases due to eddy currents losses in the conductive carbon fibre. Multiple resonances can be observed between 100kHz and 200MHz. Certainly, the real electric circuit of the coplanar capacitor electromagnetically coupled with the CFRP material is much more complex than the simplified lumped component model consisting of series resistance and series capacitance assumed by the impedance analyser. Moreover, such a model depends on simplifying assumptions appropriate for a particular excitation frequency. The material structure of CFRP is very complex from the electromagnetic point of view [20, 22], carbon fibres insulated by resin represent a complex network of capacitances. Electrical contact between woven fibres effectively represents a network of mesoscopic coils in which eddy currents are induced. Moreover, taking into account that depth of penetration of electromagnetic field into the sample decreases with increasing frequency, it is obvious that at lower frequencies the capacitive transducer is electromagnetically coupled with thicker layer of CFRP.

However, evaluating the skin depth in CFRP is very challenging due to its inhomogeneous and anisotropic properties. Spectral analysis of CI response is a simple experimental way to determine appropriate excitation frequency of inspection of given material. Based on frequency responses shown in Figure 4 it can be concluded that stable capacitive images can be obtained above 200MHz, since capacitive images at or near resonance frequencies offer low sensitivity/resolution.

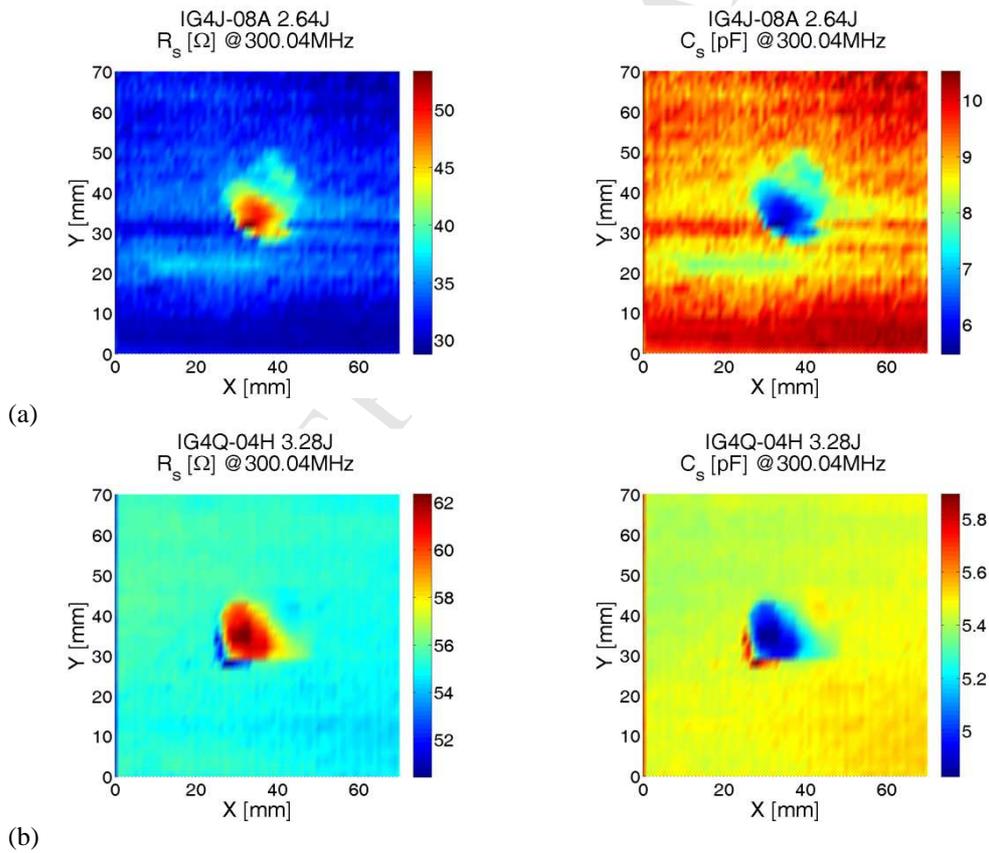
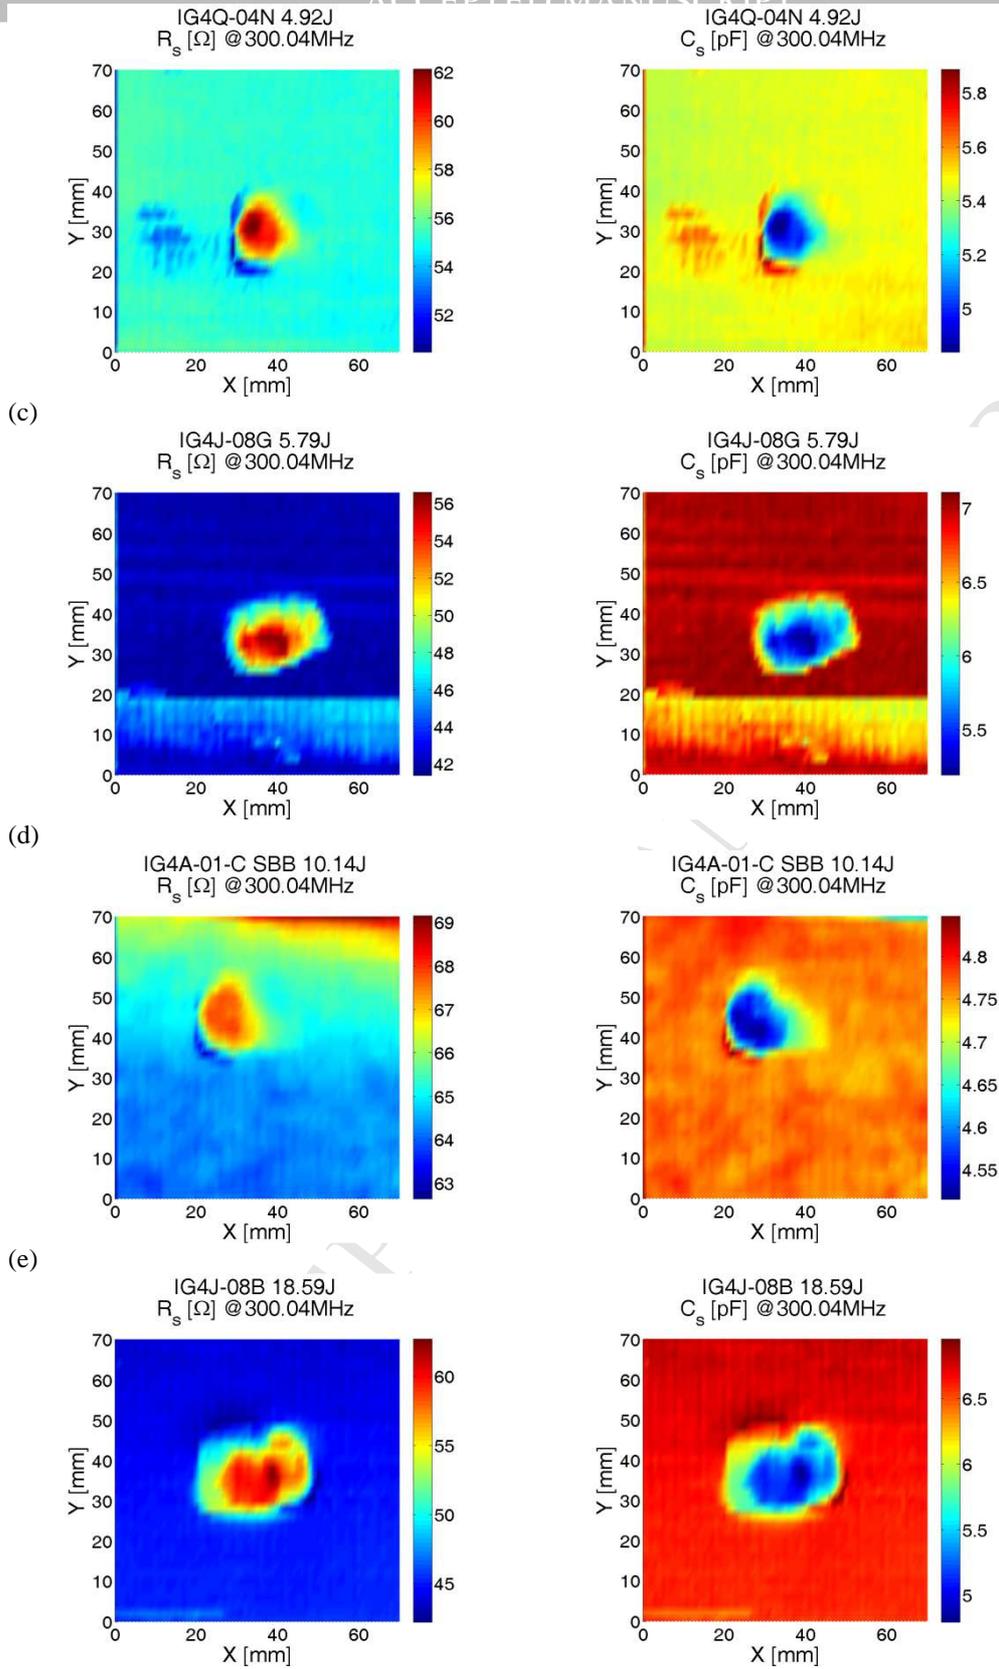
(f) Figure 5. Capacitive images of delamination due to impact in the CFRP samples acquired at 300.04MHz, left column represents serial resistance, right column represents serial capacitance: (a) IG4J-08A, (b) IG4Q-04H, (c) IG4Q-04N, (d) IG4J-08G, (e) IG4A-01C, (f) IG4J-08B

Figures 5(a-f) show capacitive images of delaminations caused by impact in the CFRP samples acquired at 300.04MHz, the left column representing series resistance and the right column representing series capacitance. For each sample a clear image of damage is obtained with the area of the defect response being much bigger than area of the visible flaw on the samples' surfaces caused by impact. The sizes of the impact damage signatures in the capacitive images are comparable with those shown in ultrasonic PA C-scans, Fig.3. This indicates that capacitive images of the impacted samples show signatures of subsurface defects, that is the delaminations. It has to be pointed out that the edges of impact dents were flat for the most of the samples, therefore the CI responses are not due to tilting of the transducer. Notice that samples (b), (c) and (e) which had polymer films on the impact surfaces (see Fig. 1) have background signals which differ from the rest of the samples due to different dielectric properties on the interfaces with the films.

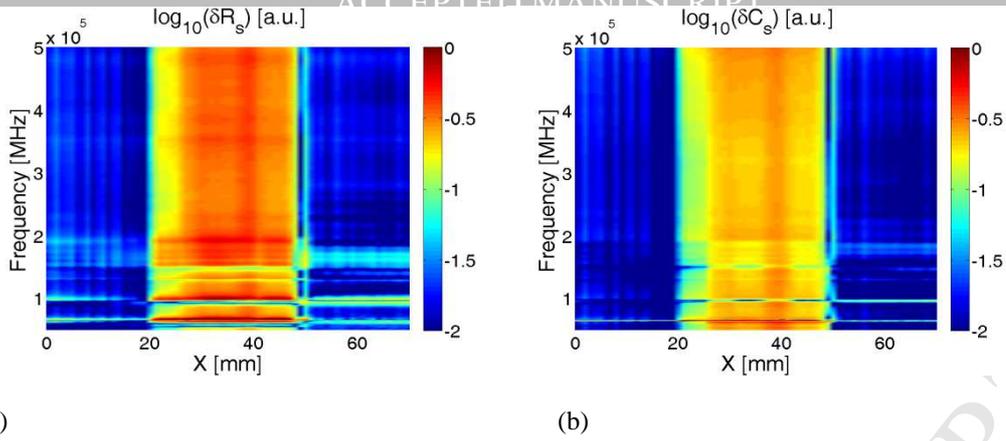
Figure 6. Spectrograms obtained along a single line scan in X direction across sample IG4J-08B at Y = 35mm (B-scans): (a) relative difference serial resistance, (b) relative difference serial capacitance

Figures 6(a&b) show spectrograms obtained along a single line scan in X direction across sample IG4J-08B at $Y = 35\text{mm}$ (B-scans): relative difference serial resistance and relative difference serial capacitance, respectively. A spectrogram is a 2D representation of the spectrum of frequencies in the CI response as they vary with the scan distance across a sample. Top of a spectrogram (highest frequency) corresponds to the sample surface due to the skin depth. Figures 7(a&b) illustrate line scans obtained along a single line scan in X direction across sample IG4J-08B at $Y = 35\text{mm}$ at three

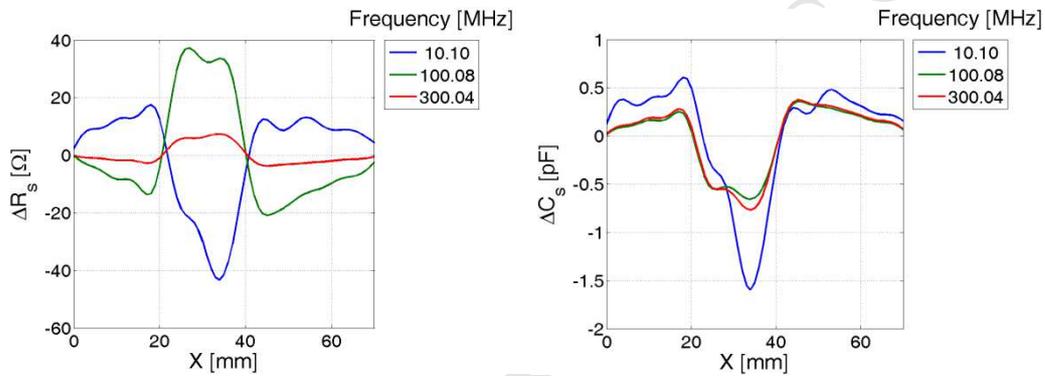
Figure 7. Line scans obtained along a single line scan in X direction across sample IG4J-08B at Y = 35mm at three selected frequencies: (a) absolute difference serial resistance, (b) absolute difference serial capacitance

selected frequencies: absolute difference serial resistance and absolute difference serial capacitance, respectively.

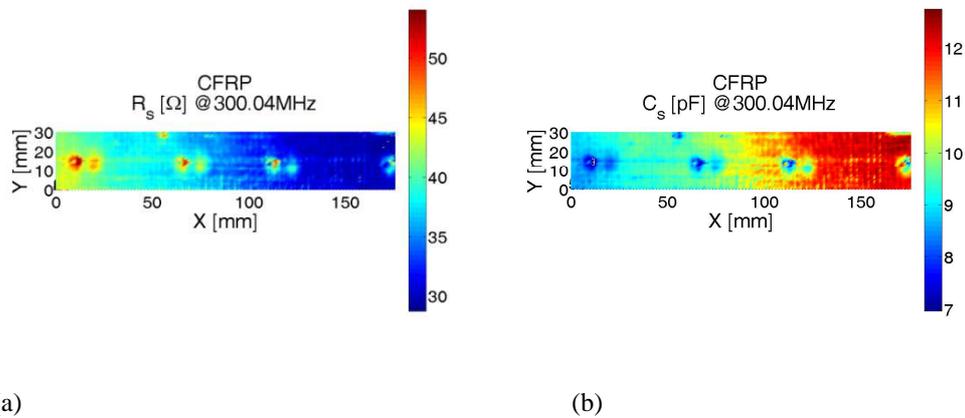
Figure 8. Capacitive images of drilled holes in a CFRP slab: (a) serial resistance, (b) serial capacitance
