Surface and subsurface damage of reaction-bonded silicon carbide induced by electrical discharge diamond grinding

Abstract: Reaction-bonded silicon carbide (RB-SiC) ceramic, one of the best candidates for large optical mirrors, is difficult to machine because of its high hardness and brittleness. A hybrid process called electrical discharge diamond grinding (EDDG) exhibits potential for improving the machinability of RB-SiC by combining electrical discharge machining (EDM) and diamond grinding. However, this hybrid process leads to damages that differ from those in conventional processes owing to the simultaneous actions of EDM and diamond grinding. In the present study, surface and subsurface damages induced by the interactions between EDM and diamond grinding during the EDDG of RB-SiC were examined. The effect of the discharge energy was considered. The surface and subsurface topographies and microstructures were characterized via scanning electron microscopy, Raman spectroscopy, and transmission electron microscopy. The EDM and grinding zones exhibited distinctive surface topographies and different dominant material removal mechanisms. An increase in the discharge energy facili

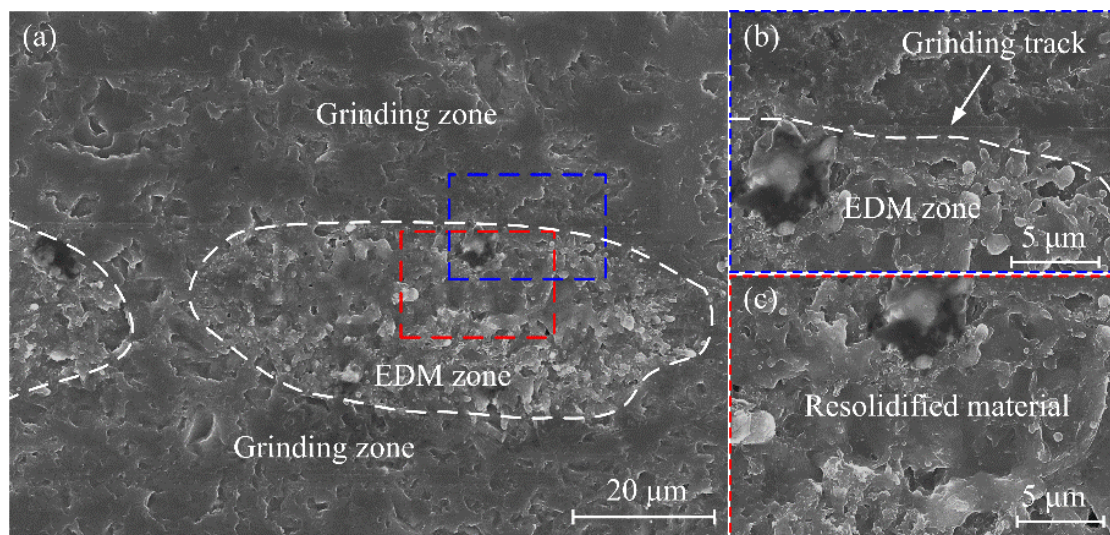
Fig. 5 (a) Typical machined surface of the RB-SiC specimen ground by EDDG. (b) Boundary between the grinding and EDM zones. (c) EDM zone.

Fig. 5 shows the typical machined surface of the RB-SiC ceramics ground by EDDG. Two distinct zones, i.e., EDM and grinding zones, with different surface characteristics were identified, as shown in Fig. 5 (a). In the grinding zone, a relatively flat surface was obtained, because the diamond grinding dominated the material removal of the RB-SiC sample. The discharge-induced thermal energy caused material softening, resulting in large ductile grinding tracks at the boundary between the EDM and the grinding zones, as shown in Fig. 5 (b). Craters were formed in the EDM zone. The RB-SiC material melted by discharge sparks was rapidly cooled by the dielectric fluid, resulting

in the formation of resolidified material in the EDM zone, as shown in Fig. 5 (c). The different surface topographies reveal the dominant material removal mechanism in the EDM and grinding zones, respectively.

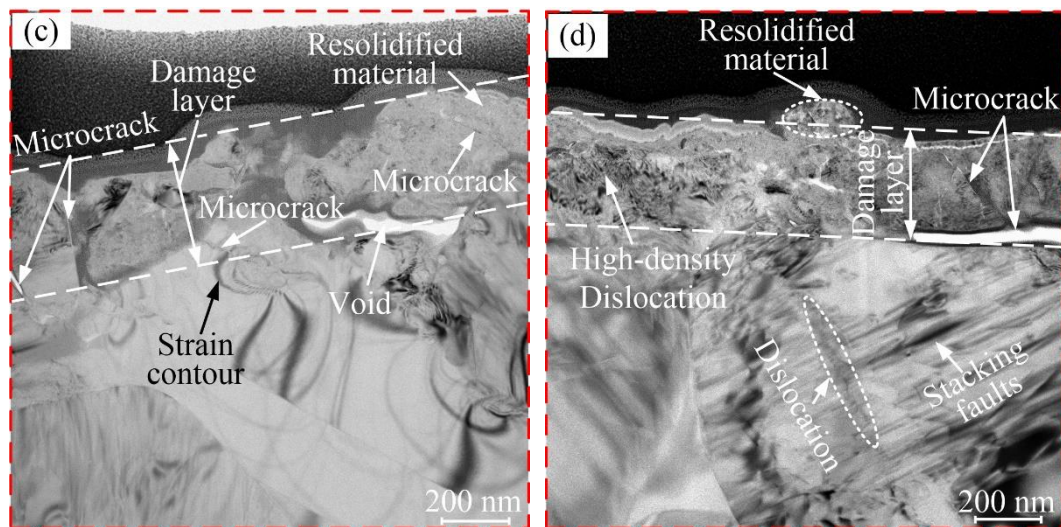
Fig. 11 Typical TEM images of subsurface damage. (a) Bright field (BF) image of pristine RB-SiC and (b) BF image of the cross section at middle energy. (c) and (d) enlarged images of the location close to EDM zone and grinding zone in (b), respectively.

To determine the subsurface damage in the EDDG process, a cross section of pristine RB-SiC was firstly detected by TEM, as shown in Fig. 11 (a). It reveals stacking faults in the SiC grains, and dislocation in the SiC grain with phase boundary generated by the sintering process. However, the SiC grain below the polished surface was almost defect-free, except for a thin damage layer (about 68 nm) induced by the polishing process. Moreover, no void was observed in the SiC grains. Thus, any subsurface damage beneath the machined surface must be induced by the EDDG process.

Fig. 11 (b)–(d) presents the typical TEM image of subsurface damage at middle discharge energy in the EDDG process. The subsurface structure composed of SiC grains, the remaining Si, and their boundaries, is shown in Fig. 11 (b). A distinctive damage layer was observed beneath the machined surface. To further investigate the subsurface damage induced by the interaction between EDM and diamond grinding, two regions, *c* and *d*, were selected at locations close to the EDM and grinding zones, respectively. In region *c*, microcracks and voids were found in the damage layer. The resolidified material protruded from the ground surface because EDM played a more important role than diamond grinding in this region, as shown in Fig. 11 (c). Furthermore, strain contours only occurred in the Si phase directly beneath the damage layer. This is because the bulk material was subjected to the thermal effect but with less

mechanical force. However, high-density dislocation and microcracks were observed in the upper part of the SiC grains beneath the ground surface in region *d*, as shown in Fig. 11 (d), whereas numerous dislocations and stacking faults were generated in the low part of the SiC grains. This is attributed to the increase in the role of diamond grinding in this region. The results reveal a different influence of EDM and diamond grinding on the subsurface damage at different locations.
