# Profiling Corrosion Rates for Offshore Wind Turbines with Depth in the North Sea

**Abstract:** Corrosion in the marine environment is a complex and expensive form of damage. It is commonly studied by the deployment of coupons that reflect the marine corrosion a structure will experience, thus allowing design and maintenance prevention strategies to be developed accordingly. This study stems from the lack of information in the literature regarding the profiling of corrosion with respect to marine depth in the North Sea where important wind farm developments have been undertaken. To address such issue a field experiment has been designed and carried out in the vicinity of the Westernmost Rough Windfarm in the North Sea. The field experiment consists of deploying steel S355 coupons below the tidal area and capturing the effects of corrosion, the mass loss from which the corrosion rate is derived and the chemical products that makes up the rust with water depth. The study involves proper planning and logistics to ensure that the field experiment survives the rough conditions of the North Sea for a duration of 111 days. A high corrosion rate of 0.83 mm/year has been observed in this

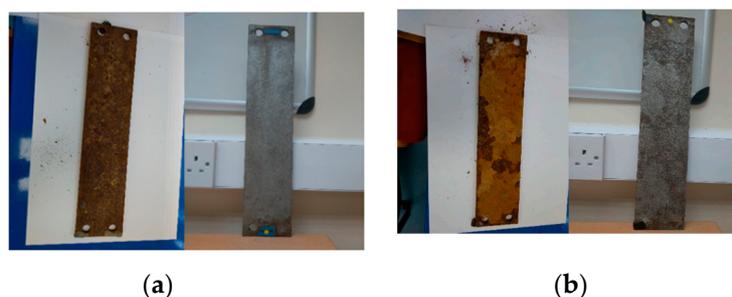
**Figure 7.** Samples: (a) before cleaning, (b) after cleaning.

The plates were cleaned according to the ASTM G1 standard where 1000 mL HCl, 20 g antimony trioxide ( $\text{Sb}_2\text{O}_3$ ), 50 g stannous chloride ( $\text{SnCl}_2$ ) were used and shown in Figure 7a,b [28].

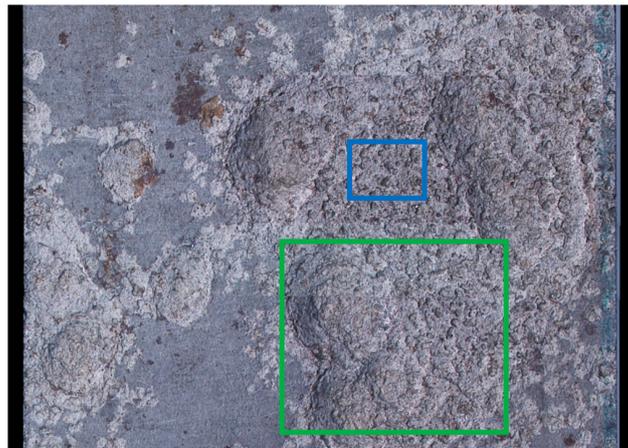
**Figure 9.** Pit coalescence highlighted in green and micro pits highlighted in blue.

It was estimated for instance in the 3-black case that the number of pits on the front side was more than that on its back side. This difference is hard to explain due to a variety of factors that have affected the experiment. This observation has to be re-tested though to come out of the hypothetical shell to a scientific explanation with appropriate instrumentation such as the water velocity, the corrosion current and the biological and chemical influences of the water combined together in the complex sea water without the failure of the ropes and the depth preserved. The surface was more rugged as shown by Figure 9 when pitting corrosion seemed to be the dominating form of corrosion.
