# Calandria Tubesheet Bore Inspection Decision Support

Andrew Young, Zhouxiang Fei, Jaime Zabalza, Paul Murray, and Graeme West

Institute for Energy & Environment, University of Strathclyde, Glasgow, UK  
Email : andrew.young.101@strath.ac.uk

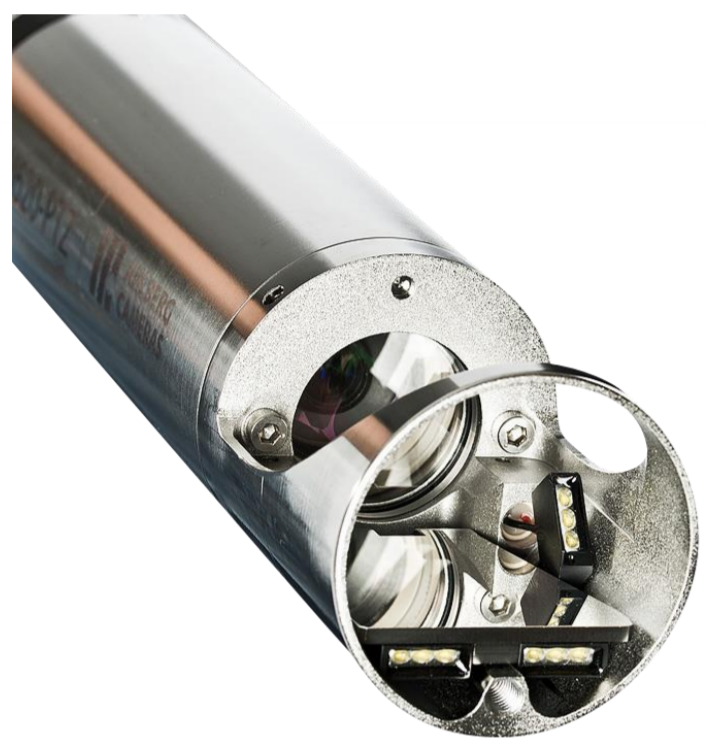
Ahlberg radiation hardened camera used for CTSB inspection.
