# Investigation of exit-hole repairing on dissimilar aluminum-copper friction stir welded joints

Exit-holes in friction stir welded dissimilar aluminum-copper (Al–Cu) joints are repaired by using probeless tools, forcing the surrounding material to fill the exit-hole cavity. The repair by refilling the same base materials is performed in two steps using probeless tools of different diameters. In this study, two different conditions are investigated, keeping the processing parameters constant and varying the tool shoulder diameters. Namely, the repair is performed using a two steps sequence of probeless tools with shoulder diameters of: (1) 12 and 19 mm, and (2) 12 and 27 mm. The refill action is achieved using only the base materials. A comprehensive experimental campaign, including tensile tests, microhardness measurements, scanning electron microscopy and energy dispersive x-ray spectroscopy investigations, have been conducted to evaluate the effectiveness of the repairing. The results showed that the usage of probeless tool is an effective strategy to repair the exit-hole of dissimilar Al–Cu friction stir welds, with exclusive contribution from the same Al and Cu base materials

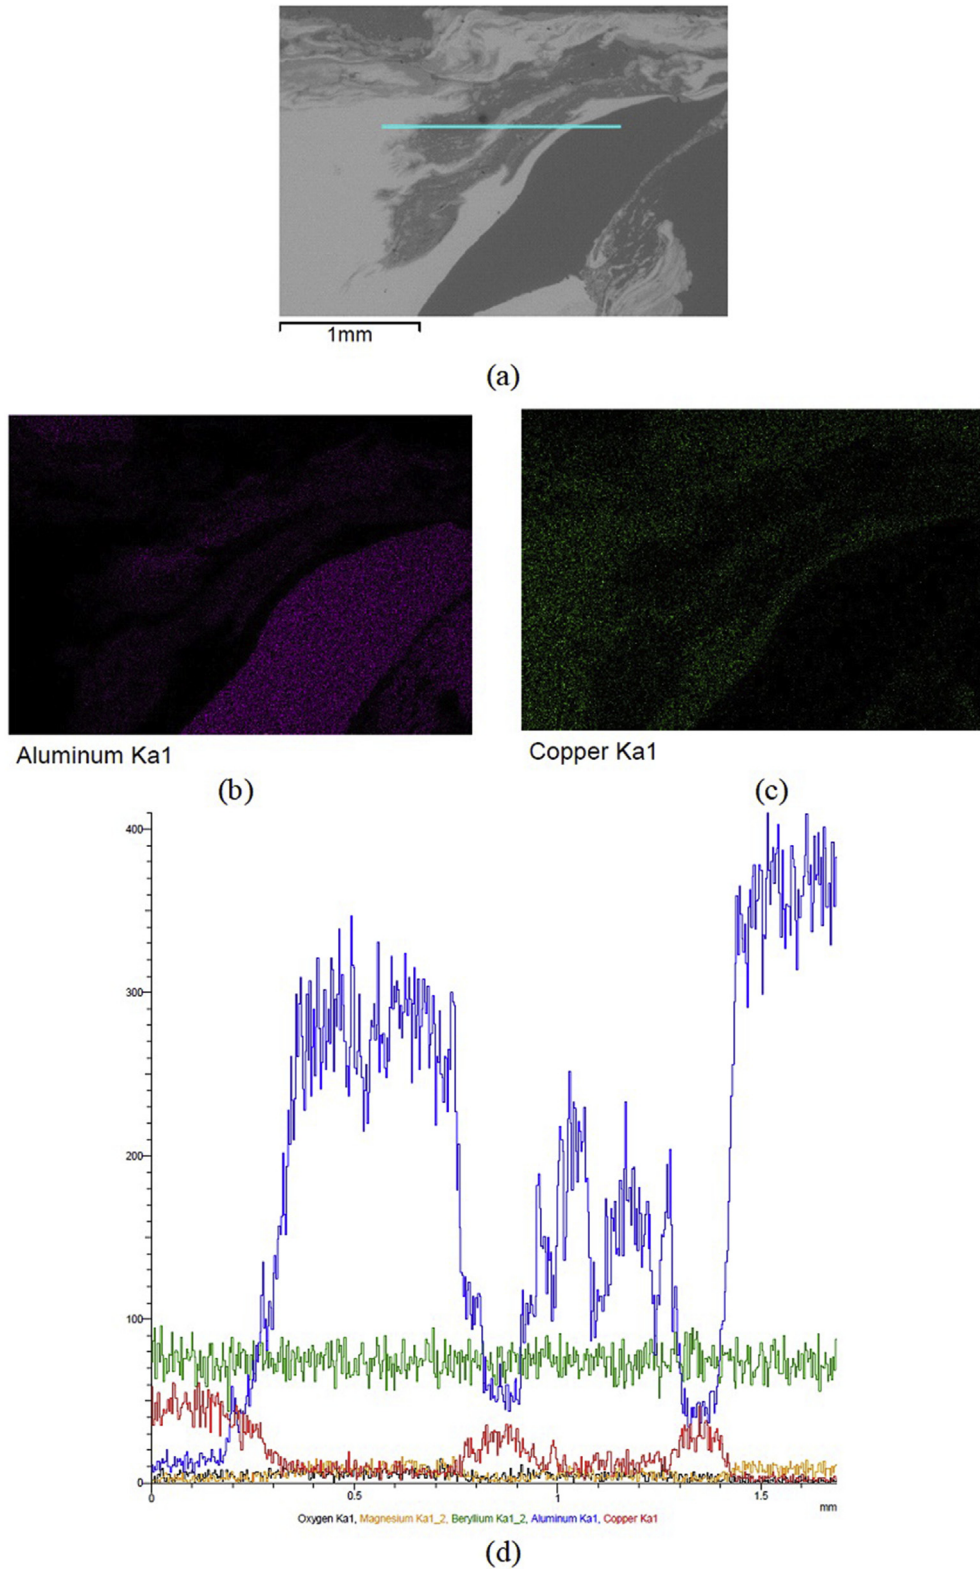
**Fig. 9** – Materials mixing in exit-hole repaired zone processed by shoulder diameters of 12 and 27 mm corresponding to [Fig. 8\(a\)](#); (a) SEM image indicating scanning line for EDS, (b) and (c) area elemental mapping for image shown as (a), and elemental mapping of Al and Cu for the line shown in (a).

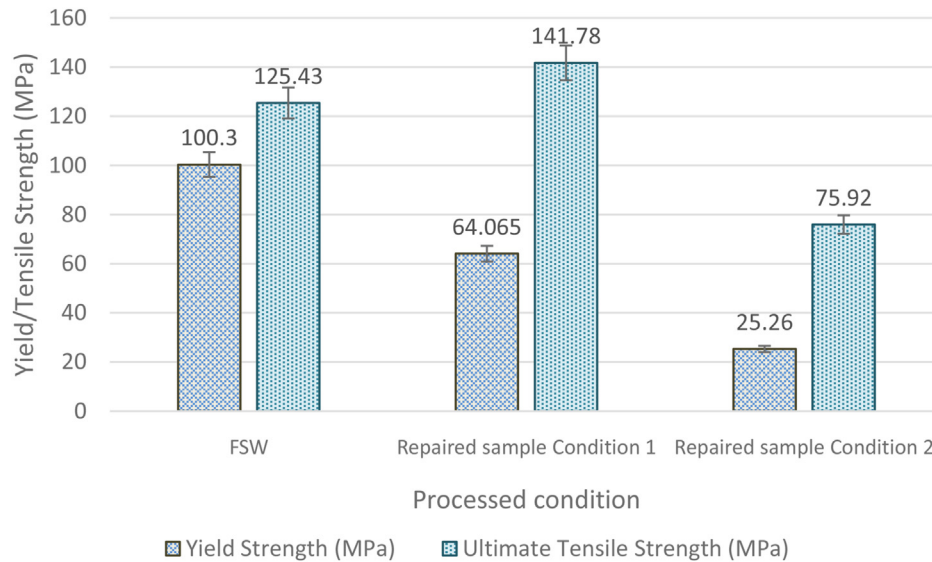
**Fig. 11 – Tensile testing results of processed samples, FSW, exit-hole repaired by shoulder diameters of 12 and 19 mm (repaired sample condition 1), and exit-hole repaired by shoulder diameters of 12 and 27 mm (repaired sample condition 2).**

Figure 11 shows tensile testing results of processed samples such as FS welded sample, exit-hole repaired sample processed by shoulder diameters of 12 and 19 mm, and 12 and 27 mm. Maximum ultimate tensile strength of 141.8 MPa is obtained for exit-hole repaired sample processed by shoulder diameters of 12 and 19 mm, which is 13% higher as compared to FS welded region (125.4 MPa). Minor difference in ultimate tensile strength between FS welded and exit-hole repaired regions can be attributed to differences in materials mixing caused by two different processing ways. In the exit-hole repairing by shoulder diameters of 12 and 19 mm, the multi-axial forging in the cavity of exit-hole, with enhanced bonding inside the repaired zone, is more pronounced as compared to FS welded region. This may be the origin of the 13% increase in ultimate tensile strength. At least for this specific 8 mm exit-hole diameter, the exit-hole repairing by shoulder diameters of 12 and 19 mm is therefore recommended. The yield strength of 64.1 MPa is observed for exit-hole repaired by shoulder diameters of 12 and 19 mm, which is lower as

compared to FS welded sample (100.3 MPa). This may be due to localized harder zones, within the repaired region, that trigger early localized strain mechanisms starting the plastic deformation. Besides, ultimate tensile strength of 75.9 MPa and yield strength of 25.3 MPa are received for exit-hole repaired zone by shoulder diameters of 12 and 27 mm. Inadequate materials mixing between Al and Cu in addition to the presence of defects such as voids and cracks in the repaired region also lead to low tensile strength.
