# Investigating the Performance of Glass Fibre-Reinforced Polymer (GFRP) in the Marine Environment for Tidal Energy: Velocity, Particle Size, Impact Angle and Exposure Time Effects

**Abstract:** Tidal energy, with its potential to provide a consistent energy output and reduce carbon emissions, has garnered significant interest. This study, which evaluates the performance of tidal turbine blades in seawater conditions and with sand particles, presents a novel approach. A slurry rig was developed to examine composite materials, and a glass fibre-reinforcement polymeric material was tested over a range of particle sizes, velocities, and impact angles. In addition, this paper used a new test protocol with 14 days (336 h) and 91 days (2184 h) of pre-exposure time of materials before testing. The results, which show significant changes in the erosive mechanisms of GFRP in short- and long-term pre-exposure time as a function of these variables, have profound implications for the design and performance of tidal turbine blades. The study also utilised scanning electron microscopy (SEM), depth profiling analysis, and erosion mapping techniques to compare the erosion behaviours of GFRP. Thes

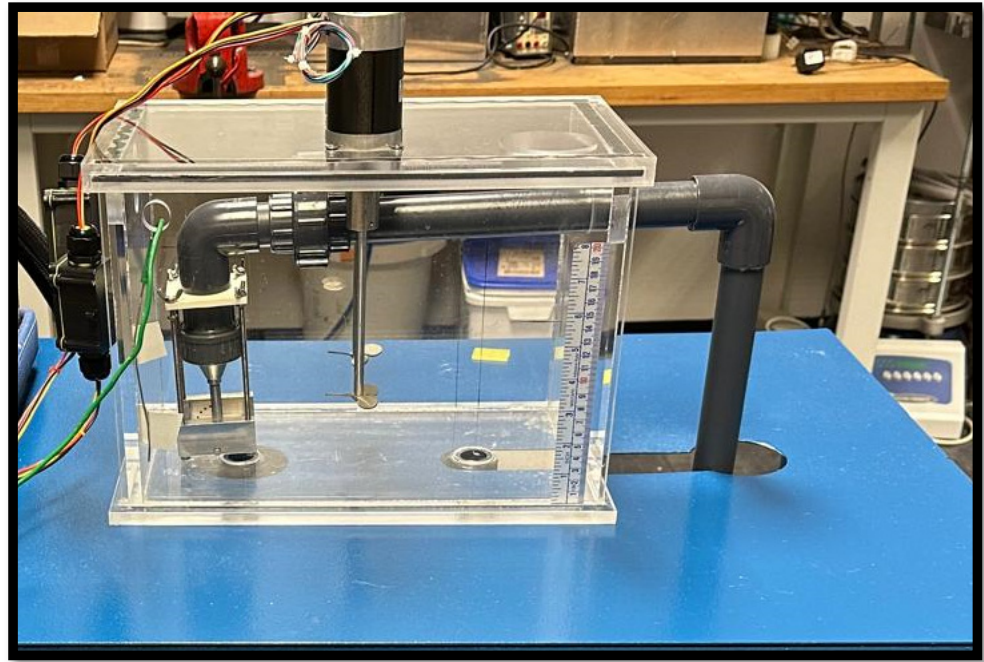
aim of investigating erosion in harsh marine environments. The main components of the rig are as follows: a water tank container with two outlets at the bottom, one connected to the pump to deliver the solution to the specimen, and the other for cleaning the container after the test. A velocity control converter was integrated into the water pump to regulate velocities via frequency (Hz). Additionally, a dual impeller system was installed at the top to mix the sand and salt with the water during the test. To maintain a stable container temperature, an immersion cooler with a sensor was added, ensuring the temperature remained at  $10 \pm 1$  °C. Figure 1 displays a photograph of the slurry erosion impingement rig.

**Figure 1.** Slurry Erosion Impingement Rig.

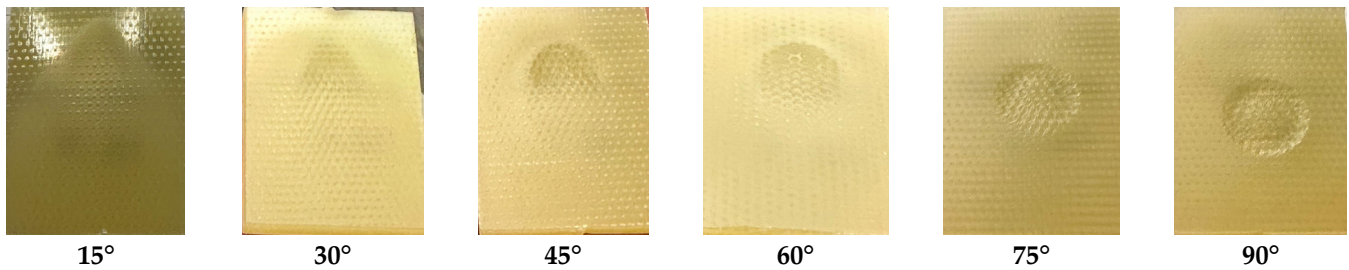
Figure 2 below shows some images of the specimens after the test for 14 days (336 h) pre-exposure.

**Figure 2.** Images of test specimens of GFRP after 14 days (336 h) of pre-exposure at a velocity of  $12.5 \text{ ms}^{-1}$  and sand size of  $100\text{--}150 \mu\text{m}$ .

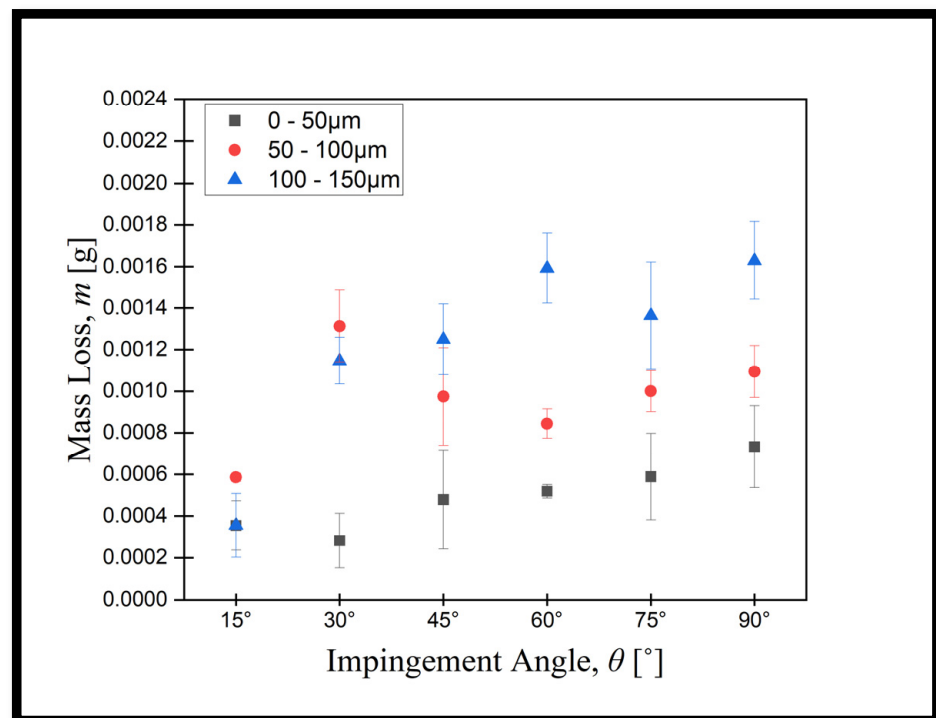
Figures 3–5 illustrate the mass loss per gram of abrasive particle for GFRP specimens after a 14-day pre-exposure duration. The pattern of erosion with impact angle is depicted in Figure 3; specifically, within the sand particle size range of  $100\text{--}150 \mu\text{m}$  and a velocity of  $6.425 \text{ ms}^{-1}$ , the maximum erosion rate occurred at a  $90^\circ$  angle of attack, with the lowest erosion observed at  $15^\circ$ . In the meantime, in the  $50\text{--}100 \mu\text{m}$  sand particle size range at the same velocity, the highest erosion rate was recorded at a  $30^\circ$  angle of attack as a consequence of erosive wear of the specimen. Notably, for the  $0\text{--}50 \mu\text{m}$  range, a higher erosion rate was evident at  $90^\circ$ , contrasting with a lower erosion rate at  $30^\circ$ .

**Figure 3.** Mass loss (g) of GFRP after 14 days (336 h) pre-exposure at a velocity of  $6.425 \text{ ms}^{-1}$  and sand size of  $0\text{--}50 \mu\text{m}$ ,  $50\text{--}100 \mu\text{m}$ ,  $100\text{--}150 \mu\text{m}$ .

In Figure 3, the mass loss increases with particle size from  $45^\circ$  to  $90^\circ$ ; the relationship at this range is more likely to be a linear. Otherwise, at  $30^\circ$ , the mass loss for particle sizes  $50\text{--}100 \mu\text{m}$  was higher than that for the  $100\text{--}150 \mu\text{m}$  range. A possible explanation for this might be that the particle slides on the surface at the lower impact angles and particle velocities. In addition, this phenomenon is commonly found in ductile materials, which leads to cutting and ploughing. Similarly, researchers indicate that the erosion rates of ductile materials generally peak at impact angles of  $30\text{--}50^\circ$  as a consequence of micro-cutting. On the other hand, in Figures 4 and 5, the mass loss was higher at a  $90^\circ$  impingement angle under this condition, which is a high impact angle and low particle velocity. The primary erosion mechanism is the flattening of ridges and plastic deformation, as seen in Figure 9.

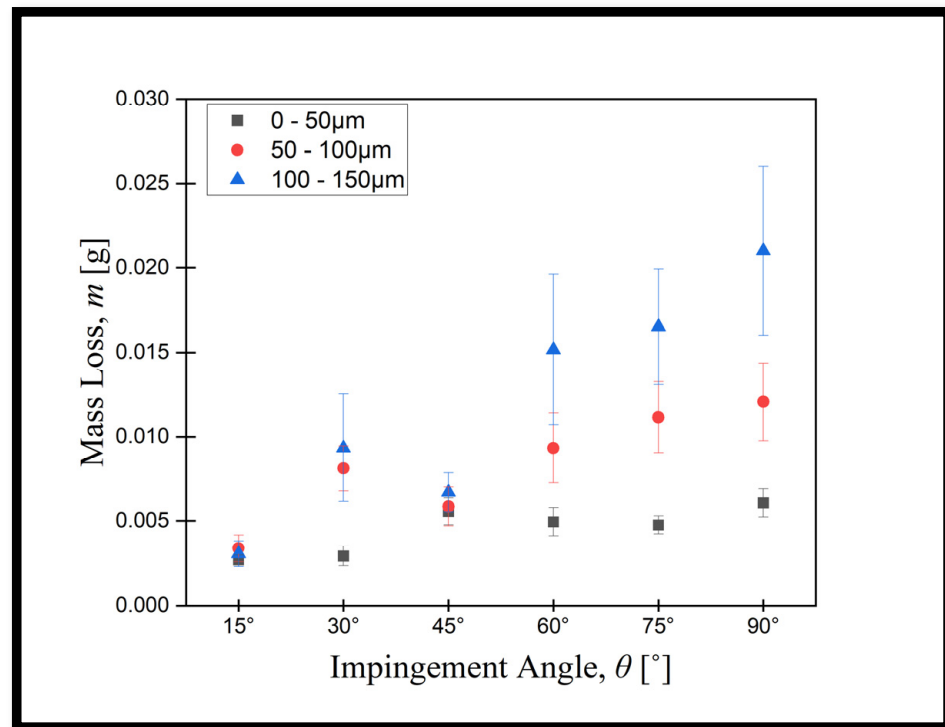
**Figure 4.** Mass loss (g) of GFRP after 14 days (336 h) pre-exposure at a velocity of  $9.914 \text{ ms}^{-1}$  and sand size of 0–50  $\mu\text{m}$ , 50–100  $\mu\text{m}$ , 100–150  $\mu\text{m}$ .

Figure 4 shows a distinct shift in the erosion mechanism compared to Figure 3. It is evident that within the sand particle size ranges of 100–150  $\mu\text{m}$ , 50–100  $\mu\text{m}$ , and 0–50  $\mu\text{m}$  with a velocity of  $9.914 \text{ ms}^{-1}$ , the peak erosion occurs at a  $90^\circ$  angle of attack. On the other

hand, the lowest erosion rates are observed at  $15^\circ$  for all sand size ranges. In addition, although three different sizes of sand were used in the test, at  $45^\circ$ , the erosive wear remained the same. The material exhibits a transition between ductile and brittle erosion processes at average angles. At  $45^\circ$ , both ductile cutting and brittle cracking may occur at the same time. The particles impact the surface with sufficient force to create fractures (brittle erosion), while in parallel sliding over the surface to facilitate material removal by ploughing or cutting (ductile erosion). This amalgamation of both processes leads to increased erosion rates relative to lower angles; however, these are not as severe as that observed at the  $90^\circ$  impact angles when brittle fracture prevails [27].

Figures 6 and 7 show the mass loss after 91 days (2184 h) of pre-exposure using the same 14 days (336 h) pre-exposure time parameters with changed erosion transactions. For example, in Figure 7, the peak of mass loss was at a  $75^\circ$  impact angle, while in Figure 4, it was higher at a  $90^\circ$  impact angle. The change in erosion transaction may be because the glass fibre material typically comprises various very slight glass fibres. Additionally, the impact angle, also known as the impingement angle, between the material surface and the particle's trajectory at  $75^\circ$  is regarded as a higher angle. Impacts at higher angles transfer the most energy to the materials [31].

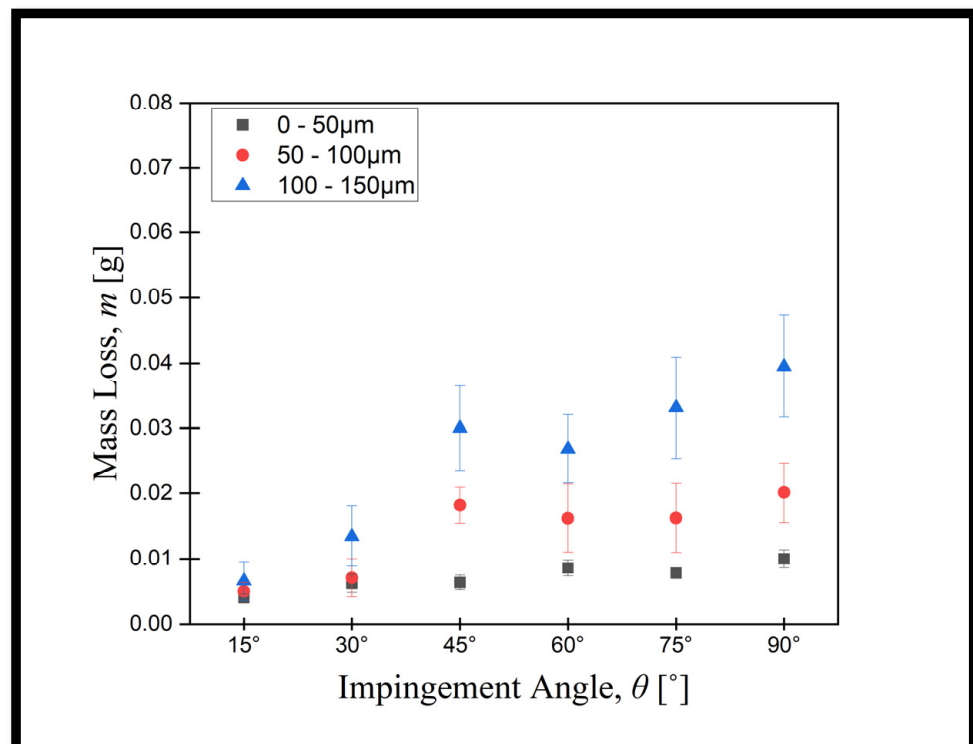
**Figure 5.** Mass loss (g) of GFRP after 14 days (336 h) of pre-exposure at a velocity of  $12.5 \text{ ms}^{-1}$  and sand size of 0–50  $\mu\text{m}$ , 50–100  $\mu\text{m}$ , 100–150  $\mu\text{m}$ .

In Figure 5, the trend at a velocity of  $12.5 \text{ ms}^{-1}$  is shown alongside varying sand particle sizes in the ranges of  $100\text{--}150 \mu\text{m}$ ,  $50\text{--}100 \mu\text{m}$ , and  $0\text{--}50 \mu\text{m}$ . When comparing Figures 3 and 4, the highest erosion rate consistently occurs at a  $90^\circ$  impingement angle, indicating no significant changes in this regard. However, there are notable differences in the lowest erosion rates, where, for all sand particle size ranges, the angle associated with the lowest erosion is consistently recorded at  $15^\circ$ . All examined samples exhibit a predominantly brittle response, with maximum erosion rates observed at angles from  $75^\circ$  to  $90^\circ$ .

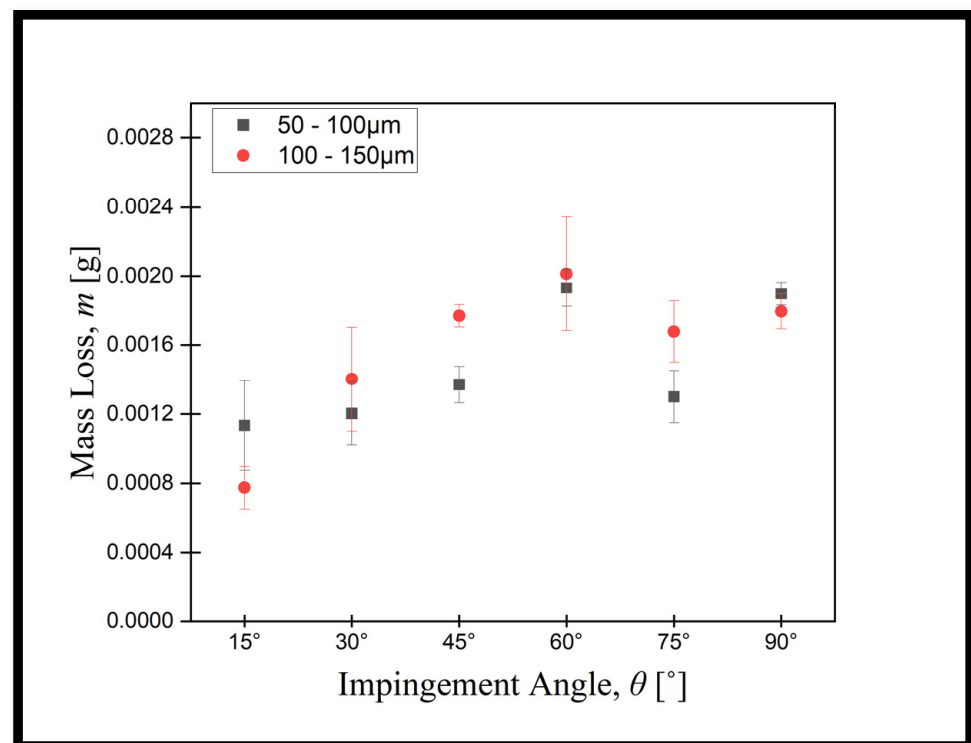
**Figure 6.** Mass loss (g) of GFRP after 91 days (2184 h) pre-exposure at a velocity of  $6.425 \text{ ms}^{-1}$  and sand size of  $50\text{--}100 \mu\text{m}$ ,  $100\text{--}150 \mu\text{m}$ .

Figure 6 displays an atypical pattern in mass loss at a velocity of  $6.425 \text{ ms}^{-1}$ : the largest point of mass loss occurred for sand particles measuring 100–150  $\mu\text{m}$  at an angle of  $60^\circ$ . Nevertheless, when the impact angle was at  $15^\circ$ , the reduction in mass was at its minimum and was lower than that observed for sand particles measuring 50–100  $\mu\text{m}$ . Moreover, there is a reduction in the mass loss as the impact angle changes from  $60^\circ$  to  $75^\circ$ . Figure 7 illustrates the reduction in mass when moving at a velocity of  $9.914 \text{ ms}^{-1}$ , using sand particles ranging in size from 50–100  $\mu\text{m}$  and 100–150  $\mu\text{m}$ . Despite the sand particle size of 100–150  $\mu\text{m}$  being higher than the sand particle size range of 50–100  $\mu\text{m}$ , there is a lower mass loss when the impact angles range from  $15^\circ$  to  $30^\circ$ . Furthermore, when the impact angle reaches  $75^\circ$ , the mass loss is considered at its peak at both sand sizes.

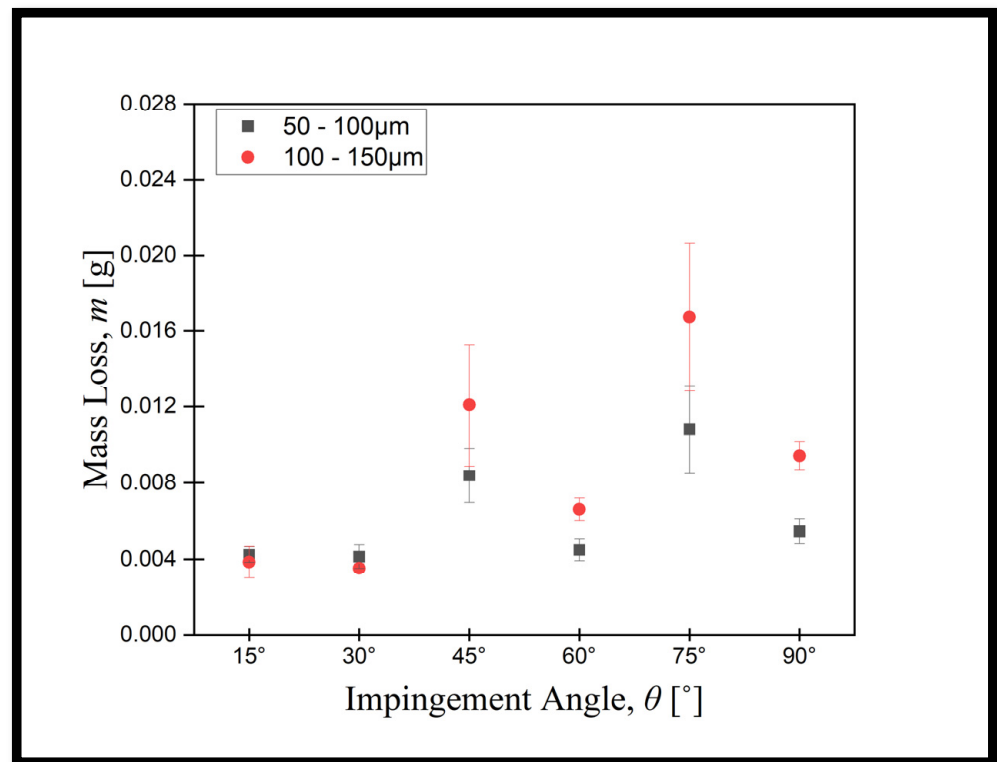
**Figure 7.** Mass loss (g) of GFRP after 91 days (2184 h) pre-exposure at a velocity of  $9.914 \text{ ms}^{-1}$  and sand size of 50–100  $\mu\text{m}$ , 100–150  $\mu\text{m}$ .

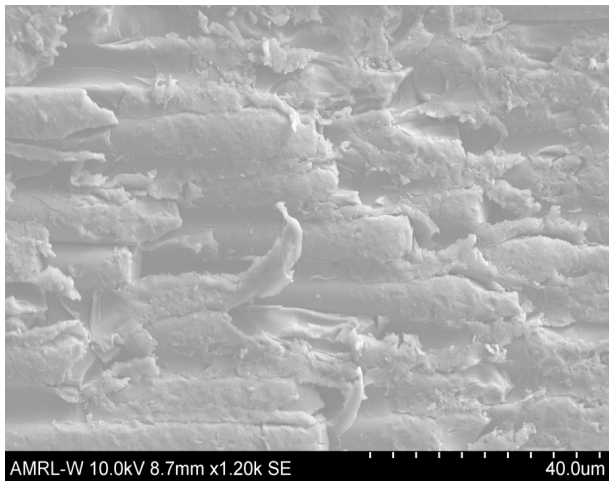
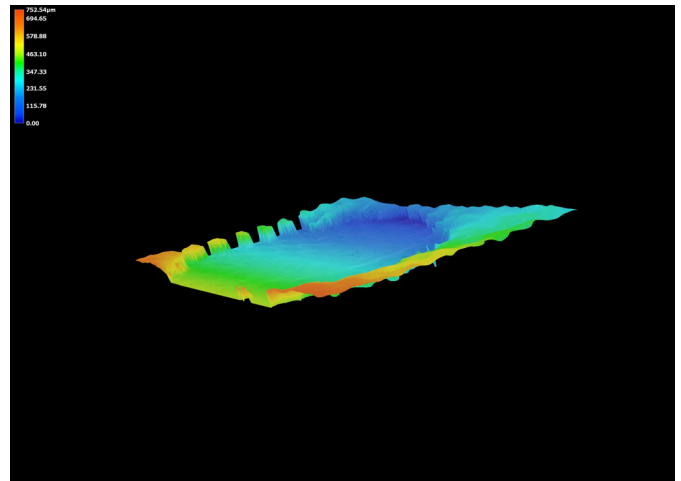
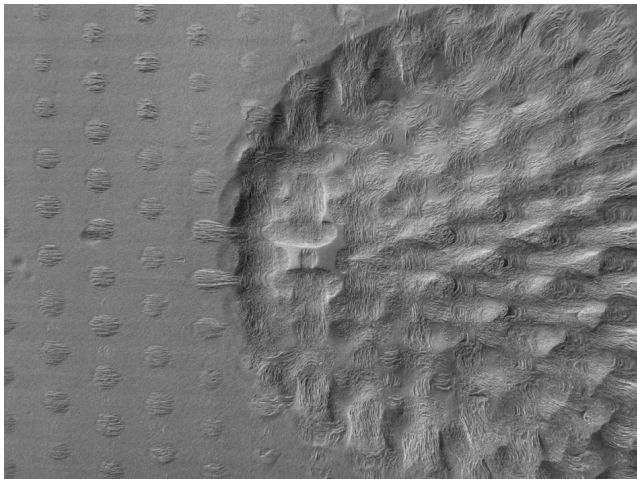
**Figure 8.** (a) SEM microphotograph of GFRP specimen surface for 14-day (336 h) pre-exposure at 100–150  $\mu\text{m}$  sand particle size velocity of  $12.5\text{ ms}^{-1}$  and impact angle of  $60^\circ$ . (b,c) Views of depth profiling analysis.

Figure 8 shows the surface morphology of the specimen using the scanning electron microscope (SEM) of pre-exposure time for 14 days (336 h) at a fixed  $60^\circ$  impact angle with a slurry velocity of 12.5 m/s. The type of defect in the specimen can be summarised into melting and surface degradations, as the SEM shows a rough surface, suggesting localised heating and softening from the particle impact. The depth profiling analysis was used to understand the mechanisms better, as shown in Figure 8b,c. The depth profiling establishes that the material removal in the composite is approximately in the range of 752  $\mu\text{m}$  in depth. This technique indicates a sizeable crater-shaped cavity, caused by repeated high-energy impacts, resulting in significant localised material removal.

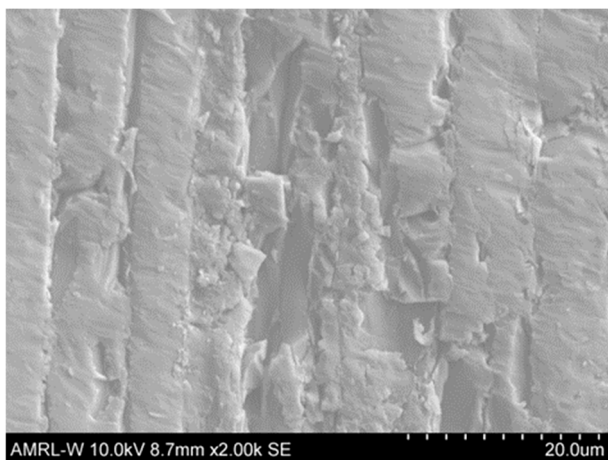
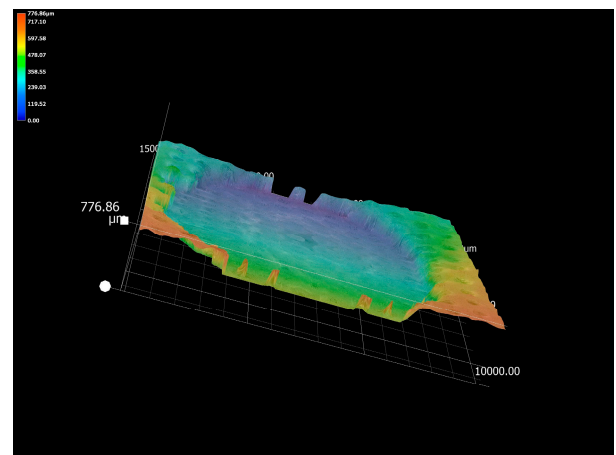
**Figure 9.** (a) SEM microphotograph of GFRP specimen surface for 14-day (336 h) pre-exposure at sand particle size of 100–150  $\mu\text{m}$ , velocity of  $12.5 \text{ ms}^{-1}$  and impact angle of  $90^\circ$ . (b,c) Views of depth profiling analysis showing the depth of GFRP for the 60 min test.

A similar analysis was taken at  $90^\circ$ , as shown in Figure 9a–c. The sample failure could be summarised into two main points: the failure of the matrix, which in this case is epoxy, and the failure of the fibre reinforcement, causing fractures. This matrix separation exposes the underlying fibres, signifying the beginning of the erosion process. The exposure of fibres clearly shows the incapacity of the matrix to resist the erosive stresses, which will finally cause failure in the composite structure [31]. In addition, the depth profile appears to be deeper at  $90^\circ$  when recorded at a value of 776  $\mu\text{m}$ .

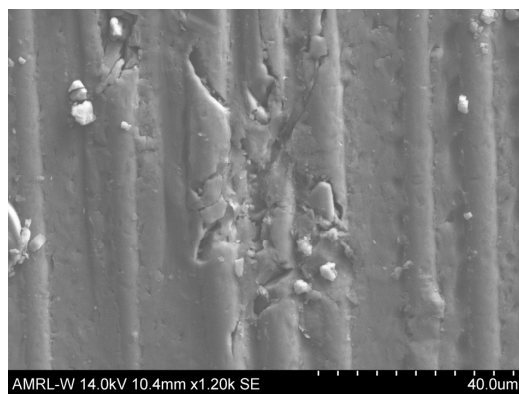
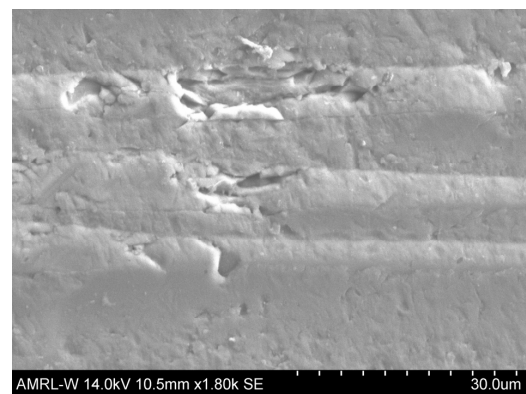
Figure 10 below illustrates the harsh cutting action of the erodent. Additionally, the severe brittle fractures are a result of this cutting action. Figure 11 below shows images of the specimen after depth profiling. The aggressive marine environment at a  $75^\circ$  angle altered the specimen shape, making the erodent cutting action more apparent.

**Figure 10.** (a) SEM micrograph of GFRP specimen surface for 91 days (2184 h) pre-exposure at sand particle size of 100–150  $\mu\text{m}$ , velocity of  $6.425 \text{ ms}^{-1}$  and impact angle of  $60^\circ$ . (b) SEM for sand particle size of 50–100  $\mu\text{m}$ , velocity of  $6.425 \text{ ms}^{-1}$  and impact angle of  $60^\circ$ .

Figures 10a,b, and 11a,b present the erodent that occurs on the specimens after a pre-exposure time of 91 days (2184 h). At this phase, matrix degradation occurs on the surface of specimens. Fibre/matrix debonding undermines the structural integrity of the composite, resulting in reduced mechanical characteristics and heightened vulnerability to more erosive degradation. In addition, subsequent particle impact may result in fibre fragmentation, characterised by cracking and numerous fractures of the fibres [31].

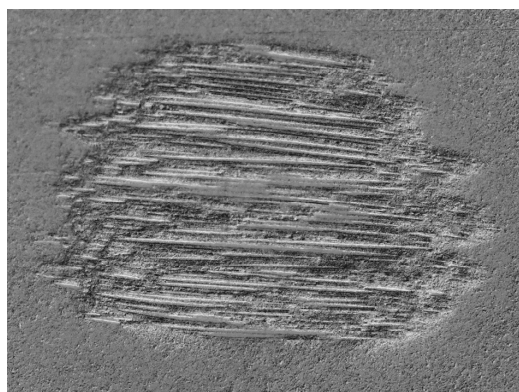
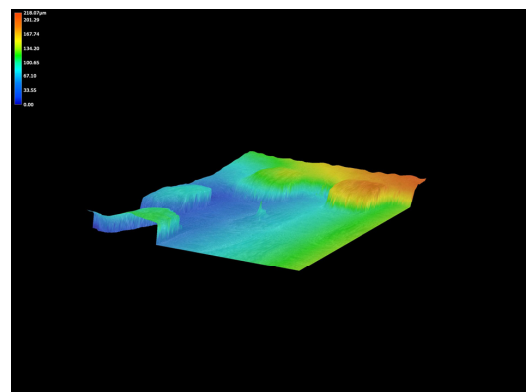
**Figure 11.** (a,b) Depth profiling of the specimen surface for 91 days (2184 h) pre-exposure at 100–150  $\mu\text{m}$  sand particle size, velocity of  $9.914 \text{ ms}^{-1}$ , and impact angle of  $75^\circ$ .

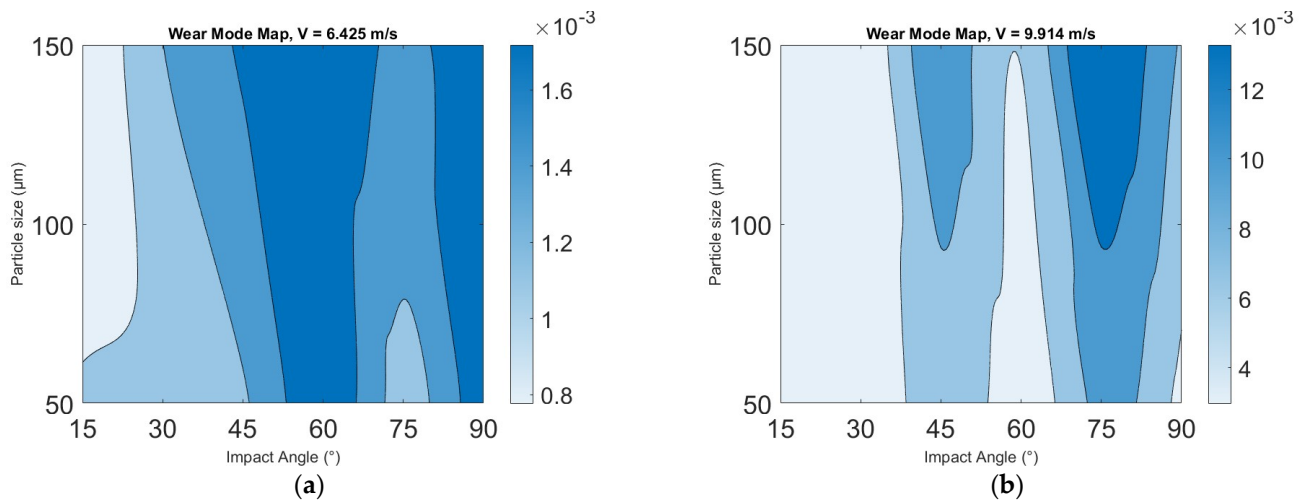
Moreover, the 91 days (2184 h) pre-exposure erosion wastage maps were found at velocities of  $6.425\ \text{ms}^{-1}$  and  $9.914\ \text{ms}^{-1}$  for sand particle sizes of  $50\text{--}100\ \mu\text{m}$  and  $100\text{--}150\ \mu\text{m}$ , as shown in Figure 13a,b.

**Figure 13.** Erosion wastage maps of mass loss (g) GFRP specimens for 91 days (2184 h) pre-exposure in aqueous media (a)  $6.425 \text{ ms}^{-1}$  (b)  $9.914 \text{ ms}^{-1}$ .

Wear and erosion maps illustrate the mechanistic alterations occurring on the worn surfaces of the test samples in various operation situations [2,28,32,33]. Constructing wear mode maps aids in comprehending the mechanisms of material deterioration and the chemical degradation of the surface. Wear mode maps clearly represent the rates at which materials undergo mass loss and also indicate the optimal operating parameters for the chosen material. Figures 12 and 13 suggest that these maps can ease the interpretation of the multi-variable interactions involved in the process. Such maps are essential for optimising tidal energy material degradation due to erosion parameters.
