# The dislocation mechanism of stress corrosion embrittlement in Ti-6Al-2Sn-4Zr-6Mo

An observation of the dislocation mechanisms operating below a naturally initiated hot salt stress corrosion crack is presented, suggesting how hydrogen may contribute to embrittlement. The observations are consistent with the hydrogen enhanced localised plasticity mechanism. Dislocation activity has been investigated through post-mortem examination of thin foils prepared by focussed ion beam milling, lifted directly from the fracture surface. The results are in agreement with existing studies, suggesting that hydrogen enhances dislocation motion. It is found that the presence of hydrogen in (solid) solution results in dislocation motion on slip systems that would not normally be expected to be active. A rationale is presented regarding the interplay of dislocation density and the hydrogen diffusion length.

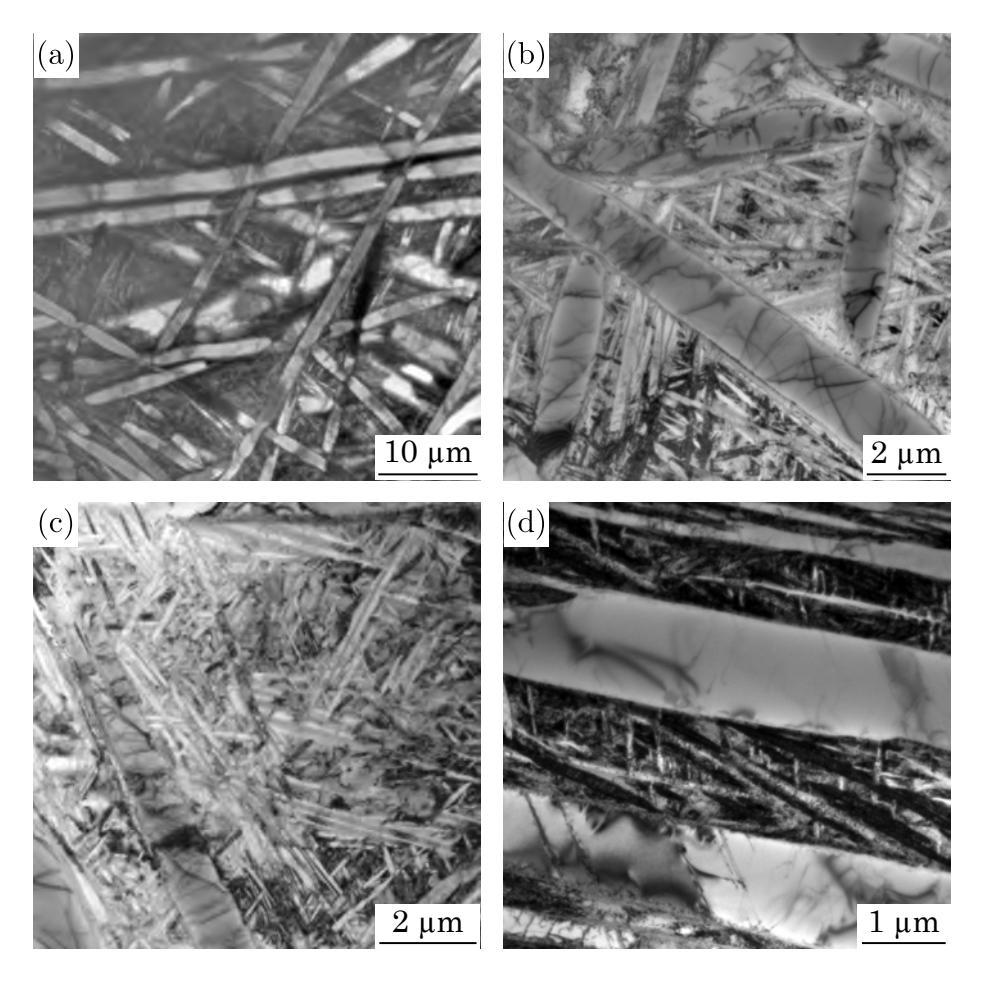
Figure 1: Bright field (BF) TEM images: (a) Overview of lamellar  $\alpha/\beta$  microstructure, (b) and (c) Primary and secondary alpha laths, (d) Secondary alpha residing between coarse primary alpha laths.

The Ti-6246 material used during this study was provided by Rolls-Royce <sup>95</sup> plc., and was tested at the Mechanical Testing Operations Center (MTOC), Rolls-Royce Deutschland. Two specimens were examined ("blue spot" specimen U7-086 [29] and "datum" specimen LCF127 ) which were tested at 450 °C with a maximum stress ( $\sigma_{max}$ ) of 600 MPa (U7-086) and 640 MPa (LCF127) and an R ratio of 0.1. The material was processed with a final heat treatment in the  $\beta$  phase field followed by ageing in the  $\alpha + \beta$  phase field, to produce the lamellar microstructure shown in Figure 1. The microstructure consisted of coarse, high aspect ratio primary  $\alpha$  laths, and fine secondary  $\alpha$  laths residing within a retained  $\beta$  matrix. Fully lamellar microstructures are used to maximise fracture toughness [5], with elevated strength provided by the fine secondary alpha phase.

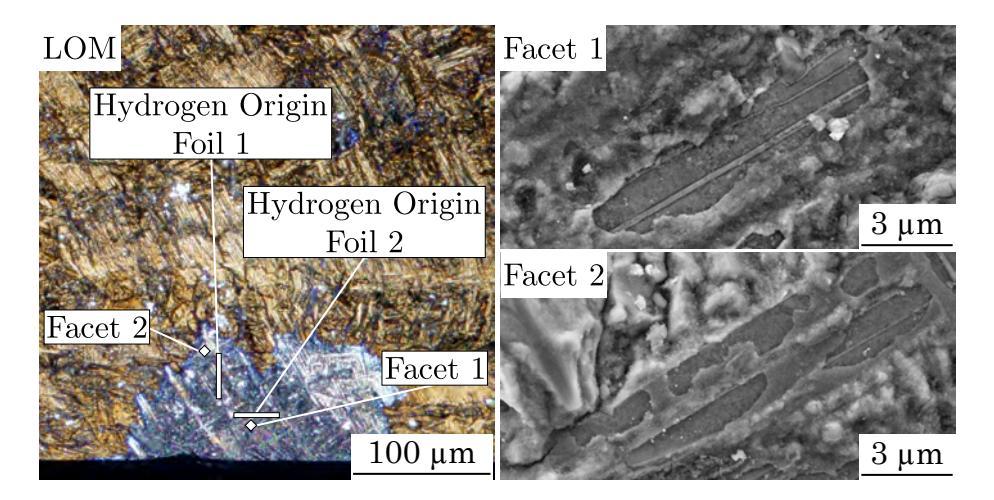
Figure 2: The hydrogen embrittled zone is demonstrated by the blue semi-elliptical feature at the fatigue crack origin. The locations of the facets for the QTF/EBSD technique, as well as the position of the foils for dislocation contrast analysis, are given.

Oxford Instruments EBSD detector, was used. By identifying the spatial orientation of the fracture features using QTF [34, 35, 36] it was possible to index Kikuchi diffraction patterns obtained directly from the fracture surface. Two facets within the hydrogen embrittled initiation site were analysed, Figure 2.

In situ FIB lift out was used for the preparation of thin foils from the "blue spot" origin in U7-086, Figure 2, from the crack initiation site in LCCF127 and from the region of fatigue crack growth in U7-086, 600  $\mu$ m from the origin. FIB milling was carefully performed so as to minimise the surface damage due to irradiation by the Ga<sup>+</sup> beam [37, 38], commonly attributed to Ga<sup>+</sup> ion implantation, which can, in some cases, affect defect structures. Initially, a sample was produced from as-received material that had not undergone further deformation since forging, using a dual beam FEI Helios NanoLab 600. Approximately 2  $\mu$ m of platinum was deposited onto the region of interest to protect the surface from the 30 kV primary Ga<sup>+</sup> beam. After lift-out, the sample was thinned down to ~ 180 nm. The final thinning stage involved low current (28 pA), low

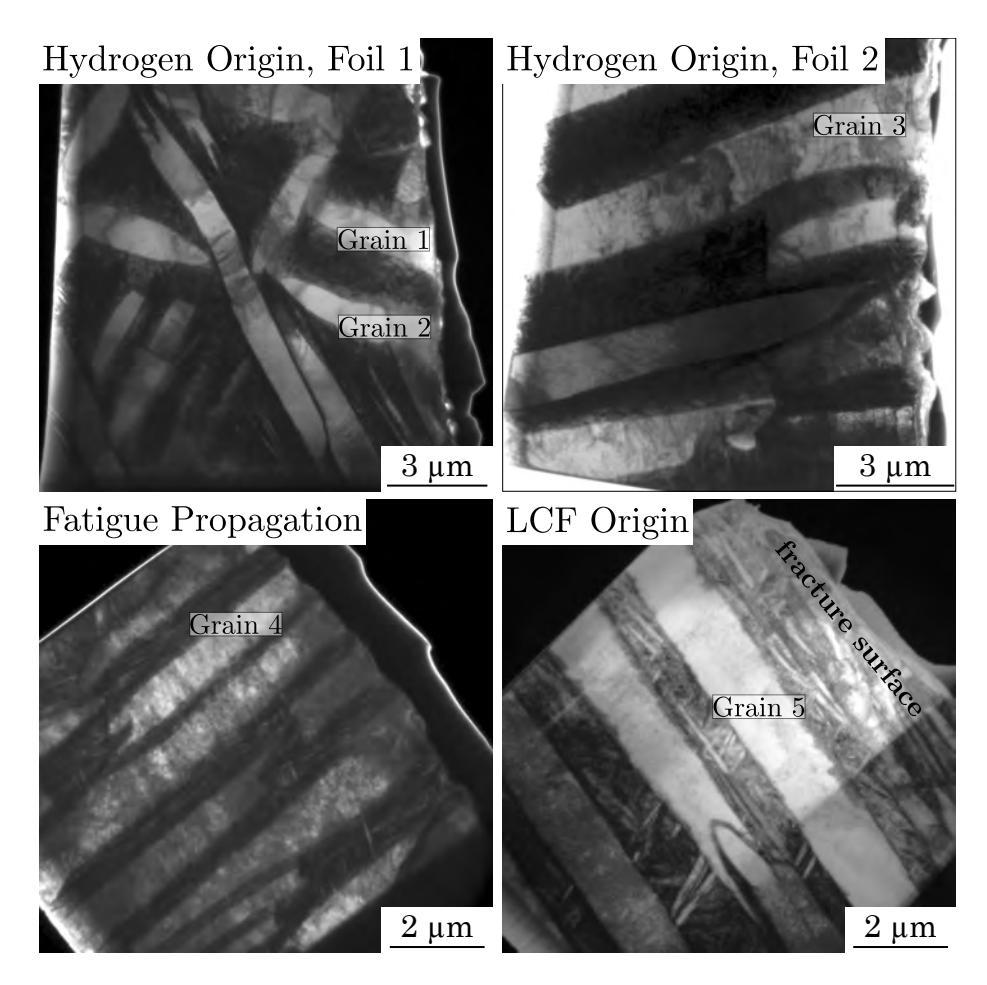
Figure 3: Position of the grains of interest within the respective FIB-prepared TEM foils.

- provided consistent results in the TEM, see Appendix. All site-specific samples were then lifted directly from the fracture surface using the same FIB lift-out procedure. The optimal sample thickness was found to be  $\sim 180$  nm. This was thick enough to observe clear Kikuchi lines, while achieving adequate imaging conditions. For consistency, all analysis was undertaken on primary alpha laths,
  - as shown in Figure 3.

nisms associated with the fracture process, it was deemed important to analyse grains connected to the fracture surface, i.e. not subsurface; Figure 3 shows the positions of the analysed grains with respect to the fracture surface.

- and the consequent collision with another primary alpha lath; refer to Figure 3, hydrogen origin foil 1. These observations again suggest that these dislocation structures are restricted to material only a few microns sub-surface of the growing crack. Observations based on trace analysis and invisibility contrast suggest that, like grain 1, the linear dislocation segments spanning across the

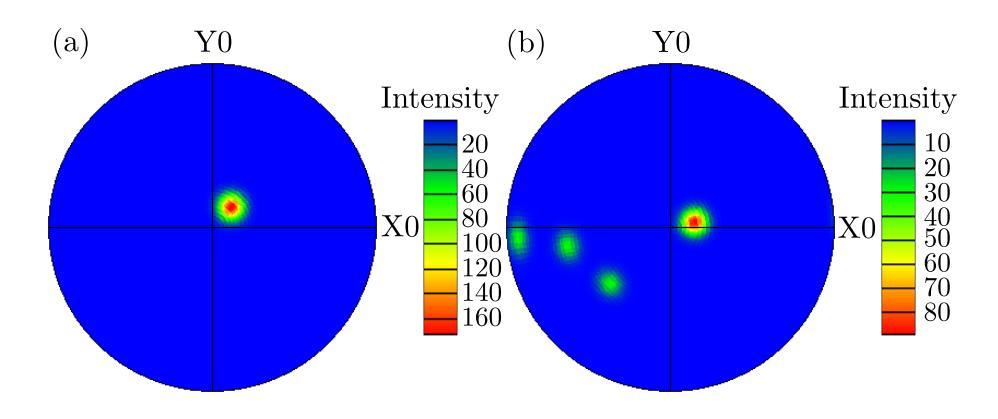
Figure 4: [0001] pole figures obtained from facets within the hydrogen embrittled origin: (a) Facet 1 ~14 ° from the basal plane , (b) Facet 2 ~14 ° from the basal plane.

- <sup>160</sup> pole figures, demonstrated in Figure 4, it can be seen that both facet normals lie close to the [0001] direction. In fact, the facet normals are measured to be orientated ~14° away from the [0001] direction, indicating that the plane of the facet, and thus fracture plane, coincides with either the  $\{10\overline{1}7\}$  or  $\{10\overline{1}8\}$ planes, inclined at 15° and 13° away from the basal plane respectively. Both the  $(10\overline{1}7)$  and  $(10\overline{1}8)$  planes are become to be accurate both and the planes [20]
- {1017} and {1018} planes are known to be common hydrogen habit planes [39], indicating that the fracture mechanism is likely to have been modified by the presence of hydrogen. It should be noted that the three low intensity spots in Figure 4(b) have arisen from indexing of an adjacent, and differently orientated grain.

cracks to have formed from these slip planes [41]. Additionally, Bantounas et al. found evidence suggesting facets on a high-cycle fatigue fracture surface to be associated with basal slip [42]. Figure 4 demonstrated pole figures achieved from direct indexing of facets in the hydrogen embrittled origin region. These 395 pole figures suggested the plane of fracture to be a high index plane, such as  $(10\overline{1}7)$  or  $(10\overline{1}8)$ , which are known hydrogen habit planes. The facets in question contain structure, and are certainly not featureless, thus it is suggested that the formation of these low  $\Delta K$  features arises *via* a slip induced mechanism, perhaps on one of the high index planes stated above.

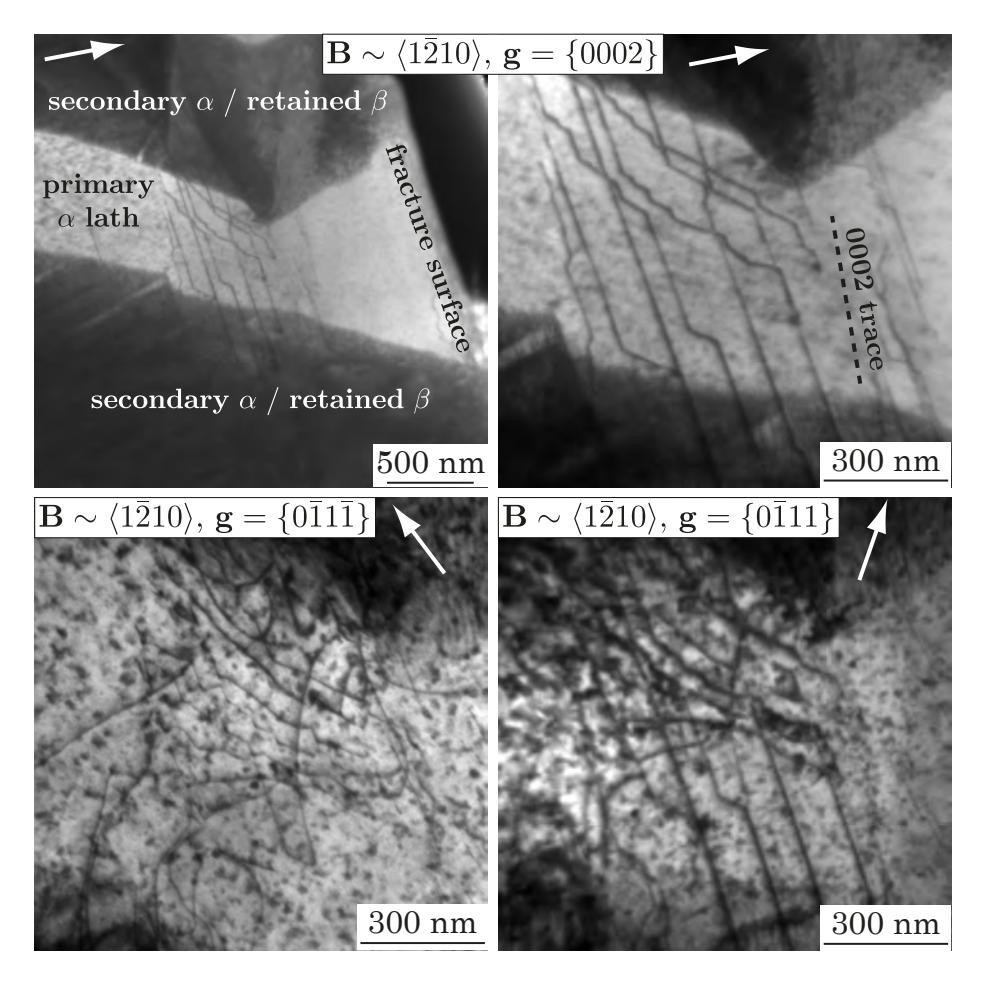
Figure 5: BF dislocation contrast images for grain 1, for diffraction conditions of  $\mathbf{g}_{0002}$ ,  $\mathbf{g}_{0\bar{1}1\bar{1}}$  and  $\mathbf{g}_{0\bar{1}11}$ . The white arrows indicate the direction of the  $\mathbf{g}$  vector.

Grain 1's {0002} plane normal was found to be  $\sim 70^{\circ}$  to the tensile-fatigue loading axis. Figure 5(a) shows bright field (BF) TEM micrographs, imaged with several diffraction conditions. For  $\mathbf{g}_{0002}$ , an array of linear dislocation segments were observed across the width of the primary alpha grain,  $\sim 700 \text{ nm}$

- residing in the basal plane, and imaged under these conditions edge-on, would appear as straight line segments, parallel to the (0002) trace. Slight misorientation between the trace and the dislocation segment is likely to result from the small rotation of the SADP (from which the trace is obtained) when the sample is tilted away from the pole to reach the required **g** vector. From trace analysis, it is therefore implied that the array of dislocations in Figure 5 ( $\mathbf{g}_{0002}$ ) has resulted from slip on the basal plane.

Basal glide has frequently been observed in  $\alpha$  titanium, but this occurs almost exclusively with  $\langle 11\bar{2}0 \rangle$  type Burgers vectors. Under  $\mathbf{g}_{0002}$  diffraction conditions, as in Figure 5 (upper), all screw dislocations with  $\langle a \rangle$  type  $\langle 11\bar{2}0 \rangle$ Burgers vectors should have zero contrast, and thus be invisible, which is not the case here. It then became necessary to evaluate the edge component also, incorporating the  $\mathbf{g} \cdot (\mathbf{b} \times \mathbf{l})$  criterion. Introducing a perpendicular line vector, with indices  $\langle 1\bar{1}00 \rangle$ , demonstrates positive contrast for edge dislocations gliding on (0002) planes, when imaged with  $\mathbf{g}_{0002}$ . However, for all the  $\{1\bar{1}00\}$  glide

The same area was viewed at alternative diffraction conditions of  $\mathbf{g}_{0\bar{1}1\bar{1}}$  and  $\mathbf{g}_{0\overline{1}11}$  in an attempt to determine the active dislocation type. Contrast of the 230 original linear dislocation array, as seen for  $\mathbf{g}_{0002}$ , remains for both  $\mathbf{g}_{0\bar{1}1\bar{1}}$  and  $\mathbf{g}_{0\bar{1}11}$ , in varying intensity. This observation essentially excludes edge  $\langle c+a \rangle$ dislocations gliding on first order pyramidal planes, since the invisibility criterion suggests zero contrast for either  $\mathbf{g}_{0\bar{1}1\bar{1}}$  and  $\mathbf{g}_{0\bar{1}1\bar{1}}$ , in most cases. Table 2 provides details of the invisibility criterion for a number of  $\mathbf{g}$  vectors. Furthermore, the 235 elastic energy of a dislocation is proportional to the magnitude of the Burgers vector, with the  $\langle c + a \rangle$  energy almost twice that of the  $\langle a \rangle$  type Burgers vector. Finally edge  $\langle a \rangle$  show zero contrast at  $\mathbf{g}_{0002}$  for prismatic planes and at  $\mathbf{g}_{0\bar{1}11}$ for first order pyramidal planes. Hence, it is tentatively suggested that the linear dislocation arrays observed for grain 1 in Figure 5 are associated with edge dislocations undergoing basal slip in the direction of  $\langle 11\bar{2}0 \rangle$  type Burgers vectors.

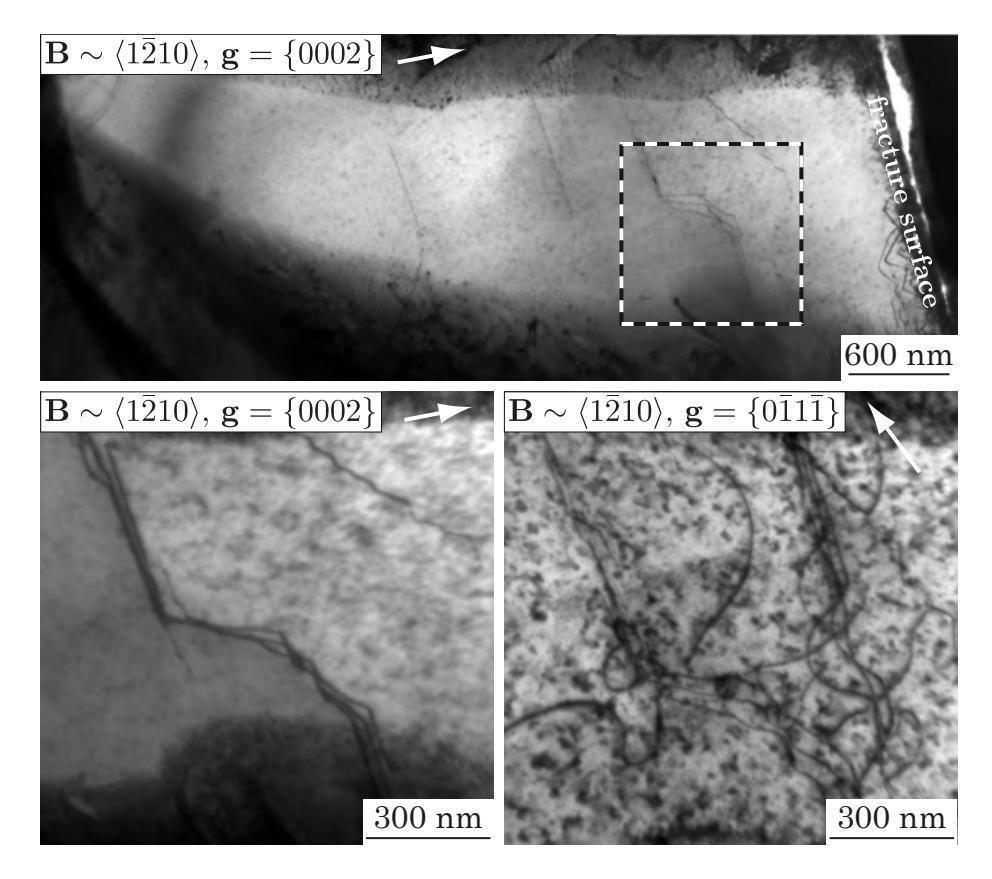
Figure 6: BF dislocation contrast images for grain 2: (Upper) Stitch of low magnification images for  $\mathbf{g}_{0002}$ , (Lower) Increased magnification views for  $\mathbf{g}_{0002}$  and  $\mathbf{g}_{0\bar{1}1\bar{1}}$ . The dashed box indicates the area magnified from the stitch in the lower left image. In all cases, the white arrow indicates the direction of the  $\mathbf{g}$  vector.

- lath have edge character, and have arisen from  $\langle 11\bar{2}0\rangle \{0001\}$  type slip. Imaging under  $\mathbf{g}_{0\bar{1}1\bar{1}}$  repeats these findings; Figure 6. With reference to the high magnification micrograph for  $\mathbf{g}_{0002}$  given in Figure 6, the short, inclined dislocation segments first observed in grain 1, are indicated again in grain 2. In this instance, at least three individual linear dislocations can be resolved, with

- each inclining away from the (0002) trace at angles between  $\sim 105 120^{\circ}$ . A collection of non-linear dislocations can also be identified directly beneath the fracture surface of grain 2 for conditions of  $\mathbf{g}_{0002}$ ; see low magnification image. These looping dislocations appear to have been emitted from the 200 nm thick oxide layer, that covers the hydrogen embrittled origin. It is, however, unclear

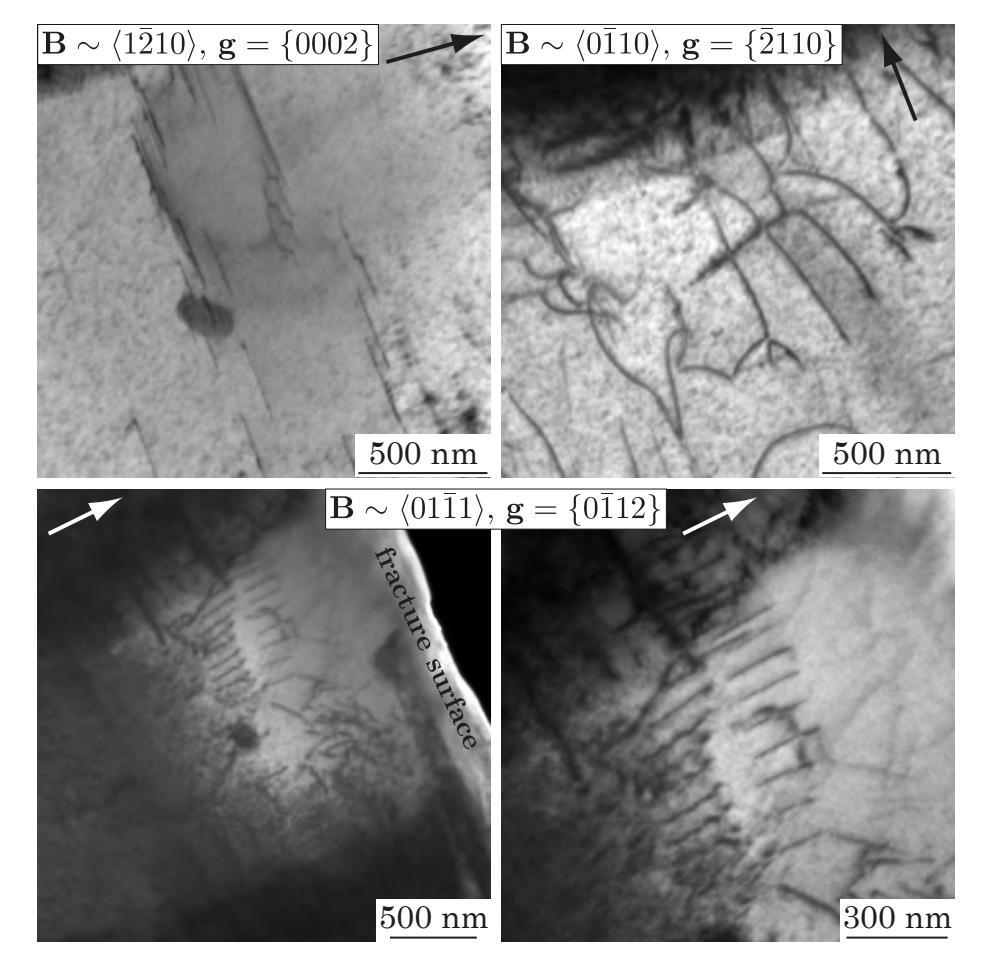
Figure 7: BF dislocation contrast images for grain 3, for diffraction conditions of  $\mathbf{g}_{0002}$ ,  $\mathbf{g}_{\bar{2}110}$  and  $\mathbf{g}_{0\bar{1}12}$ . The arrows indicate the direction of the  $\mathbf{g}$  vector.

Figure 7 presents increased magnification micrographs of a bright field image for  $\mathbf{g}_{0\bar{1}12}$ . Two rows of parallel dislocation arrays are seen to give contrast at these imaging conditions, as discussed above. Consistent with findings from grains 1 and 2, the dislocations only reside immediately beneath the fracture surface, up to ~ 1.5 µm sub-surface. Considering the FIB foil in 3D, but noting its transparency, it is likely that the discontinuous appearance of the dislocation segments is an effect of the position and orientation of the dislocations within the foil. Moreover, because the dislocations do not lie in the plane of the foil, and thus are restricted to the foil thickness, they appear in short segments where they "run out" the front and back planes of the foil. The two rows observed

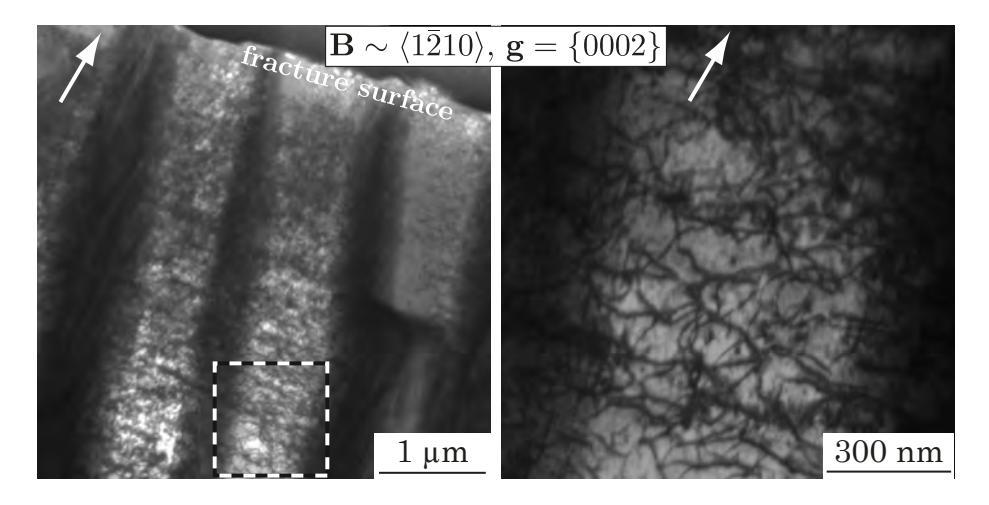
Figure 8: BF dislocation contrast images for grain 4, for diffraction conditions of  $\mathbf{g}_{0002}$ . The white arrows indicate the direction of the  $\mathbf{g}$  vector.

- therefore not experienced any effect of solute hydrogen. Since grains 3 and 4 have similar crystallographic orientations ({0002} normal ~ 25° vs. ~ 30° from the loading axis), direct comparisons can be made between them. Figure 8 provides BF diffraction contrast images taken with diffraction conditions of  $\mathbf{g}_{0002}$ . A high dislocation density is seen to extend down the length of the

- primary alpha laths. This is in stark contrast to observations from hydrogen embrittled grains. For grains 1-3, a low density of individual dislocation arrays were observed, and appeared to be restricted to the first few microns, directly beneath the fracture surface. The low magnification image given in Figure 8 has been included to demonstrate these differences. Although not included

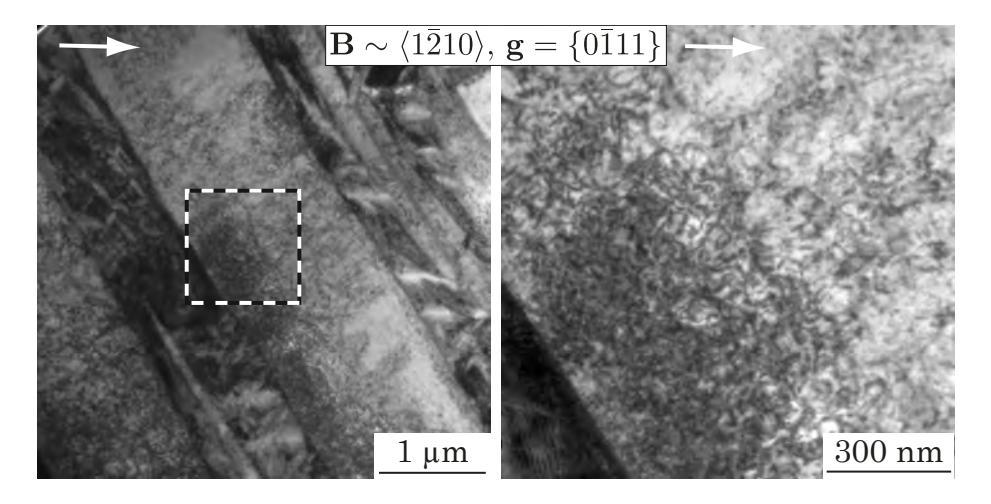
Figure 9: BF dislocation contrast images for grain 5, for diffraction conditions of  $\mathbf{g}_{0\bar{1}11}$ . The white arrows indicate the direction of the  $\mathbf{g}$  vector.

Figure 9 illustrates the dislocations observed in a primary  $\alpha$  lath (grain 5) beneath the origin of a low cycle fatigue test specimen not subjected to hot salt stress corrosion cracking, in similar testing conditions. A low magnification view of the TEM foil is provided in Figure 3. A high density of dislocations can be observed for  $\mathbf{g}_{0\bar{1}11}$ , in common with the low cycle fatigue propagation region (grain 4) already examined. The c-axis of grain 5 is inclined at ~80° to the fatigue loading axis and therefore grain 5 can be directly compared with

grains 1 and 2; see Table 1. The observation of a higher dislocation density in the low cycle fatigue crack growth region is consistent with those observed in a conventional low cycle fatigue origin, and quite distinct from those in the hot salt stress corrosion crack origin region. Thus, an effect of crack length can be

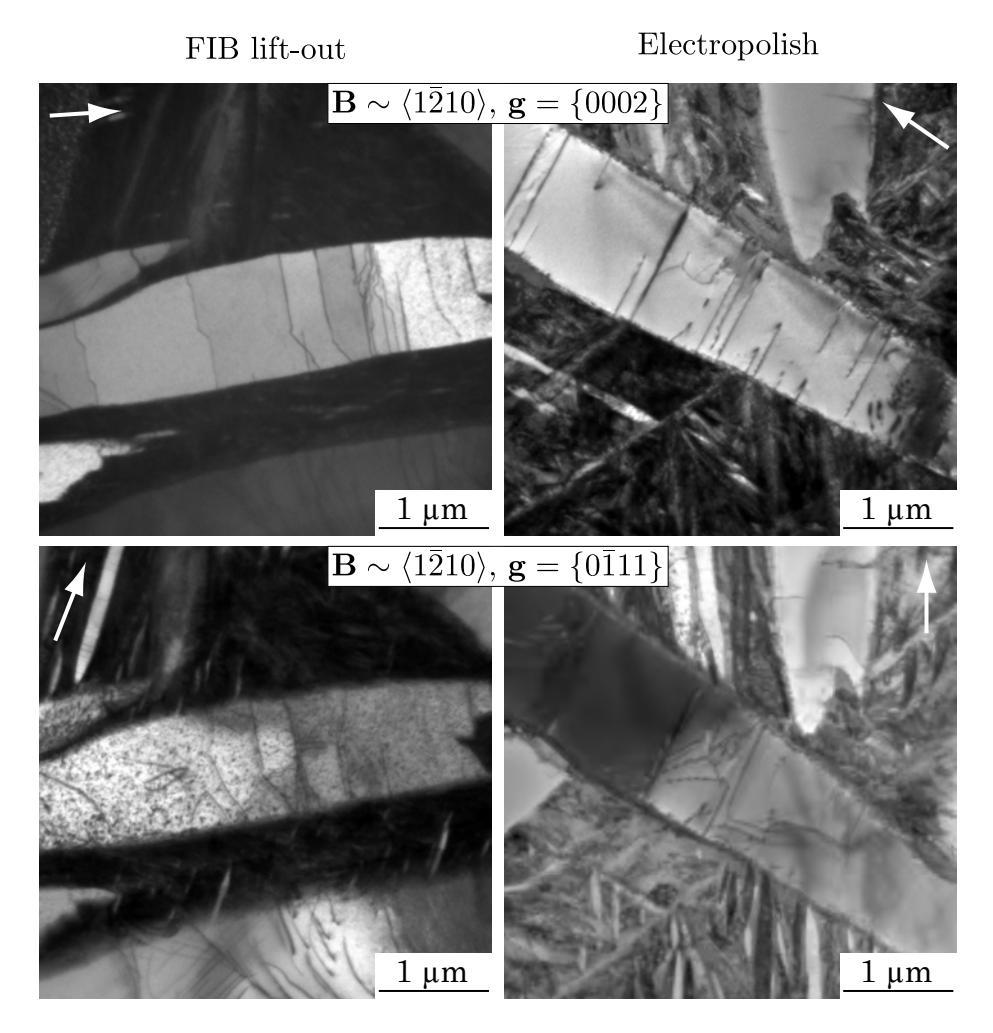
Figure 10: BF dislocation contrast images for FIB and electropolished prepared thin foils, for diffraction conditions of  $\mathbf{g}_{0002}$  and  $\mathbf{g}_{0\bar{1}11}$ . The white arrows indicate the direction of the  $\mathbf{g}$  vector.

Figure 10 demonstrates two different imaging conditions for: 1. a primary alpha lath within a FIB prepared foil, and 2. a primary alpha lath within an electropolished foil. Both samples were prepared from as-received material that had undergone no further mechanical deformation since the forging process. For invisibility conditions of  $\mathbf{g}_{0002}$ , both samples show a low density of linear dislo-370 cation segments, which extend across the width of grain. For both preparation techniques the dislocations are also distributed throughout the length of the primary alpha. For an alternative contrast condition of  $\mathbf{g}_{0\bar{1}11}$ , the dislocation density and distribution is again comparable for the grains in either sample, as is the general appearance of the dislocation segments. Evidence of FIB dam-375 age can be seen at both imaging conditions, but is more severe for  $\mathbf{g}_{0\bar{1}11}$ . The supposed FIB damage can be observed as the speckled contrast throughout the alpha lath, that is likely to be associated with strain accumulation caused by Ga<sup>+</sup> ions implanted during milling. As a result, the dislocations within the FIB foil are slightly less distinctive than those in the electropolished foil. How-380 ever, the dislocation contrast in the FIB foil remains adequate, so it is possible to differentiate between the dislocations and the FIB damage. It is hence concluded that preparation using FIB milling has not effected the ability to analyse

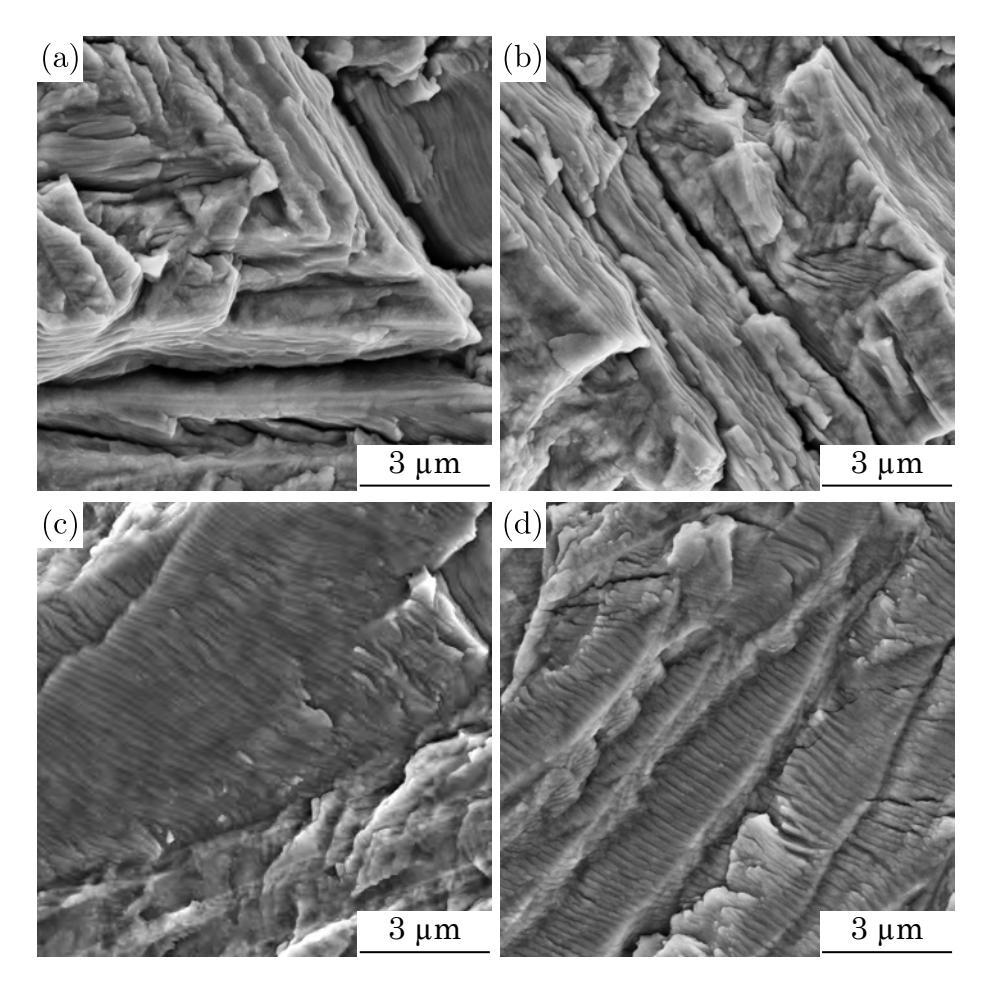
Figure 11: Secondary electron images taken from the fatigue crack propagation region, all at a crack length of  ${\sim}600\,\mu{\rm m},$  close to the location from which the foil containing grain 4 was extracted: (a) and (b) secondary cracking, (c) and (d) evidence of underlying microstructure as primary alpha lath structures and torn striations.

Figure 11 demonstrates a representative overview of the general fractography observed at a crack length of  $600 \,\mu m$  (grain 4). Both secondary cracking, (a) and (b), and striated growth, (c) and (d), are plastic processes, indicating that the material at this crack length has undergone significant plasticity prior to crack propagation. Not only do the secondary cracks appear to be held open, but the 405 fine ligaments of material between individual striations are observed to have torn apart, 11(d), which is a further indication of significant plasticity. Contrastingly, the material within the hydrogen embrittled region is largely facetted and has a macroscopically brittle appearance (grains 1-3); refer to Chapman et al., Figure 4 [29]. 410
