Engineering Failure Analysis

Designing nickel coatings for water erosion performance: Optimisation of grain size and thickness

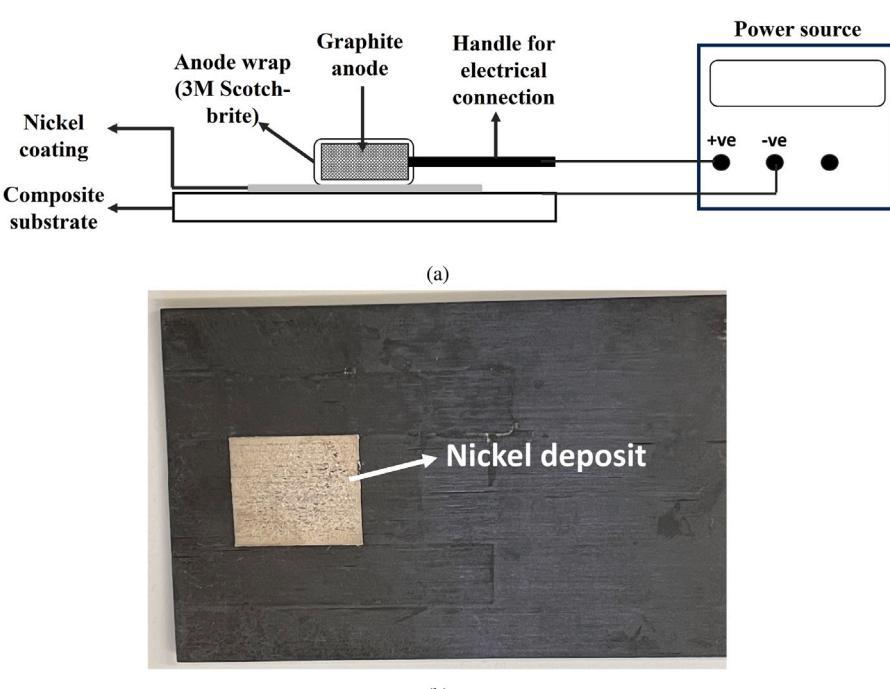
Fig. 1. Schematic of brush plating set up is shown in (a). An example of nickel deposit on composite plate is shown in (b).

Brush plating is an electrodeposition technique that provide a mobile and highly productive solution to deposit metallic materials. The technique setup involves a rectifier and brush covered anode(s) soaked with surface preparatory/plating solution(s) (see Fig. 1(a)). A SIFCO model SPL-75 was used as rectifier [26], which is capable of being switched rapidly between cathodic and anodic modes. The anode was special heat-resistant graphite block, typically covered with white, particle-free non-abrasive 3M Scotch-brite[®] cloth. All solutions are industrial products manufactured by SIFCO ASC, which includes surface preparatory as well as plating solutions.

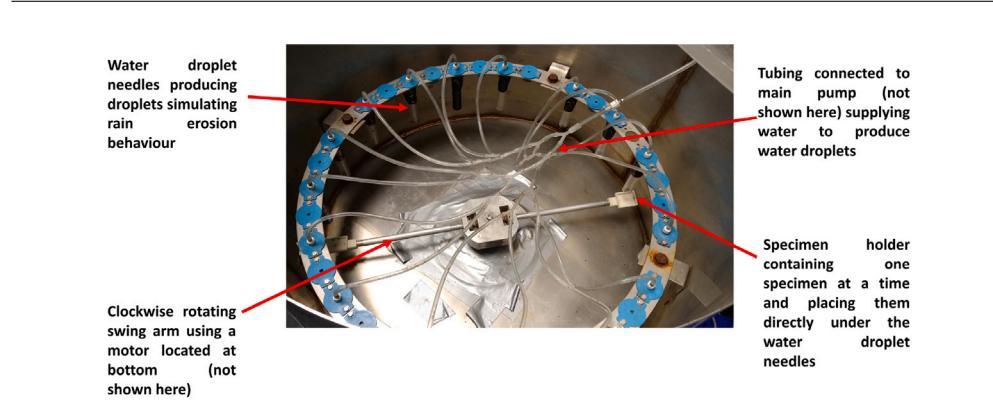
Fig. 2. Water droplet erosion rig at University of Strathclyde.

Rain erosion tests were performed using a bespoke whirl arm erosion rig at the University of Strathclyde (Fig. 2). The design involves a motorised rotating swing arm which holds the specimen in the designed holder [30]. The specimens were trimmed down to 35×25 mm to fit the test rig specimen holder. Care was taken for the coated area to remain unaffected during the cutting process. For comparison, we also evaluated uncoated carbon-fibre reinforced polymer (CFRP) and glass-fibre reinforced polymer (GFRP) (information about GFRP can be found here [31]). Rain behaviour was simulated using water droplet needles, which are supplied with water using a pump. Table 3 lists the parameters selected for the erosion tests.

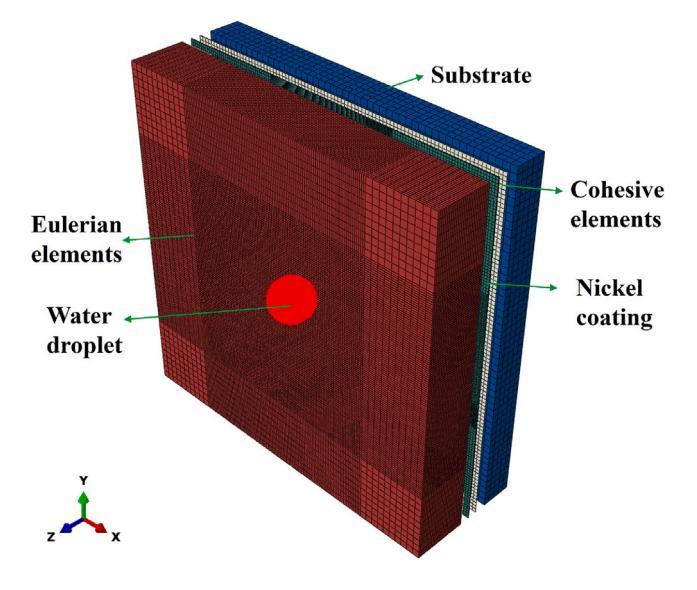
Fig. 3. Finite element model for water erosion. The water droplet was modelled as Eulerian elements while the interface between coating and substrate was modelled as cohesive elements. Delamination of the coating was estimated when scalar stiffness degradation value reached 1.

thickness nickel coating, directly facing the rainwater droplets impact. The nickel deposit is a typical "cauliflower" microstructure, however the model did not consider that and assumed a homogeneous microstructure without any textural input. A 20 μ m thick cohesive layer, is included at the composite substrate/nickel interface to simulate the coating delamination process. The impact of a droplet 2.7 mm in diameter is simulated by defining a 4 mm thick Eulerian region (Fig. 3) above the sample discretised by 3D linear Eulerian elements with reduced integration (EC3D8R). Water is modelled as nearly incompressible Newtonian fluid using the linear Us – Up Hugoniot form of the Mie-Grüneisen equation of state. It has a density of 1 gm/cm³ and dynamic viscosity of 1 mPa s. The Eulerian volume is divided into an initial region occupied by the droplet water using Abaqus volume fraction capability [33]. The remaining Eulerian volume is filled with air. The water impact is simulated by imposing an initial velocity of 103 m/s to the droplet volume fraction and enforcing a friction-less contact between the Eulerian region and the Lagrangian sample. The assumption is compatible with having a water boundary layer considerably smaller than the Eulerian element size.

The sample substrate and the coating are meshed by 3D linear reduce-integrated Lagrangian element (C3D8R), whereas the coating/substrate interface employs COH3D8 cohesive elements implementing a traction–separation constitutive equation [33]. A regular structured mesh of 481224 elements in total, showing refined elements size of 0.05 mm around the droplet impact area is generated, for both Eulerian and coating Lagrangian areas (Fig. 3). Eulerian far-field elements had a 0.5 mm planar square section whereas a 0.05 mm seed was used throughout the whole region thickness. The nickel coating thickness was discretised by 10 μ m thick elements and tied to a cohesive region with 0.25 mm mesh seed. A course cubic mesh of 0.5 mm was applied to the composite substrate. The element size was selected as results of mesh sensitivity studies to obtain the best compromise between computational time and damage prediction accuracy. The sample was assumed to be fixed on its whole lower surface and the droplet impact transient dynamics was simulated for a time of 40 μ s. Tables 4 and 5 list the nickel and CFRP material properties. Table 6 lists the properties for cohesive layer used in the simulation. Initiation of damage is assumed when maximum nominal stress ratio reaches a value of one. We used fracture energy based damage evolution criterion with linear softening behaviour. Table 7 list the Johnson–Cook model parameters implemented in the simulation, respectively. A detailed description of the FE model and analysis parameters can be found in [34].

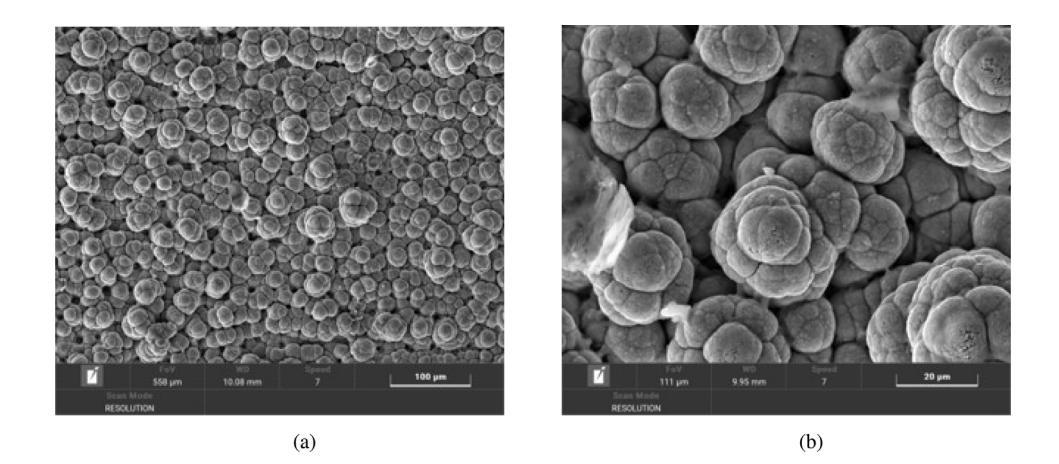
Fig. 4. Typical microstructure of the as-deposited nickel coating observed as SEM image with secondary detector. (b) displays an enlarged view of (a), revealing the magnified image of "cauliflower" structure.

The morphology of brush-plated Nickel High Speed shows the typical globular structure [38] for all deposited thicknesses. Fig. 4 shows representative SEM images of the coating at different magnifications.

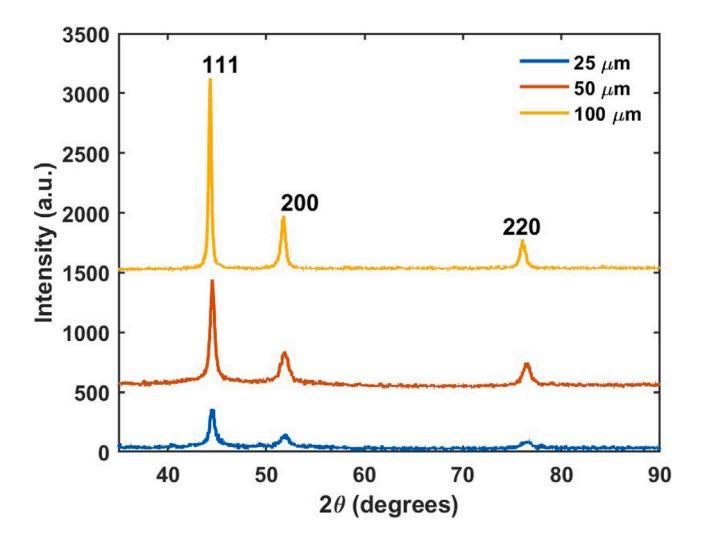
Fig. 5. X-ray peak profile data of the deposited coatings.

Further, these specimens were characterised with XRD for bulk microstructural characterisation. The results show typical diffraction pattern of nickel without additional peaks suggesting absence of any other phases Fig. 5. The most intense peak in all conditions corresponds to (111). Compared with other peak intensities ((200) and (220)), it is evident that brush-plating has not caused any textural development. Further, average crystallite size was calculated for each condition and presented in Table 8. Similar crystallite sizes across different thicknesses confirm a nearly identical bulk microstructure.

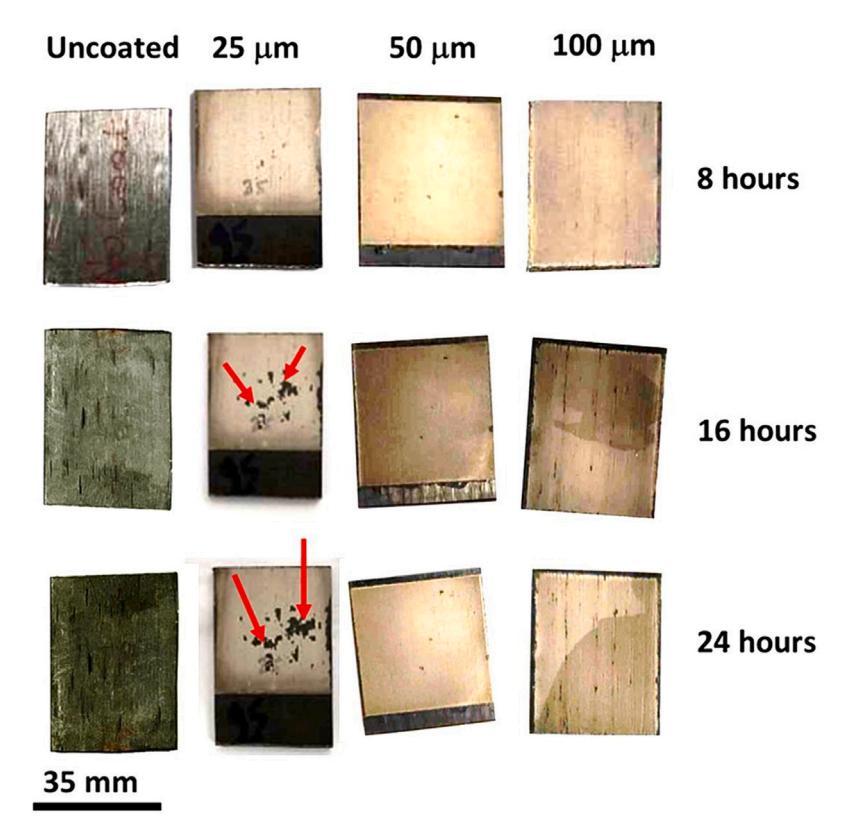
Fig. 6. Photograph of the uncoated CFRP, 25 µm, 50 µm and 100 µm coated specimens (from left to right) after 8 h, 16 h and 24 h of testing. Red arrows show loss of coating due to erosion.

Fig. 6 shows progression of erosion for different deposited conditions after each 8 h of test cycle. The uncoated carbon fibre specimens did not show clear surface damage (fibres having de-bonded from the surrounding epoxy). 25 µm thick coated specimen

starts showing visible damages as loss of coating after second cycle of testing which deteriorates further with increase in time of tests. On contrary, $50 \mu m$ and $100 \mu m$ specimens do not show any visible damage as observed with $25 \mu m$ specimen.

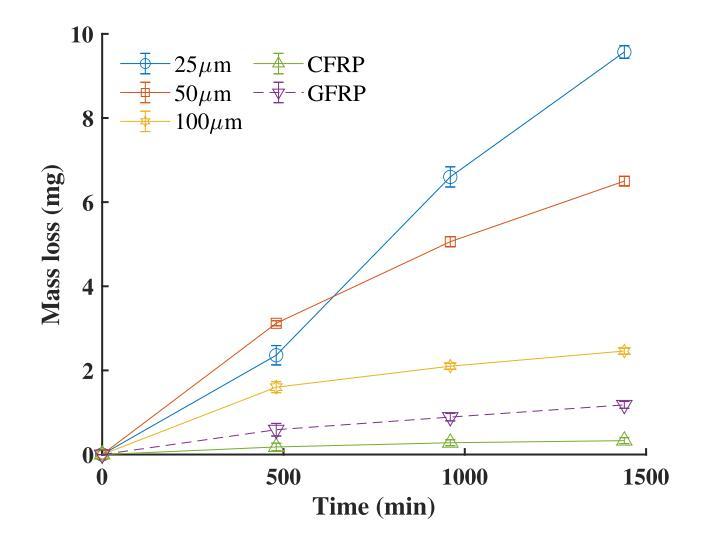
Fig. 7. Weight loss of coatings and uncoated composite specimens during water erosion tests.

Mass losses are plotted in Fig. 7 to quantify the damage of coatings. The uncoated carbon fibre specimen outperformed the glass fibre specimen with the former having 0.33 mg of cumulative erosion across 3 cycles and the latter having 1.18 mg (~3.6 times higher). The overall experimental results reveals that 100 µm coating performed the best among all coated conditions. The 25 µm coating shows comparable erosion resistance trend as of 50 or 100 µm coating for the first 8 h of cycle of testing. However, it was experiencing higher erosion in further cycles, observed as a sharp increase in mass loss (Fig. 6). Significant studies have been carried out to understand the mechanisms of erosion damage initiation and progression for coatings undergoing water droplet impact [39-42]. The initiation of damage is considered as a series of events that leads to mass loss. A typical erosion curve (denoted by mass loss vs exposure time) is represented by five stages [43,44] First is incubation stage where only surface roughness increases but no mass loss happens. This is followed by acceleration stage where mass loss starts, and micro-cracks start to generate. Towards end of this stage, cracks grow, and coating material removal starts in form of pitting, delamination or flaking. A constant erosion rate is then observed where the coating degrades progressively. This is followed by deceleration stage of erosion rate and finally terminal stage, where erosion rate is constant again (but lower than stage three) and the coating can be considered as failed to serve the purpose. Visually, the incubation stage shows minor pitting in the coating. At stage three, patches of the underlying epoxy are visible in random areas, but the coating remains partially intact. In further stages, coating gets completely removed and epoxy gets exposed. Among all the stages, incubation and constant erosion rate stage are most critical. The coating can be considered to have superior erosion resistance either by extending incubation stage or lowering the constant erosion rate by changing microstructural and/or mechanical properties. Since, erosion damage begins beyond a threshold impact velocity, a single droplet can initiate the damage. Thus, a single droplet model beyond that threshold velocity can simulate qualitatively erosion damage. The mass loss plot combined with photographs indicates beyond the first cycle, 25 µm coating reached the breakthrough phase. For 50 and 100 µm coating, the test cycles are at stage three showing a steady rate of mass loss, [43] (see Fig. 7).

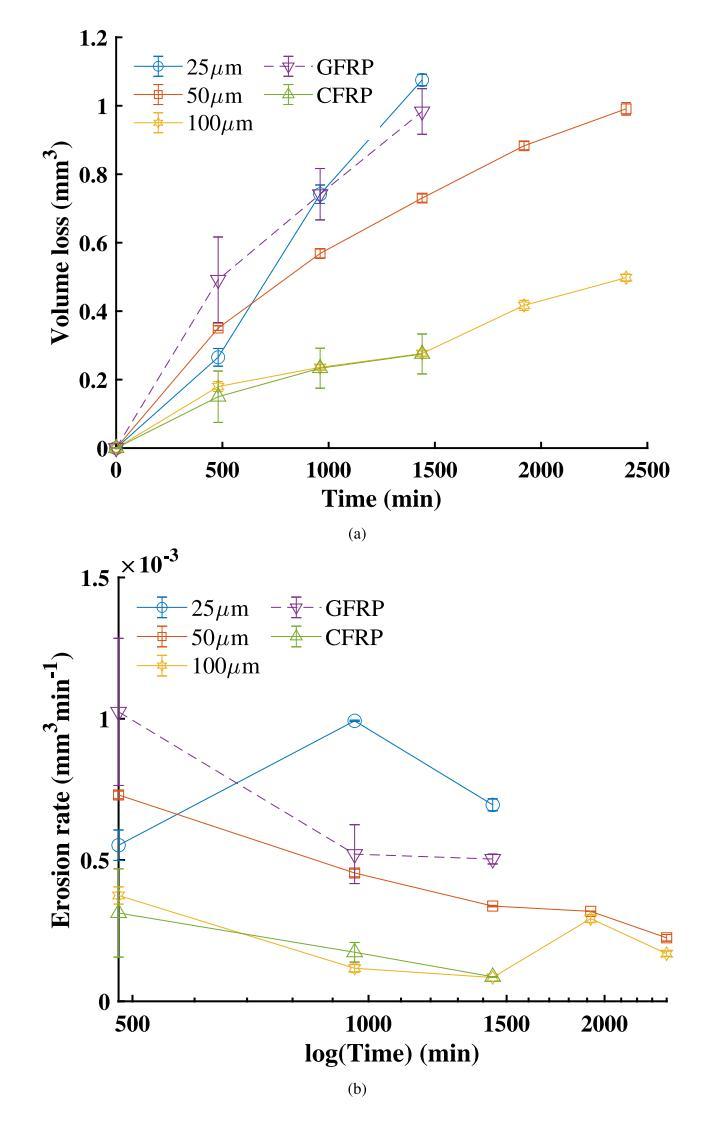
Fig. 8. (a) Volumetric loss of coatings and uncoated composite specimens during water erosion tests. (b) Erosion rate as observed for different coating thicknesses and bare GFRP and CFRP.

Hence, Fig. 8(a) presents the volumetric loss during erosion tests, computed using a density of 1.2 g/cm³ for epoxy resins of composites (since epoxy resin is being eroded in laminates) and 8.9 g/cm³ for nickel coating. Non-coated carbon fibres show similar volumetric loss as 100 μ m coated composites while glass fibres follow similar trend as 25 μ m coating. Following this, erosion rate

The results show that, for all conditions (bare and coated CFRPs), incubation stages 2 and 3 results in a change in volumetric loss rate for 25 μ m (see Fig. 8(b)). The 50 μ m coating shows comparable volumetric loss to non-coated glass fibres, whereas 100 μ m coating is almost identical to non-coated carbon fibres. For 50 and 100 μ m coating, the extended erosion tests (including additional

datapoints in Fig. 8 related to 32 and 40 h testing) show a steady state loss and no visible coating failure. The rate of mass loss was increased after 32 h erosion testing, which gave a higher erosion rate for 100 μ m coating. These results indicate that 50 - 100 μ m coating can absorb the impact energy from water droplets and protects the substrate. The constant erosion rate for 50 μ m coating, comparable with glass fibres, demonstrate decohesion is not occurring due to impact. Bare CFRP shows less erosion rate than GFRPs due to high stiffness and tensile strength. However, with gel coat as protective layer, volume loss (or erosion rate) increases compared to bare CFRP/GFRPs (~ 2 times) [45]. In our study, we observe 25 μ m coating deteriorates the erosion property of CFRPs. But with increase in coating thickness, the adverse effect gets diminished. As shown in previous researches [19,46], a nickel coating of 30 μ m thickness applied to copper-cladded GFRPs exhibited nearly 20 times greater impact resistance compared to bare GFRPs, with approximately 80% of the deposited coating thickness remaining intact. No significant visible damage to either the coating or substrate was observed, which aligns with the findings of our study. The comparable erosion rate of bare CFRP and 100 μ m thick coating suggests nickel coating is as strong as CFRPs. Based on these observations, we find that a coating thickness of at least 40 μ m is necessary to withstand liquid droplet impact for a microstructure with 140 nm grain size.

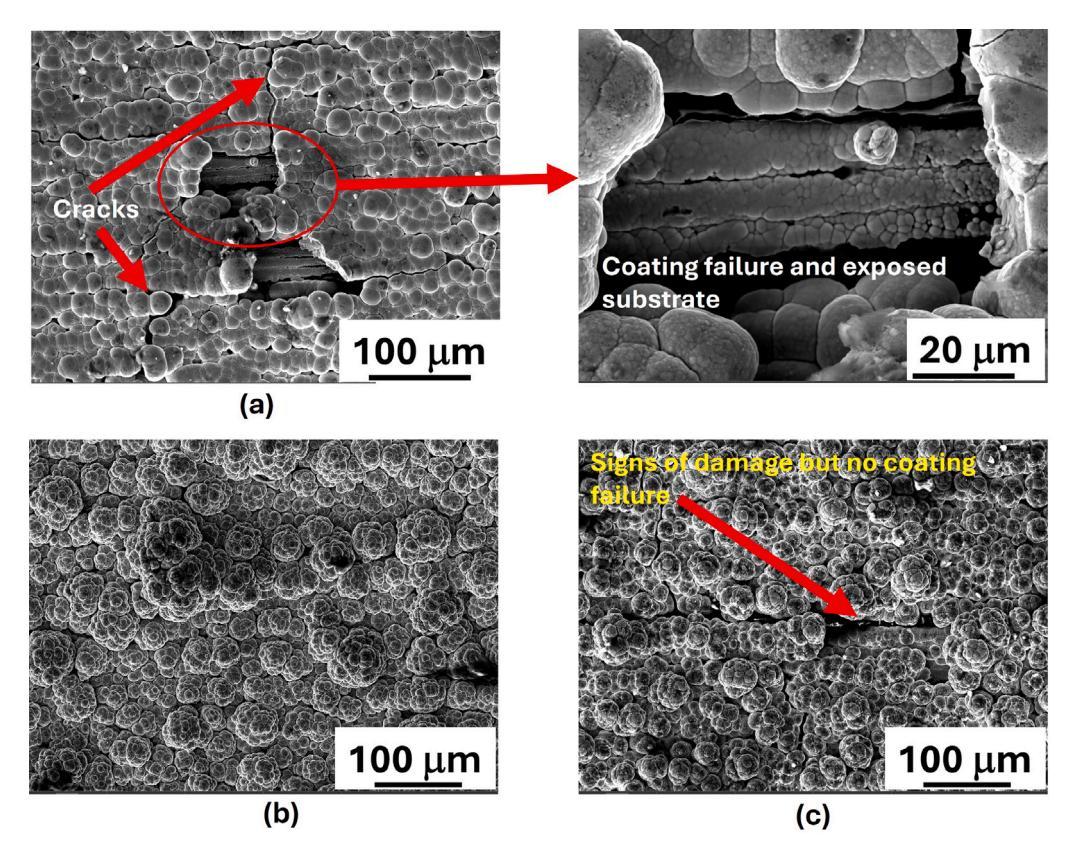
Fig. 9. Post-mortem analysis of eroded surface using scanning electron microscopy for (a) 25 µm (b) 50 µm and (c) 100 µm coating thickness. For 25 µm thick coating, the cauliflower morphology is changed to globular/spherical shape while 50 and 100 µm thick coatings still retain the as-deposited morphology.

Fig. 9 shows post eroded surface of different coating thicknesses. Comparing to the as-deposited surface (see Fig. 4), 25 μm coating shows the crystallites are no longer in "cauliflower" morphology and changed to globular or spherical shape. Prominent cracks have started to appear on the surface and coating loss exposed the composite underneath. A closer look reveals two distinct regions (Fig. 10): early signs of damage where part of metal coating was eroded and still signs of initial layers are visible. On contrary, there are areas where coating was completely removed exposing the bare composite and upon further erosion, the resin was actually eroding, similar to bare composite erosion. This also shows lack to adhesion of nickel to composite surface due to repeated impact of water

droplets on the coating. On other hand, 50 and 100 μ m coatings show the structure is still comparable to cauliflower morphology. Though partial "crater" type appearances are visible but no signs of long cracks or exposed composite surface due to coating loss. This strengthens the hypothesis that below 50 μ m thickness, the coating quality is insufficient to droplet impact and decohesion starts from the interface leading to coating failure.

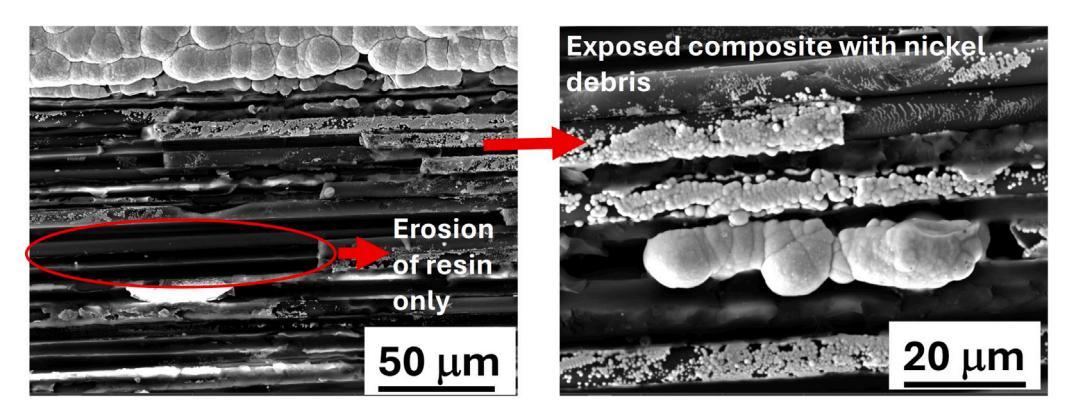
Fig. 10. Detailed view of 25 µm thick coating showing different regions of damage.

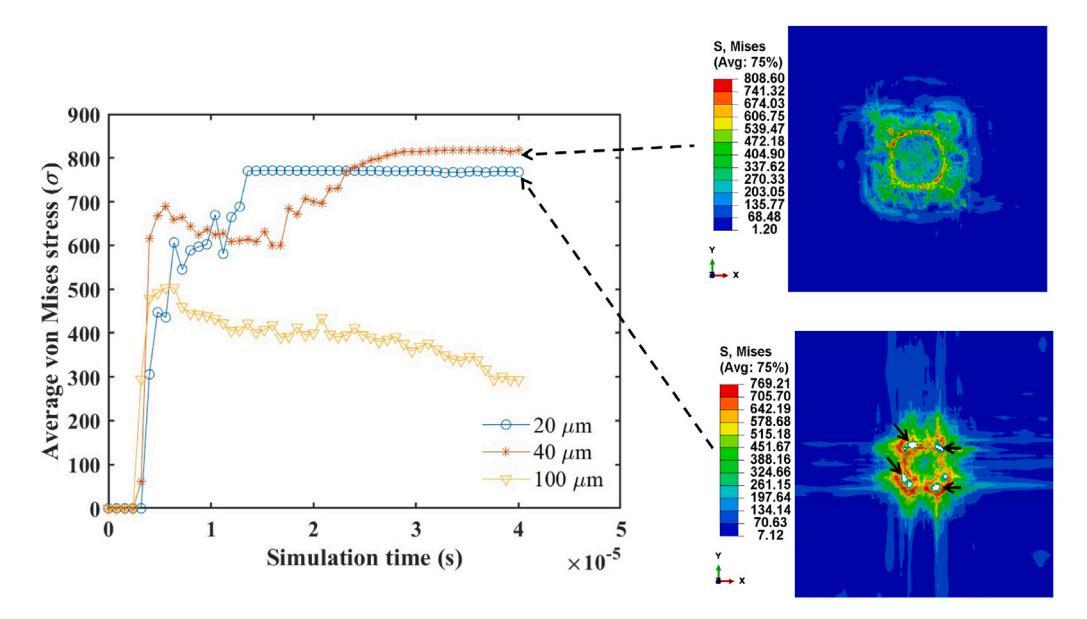
Fig. 11. Average von Mises stress for different coating thickness with 140 nm grain size. The data was averaged for the ten elements with maximum stress value in each simulation time. The solid arrows denotes failure of coating as seen by element deletion in simulation.

In case of rain erosion, stress distribution in the coating layer, generated by the water droplet impact is the main cause of erosion damage initiation and evolution. Considering the ductile nature of the nickel coating, local plastic deformations, quantified by the equivalent plastic strain in the numerical damage simulations, and the consequent void coalescence are assumed to cause erosion damage. The presence of a rigid composite substrate, with no plastic capability, affects the stress distribution and plastic energy absorbed by the tens of um deep coating. In fact, the coating/substrate interface exerting a stiffening constraint on the nickel layer reduces its permanent deformation capabilities, concentrating plasticity in specific zones (Fig. 11) and limiting the amount of stored plastic energy. This increases the interface normal and shear stresses, resulting in large interface decohesion (Fig. 12(a)). Thicker layers, being less constrained by the substrate, have the possibility of free plastic deformation, showing smaller von Mises stress and equivalent plastic strain distributions and consequent limited erosion intra-layer and interface damage (Fig. 11).

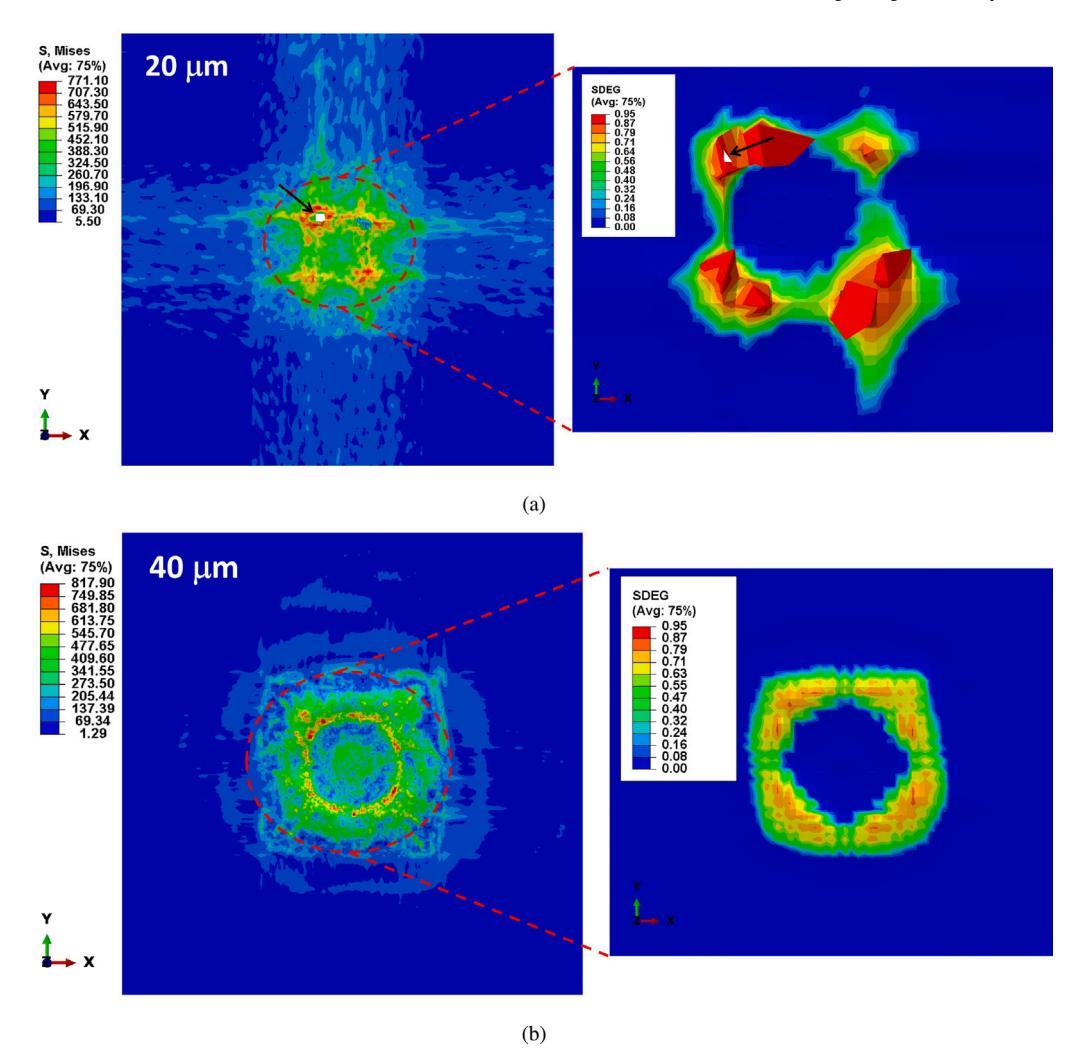
Fig. 12. von Mises stress at coating layer (left) and debonding criterion (right) for (a) 20 µm coating and (b) 40 µm coating at peak values of average von Mises stress as obtained in Fig. 11. The black solid lines indicate the initiation of failure.

Further, the simulations reveal the coating failure happens due to debonding between coating and substrate, see Fig. 12. Though the average von Mises stress in coating is comparable in 20 and 40 μ m coatings, the thinner nickel coating dissipates the droplet impact energy by debonding from the substrate and local surface erosion. Damage mechanism limits the coating strain energy and consequently the averaged von Mises stress. Since we have used a single droplet model, we captured qualitative behaviour of erosion damage from simulations. By combining the cohesive delaminated area from simulations and the erosion experimental observations, we can conclude multiple droplet erosion model, similar to experimental scenario, can produce a complete coating erosion. Since experiments were performed under multiple droplet impact, almost complete coating erosion was observed below 25 μ m coatings indicating clear insufficient tolerance to water droplet impact due to coating thickness.

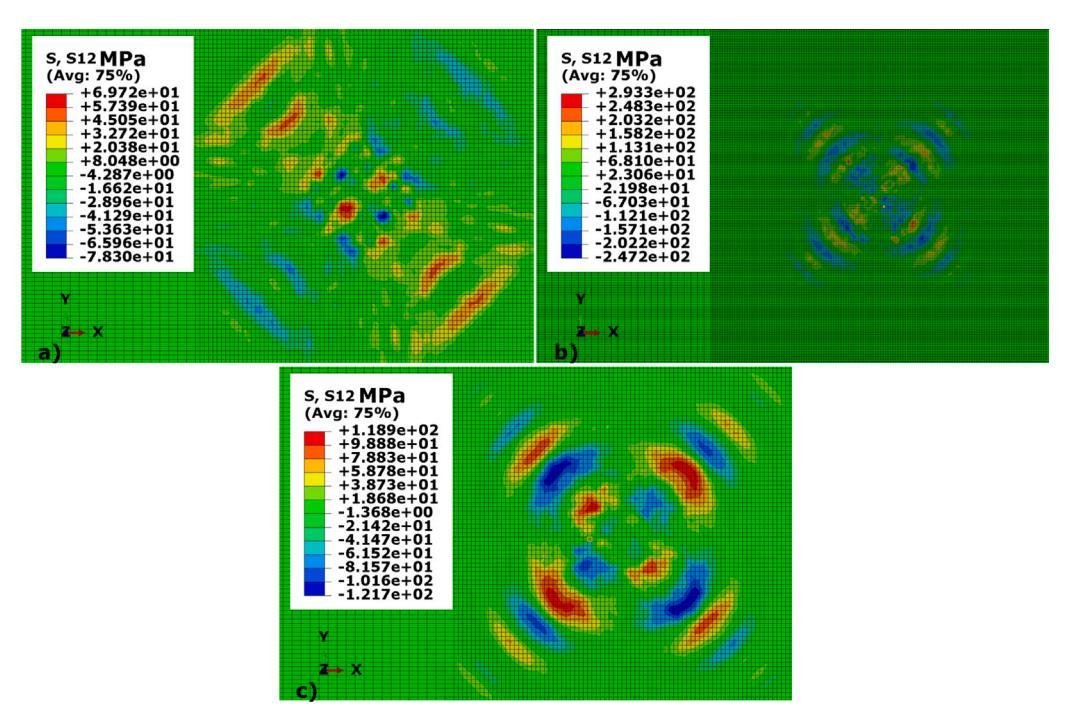
Fig. 13. In plane shear stress (τ_{12}) distribution on the droplet impact area after 8.0·10⁻⁶ s from the water/sample contact for (a) 20 μ m, (b) 40 μ m and (c) 100 μ m coating with 140 nm grain size.

Shear stresses are known to be driving factors of the water droplet erosion mechanism [11] in particular the one generating by the lateral getting. While lateral jetting and water shear layer friction are correctly simulated by the numerical model, the Johnson–Cook damage model, based on ductility fracture by void coalescences, considers the equivalent plastic strain as damage state variable [33]. Therefore, the effect of the total deviatoric deformation and not only of specific shear stress or strain components are included into the damage model, representing the standard for ductile material damage [33]. For the sake of completeness, Fig. 13 show the τ_{12} stress distribution on the specimen surface under the droplet impact area at $8.0 \cdot 10^{-6}$ s from the impact onset for (a) 20 µm, (b) 40 µm and (c) 100 µm coating with 140 nm grain size. In plane shear stresses distributions reaching their peaks along ±45° directions as expected from the problem symmetry, show a repetitive pattern highlighting the circular shock waves generated by the droplet impact and lateral jetting (Fig. 13)

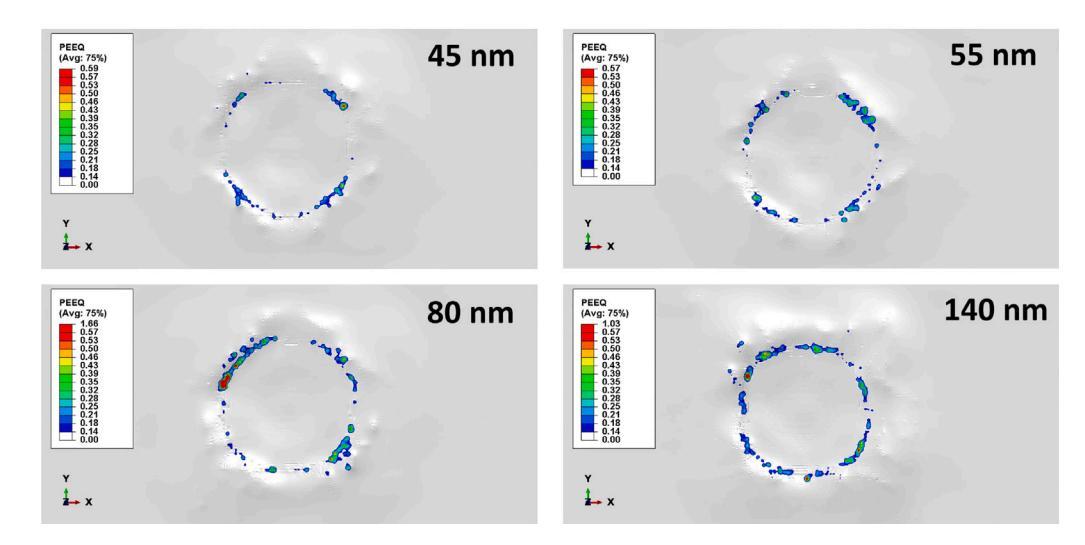
Fig. 14. Plastic strain distribution in the area of impact for 40 µm thick coating. Lowering the grain size decreases the area of deformed zone.

To comprehend the microstructural fluctuations affecting coating thickness, we varied the Johnson–Cook parameters to represent different grain sizes (45 nm, 55 nm, 80 nm and 140 nm) keeping the coating thickness constant (20, 40 and 100 μ m). This variation was transferred to the model by changing the yield stress with grain size as shown by Table 7. A grain size reduction results in a smaller coating plastic zone although maximum equivalent plastic strain magnitude is obtained for 80 nm large grain, see Fig. 14. The strain peek is thought to be caused by a mesh-driven numerical issue owing to the lack of symmetry and its localised nature.

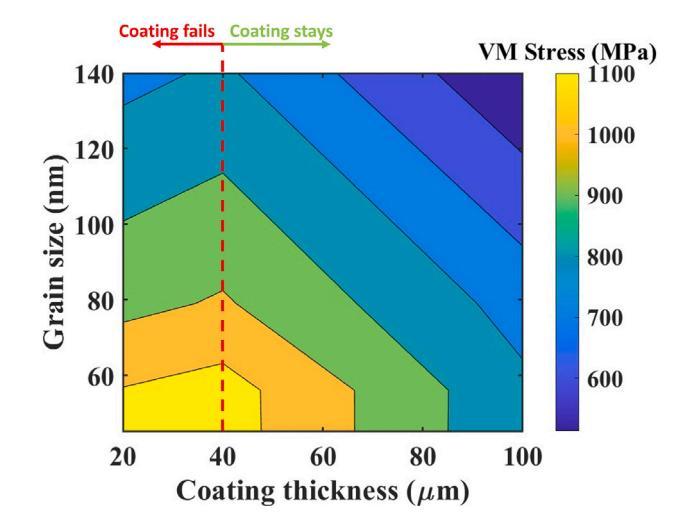
Fig. 15. Optimisation of coating thickness and grain size based on maximum stress experienced in simulation elements. The colorbar represents maximum von Mises stress in MPa.

The computational model predicted the critical combination of thickness and grain size that can maintain the coating integrity, see Fig. 15. As grain size variation comes from experimental condition to deposit the coating (current density is the primary variable for this), thickness cannot be considered as the only parameter influencing the impact resistance. Therefore, using our model, we can design the deposition conditions (e.g. current density) of a well-performing coating. Fig. 15 shows the maximum von Mises stress developed in coatings as function of its thickness and grain size. For 20 μ m coatings, even with reduction in grain size, the coating still fails indicating poor resilience to droplet impact. All the grain sizes show impact resistance for coating thicker than 40 μ m thick. Reducing the grain size enhances the maximum stress (or reduction in plastically deformed zone) that the coating can withstand. Hence, a 40 μ m coating with 45 nm grain size is a promising solution. However, the deposition conditions can restrict in having such small grain size. Therefore, minimum coating condition could be 40 μ m thick coating with grain size of 80–140 nm.
