The High Temperature Erosion/Corrosion Behavior of Industrial Thermally Sprayed Coatings

G.R. Heath, P.A. Kammer and M.M. Stack

NTSC '96

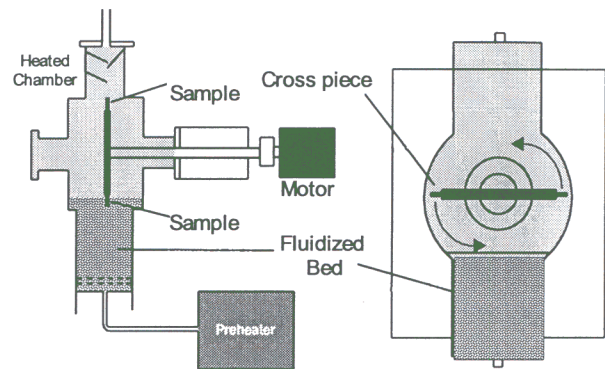
Erosion Wear Apparatus. Two different units were used, one of the Corrosion and Protection Centre, University of Manchester Institute of Science and Technology (UMIST) in England and one of Tampere University in Finland. The UMIST erosion-corrosion apparatus, described elsewhere (1), consisted of a fluidized bed of erodent particles, a heating system and a specimen holder (cross piece on a rotating axle). The specimens and axle can rotate at a range of angular velocities vertically through the fluidized bed of particles (Fig. 1). The atmosphere is air.

Fig. 1-Schematic of High-Temperature Fluidized Bed Erosion Testing Facility at UMIST, England.

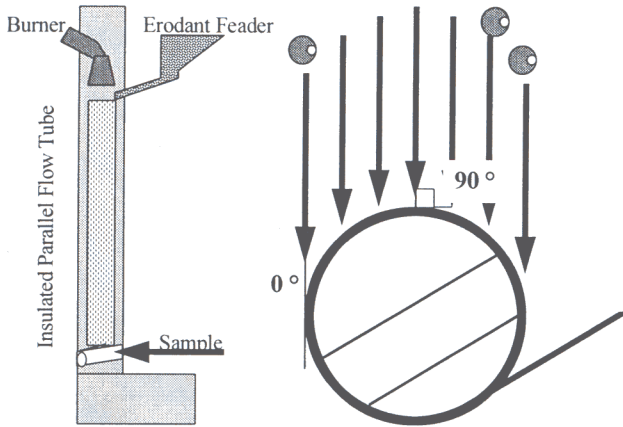
at Tampere University in Finland was used which consists essentially of a static coated tube being eroded in a stream of parallel flowing erodent (quartz of grain size between 100-600 μm) which is shown in Fig. 2 and described in more detail elsewhere (6).

Fig. 2-Schematic of High Temperature Erosion Testing Facility at Tampere University, Finland.

Here the particle velocity is 25 m.s.^{-1} and the tube sees the whole range of impact angles. The erosion loss is determined from the weight change of the whole coated tube after a set test period (16 hours) and is consequently an average loss at all angles. The testing was at 3 temperatures $20 \text{ }^\circ\text{C}$, $300 \text{ }^\circ\text{C}$ and $500 \text{ }^\circ\text{C}$. The alloys tested are detailed in Table 1.

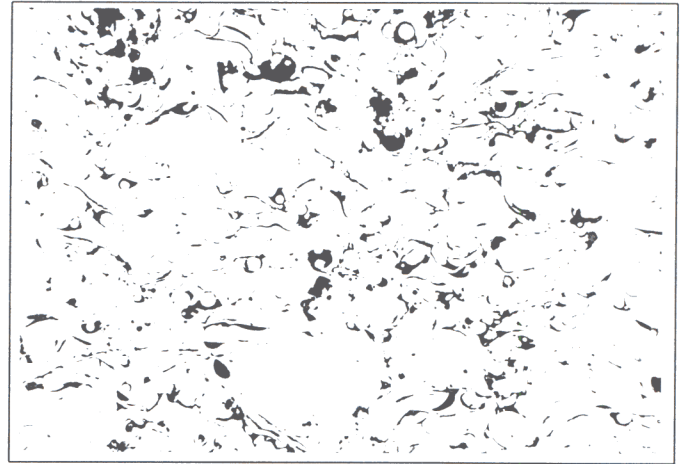
a) Plasma Sprayed Coating G

Fig. 3-Optical Micrographs of FeCrAl Coatings Produced with Different Thermal Spray Methods. (Magnification is 100 x).

Coating Microstructures. The microstructures of typical sprayed coatings are shown in Fig. 3. Image analysis was used to estimate the volume fractions of porosity and oxide. This proved extremely difficult to accurately quantify due to the variation in the nature of the coatings.

Fig. 3a, 3b and 3c represent coatings produced

via plasma, arc-wire and HVOF respectively and illustrate not only the large variation in the type of microstructure, but also the variation in coating density for the same alloy composition. Fig. 3d represents a microstructure typical of that reinforced with a hard phase.

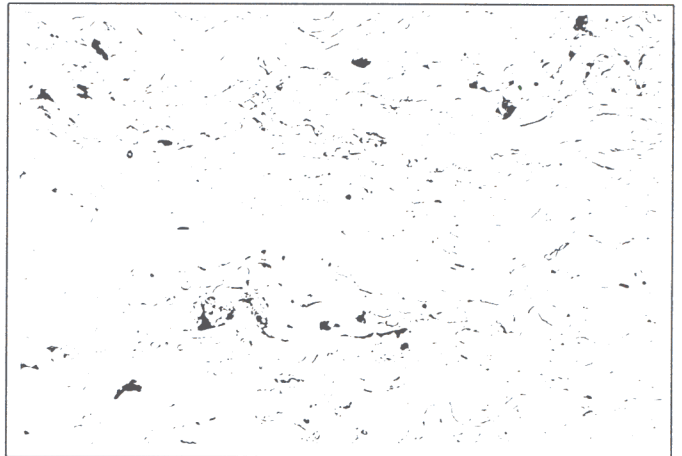
b) Arc-Wire Sprayed Coating E

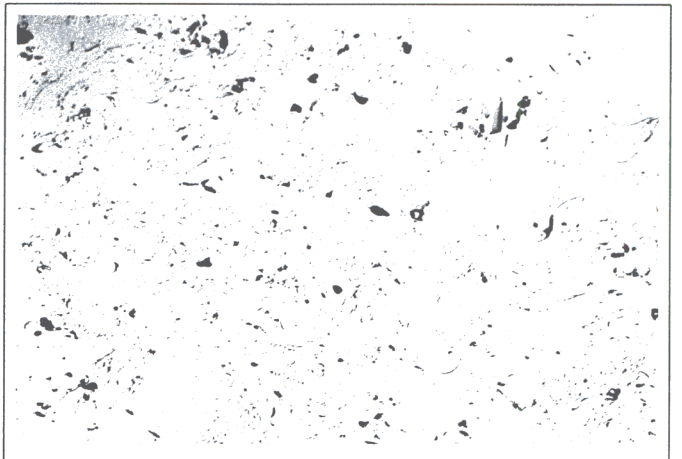
c) HVOF Sprayed Coating H

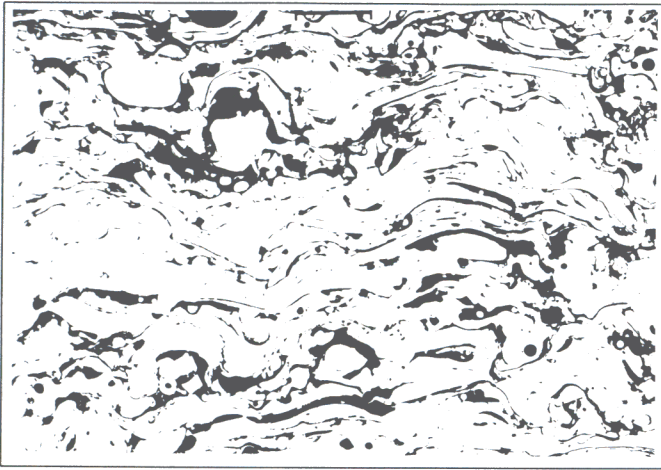
d) Arc Sprayed Containing Hard Particles Coating C

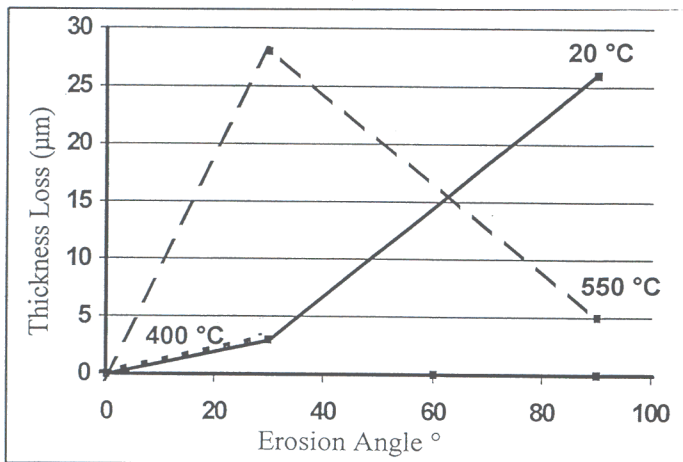
Effect of Impact Angle and Temperature on Material Erosion Rate. Coating E was tested at a range of impact angles and temperatures with the results shown in Figure 4.

Fig. 4- Impact Angle and Temperature Effects on Erosion of Arc-Sprayed Coating E.

It is observed that at 20 °C the erosion rate increases steadily with impact angle up to 90°, behaviour typical of a brittle material reported elsewhere (4,5). With increasing temperature there is an increase in erosion loss, but only above 400 °C. From 20 °C to 400 °C at low angles, erosion loss is minimal. An increase of 150 °C above 400 °C increases erosion loss by an order of magnitude. The

The thickness loss relationships with impact angle in Fig. 4 demonstrate that arc-wire sprayed materials (even if they have low microhardness) behave as brittle materials under erosive wear conditions at low temperatures (below the transition temperature). This is surprising considering the low microhardness values and is most probably due to the particular microstructure of the coating. It has a lamella structure, is highly strained, has a small crystalline size with inter-droplet particle interface defects and contains oxides and pores. All of which reduce the coating's ability to plastically deform on a macroscopic scale under erosion at intermediate temperatures. This would suggest that the erosion rate at 90° should show a decrease with increasing plasticity of the target represented by a reduction in the volume percentage of oxides, pores and other defects.

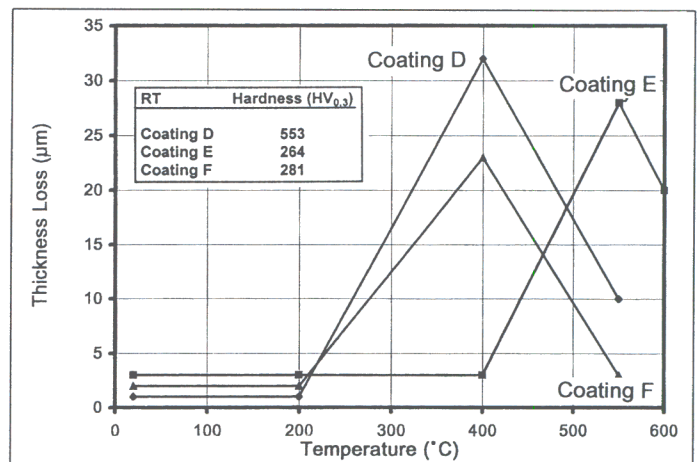
The influence of temperature on the 30° impact angle erosion rate of the 3 arc-wire sprayed coatings (D, E and F) is presented in Fig. 5.

Fig. 5-Temperature Effect on 30° Impact Angle Erosion Rate of Arc-Sprayed Coatings D, E and F.

The form of the relationship is similar for all 3 coatings in having a characteristic peak at an intermediate temperature. A second observation is that this peak temperature varies with coating composition. A similar

Coatings D and F have similar transition temperatures and wear losses at the various temperatures. This is in spite of the fact that there is a large difference in hardness (HV 553 cf HV 281) and a different alloy base. The Fe-based alloy E is more alloyed than its related alloy D with respect to high temperature alloying elements and has only 50% of the hardness. These observations suggest that it is the corrosion effect rather than a material softening which is giving rise to the wear increase at intermediate temperatures. One important observation from Fig. 5 is that at an operating temperature of 500 °C, the lower alloyed materials (with lower temperature wear peaks) is suggested to outperform the higher alloyed coating. An explanation is that the alloys D and F are in an erosion/corrosion regime where the corrosion rate is greater than the rate of corrosion product removed by erosion. Essentially the corrosive product (which is normally an oxide and harder than substrate metal) becomes the surface seen by the erodent. Alloy E is in an erosion dominated regime where material is lost by oxidation and erosion of both the soft substrate and the slowly forming corrosive product.

The bell-curve relationship is presumed with the characteristic peak erosion rate height and temperature varying with spray technique. This is comparable to Fig. 5 with the conclusion that the degree of flexibility demonstrated with changing alloy is as great as with a fixed alloy and changing spray technique. Such a conclusion suggests that for any coating solution

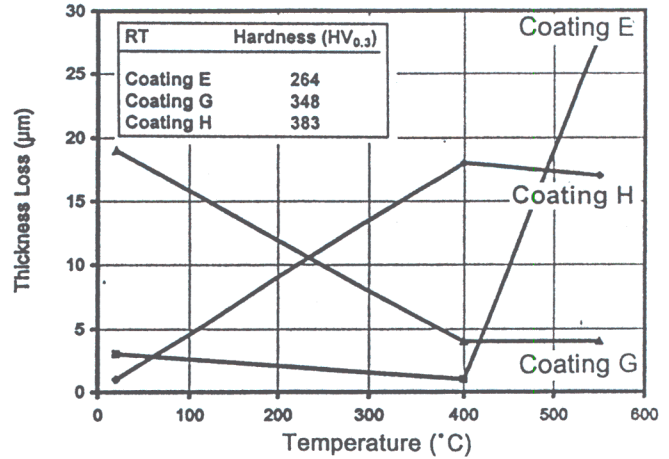
Effect of Thermal Spray Process on Coating Erosion Behaviour. The effect on high temperature erosion of changing thermal spray technique for the same alloy is illustrated in Fig. 6. Here the erosion impact angle was 30° for the 3 Coatings E, G and H. Testing for Coatings H and G was only to 550 °C. Coating E was tested to 600 °C and shows a reduction in erosion rate and thus the bell-curve relationship. Analysis of the results is initially confusing. At any temperature the ranking order of coating performance changes completely, e.g. compare 20 °C, 400 °C and 550 °C values. This change in performance is far greater than for the alloy changes with the same spray technique as in Fig. 5. This suggests an enormous effect (order of magnitude) of the coating technique on performance. Once again, a comparison of the room temperature hardnesses give very little indication of the performance

Fig. 6- The Erosion Rates at 30° Impact Angle at Different Temperatures for the same FeCrAl Alloy Sprayed with Different Thermal Spray Techniques.

Such complex results for materials sprayed with differing techniques have also been reported in the literature (18) but there has been little discussion as to the possible reasons and consequences. In the present study it is felt that the data is too limited to give a complete picture, but that there are strong indications which should be explored. From the previous work on these coatings and the results for Coating E in Fig. 6 it is proposed that the coatings could be behaving as described schematically in Fig. 7.

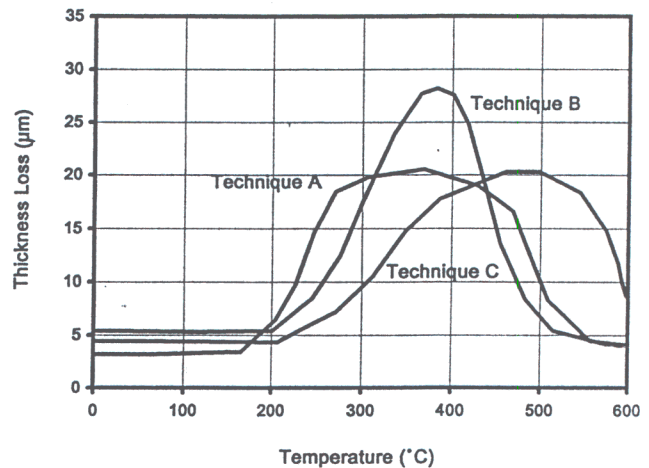
Fig. 7- Schematic of the Effect of Thermal Spray Method on the Erosion Rate/Temperature Relationship.
