Automated Video Processing and Image Analysis Software to Support Visual Inspection of AGR Cores

Abstract

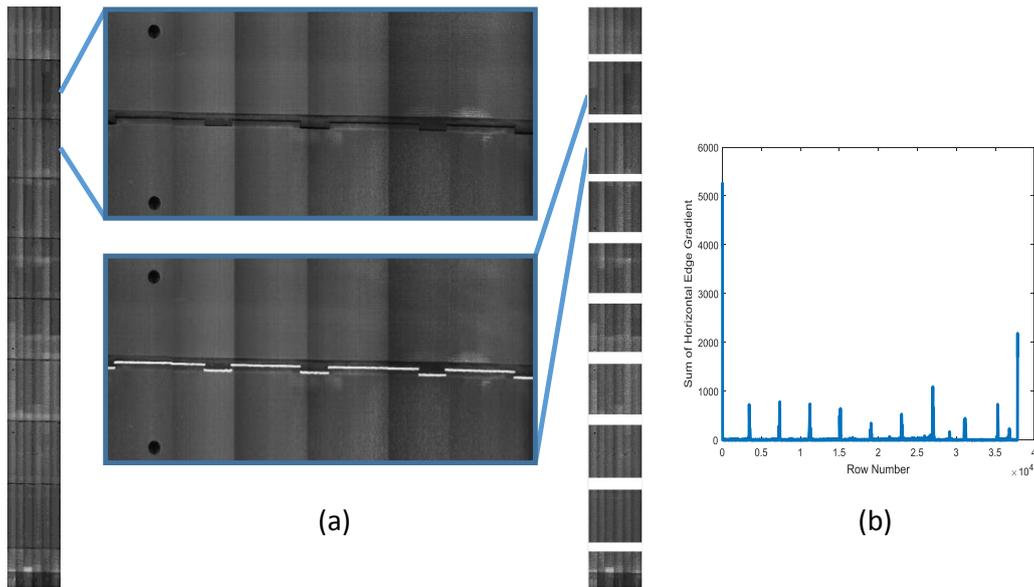
Figure 1 Brick Interface detection (a) Chanoramas and zoomed in brick interfaces and results of detection (b) The signal generated to identify the candidate brick interface regions

The graphite core is constructed from hundreds of 800mm high, hollow, cylindrical graphite bricks which are keyed together to form layers. Approximately 11 layers (the exact number varies from station to station) are stacked on top of each other and this provides housing for the fuel which is inserted into the hollow graphite fuel channels which comprise the reactor core. The brick interfaces – the join between bricks in one layer and another after stacking – appear as straight dark lines when viewed during visual inspection and in the chanoramas produced by ASIST as shown in Figure 1(a). The proposed approach for detecting brick interfaces in chanoramas first identifies candidate regions of the image likely to contain these features (highlighted in Figure 1(a)) before these areas are searched for pixels which lie on brick interfaces. The candidate regions are detected following an approach outlined in (Riveiro *et al.* 2015) which involves filtering the image using traditional median filtering and Gaussian smoothing before a Sobel edge mask is used to compute the horizontal gradient image. Then, the squared sum of each row is computed to generate a signal like the one shown in Figure 1(b). Peaks which are separated by a fixed distance equivalent to the brick height are extracted and a small area - equivalent to approximately twice the height of a brick interface - around each candidate point is searched for the minimum (darkest) pixel expected to be the brick interface. The results of first identifying candidate regions and the accurate extraction of one brick interface are shown in Figure 1(a) by the overlaid binary result.

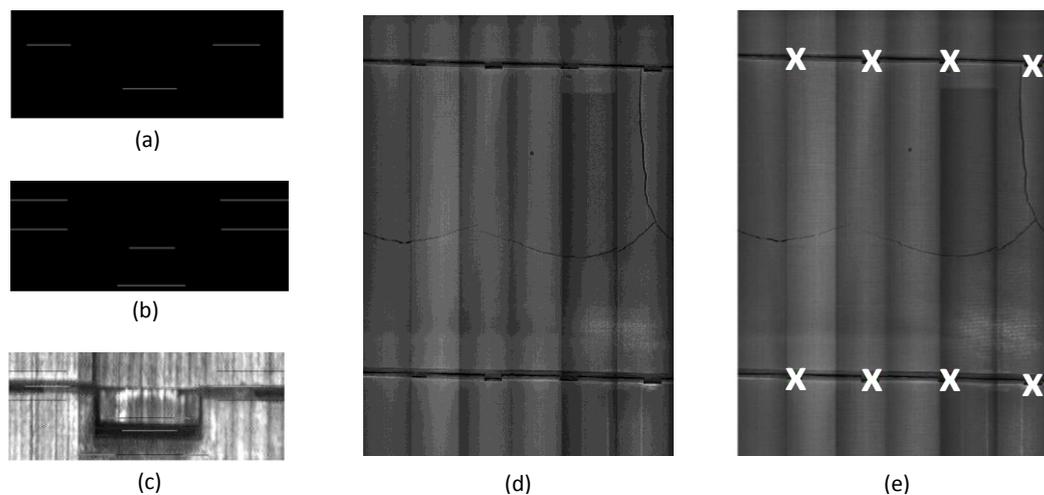
Figure 2 Hit-or-Miss Transform used to detect keyways (a) Foreground and (b) Background templates (c) Both templates overlaid on keyway to demonstrate fit (d) Brick layer region cropped from chanorama under test (e) Result of applying HMT to a chanorama. (d) and (e) are at different scales from (a) – (c)

Keyways which physically connect one brick layer to others above and below are shown in Figure 1 and Figure 2. Since the keyway shape and size are known, the Hit-or-Miss Transform (HMT), a well-known template matching method from Mathematical Morphology (Serra, 1968) is used to detect their presence in chanoramas and store their location. The HMT uses a complementary pair of templates, known as Structuring Elements (SEs) in morphology, to search an image for places where both SEs simultaneously fit the image. One SE, the foreground template, Figure 2(a), searches for and marks locations where it is completely contained in the image. Then, a second SE, the background template (Figure 2(b)) marks places where it fits the complement image (the background). The output of the HMT is the set of points where both the foreground and background SEs simultaneously fit the image. These locations mark the presence of the sought object in the image as shown in Figure 2(e).

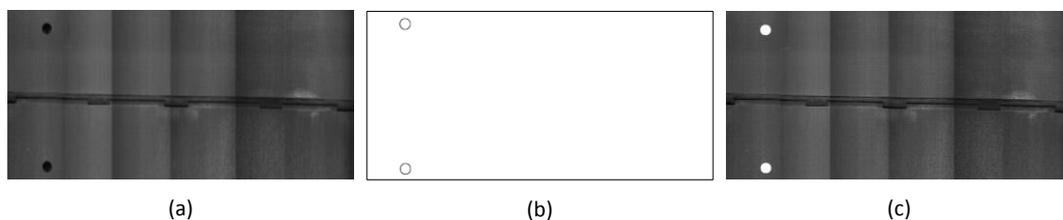
Figure 3 Trepanned hole detection using Hough Transform for circle detection – (a) original image (b) Binary result of circle detection algorithm (c) circles detected overlaid on original and filled in

Since the size and shape of the trepanned holes is known, and since they can be seen clearly in any chanoramas produced for any fuel channels which have been trepanned, these features can be detected using image processing techniques and their dimensions can be extracted in pixels, converted to mm and used to accurately size any cracks or defects present. Furthermore, detecting and quantifying holes in the channel due to trepanning will facilitate their analysis too. The Hough Transform for circle detection (Kimme *et al.*, 1975) is therefore used to search the chanoramas for circles whose dimensions match that of the trepanned holes in the chanorama. The Hough Transform is a well-known approach for circle detection in image processing which operates on binary edge images, is robust to noise and can be designed to detect circles of any size in a given image. In our case, the search can be restricted to save processing time based on the expected dimensions of trepanned holes in the chanoramas. An example input image which contains two trepanned holes and the result of applying Hough Transform for circle detection is shown in Figure 3.

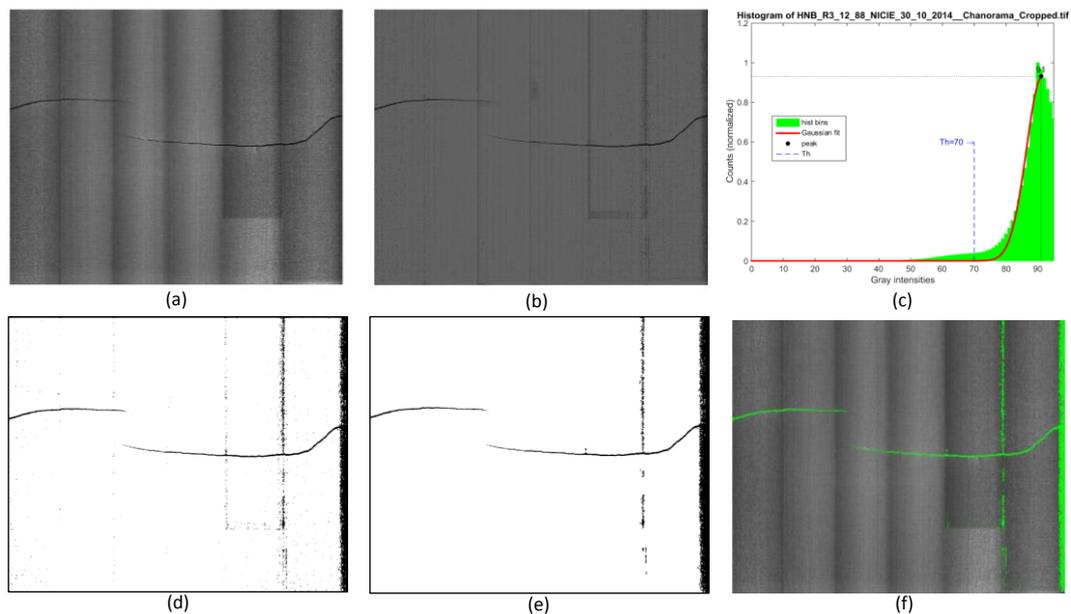
Figure 4 Crack detection process based on (Oliveira, Correia, 2014). (a) original input image (b) saturated image (c) Gaussian fitted to image histogram and threshold computation (d) result of thresholding (e) thresholded result after post-processing (f) final result overlaid on (a).

A key priority of the visual inspection process is to allow station operators to identify and visualise surface breaking defects and cracks (Bradford, 2014). In order to detect cracks automatically, tools originally developed to detect cracks in road surfaces (Oliveira, Correia, 2014) have been adopted and applied to automatically analyse cracked brick layers in chanoramas of fuel channels in the AGR cores. The approach first performs image smoothing using an anisotropic filtering algorithm before the result is normalised and all bright pixels (it is assumed that cracks are dark on a relatively bright background) are saturated to the average grey-level of the image itself. An image histogram of this result is then computed before a Gaussian distribution is fitted to it and used to calculate a suitable threshold value with a probability of 95.5% such that the dark crack pixels can be accurately segmented from the relatively bright background of the image. Simple filtering is then applied to the binary image to remove small objects and those which are unlikely to represent crack pixels based on low connectivity and eccentricity properties which are extracted from each connected component

in the result. The connected components which remain are then considered to be cracks and a final post-processing stage tracks the trajectory of all cracks and recovers pixels which are likely to lie on a crack but were removed in the previous step. This process and the output at each stage is shown in Figure 4.

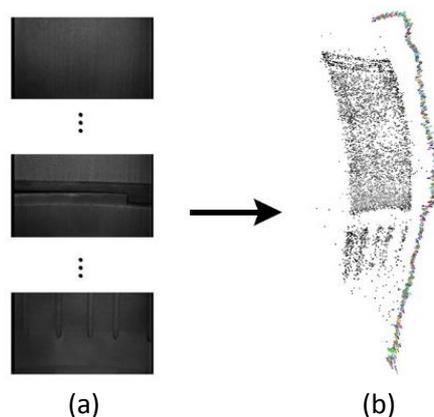
Figure 5 Extracting 3D structural estimates from overlapping video frames using SfM (a) subset of the video frames used from the bottom of the channel at one orientation (b) 3D point cloud using SfM

inspection, theoretically, the 3D geometry of any fuel channel can be obtained and, preliminary work has yielded promising results as shown in Figure 5. To create the point cloud shown in Figure 5, a small section of one inspection video was converted into frames and a feature detection algorithm known as SIFT (Scale Invariant Feature Transform) was used to extract feature descriptors from each image (Lowe, 2004). Sequence-based matching was then performed to determine feature correspondences between images before triangulation was used to estimate the 3D point locations and camera poses. Finally, Bundle Adjustment was used to fit a non-linear model to optimise the resulting 3D structure and viewing parameters. While initial results are promising, this work has highlighted various challenges for SfM including: a lack of discriminative features on the fuel channel interior, scale ambiguity caused by a monocular camera model, and non-uniform illumination and reflectance properties of the graphite itself.
