Review

# Failure Rates of Offshore Wind Transmission Systems

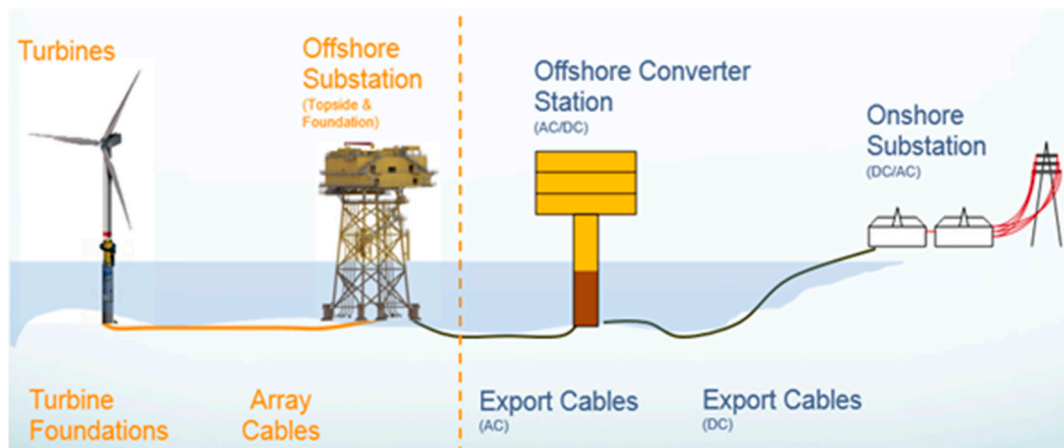
**Figure 1.** High voltage direct current (HVDC) offshore transmission systems [8].

An offshore wind farm connection is comprised of several parts. This is dependent on the type of technology used both within the windfarm itself and in the cable connection to the grid, an example of which is visualized in Figure 1. In some cases, such as the test sites found very close to shore, the connection is a short transmission cable which connects directly from the turbine to the transformer station.

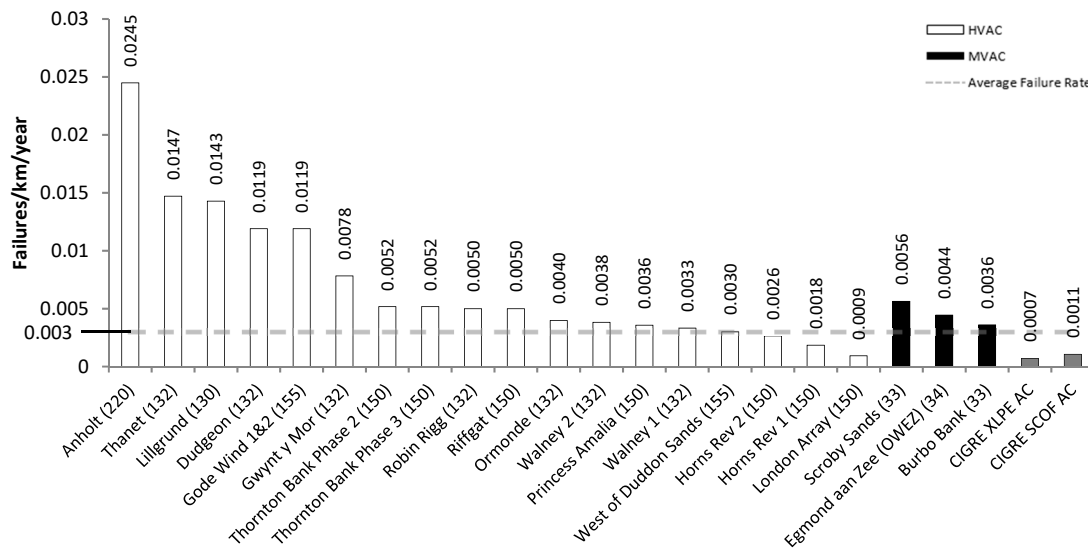
Figure 2 displays the failure rate of AC transmission systems to offshore wind farms currently operational in Europe and compares these values to the average determined by CIGRE in their reports. Note that sites which have not experienced failures have been omitted from this graph and are listed in Tables 2 and 3.

**Figure 2.** Failure rate of alternating current (AC) European offshore wind farm transmission connections until March 2018.

Excluded from the figure is Bard Offshore 1, which, due to its early life, short export cable connecting it to BorWin 1, and high number of failures, had a failure rate of around 0.0091 failures/km/year when considering all failures until March 2018. It can be seen that for those sites which have experienced any cable failures, the failure rate is higher than the figures published by CIGRE for XLPE cables. Additionally, it can be observed that the average failure rate across all offshore transmission systems connected to European wind farms—shown as the grey dotted line—was significantly higher than these published numbers.

After examining the failure rates visualized in the graph, it can be seen that there was a significant difference in failure rate comparing site to site. An example of this can be seen in comparing the failures at Anholt, where several failures were experienced in early life—with a cable length of 24.5 km—to London Array, which has experienced a similar number of failures in the same lifetime but has a total cable length of 268.8 km due to the four cables connecting it to shore. This is significant, as if either of these sites were omitted from reliability analysis for future wind farm connections, the data could be misinterpreted.

From the graph in Figure 2, it would appear that the failure rates experienced by cables in the medium voltage (10–66 kV) region is comparable to that experienced across HVAC (110–245 kV) ratings. However, it must be considered that many of these sites have been operational for a number of years more than those with higher capacities and higher cable ratings.

The graph in Figure 2 compares the average failure rates published by CIGRE in their reports to the failure rate for all European offshore wind farms. The methodology for calculating these figures is outlined in the Failure Metric Comparison section of the paper.
