Gulf Organisation for Research and Development
International Journal of Sustainable Built Environment

Original Article/Research

Case study investigation of indoor air quality in mechanically ventilated and naturally ventilated UK social housing

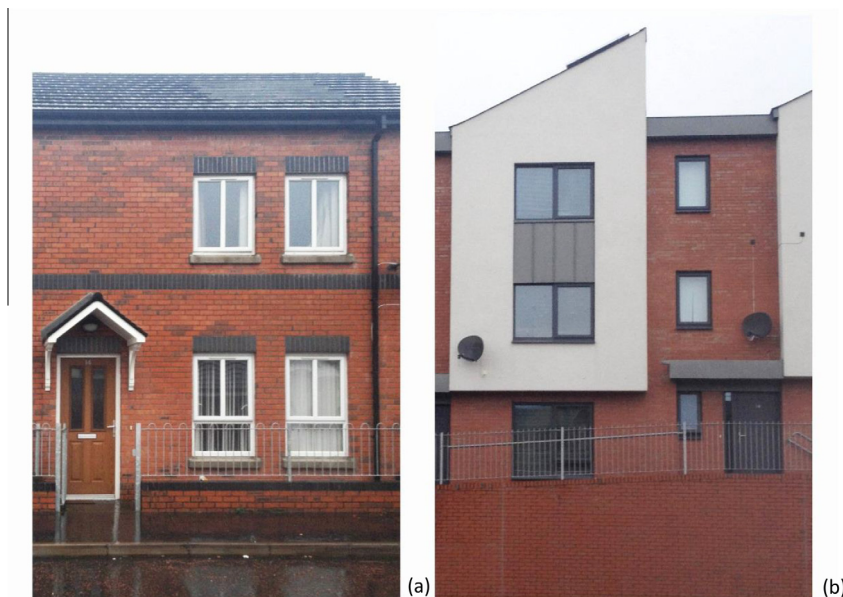
Figure 1. (a) Code 3 dwelling, (b) Code 4 dwelling.

Code 3 (C3) and Code 4 (C4) homes are both located in Northern Ireland, within 0.3 miles of each other. The homes are all 2/3 bedroom terraced houses, heated primarily with gas. Code 4 homes (Fig. 1b) are three storied and utilise Mechanical Ventilation with Heat Recovery (MVHR) systems for ventilation, where-as Code 3 homes (Fig. 1a) are two storied and naturally ventilated with trickle vents. The dwellings are part of two new-build social

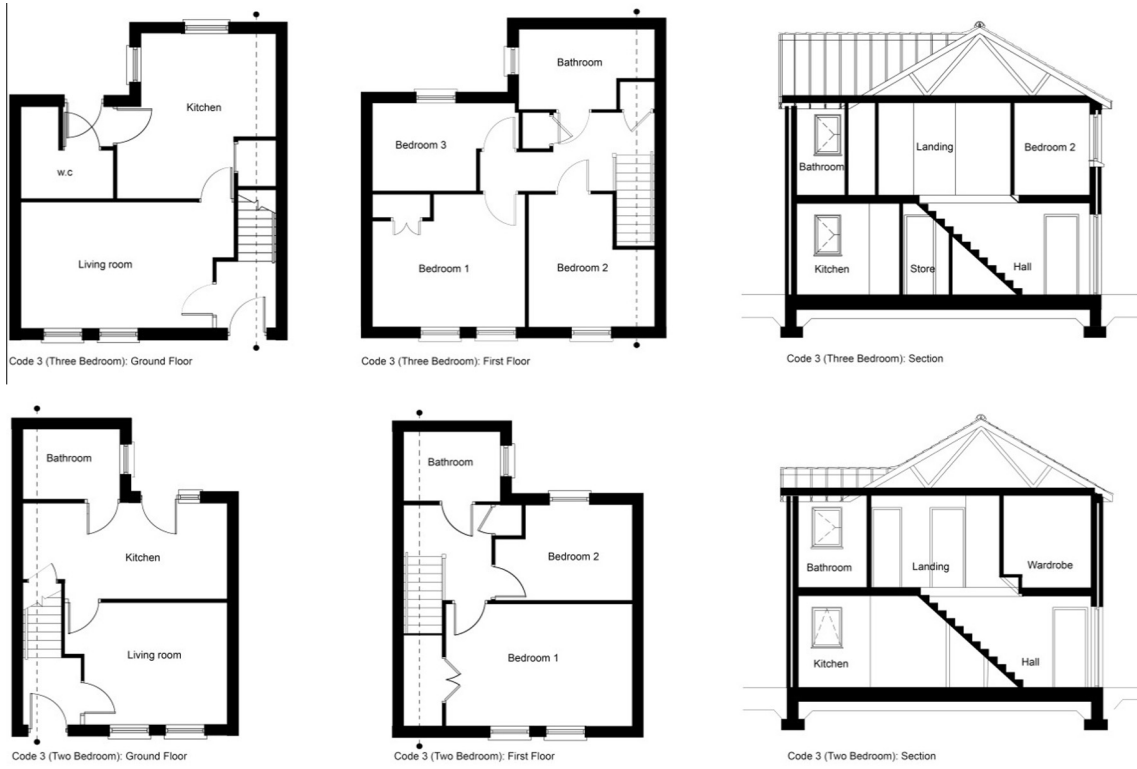
Figure 2. Plans and sections of Code 3 dwellings (Two and three bedroom).

As illustrated in Table 1, household occupancy ranged from 3 to 6 people in Code 4 dwellings and 2–3 people in Code 3 dwellings. Smokers were present in three Code 4 and two Code 3 dwellings, however all households stated cigarettes were not smoked in the home, with the exception of Code 3:No.4. Occupancy of the case study dwellings was generally high; with two Code 3 and three Code 4 households stating that the homes are occupied on average twenty-four hours a day during weekdays. The dwellings were occupied by families with ages ranging from 1 to 67 years (Figs. 2 and 3).

Three of the case study dwellings are end terraces (C4:No.1, C3:No.1, C3:No.4); the remaining are mid-terraces. The dwellings are located in a residential area of moderate to high traffic flow. Dwelling construction and energy efficiency information is presented in Tables 2 and 3.
