Article

# Characterisation of InGaN by Photoconductive Atomic Force Microscopy

Thomas F. K. Weatherley, Fabien C.-P. Massabuau

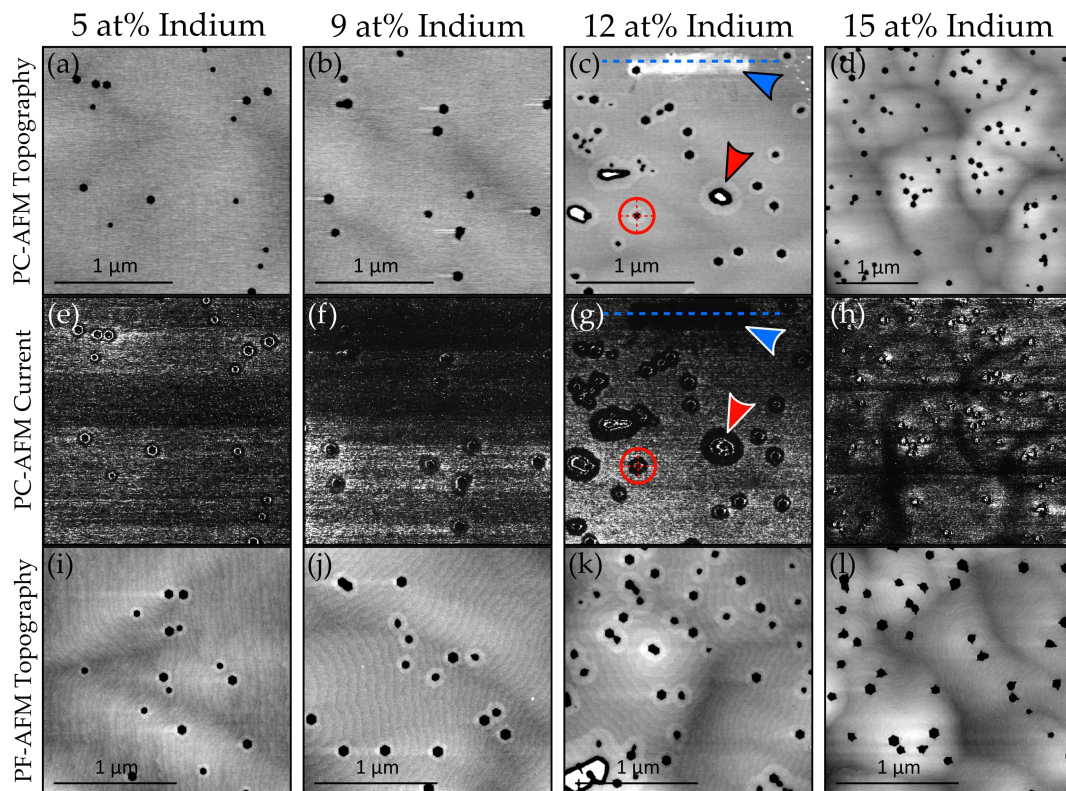
**Figure 1.** Topography maps obtained from PC-AFM for (a) In<sub>0.05</sub>Ga<sub>0.95</sub>N ( $\Delta z = 6.5$  nm) (b) In<sub>0.09</sub>Ga<sub>0.91</sub>N ( $\Delta z = 6.0$  nm) (c) In<sub>0.12</sub>Ga<sub>0.88</sub>N ( $\Delta z = 6.0$  nm) and (d) In<sub>0.15</sub>Ga<sub>0.85</sub>N ( $\Delta z = 12.0$  nm), along with their corresponding current maps in (e) ( $\Delta I = 6.0$  pA) (f) ( $\Delta I = 30.0$  pA) (g) ( $\Delta I = 250.0$  pA) and (h) ( $\Delta I = 30.0$  pA), all obtained under illumination. Blue arrows highlight the presence of an insulating layer, while red arrows indicate an example of a defect ridge. Applied bias was +5.5 V for In<sub>0.05</sub>Ga<sub>0.95</sub>N, and +4.5 V for all other samples. PF-AFM topography maps for each sample are given in (i) ( $\Delta z = 3.5$  nm) (j) ( $\Delta z = 3.0$  nm) (k) ( $\Delta z = 4.5$  nm) and (l) ( $\Delta z = 6.0$  nm).

Figure 1 presents the PC-AFM topography and current maps for all samples, along with the surface topography measured by PF-AFM. PC-AFM without illumination resulted in nearly no measurable current flow, so all PC-AFM data in this figure were obtained under illumination. In addition, topography from PC-AFM shows low spatial resolution since contact mode with a higher radius tip was required; PF-AFM was therefore used to obtain higher quality topography images.

Focussing on the PC-AFM topography of the In<sub>0.12</sub>Ga<sub>0.88</sub>N film (Figure 1c), hexagonal V-pits and trench defects are visible, along with elevated ridges around both types of defect (example indicated by the red arrow). PF-AFM confirms these observations (Figure 1k). The raised plateau (blue arrow) corresponds to a layer formed by a previous PC-AFM scan over this smaller area; comparing with the relevant current map in Figure 1g, the layer appears to be insulating. This suggests that oxidation

is still occurring at the surface of InGaN as it did for pure GaN—such a layer formed on all InGaN samples during PC-AFM scans. Also noticeable is high current flow around the edges of defects; however, this is very similar to the effect observed by Kim et al. [18] which was likely due to tip-sample contact area changes, and as such should be treated with suspicion. A particularly noteworthy feature is the current drop which occurs around each defect (e.g., see red arrow), corresponding very well to the raised ridges in the topography. The ridges exhibit plateaus up to several 10s of nm wide, and across these flat raised regions the tip-sample contact area is expected to be constant. Figure 2 presents height and photocurrent cross sections of the insulating layer, along with average radial height/current cross sections of a ridge around a typical V-pit. The positions from which the layer and ridge cross sections were taken are indicated in Figure 1c,g by blue dashed lines and red circles respectively.

PC-AFM results gained from the  $\text{In}_{0.05}\text{Ga}_{0.95}\text{N}$  and  $\text{In}_{0.09}\text{Ga}_{0.91}\text{N}$  samples (Figure 1a,b,e,f) are similar to those from the  $\text{In}_{0.12}\text{Ga}_{0.88}\text{N}$  film; however, the ridges around the V-pits cannot be made out in the PC-AFM topography. On the other hand, they are visible in the higher spacial resolution PF-AFM images (Figure 1i,j), and the corresponding photocurrent maps again indicate reduced current flow in these regions. (It is worth noting that the streaks after V-pits in Figure 1b are artefactual, arising from feedback gain being too high during image acquisition).

Finally, it's also worth noting the lower current measured in regions with no pits in both Figure 1e,f. We speculate that this is due to the tip becoming contaminated and leading to a contact resistance increase, before sudden height changes at a V-pit place more force on the tip and clear some of the contamination, causing a current increase on the first line after encountering a V-pit.

Results from the  $\text{In}_{0.15}\text{Ga}_{0.85}\text{N}$  sample (Figure 1d,h,l) make it clear that this film is substantially different from those previously analysed. The surface is significantly rougher, with noticeable hills and valleys over a 12 nm height scale. Ridges are not visible in either the PC-AFM or PF-AFM topography, and no photocurrent drops are observed around the pits in the current map. The current map also shows connected regions of low current which correspond very well to the valleys observed in the topography. Current readings within the pits are different from before, with one side of the pit exhibiting higher current than the other side. This is likely due to the feedback system not keeping up with rapid height changes, leading to lower contact force on one side (and hence lower current) and higher contact force on the other side (increased current). This effect may be present only in the  $\text{In}_{0.15}\text{Ga}_{0.85}\text{N}$  film results due to different feedback gains or a differently shaped tip compared to similar measurements on the other samples. It is worth noting that to facilitate observation of the features associated with the valleys between the dislocations, Figure 1d,h are presented at a different lateral scale to the other parts of the figure.

A key observation in this study has been how surface current flow is altered by elevated ridges around defects in the 5–12% InN samples; illuminated PC-AFM maps show that much less current is measured on these ridges than on the rest of the surface (Figure 1). In addition,  $V_T$  was seen in Figure 3 to decrease with increasing In content and was also found to be much greater on V-pit ridges (Figure 4).

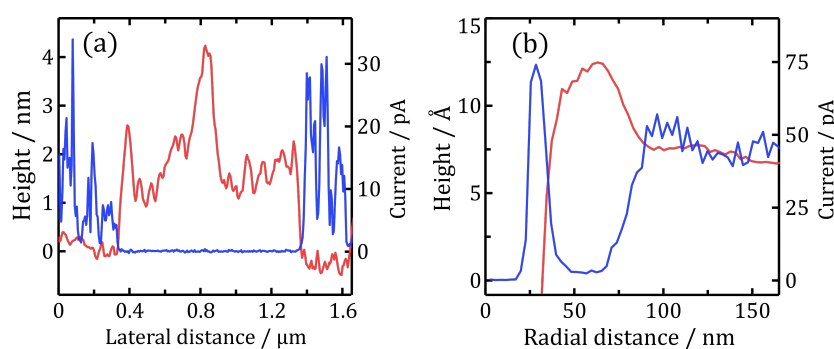
**Figure 2.** (a) Height (red line) and photocurrent (blue line) cross sections of the insulating layer, acquired from blue dashed lines in Figure 1c,g; (b) Average radial height (red line) and photocurrent (blue line) cross sections of a V-pit ridge, centred on the V-pit marked by red circles in Figure 1c,g.

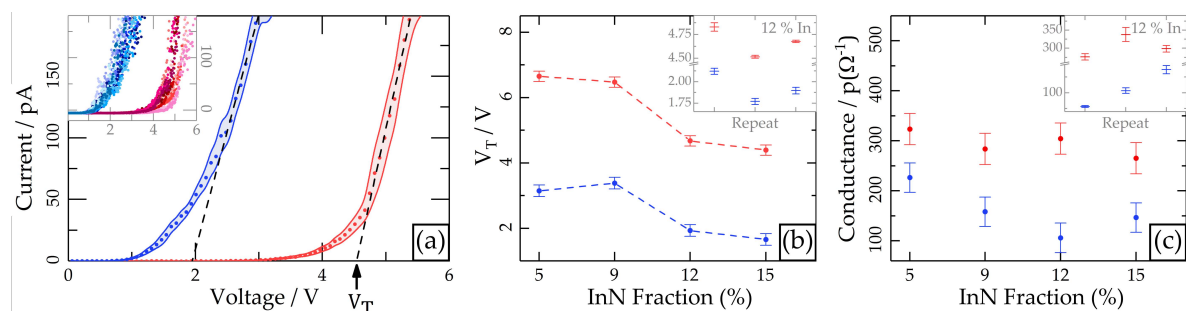
**Figure 3.** Current-voltage data obtained under illumination (blue) and no illumination (red) away from any defects. (a) Inset: raw data from  $\text{In}_{0.12}\text{Ga}_{0.88}\text{N}$  showing twenty I-V curves, ten with no illumination and ten with illumination. Main: average curves, which have been linearly fitted to extract a “turn-on” voltage ( $V_T$ , x-intercept) and conductance ( $G$ , gradient); (b)  $V_T$  for all InGaN thick films, where the error bars represent the standard deviation in repeated measurements over the course of the session. Inset: repeatedly measured  $V_T$  for the  $\text{In}_{0.12}\text{Ga}_{0.88}\text{N}$  film, with error bars representing the standard error in the x-intercept of the linear fit; (c) Conductance results presented in a similar manner to (b).

I-V curves obtained away from any defects exhibit diode-like behaviour, likely because the tip forms a rectifying contact with the surface. They are also quite noisy (see Figure 3a inset), so analysing them individually would lead to significant error. Instead, an effective method is to take ten I-V curves in the region of interest with the same sampling rate and voltage range, and then average the measured current at each voltage point over all the I-V curves. As such the standard error in each current value can also be found, which allows for more meaningful comparison of current-voltage behaviour on different samples with/without illumination. The linear portion of the curve can then be fitted with a straight line, and extrapolated back to obtain a “turn-on” voltage,  $V_T$ ; the gradient of this line also gives an indication of the conductance of the system,  $G$ . All of the above leads to quite a cluttered I-V plot, so to simplify interpretation error bars are represented by lines; the final result can be seen in Figure 3a. Together,  $V_T$  and  $G$  provide a means of quantitatively comparing the current-voltage characteristics of different samples away from any V-pit ridges, as shown in Figure 3b,c.

All films were analysed in one session with the same AFM tip, in the testing order  $\text{In}_{0.12}\text{Ga}_{0.88}\text{N} \rightarrow \text{In}_{0.09}\text{Ga}_{0.91}\text{N} \rightarrow \text{In}_{0.05}\text{Ga}_{0.95}\text{N} \rightarrow \text{In}_{0.12}\text{Ga}_{0.88}\text{N} \rightarrow \text{In}_{0.15}\text{Ga}_{0.85}\text{N} \rightarrow \text{In}_{0.12}\text{Ga}_{0.88}\text{N}$ . The  $\text{In}_{0.12}\text{Ga}_{0.88}\text{N}$  film was repeated throughout to track the tip status; any change in  $V_T$  or  $G$  for this sample between the different measurements would indicate a change in the tip. The inset of Figure 3b shows how  $V_T$

for the  $\text{In}_{0.12}\text{Ga}_{0.88}\text{N}$  film varied over the course of the session, with the error bars corresponding to the standard error of extrapolating the linear fit to  $V_T$  in each case. It can be seen there is no overall drift in  $V_T$  as the test is repeated, but the standard error of extrapolation is much lower than the change in  $V_T$  each time, which indicates that tip changes dominate the error in these measurements. As such the standard deviation of these three measurements is used to roughly gauge the error in all the measurements, and is plotted as error bars in the main plot of Figure 3b. The value for the  $\text{In}_{0.12}\text{Ga}_{0.88}\text{N}$  film in the main plot is the average of the three repeated measurements.

$V_T$  was always much lower when light was incident on the film; this is expected, since incoming photons will generate electron-hole pairs in the InGaN, increasing carrier density at the Schottky contact with the PC-AFM tip and thereby reducing the Schottky barrier height. Hence the applied voltage required to overcome the Schottky barrier ( $V_T$ ) is lower under illumination. The trend between different samples is less clear; generally,  $V_T$  seems to decrease with increasing In content, which could be expected from the corresponding decrease in bandgap.

Figure 3c shows data for conductance,  $G$ , obtained from the same experiment; in this case the variance of the repeat measurements is large (inset), so no comparison can clearly be made between samples. Carrying out more repeats would be difficult due to the trade-off between identifying tip changes and further damaging the tip to do so. Interestingly,  $G$  was always lower when the light was on, which is unexpected. This could be explained by the insulating layer that builds up on the surface once current starts to flow; higher initial current may lead to more insulating layer being generated, which would reduce the measured conductance. Conversely,  $V_T$  should be unaffected since no current has been generated at this point in the I-V curve and an electrochemical reaction should not be able to occur without the movement of charge.

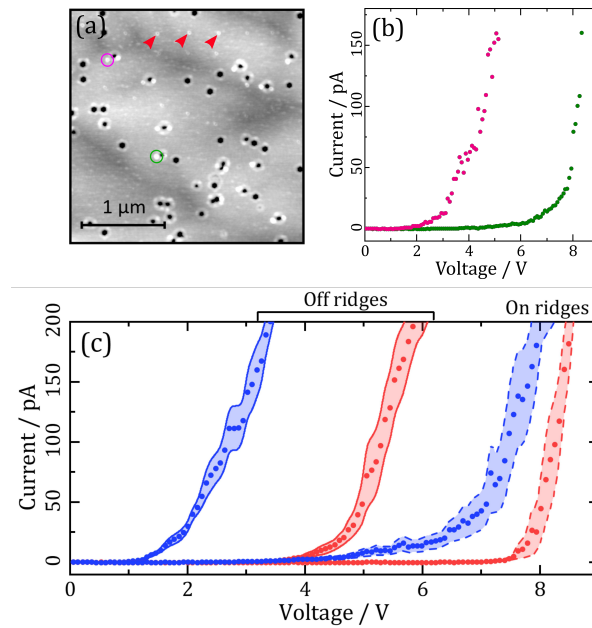
**Figure 4.** (a) Topography map taken after I-V curves were measured on the  $\text{In}_{0.12}\text{Ga}_{0.88}\text{N}$  layer. The pink and green circles enclose a spot of insulating layer where an I-V curve was previously taken; (b) I-V curves obtained with illumination from the green and pink enclosed regions in (a); (c) Overall average results for  $\text{In}_{0.12}\text{Ga}_{0.88}\text{N}$ , under illumination (blue) and no illumination (red), on and away from dislocation ridges.

Measuring I-V curves also provides a way to quantify nanoscale features such as the defect ridges, since the location at which the I-V curve is taken can be specified. A key consideration is that the ridges are not much larger than the tip radius, so any drift in the sample after the initial topography map is taken could lead to the tip missing the ridge and mistakenly taking an I-V curve of background material. Figure 4a,b illustrate how the formation of insulating layer can actually be helpful in identifying when this occurs, allowing for the resultant curves to be excluded from the analysis. The topography map taken after I-V measurements (with the light on) in Figure 4a shows that if the tip misses the ridge, the insulating layer also forms away from the ridge (pink circle). On the other hand, if the tip correctly contacts the ridge, we see insulating layer there (green circle). Figure 4b shows the individual I-V curves obtained from the pink and green circle measurements—there is a large difference between the two. Hence the “pink” result should be excluded from our ridge current-voltage analysis. Figure 4a was acquired after extensive use of the AFM tip, so the light “speckles” over the surface can be attributed to tip damage. However, these artefactual speckles must not be confused with insulating regions which were formed in regular arrays on the surface by I-V curve measurements (e.g., red arrows).

Figure 4c presents the average I-V curves obtained with the light on and off, away from defect ridges and on them, using this method on the  $\text{In}_{0.12}\text{Ga}_{0.88}\text{N}$  layer. Measured turn-on voltage was much higher on the ridges; the increases were  $4.93 \pm 0.07$  V and  $3.2 \pm 0.04$  V with the light on and off respectively. Interestingly, conductance was also higher on the ridges once current did start flowing, with an increase of  $34 \pm 11$   $\text{p}(\Omega^{-1})$  and  $130 \pm 15$   $\text{p}(\Omega^{-1})$  for the light on and off; but as previously stated, conductance measurements are made unreliable due to the insulating layer.

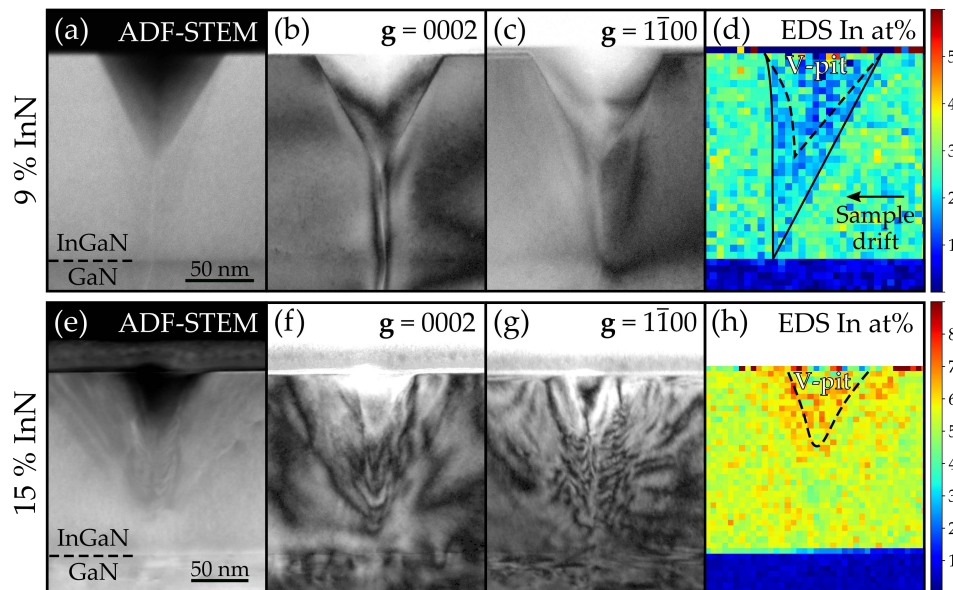
**Figure 5.** TEM results for a V-pit cross section in the  $\text{In}_{0.09}\text{Ga}_{0.91}\text{N}$  sample showing (a) ADF-STEM (b) bright field image taken with  $g = 0002$  (c) bright field image taken with  $g = 1\bar{1}00$  and (d) STEM-EDS indium concentration map - the V-pit edges are indicated by a dashed line, and the solid line marks the boundary of a low indium region. (e–h) show similar results for a V-pit cross section in the  $\text{In}_{0.15}\text{Ga}_{0.85}\text{N}$  sample. All images taken looking down the  $\langle 11\bar{2}0 \rangle$  zone axis.

Figure 5 presents TEM results for the  $\text{In}_{0.09}\text{Ga}_{0.91}\text{N}$  and  $\text{In}_{0.15}\text{Ga}_{0.85}\text{N}$  layers, focussing on a single V-pit cross-section in each. Comparison between these two samples is particularly apt since  $\text{In}_{0.09}\text{Ga}_{0.91}\text{N}$  is representative of the samples with ridges around pits and photocurrent drops (low indium content samples), while  $\text{In}_{0.15}\text{Ga}_{0.85}\text{N}$  had no ridges or drops.

Looking at the annular dark field (ADF) scanning TEM (STEM) image of the  $\text{In}_{0.09}\text{Ga}_{0.91}\text{N}$  film in Figure 5a, there is clear contrast between the pure GaN buffer layer and the InGaN thick layer, with the GaN appearing darker due to its lower average atomic mass. Of most interest is the faintly visible darker region around the V-pit extending down to the GaN interface, which suggests lower indium concentration in this area. This is confirmed by the STEM energy-dispersive X-ray spectroscopy (EDS) map of indium concentration (Figure 5d), once the drift in the specimen has been accounted for. Figure 5b,c present bright field TEM images with  $g = 0002$  and  $1\bar{1}00$  respectively, and demonstrate that the only dislocation present is the threading dislocation at the V-pit apex. Faint contrast is also visible at the boundary of the indium-deficient region.

Figure 5e–h present results from the same methods applied to the  $\text{In}_{0.15}\text{Ga}_{0.85}\text{N}$  V-pit. Focussing on Figure 5e, ADF-STEM no longer shows clear contrast between the GaN buffer layer and the InGaN, suggesting strain is affecting the contrast. More interestingly, the bright field TEM images suggest there are multiple dislocations branching out around the V-pit. STEM-EDS shows no reduction in indium concentration around the V-pit, and perhaps even indicates a slightly increased concentration close to the facets.

The STEM-EDS maps provide indium content as atomic percent rather than as  $x$  in  $\text{In}_x\text{Ga}_{1-x}\text{N}$ . Hence, the values on the scale bars in Figure 5 should be doubled to allow comparison with the XRD results in Table 1. Such a comparison, however, suggests a lower average indium content in the STEM-EDS measurement than in XRD. This is likely due to a systematic error in the EDS quantification method, but does not effect the above observations concerning relative indium contents.

These data are consistent with the STEM-EDS results in Figure 5d, which clearly show an indium-deficient region around the V-pit facets in the  $\text{In}_{0.09}\text{Ga}_{0.91}\text{N}$  film. Hence the low current flow and higher  $V_T$  in the ridge area is at least partly attributable to the decreased In content in this region; however, it should be noted that the position of the ridge and the indium-deficient zone do not exactly overlap. To understand how this sharp-edged low indium region seen in EDS could have formed, the growth mechanism and morphology of the V-pit must be appreciated.

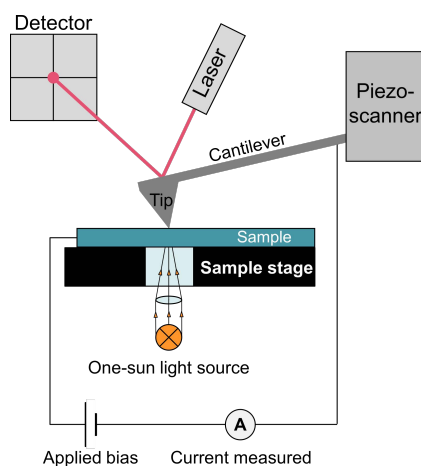
Figure 6. Simple schematic of the PC-AFM setup.

Figure 6 displays a simple schematic of the PC-AFM instrumentation; the setup is very similar to usual C-AFM, but includes a 75 W ozone free xenon lamp (wavelength range 200–2500 nm) which simulates solar illumination. AFM maps were acquired using a Bruker Dimension Icon AFM with an applied bias range of  $-10 \text{ V}$  to  $+10 \text{ V}$ . Contact mode with a Pt/Ir coated Sb (n) doped Si tip was used for PC-AFM, while PF-AFM was carried out with a sharp nonconductive  $\text{Si}_3\text{N}_4$  tip. Obtaining I-V curves required a Si tip coated with highly conductive boron-doped diamond, to maintain tip conductivity over repeated measurements. The InGaN films were electrically contacted to the sample stage using silver paint and conductive clips. AFM topography data processing consisted of removal of second order polynomial background and median line matching.
